Expertise

Protocol number: 46109767  
Order No. / Reference: 26453010  
Inspection date: 23 Jun 2026

Manufacturer: Mercedes-Benz  
VIN: W1NKM5BB4PU006940

Model: GLC 200 4Matic 9G-TRONIC AMG Line Advanced

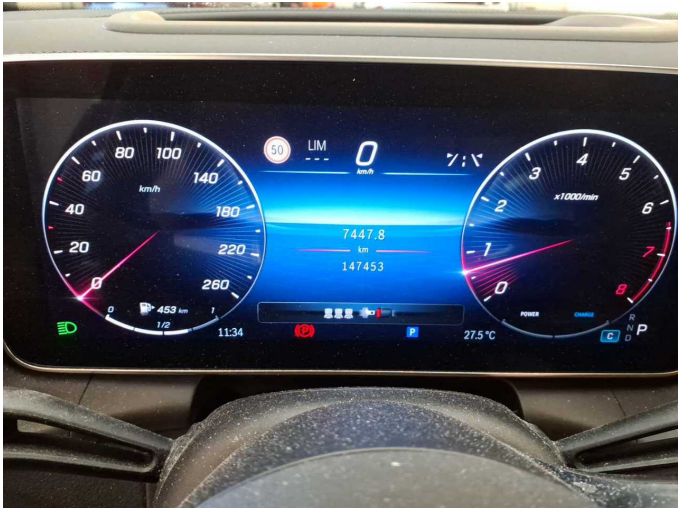
| Vehicle details | |
|---|---|
| Mileage (Read) | 147,453 km |

Figure 7: Instrument cluster

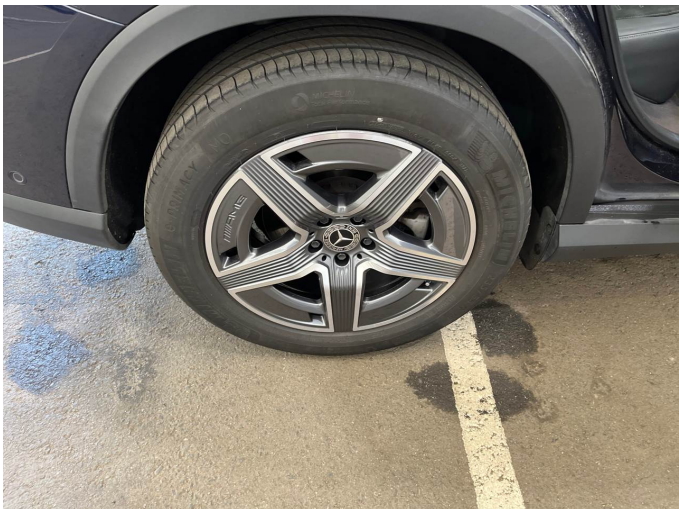
| Tyres | | | | |
|---|---|---|---|---|
| 1) | 235/55 R19 105W | Summer tyres on Light alloy | Michelin | 4mm / 4mm |
| 2) | 235/55 R19 105W | Summer tyres on Light alloy | Michelin | 5mm / 5mm |

Figure 12: Mounted tyres

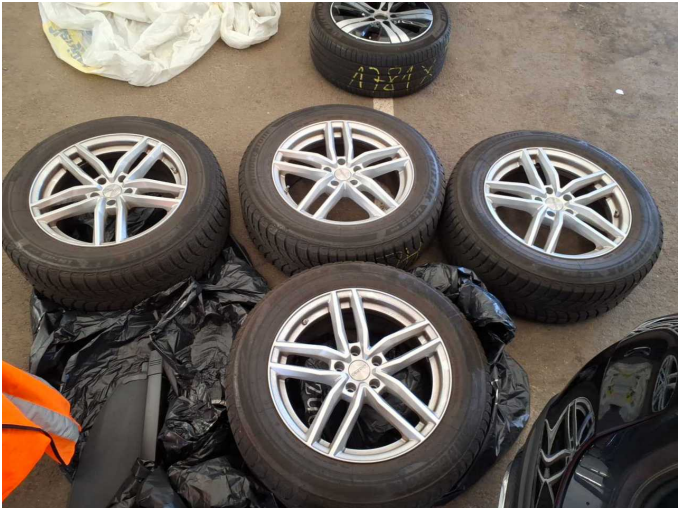
| Tyres | | | | |
|---|---|---|---|---|
| 1) | 235/60 R18 103H | Winter tyres on Light alloy | Bridgestone | 5mm / 5mm |
| 2) | 235/60 R18 103H | Winter tyres on Light alloy | Bridgestone | 6mm / 6mm |

Figure 16: Additional tyres

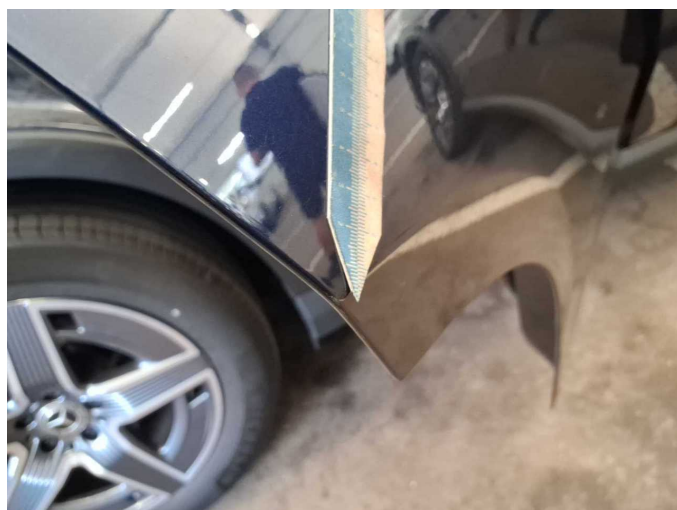
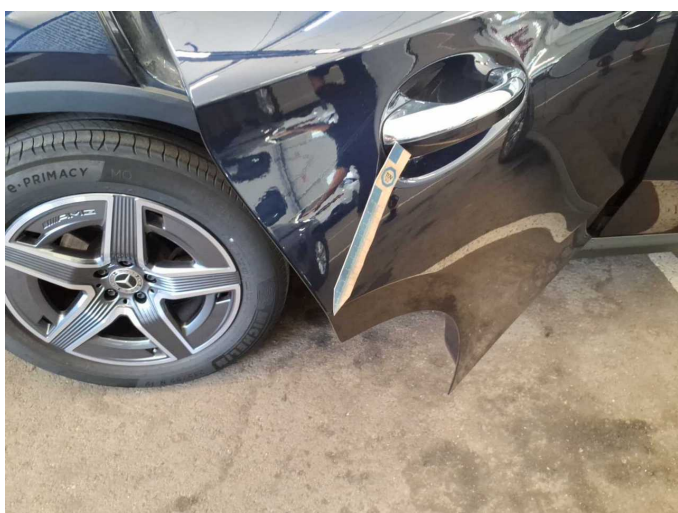
| No. | Component group | Description |
|---|---|---|
| 1 | Door - rear right side | Door edge - Scratch(es) - Smart repair |

Damage 1: Door - rear right side: Door edge - Scratch(es) - Smart repair

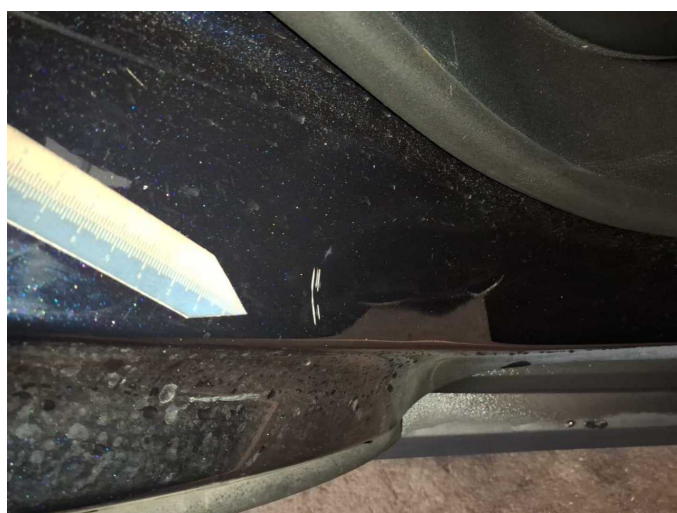
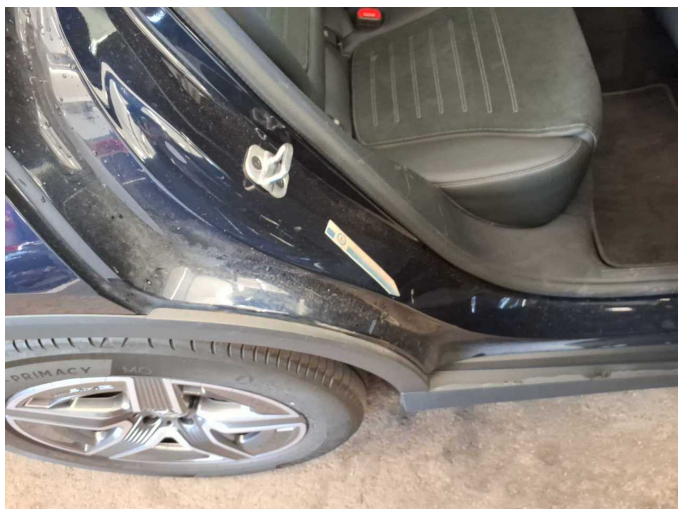
| No. | Component group | Description |
|---|---|---|
| 2 | Side panel - rear right side | Sill - Scratch(es) - Smart repair |

Damage 2: Side panel - rear right side: Sill - Scratch(es) - Smart repair

**Damage 2:** Side panel - rear right side: Sill - Scratch(es) - Smart repair

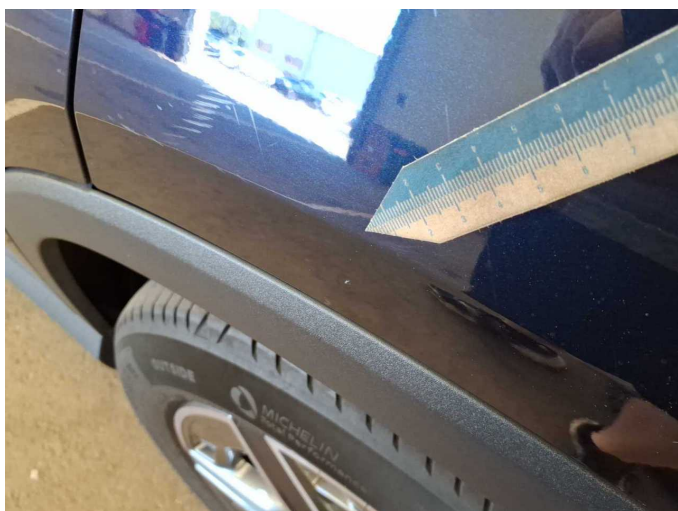
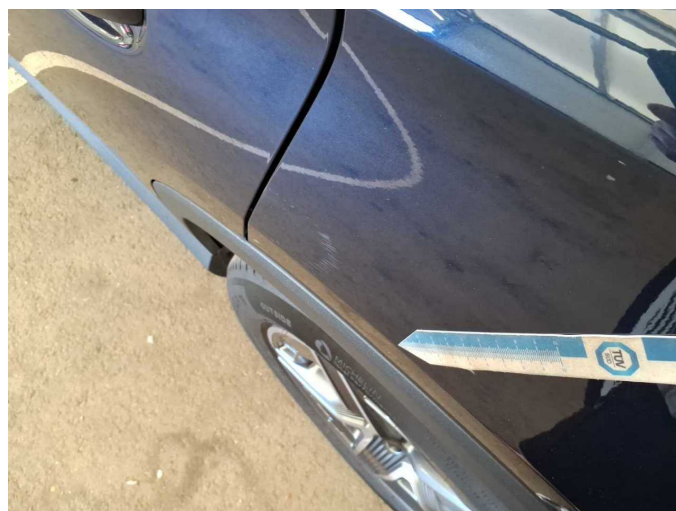
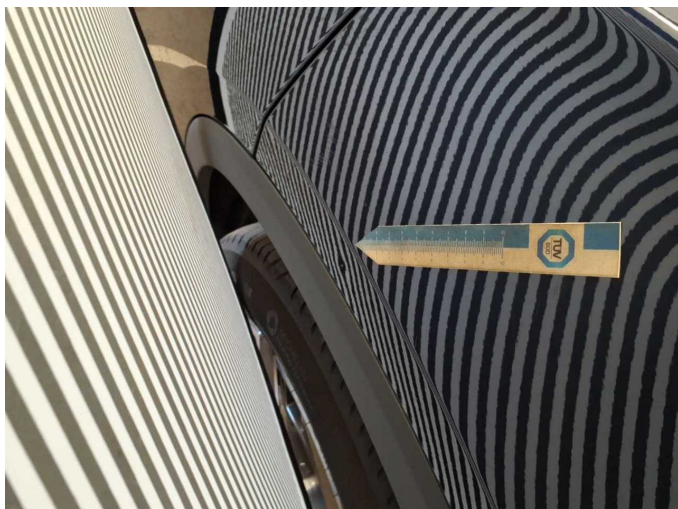
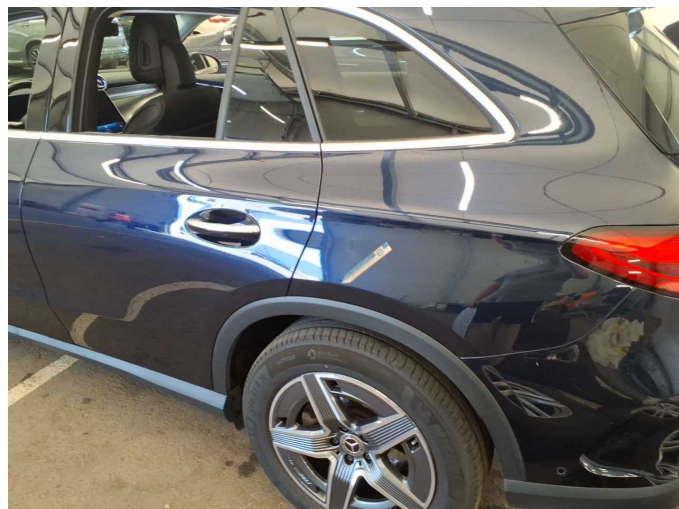
| No. | Component group | Description |
|---|---|---|
| 4 | Side panel - rear left side | Side panel - Dent / paintcoat damage - Repair and paint |

**Damage 4:** Side panel - rear left side: Side panel - Dent / paintcoat damage - Repair and paint

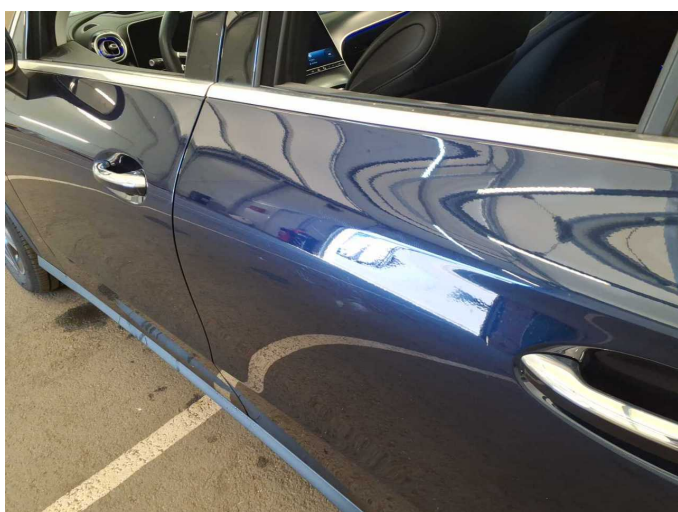
| No. | Component group | Description |
|---|---|---|
| 1 | Door - rear left side | Door - Scratch(es) - No deduction |

**Wear and tear 1:** Door - rear left side: Door - Scratch(es) - No deduction

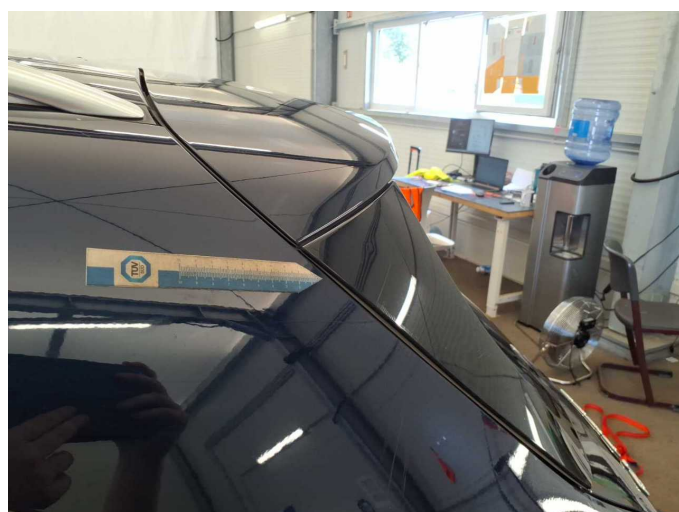
| No. | Component group | Description |
|---|---|---|
| 2 | Boot lid / rear door | Boot lid - Scratch(es) - No deduction |

**Wear and tear 2:** Boot lid / rear door: Boot lid - Scratch(es) - No deduction

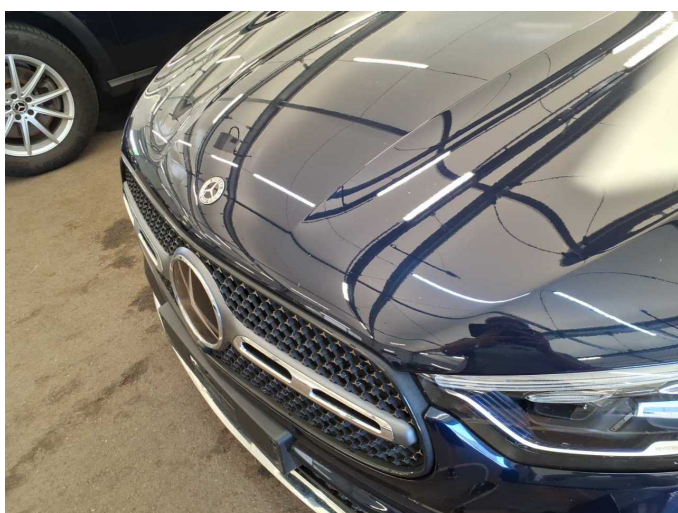
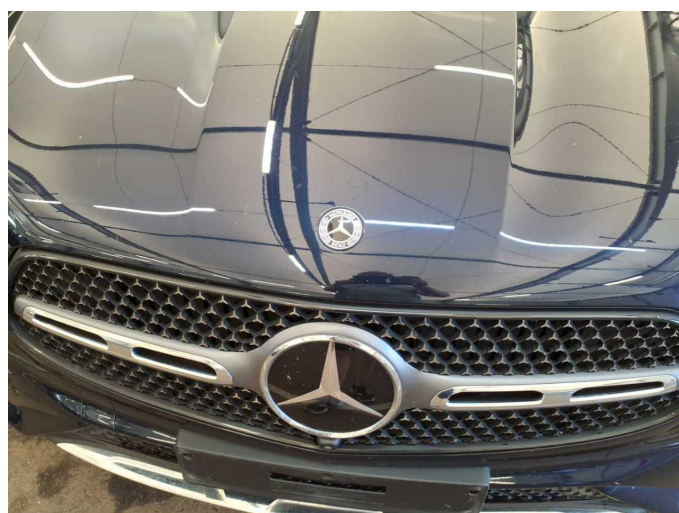
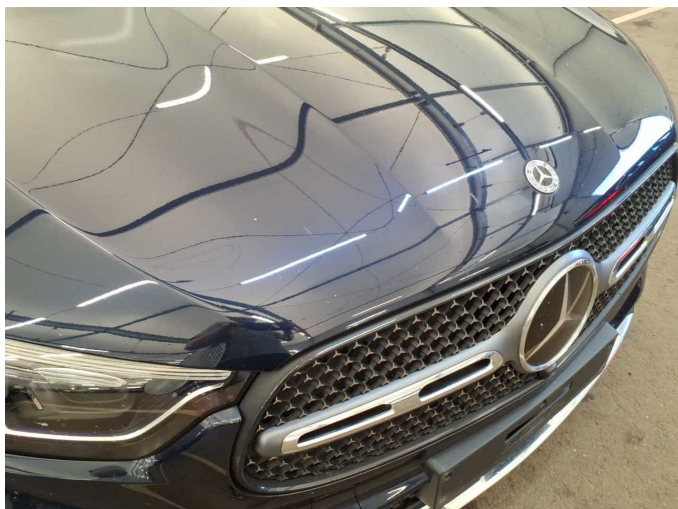
| No. | Component group | Description |
|---|---|---|
| 3 | Bonnet | Bonnet - Stone chips - No deduction |

**Wear and tear 3:** Bonnet: Bonnet - Stone chips - No deduction

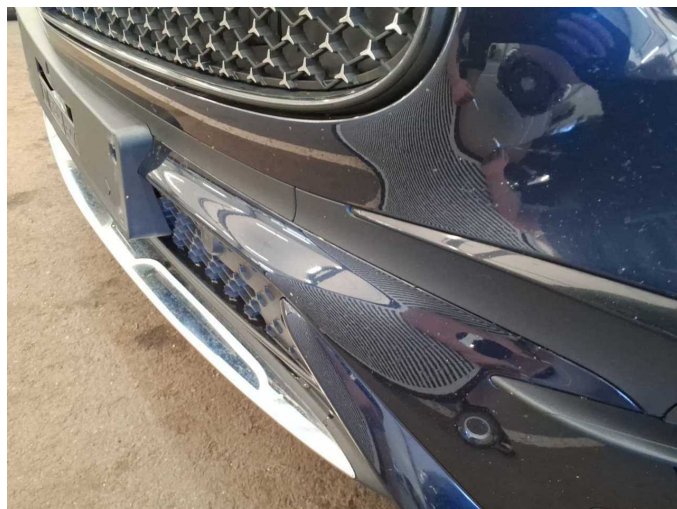
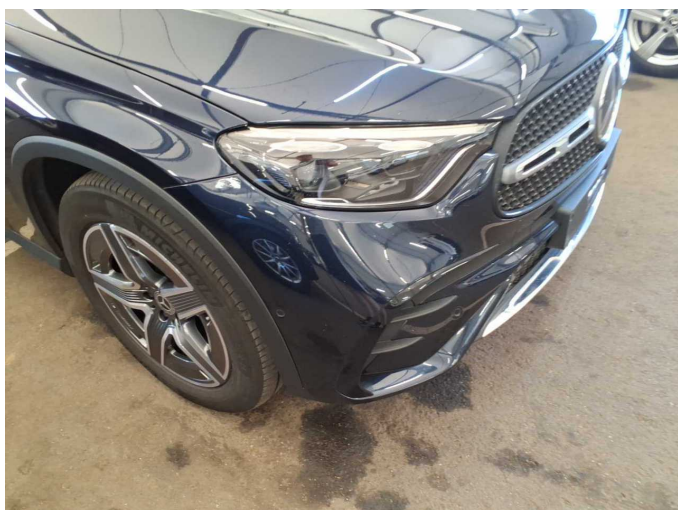
| No. | Component group | Description |
|---|---|---|
| 4 | Front bumper | Front bumper - Stone chips - No deduction |

**Wear and tear 4:** Front bumper: Front bumper - Stone chips - No deduction

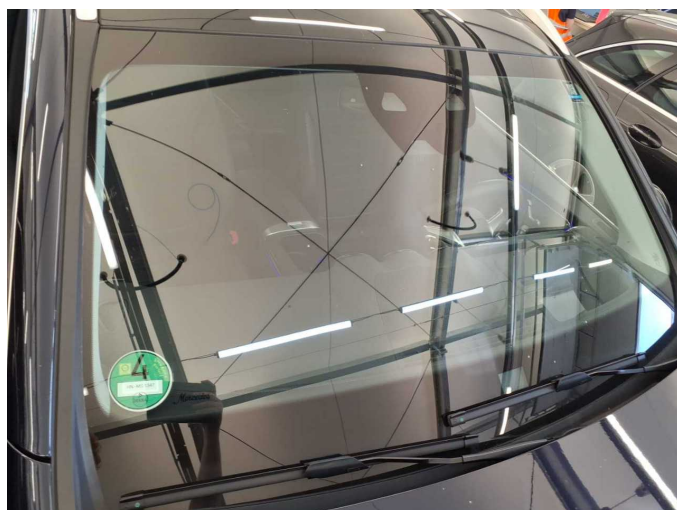
| No. | Component group | Description |
|---|---|---|
| 5 | Vehicle glazing | Windscreen - Stone chips - No deduction |

**Wear and tear 5:** Vehicle glazing: Windscreen - Stone chips - No deduction

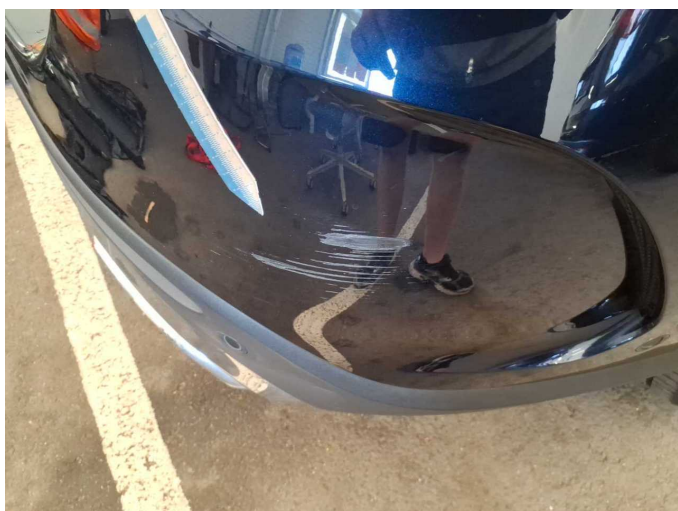
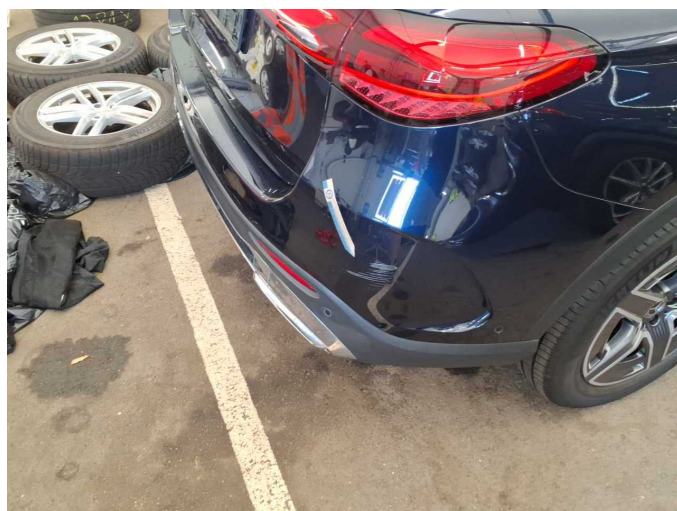
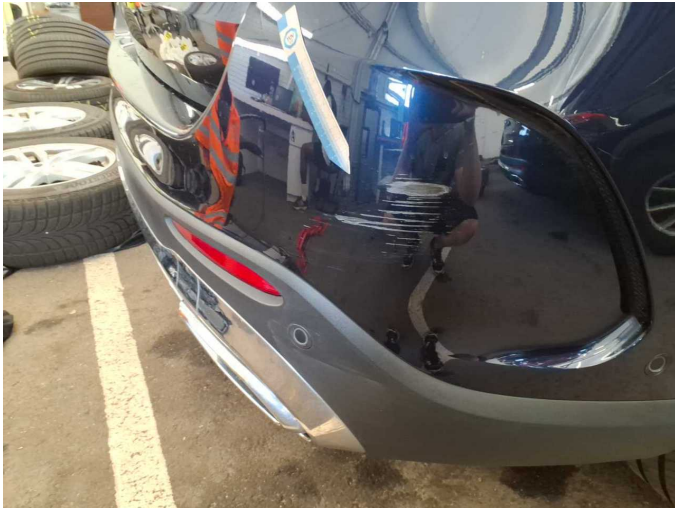
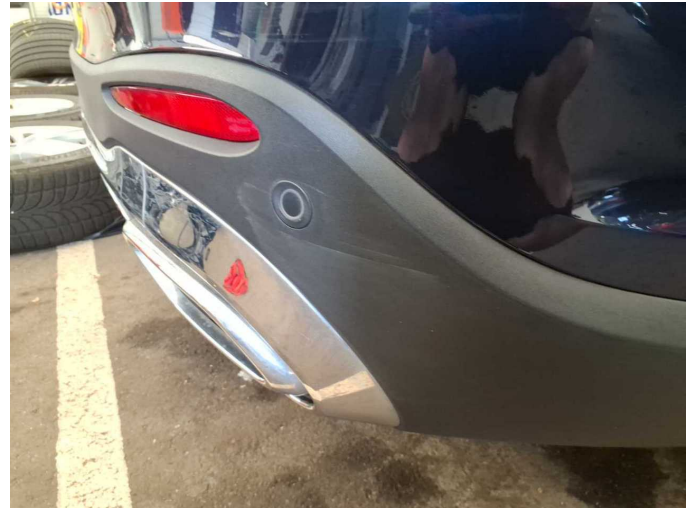
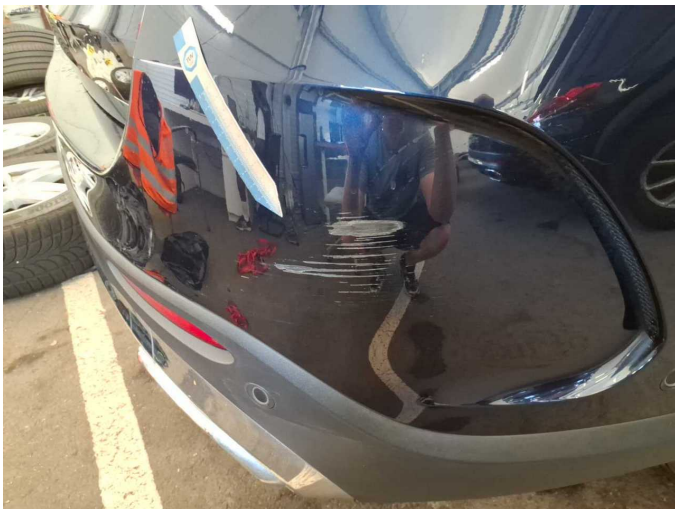
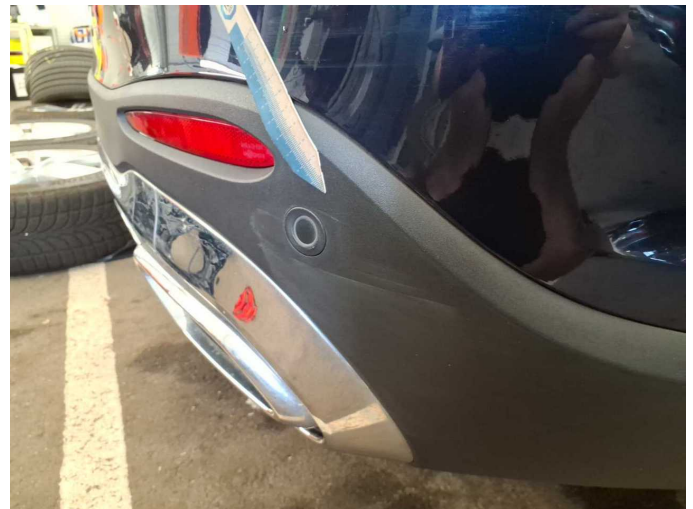
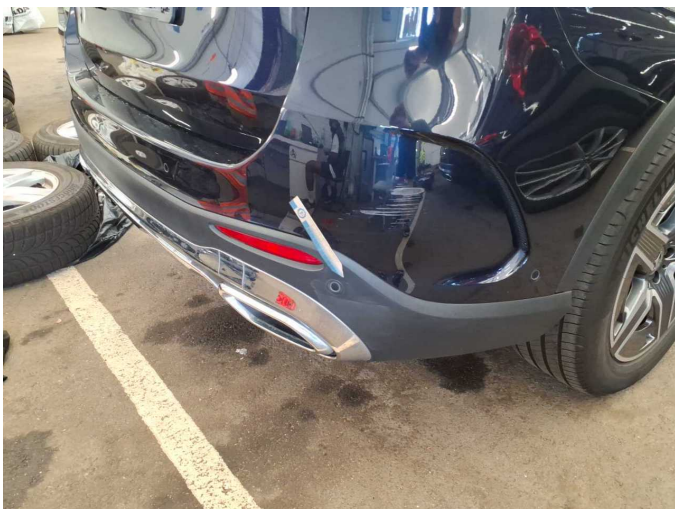
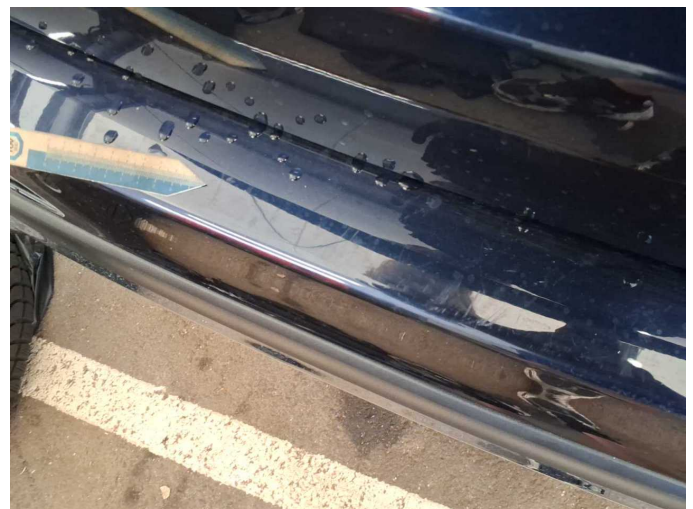
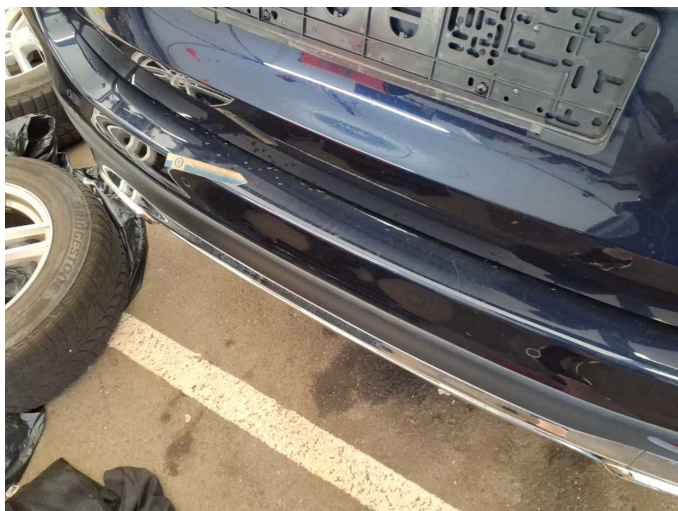
1 Rear

**Accident 1:** Rear

**Accident 1: Rear**
