Expertise

Protocol number: 46410136  
Order No. / Reference: 26598430  
Inspection date: 9 Jul 2026

Manufacturer: Volkswagen

Model: Passat Variant 1.5 TSI OPF DSG Business

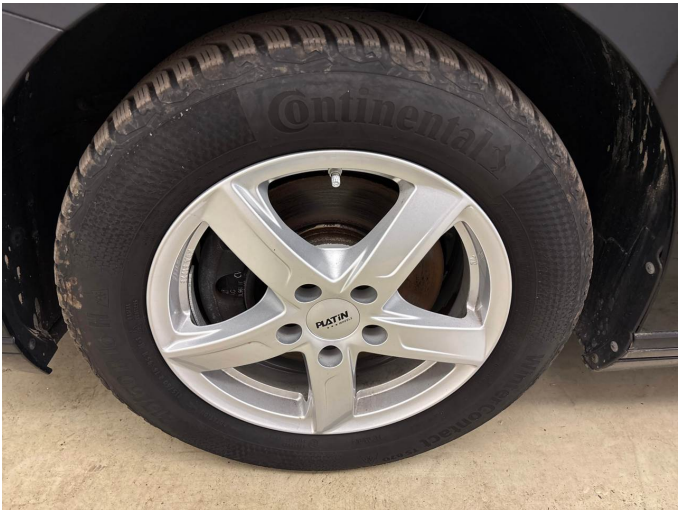
Figure 12: Mounted tyres

| # | Tyre size | Type of tyre | Manufacturer | Tread depth |
|---|---|---|---|---|
| 1) | 215/60 R16 95H | Winter tyres on Light alloy | Continental | 5mm / 5mm |
| 2) | 215/60 R16 95H | Winter tyres on Light alloy | Continental | 5mm / 5mm |

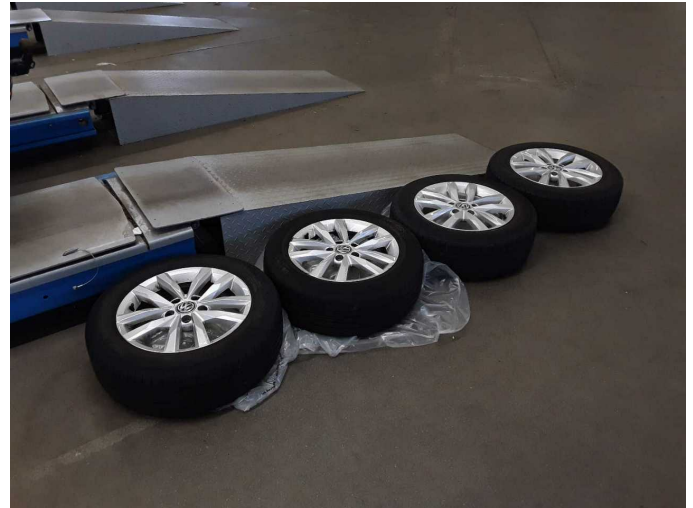
Figure 14: Additional tyres

| # | Tyre size | Type of tyre | Manufacturer | Tread depth |
|---|---|---|---|---|
| 1) | 205/60 R16 96V | Summer tyres on Light alloy | Falken | 3mm / 3mm |
| 2) | 205/60 R16 96V | Summer tyres on Light alloy | Dunlop | 3mm / 3mm |

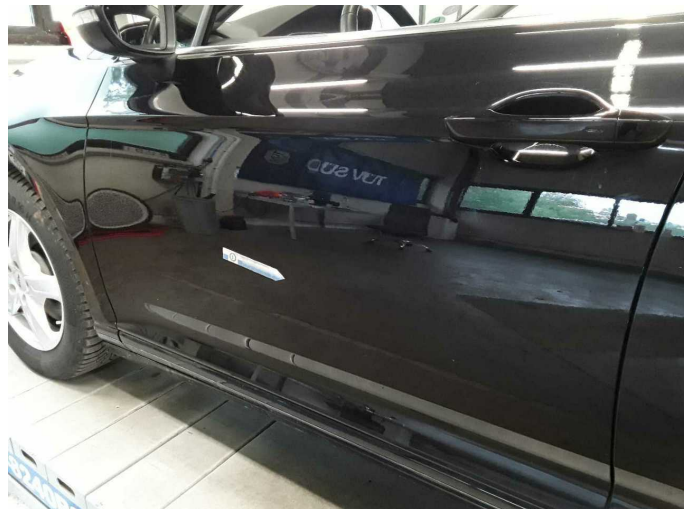
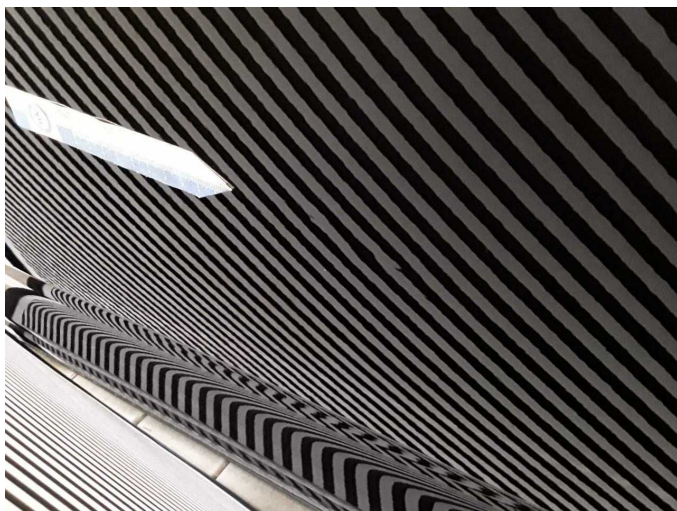
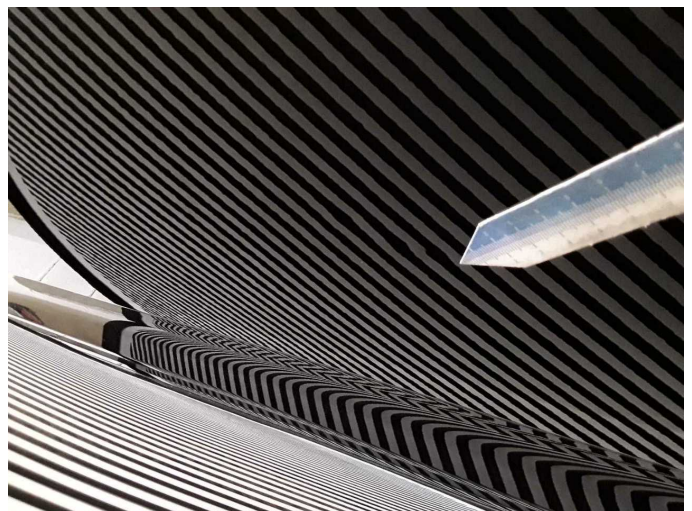
| No. | Component group | Description |
|---|---|---|
| 2 | Door - front left side | Door (3 dellen) - dent(s) - Smooth repair work |

**Damage 2:** Door - front left side: Door (3 dellen) - dent(s) - Smooth repair work

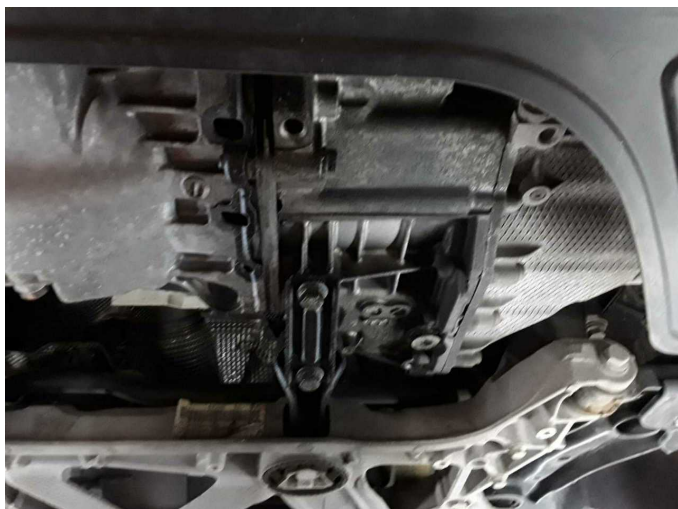
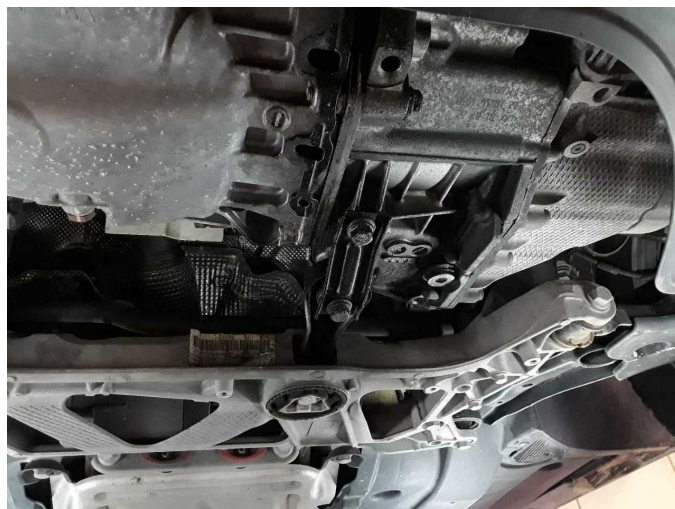
| No. | Component group | Description |
|---|---|---|
| 3 | Engine | Engine - Leaking - Diagnosed and repair if necessary |

**Damage 3:** Engine: Engine - Leaking - Diagnosed and repair if necessary

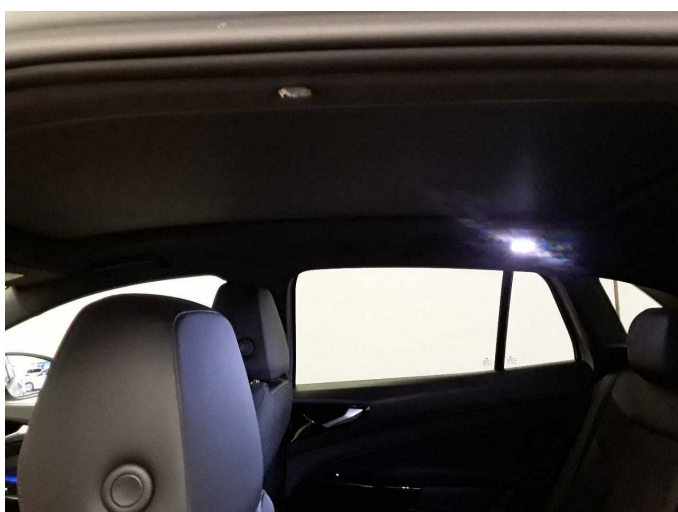
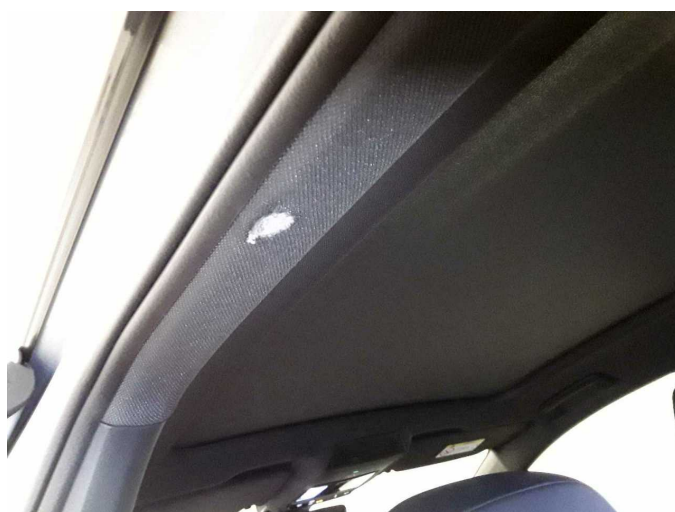
| No. | Component group | Description |
|---|---|---|
| 5 | Trim / covers | Roof lining - Holes - Smart repair |

**Damage 5:** Trim / covers: Roof lining - Holes - Smart repair

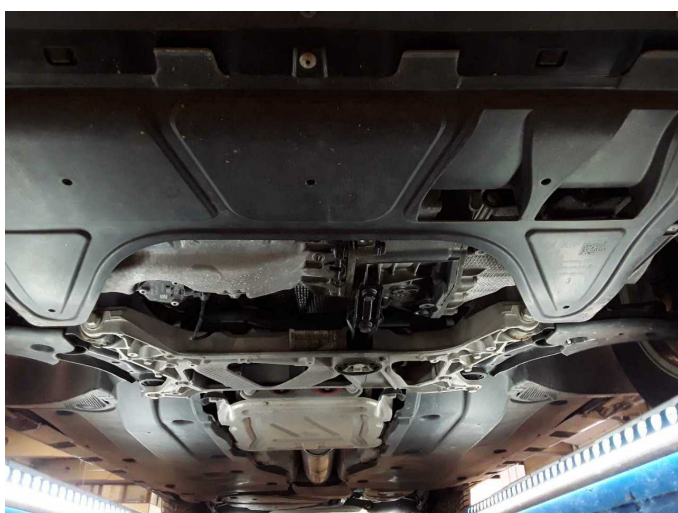
| No. | Component group | Description |
|---|---|---|
| 6 | Body | Underbody panelling - Missing - Replace |

**Damage 6:** Body: Underbody panelling - Missing - Replace

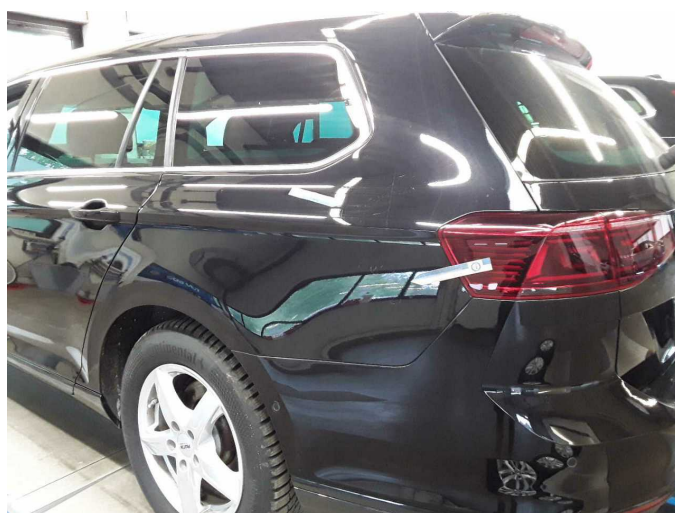
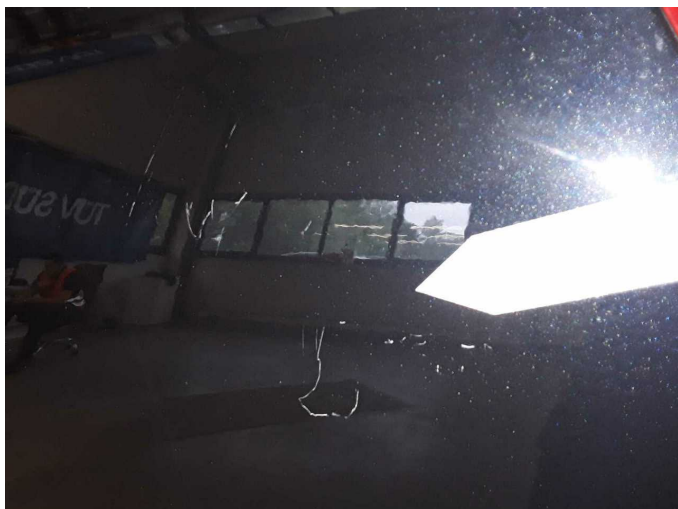
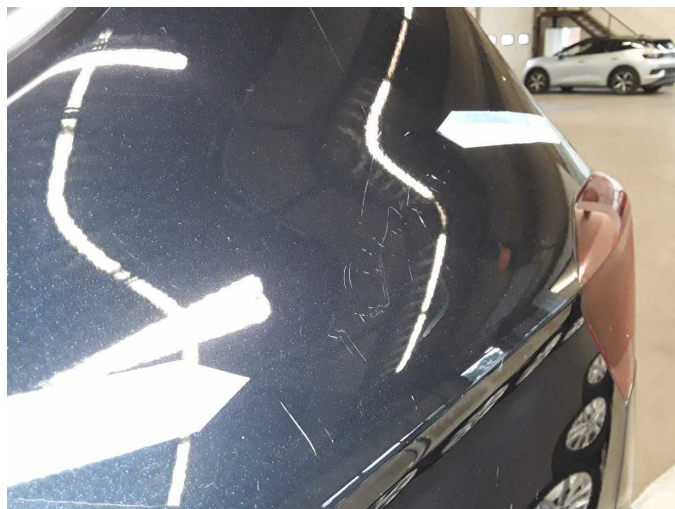
| No. | Component group | Description |
|---|---|---|
| 7 | Side panel - rear left side | Side panel - Scratch(es) - Paint |

**Damage 7:** Side panel - rear left side: Side panel - Scratch(es) - Paint

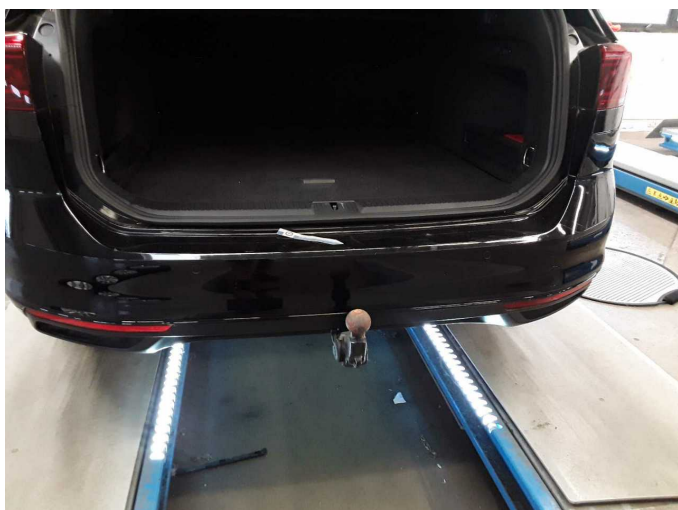
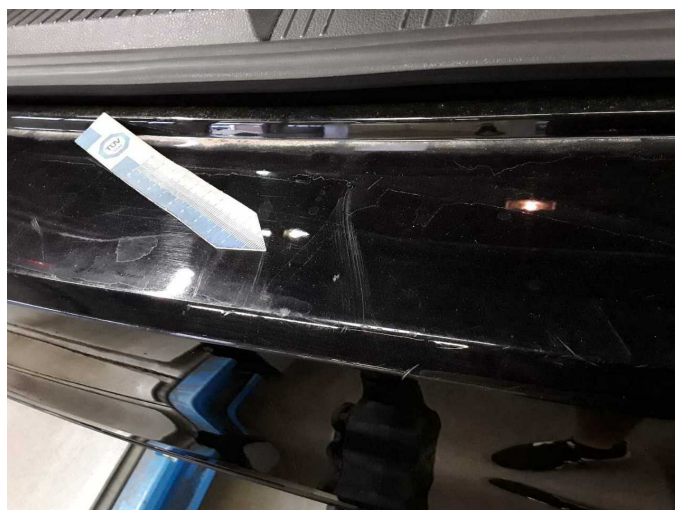
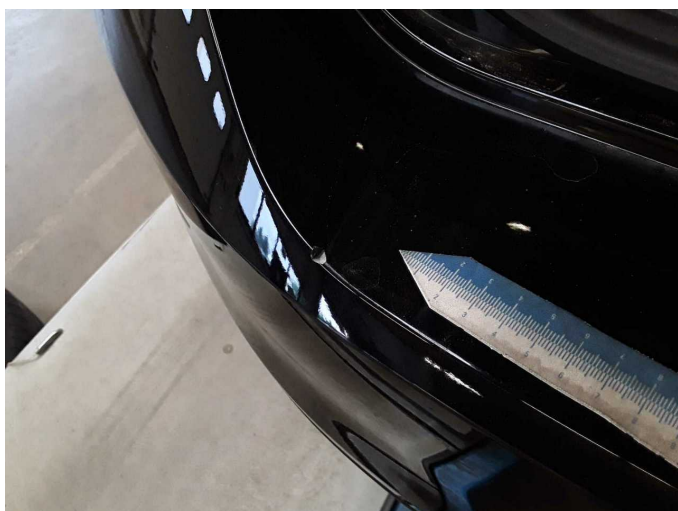
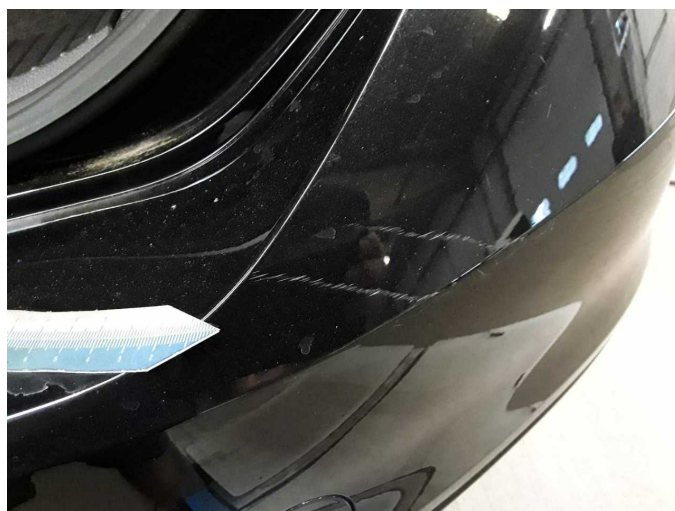
| No. | Component group | Description |
|---|---|---|
| 8 | Rear bumper | Rear bumper - Scratch(es) - Paint |

**Damage 8:** Rear bumper: Rear bumper - Scratch(es) - Paint

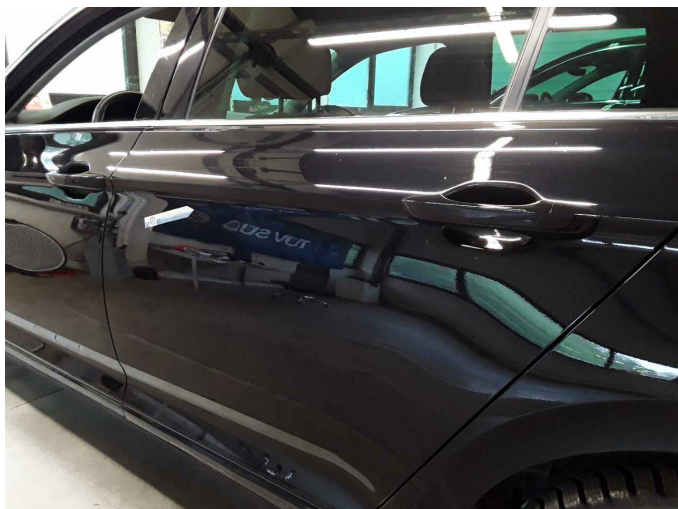
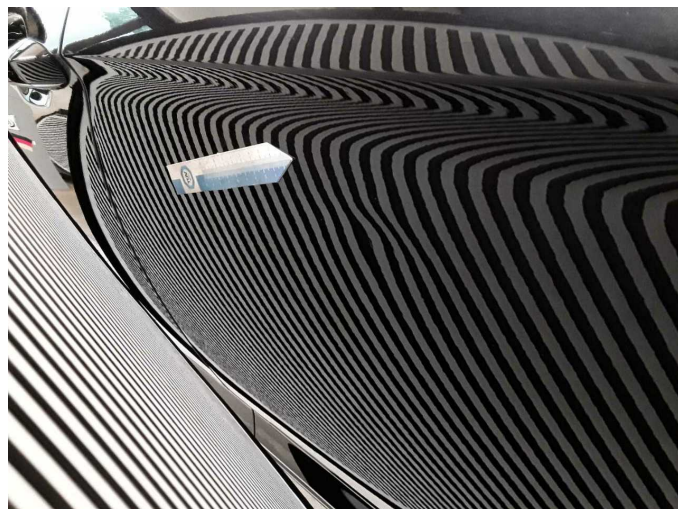
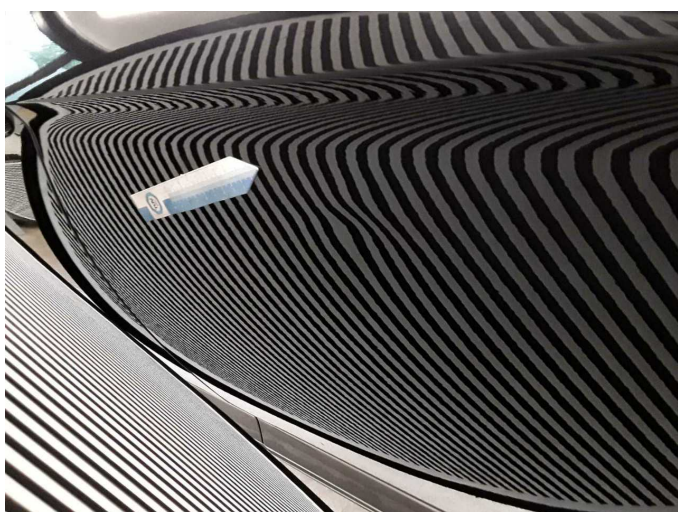
| No. | Component group | Description |
|---|---|---|
| 9 | Door - rear left side | Door - Deformed - Repair and paint |

**Damage 9:** Door - rear left side: Door - Deformed - Repair and paint

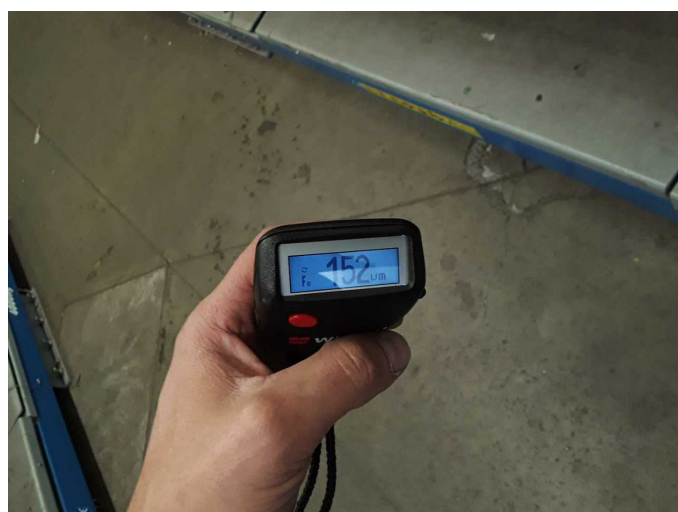
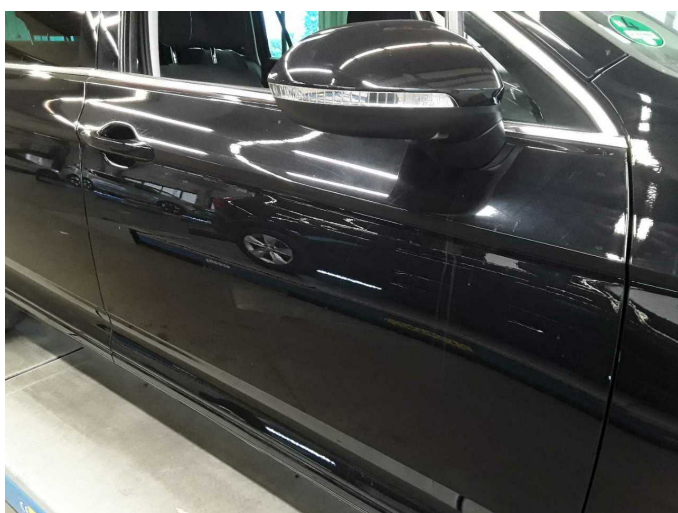
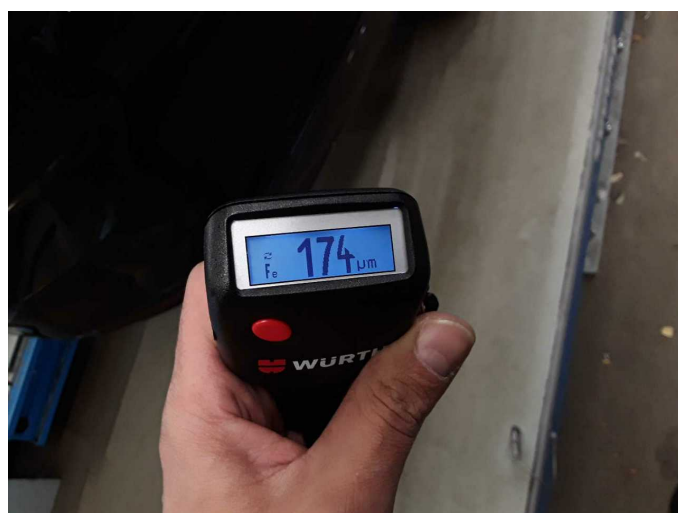
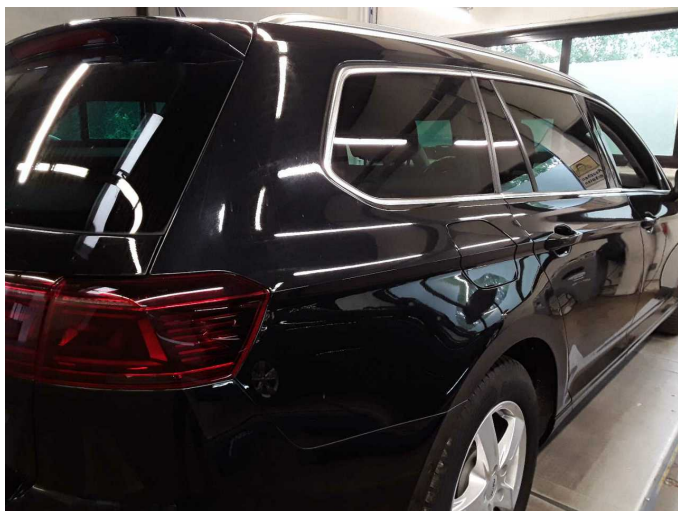
| No. | Repainting |
|---|---|
| 1 | Side panel - rear right side, Door - front right side, Professionally carried out, Invoice of repair done Non-existent |

**Repainting 1:** Side panel - rear right side, Door - front right side
