Expertise

Protocol number: 46018023  
Order No. / Reference: 26571527  
Inspection date: 18 Jun 2026

Model: C 220 d 4Matic T 9G-TRONIC Avantgarde

VIN: W1KAH0FB2PF080159

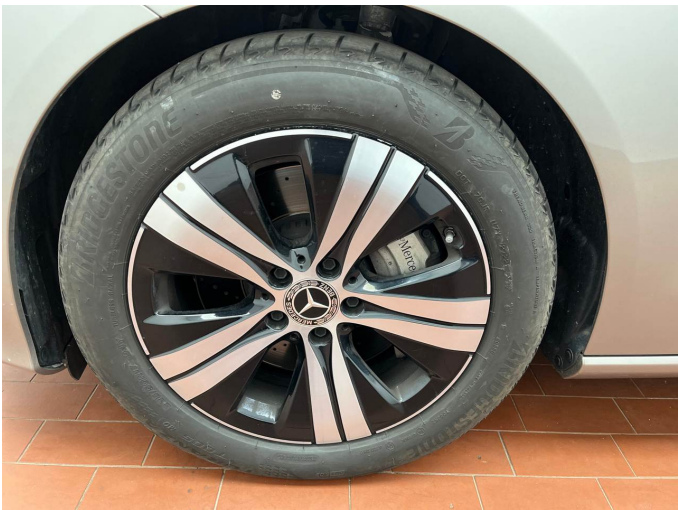
Figure 12: Mounted tyres

| # | Tyre size | Type of tyre | Manufacturer | Tread depth |
|---|---|---|---|---|
| 1) | 225/50 R17 94Y | Summer tyres on Light alloy | Bridgestone | 5mm / 5mm |
| 2) | 225/50 R17 94Y | Summer tyres on Light alloy | Bridgestone | 5mm / 6mm |

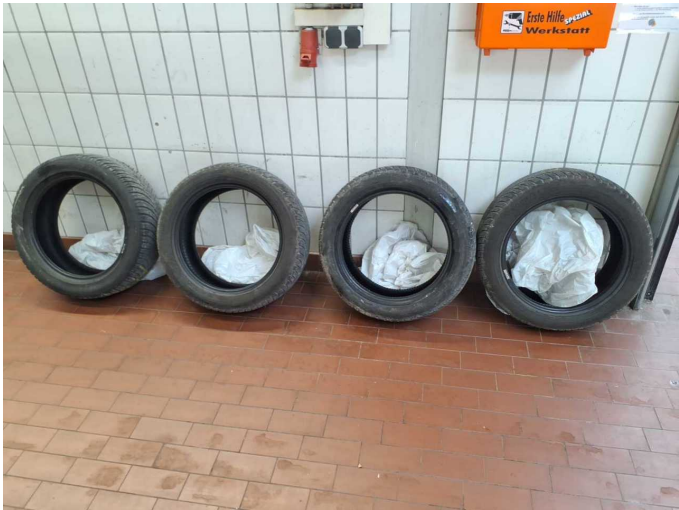
Figure 16: Additional tyres

| # | Tyre size | Type of tyre | Manufacturer | Tread depth |
|---|---|---|---|---|
| 1) | 225/50 R17 98V | Winter tyres (Without wheel rim) | Goodyear | 5mm / 5mm |
| 2) | 225/50 R17 98V | Winter tyres (Without wheel rim) | unterschiedliche Hersteller | 6mm / 6mm |

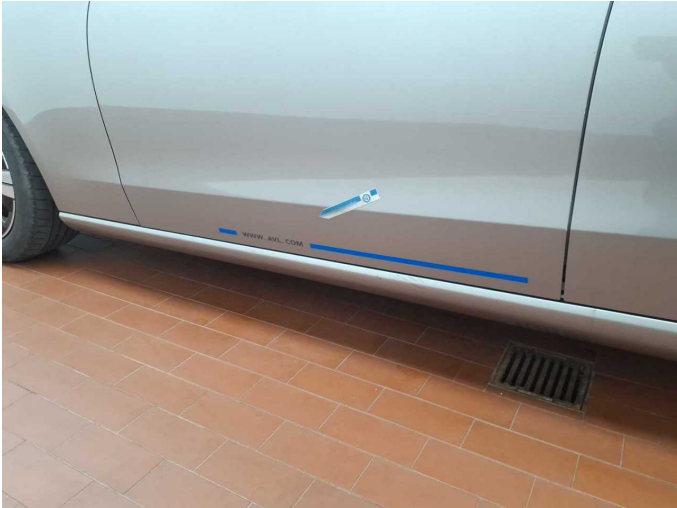
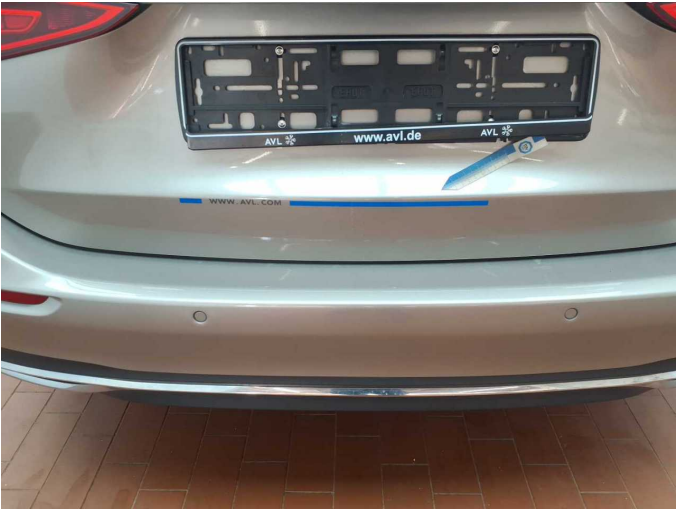
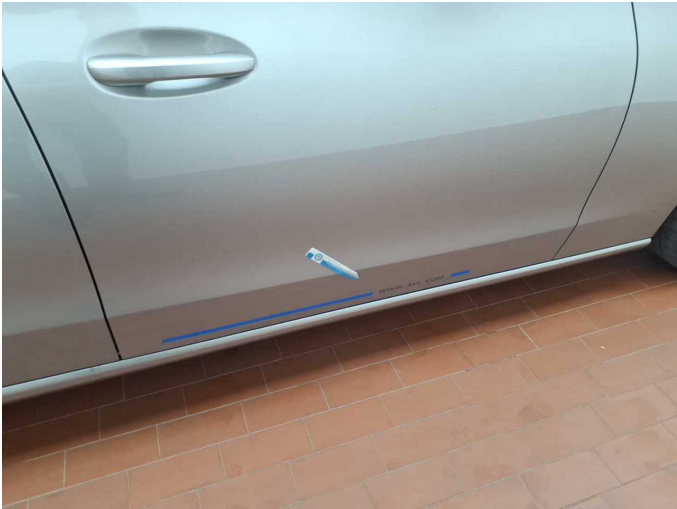
| No. | Component group | Description |
|---|---|---|
| 1 | Body | Body - Glued / labelled - De-glue / neutralise |

Damage 1: Body: Body - Glued / labelled - De-glue / neutralise

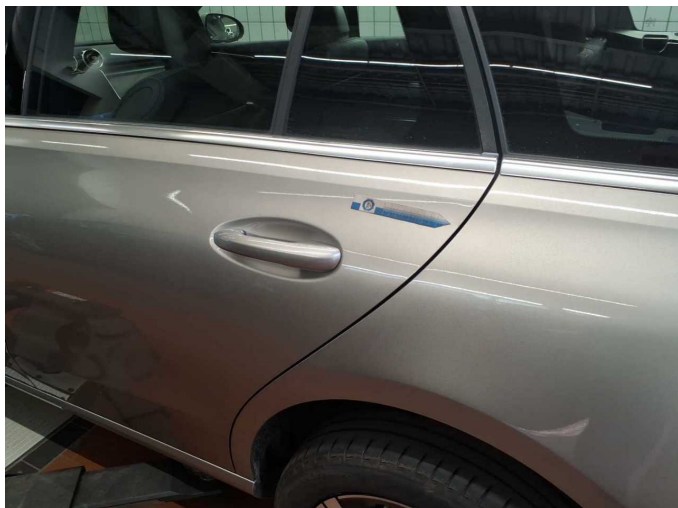
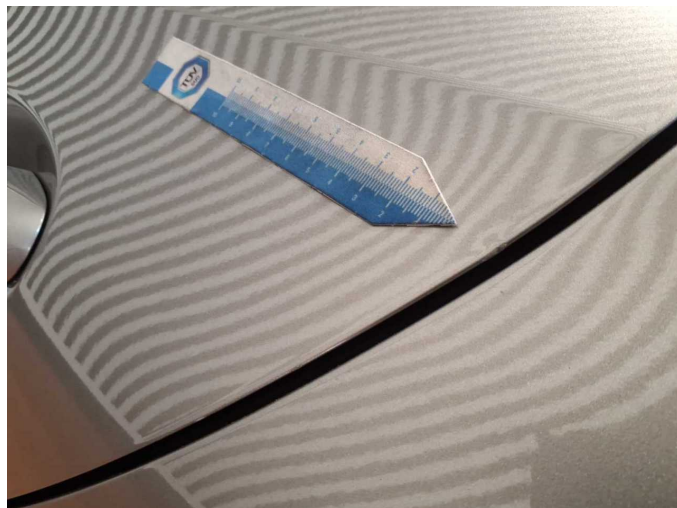
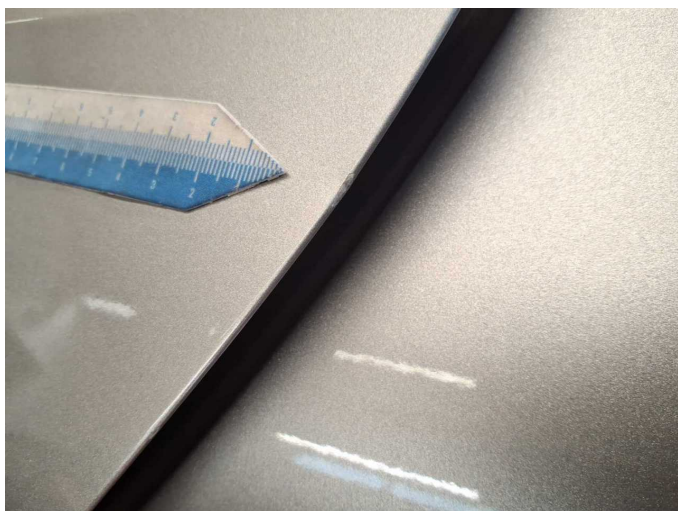
| No. | Component group | Description |
|---|---|---|
| 2 | Door - rear left side | Door edge - Dent / paintcoat damage - Smart repair |

**Damage 2:** Door - rear left side: Door edge - Dent / paintcoat damage - Smart repair

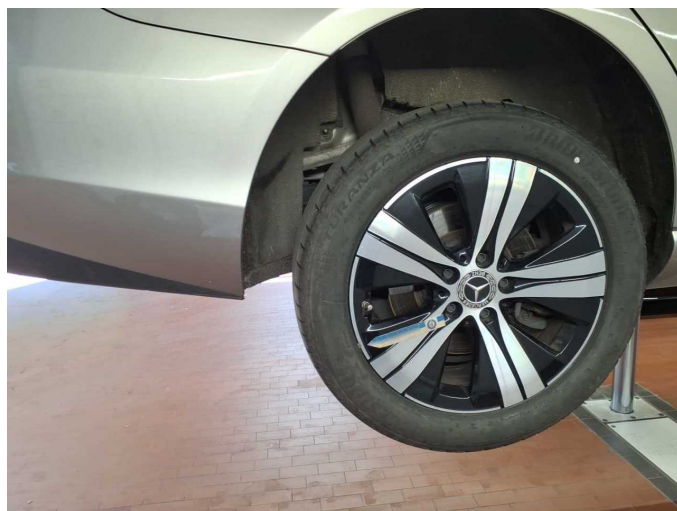
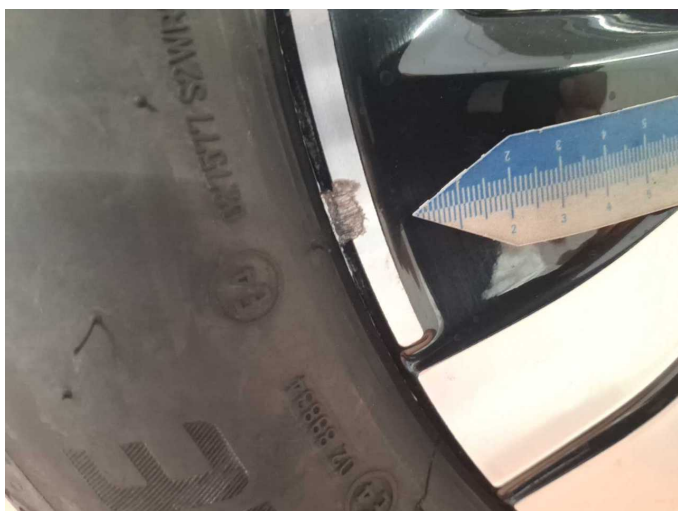
| No. | Component group | Description |
|---|---|---|
| 4 | Wheel / tyres | Alloy rim - rear right side - Scratched - Loss in value |

**Damage 4:** Wheel / tyres: Alloy rim - rear right side - Scratched - Loss in value

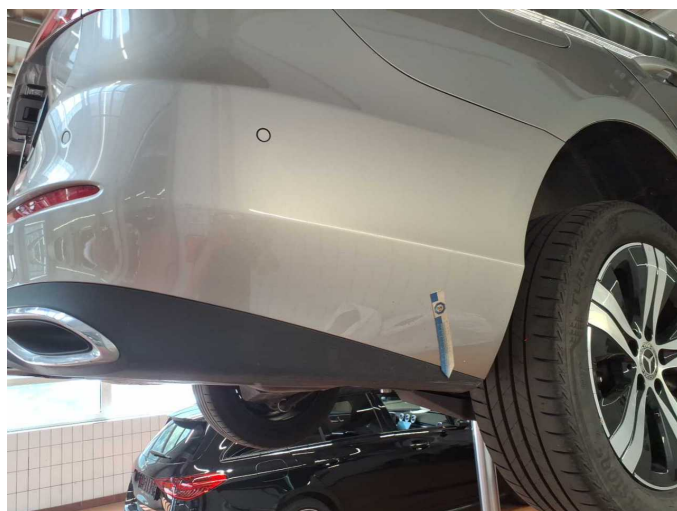
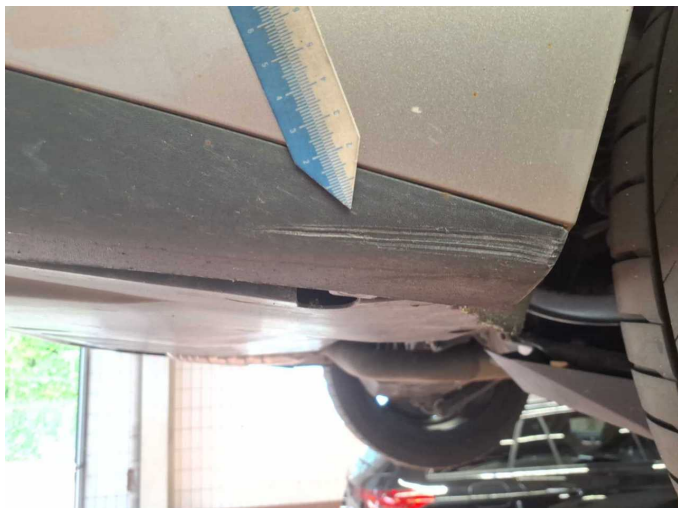
| No. | Component group | Description |
|---|---|---|
| 5 | Rear bumper | Spoiler - Scratch(es) - Replace |

**Damage 5:** Rear bumper: Spoiler - Scratch(es) - Replace

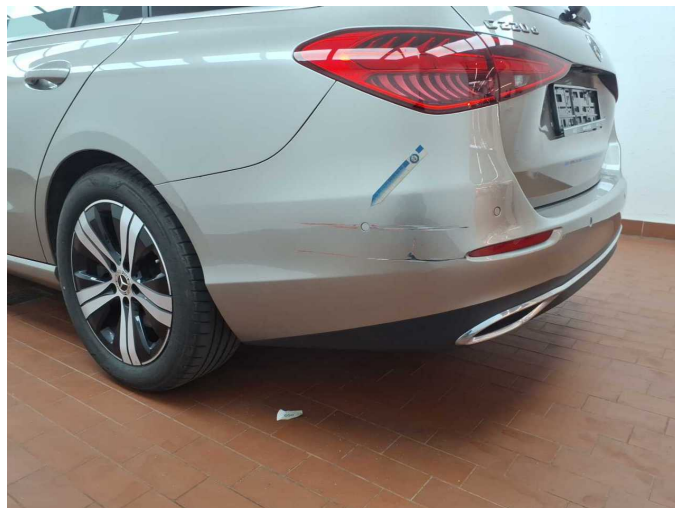
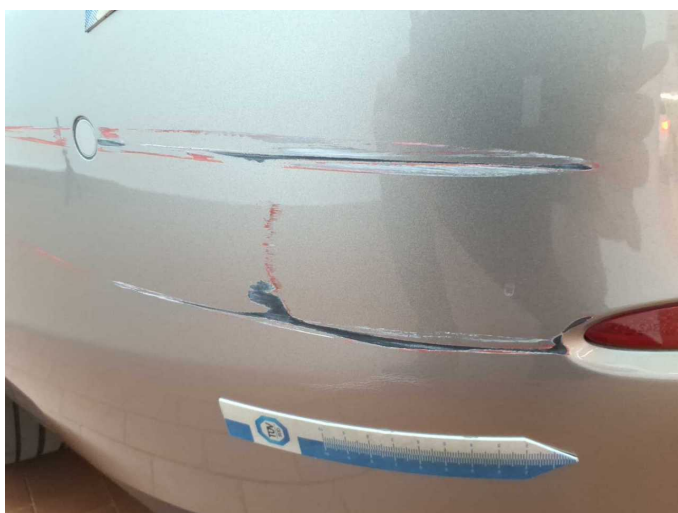
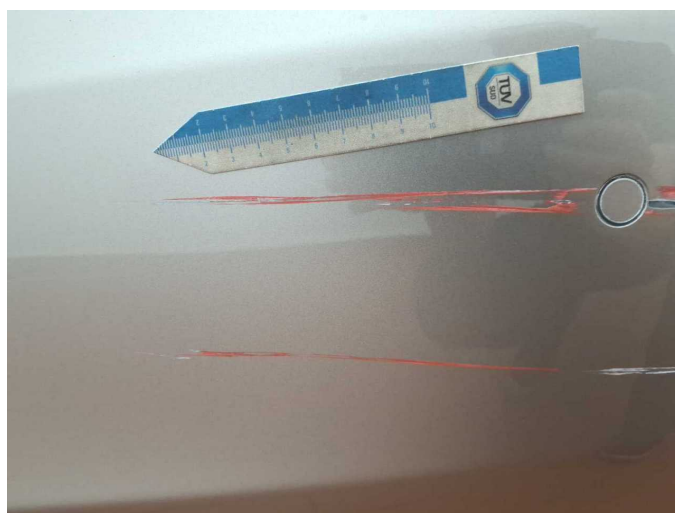
| No. | Component group | Description |
|---|---|---|
| 6 | Rear bumper | Rear bumper - Scratched - Repair and paint |

**Damage 6:** Rear bumper: Rear bumper - Scratched - Repair and paint

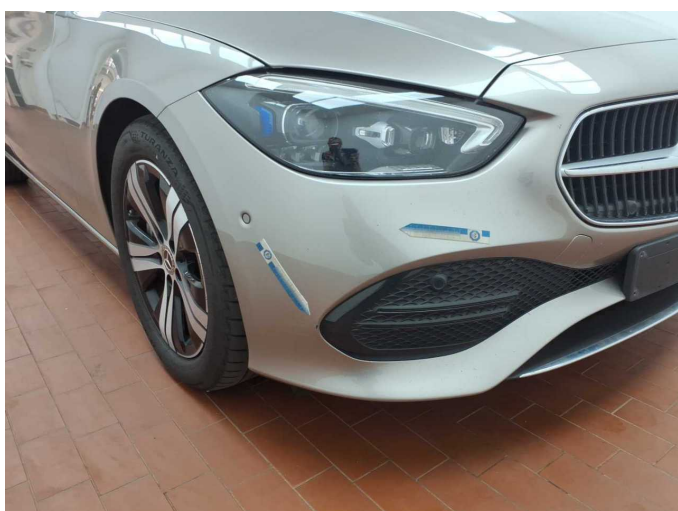
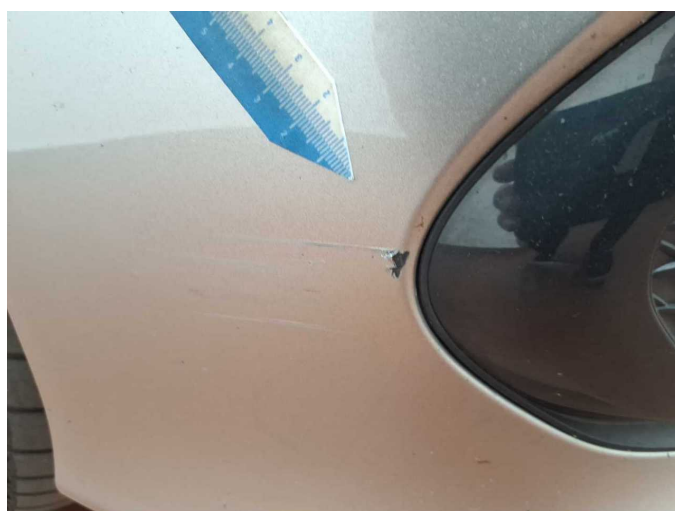
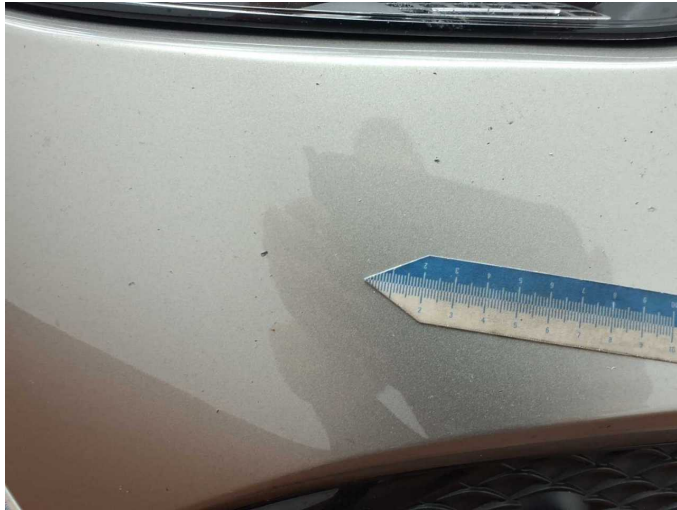
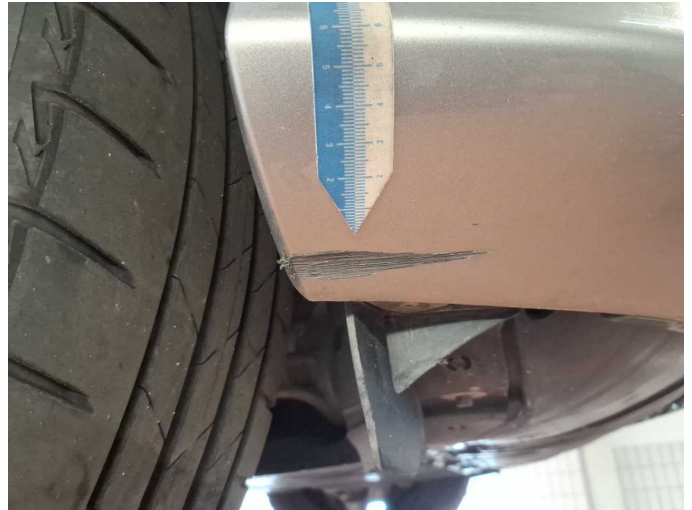
| No. | Component group | Description |
|---|---|---|
| 7 | Front bumper | Front bumper (Steinschläge) - Scratched - Paint |

**Damage 7:** Front bumper: Front bumper (Steinschläge) - Scratched - Paint
