Expertise

Protocol number: 46366706  
Order No. / Reference: 26348757  
Inspection date: 7 Jul 2026

Manufacturer: Mercedes-Benz

Model: C 200 d T 9G-TRONIC Avantgarde Advanced

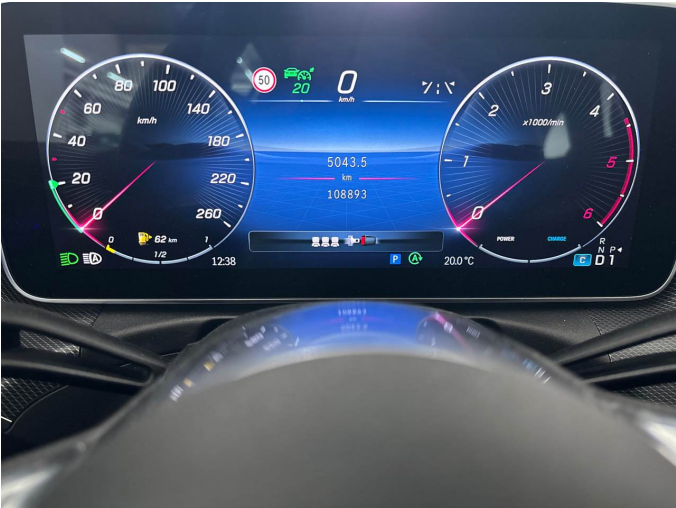
Figure 7: Instrument cluster

| Vehicle details | |
|---|---|
| Mileage (Read) | 108,893 km |

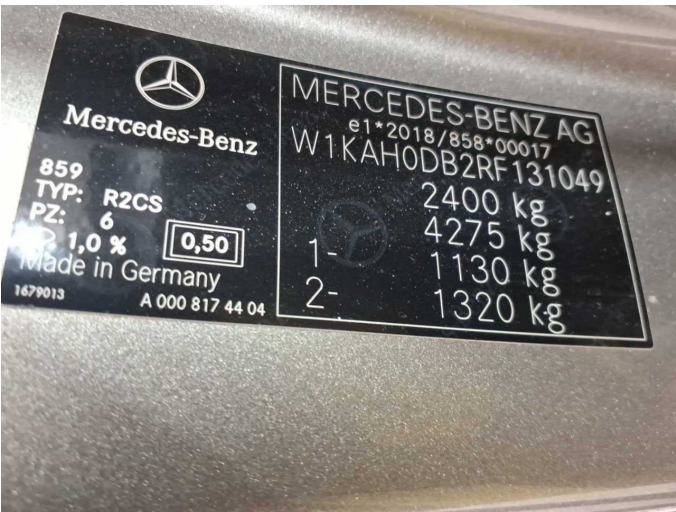
Figure 11: VIN

| VIN comparison | The vehicle identification number (VIN) was read from the vehicle and its conformity with the submitted documents was confirmed by the undersigned during the inspection. |

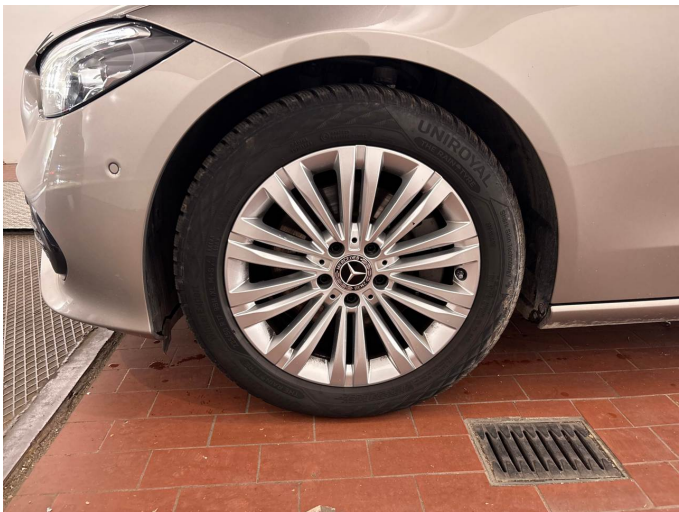
Figure 12: Mounted tyres

| Tyres | | | |
|---|---|---|---|
| 1) | 225/50 R17 98H | Winter tyres on Light alloy | 7mm / 7mm |
| 2) | 225/50 R17 98H | Winter tyres on Light alloy | 5mm / 5mm |

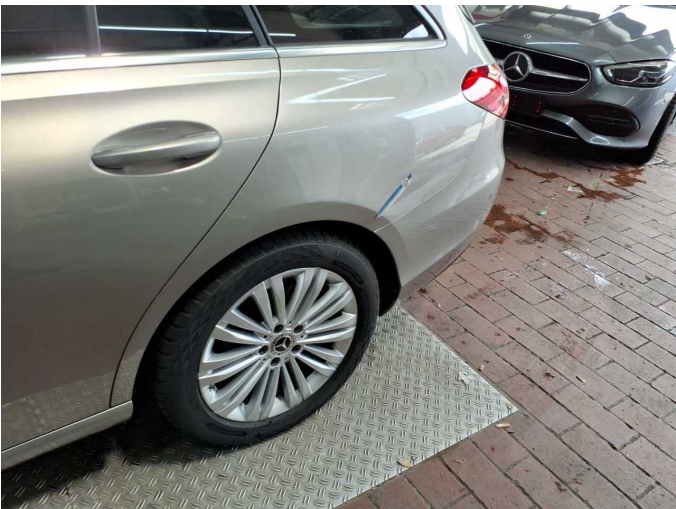
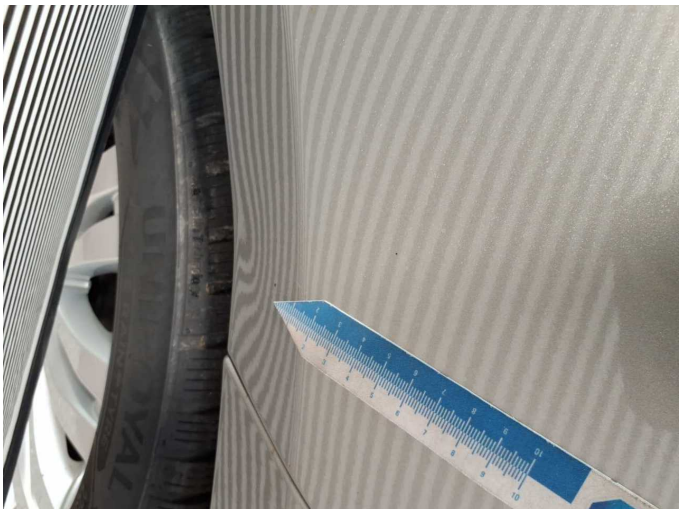
| No. | Component group | Description |
|---|---|---|
| 3 | Side panel - rear left side | Wheel arch - dent(s) - No deduction |

**Wear and tear 3:** Side panel - rear left side: Wheel arch - dent(s) - No deduction

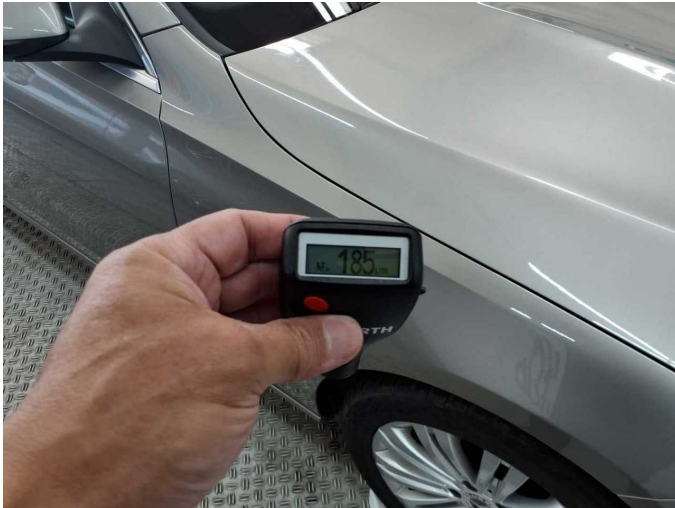
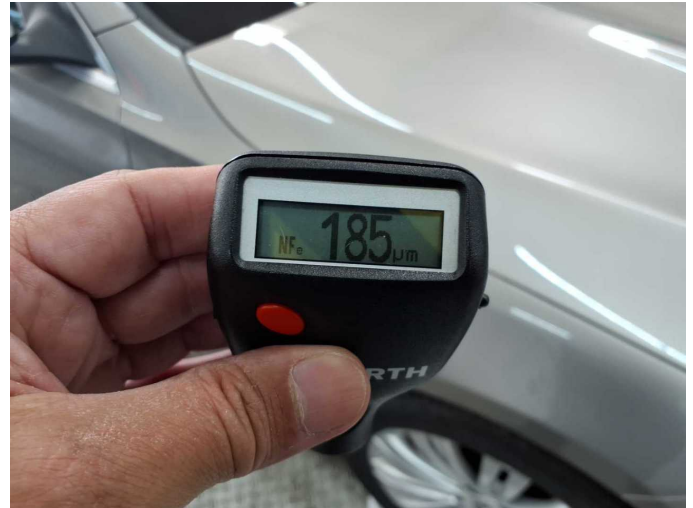
| No. | Repainting |
|---|---|
| 1 | Mudguard - right side, Professionally carried out, Invoice of repair done Non-existent |

| Mudguard - right side | 185 µm |

**Repainting 1:** Mudguard - right side
