Expertise

Protocol number: 45484828
Order No. / Reference: 26283570
Inspection date: 16 May 2026

Manufacturer: Skoda

Model: Superb Combi 2.0 TDI DSG Ambition

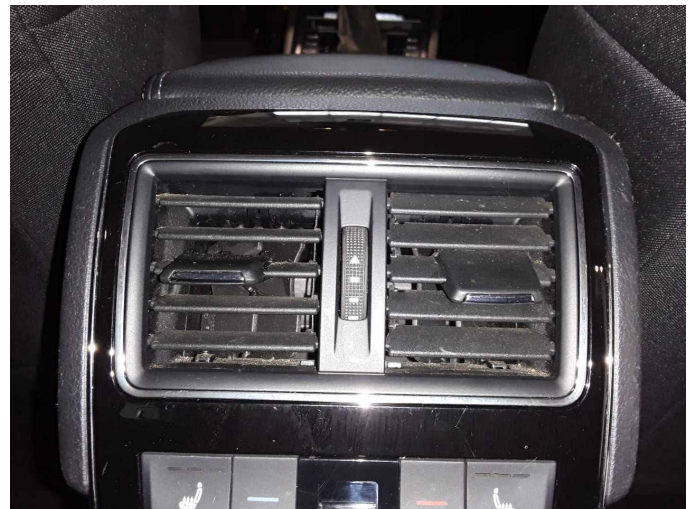
Damage 2: Instrument panel: Air nozzle - centre - Broken / torn - Replace

| No. | Component group | Description |
|---|---|---|
| 2 | Instrument panel | Air nozzle - centre - Broken / torn - Replace |

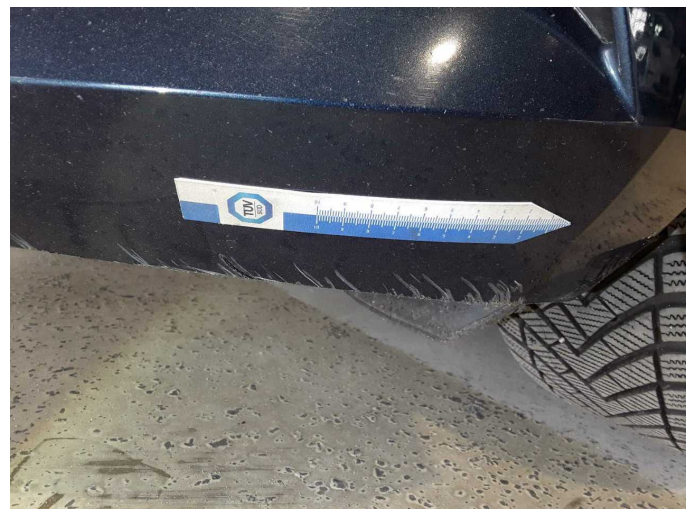
Damage 3: Front bumper: Front bumper - Scratch(es) - Smart repair

| No. | Component group | Description |
|---|---|---|
| 3 | Front bumper | Front bumper - Scratch(es) - Smart repair |

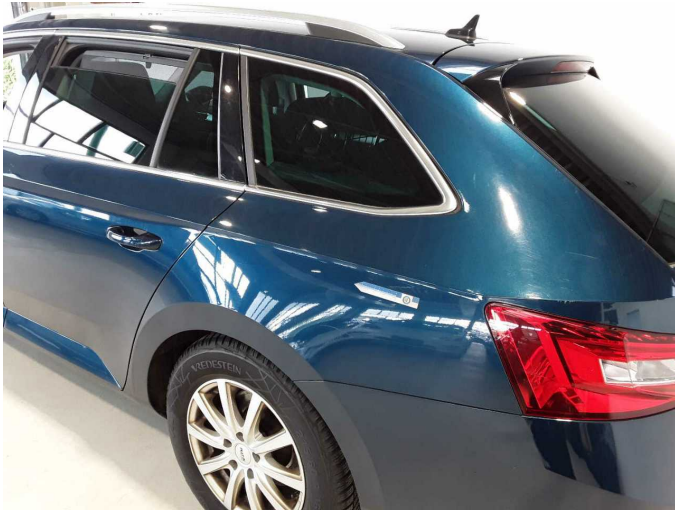
Damage 4: Side panel - rear left side: Side panel - Dent / paintcoat damage - Smart repair

| No. | Component group | Description |
|---|---|---|
| 4 | Side panel - rear left side | Side panel - Dent / paintcoat damage - Smart repair |

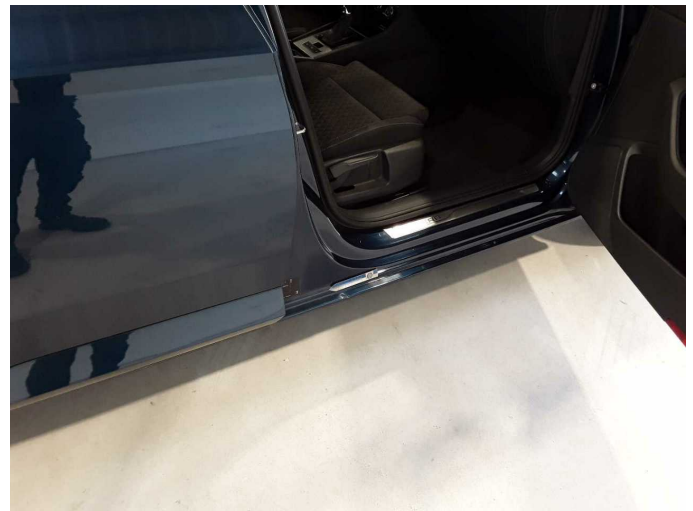
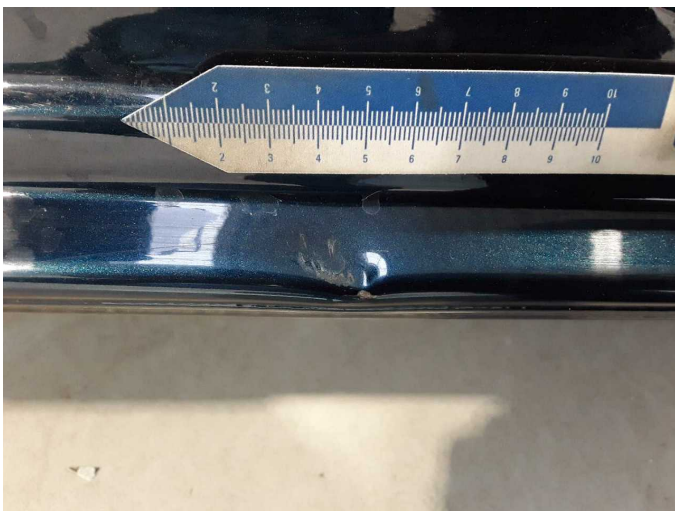
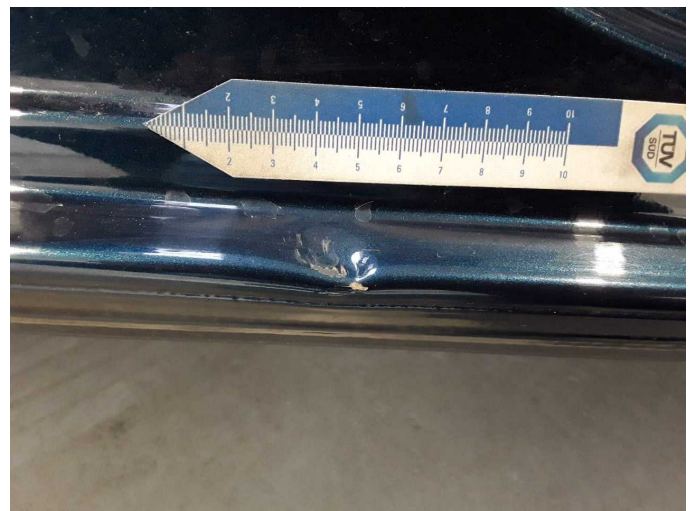
Damage 5: Sill - right side: Sill - Dent / paintcoat damage - Repair and paint

| No. | Component group | Description |
|---|---|---|
| 5 | Sill - right side | Sill - Dent / paintcoat damage - Repair and paint |

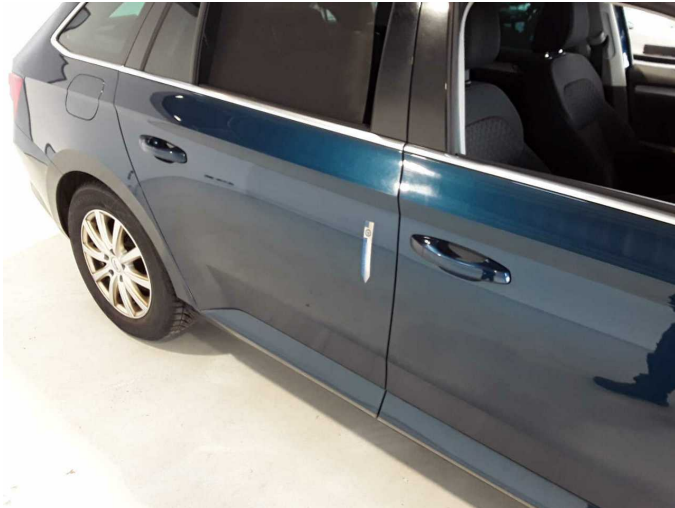
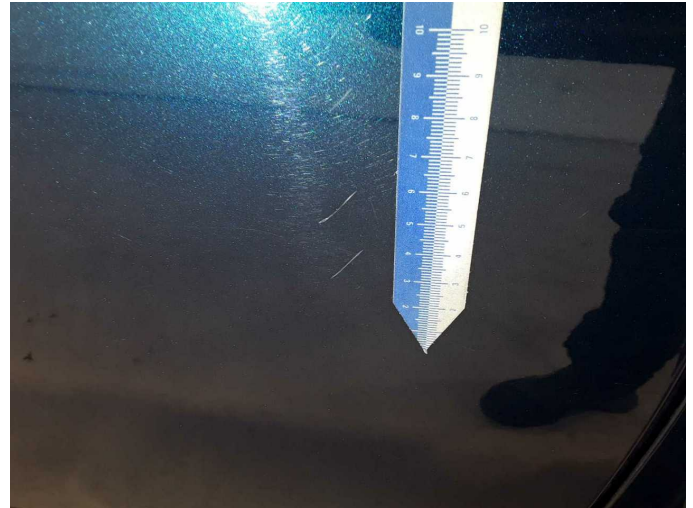
Damage 6: Door - rear right side: Door - Scratch(es) - Paint

| No. | Component group | Description |
|---|---|---|
| 6 | Door - rear right side | Door - Scratch(es) - Paint |

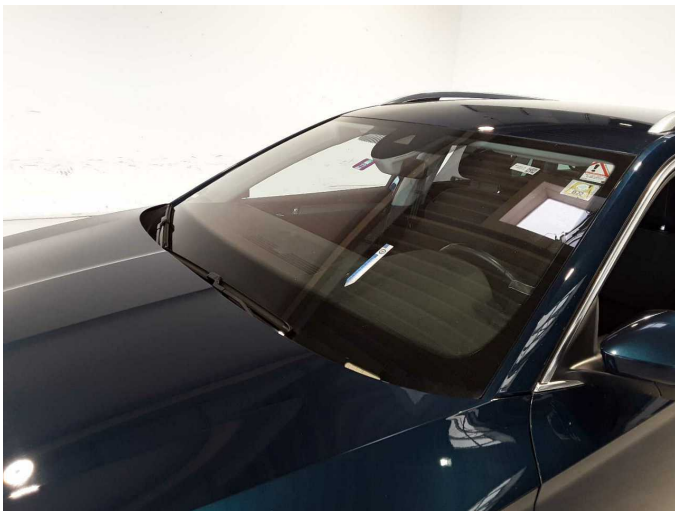
Damage 7: Vehicle glazing: Windscreen - Broken / torn - Replace

| No. | Component group | Description |
|---|---|---|
| 7 | Vehicle glazing | Windscreen - Broken / torn - Replace |

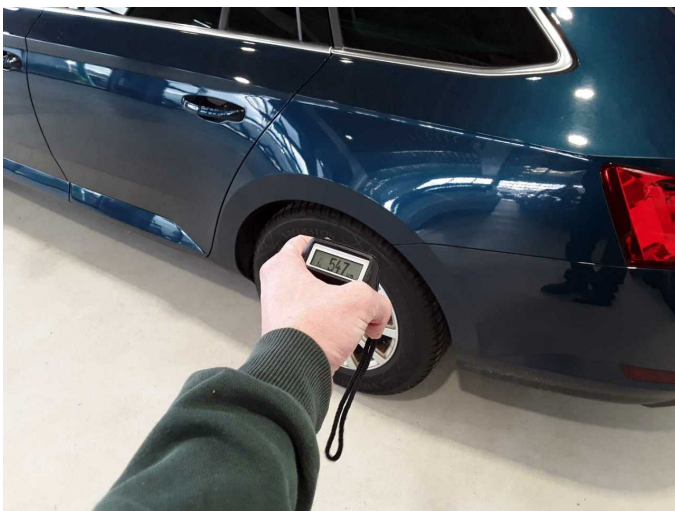
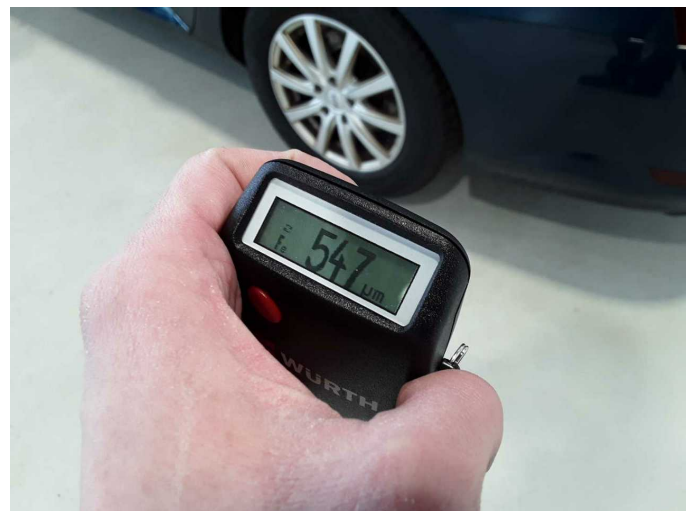
1 Side panel - rear left side, Professionally carried out, Invoice of repair done Non-existent

Side panel - rear left side 547 µm |

Repainting 1: Side panel - rear left side
