## Expertise

Protocol number: 46313961  
Order No. / Reference: 26121154  
Inspection date: 2 Jul 2026

Manufacturer: Mercedes-Benz

Model: C 200 d T 9G-TRONIC

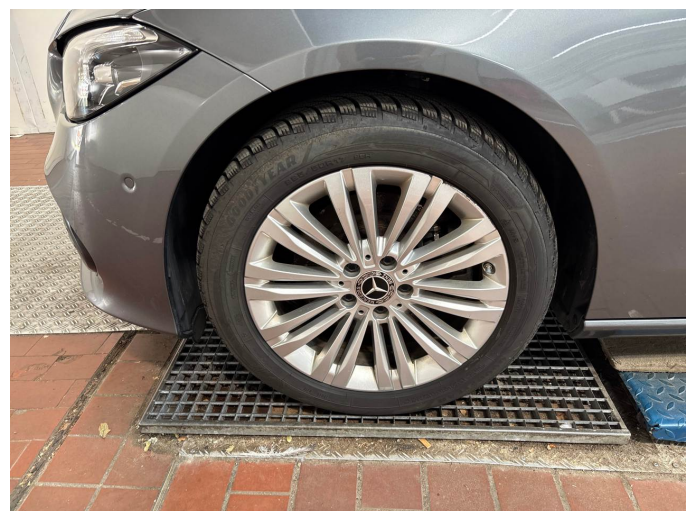
Figure 12: Mounted tyres

| # | Tyre size | Type of tyre | Manufacturer | Tread depth |
|---|---|---|---|---|
| 1) | 225/50 R17 98H | Winter tyres on Light alloy | Goodyear | 9mm / 9mm |
| 2) | 225/50 R17 98H | Winter tyres on Light alloy | Goodyear | 9mm / 9mm |

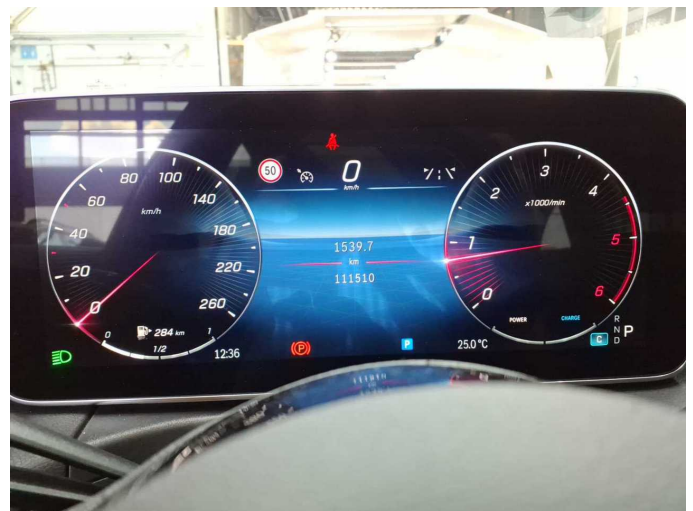
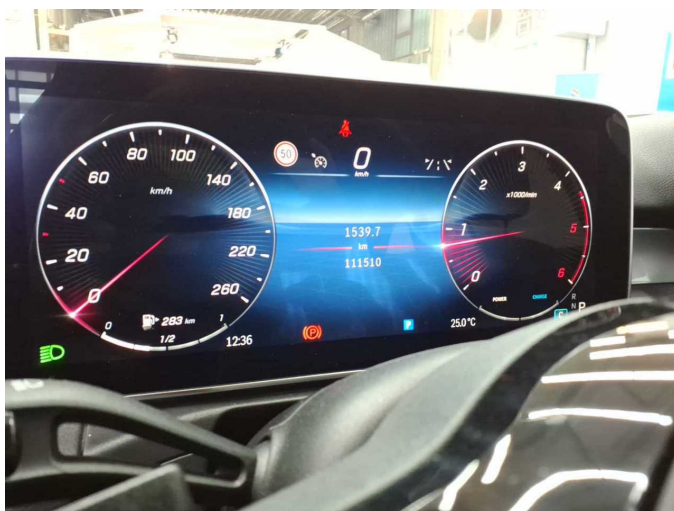
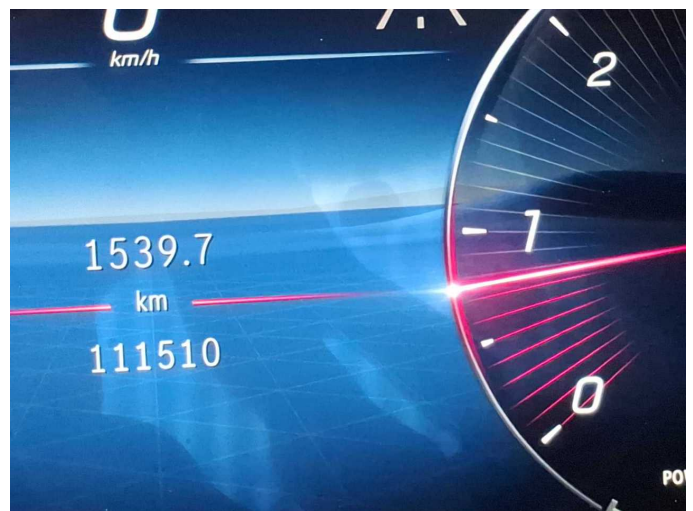
Damage 4: Instrument panel: Instrument cluster (Bildschirm Flecken) - Perform diagnosis

| No. | Component group | Description |
|---|---|--|
| 4 | Instrument panel | Instrument cluster (Bildschirm Flecken) - Perform diagnosis |

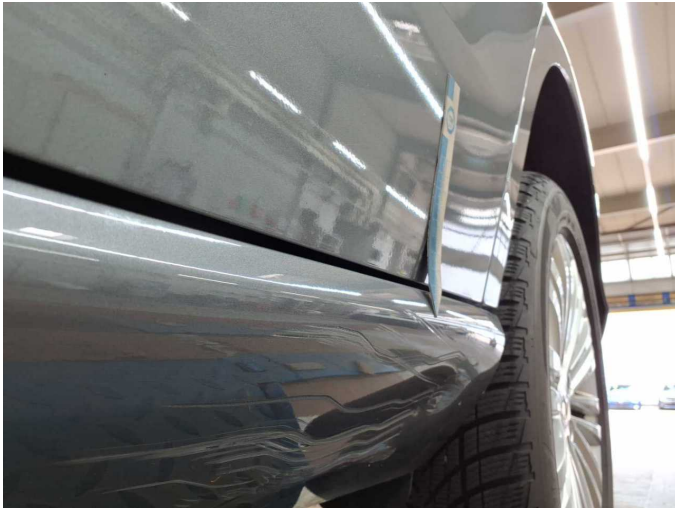
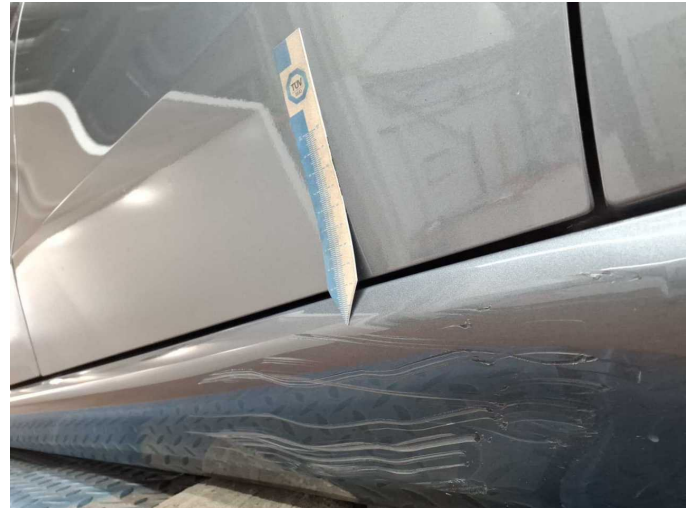
**Damage 5:** Sill - left side: Trim - Dent / paintcoat damage - Replace

| No. | Component group | Description |
|---|---|--|
| 5 | Sill - left side | Trim - Dent / paintcoat damage - Replace |

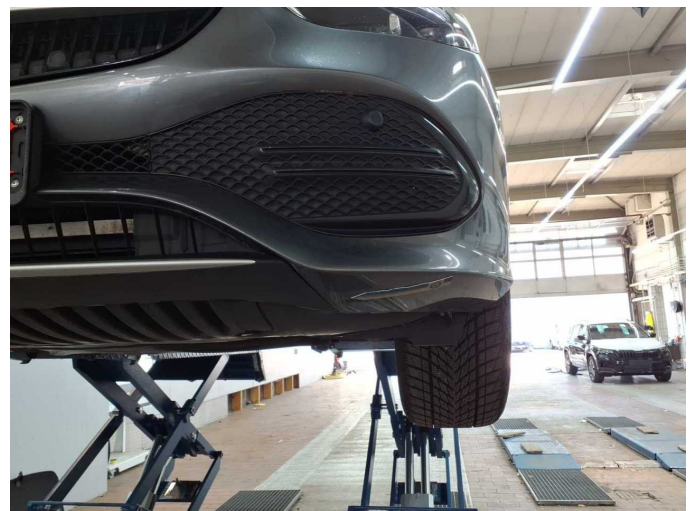
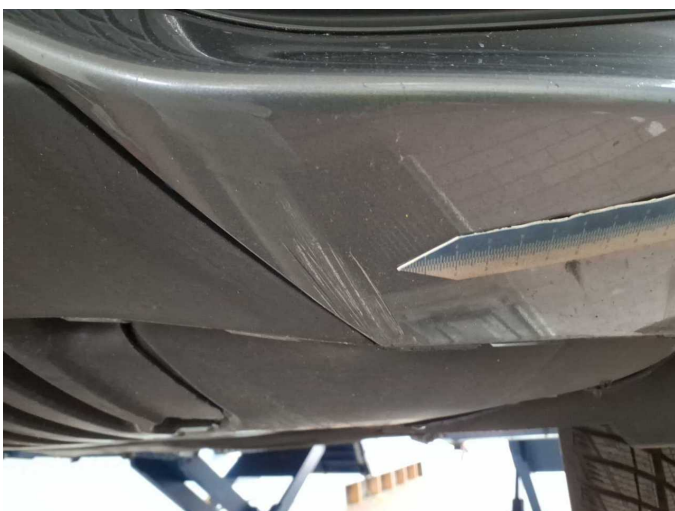
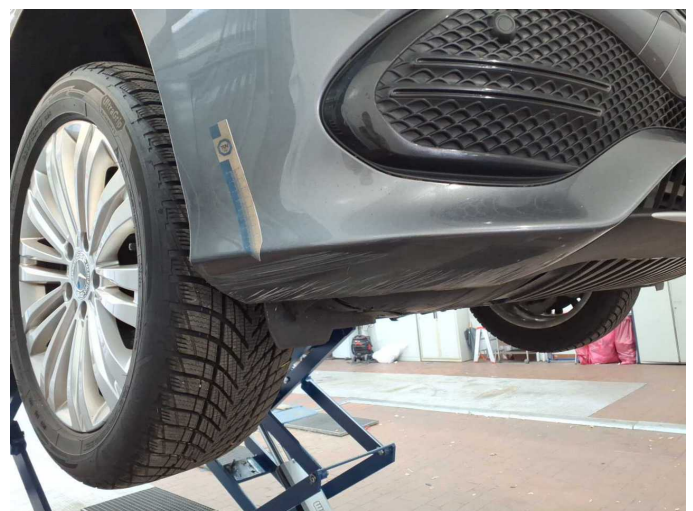
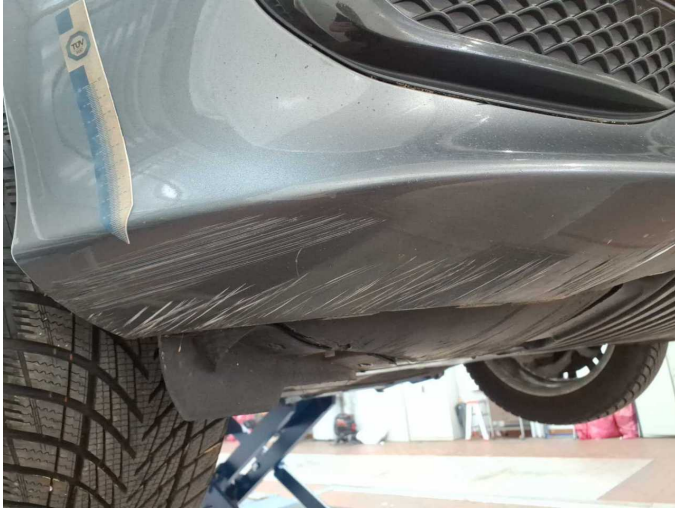
**Damage 6:** Front bumper: Front bumper - Scratch(es) - Paint

| No. | Component group | Description |
|---|---|--|
| 6 | Front bumper | Front bumper - Scratch(es) - Paint |
