Expertise

Protocol number: 45914293  
Order No. / Reference: 26415281  
Inspection date: 12 Jun 2026

Manufacturer: Skoda  
VIN: TMBLN7PS3ST062895

Model: Kodiahq 2.0 TDI 4x4 DSG Selection

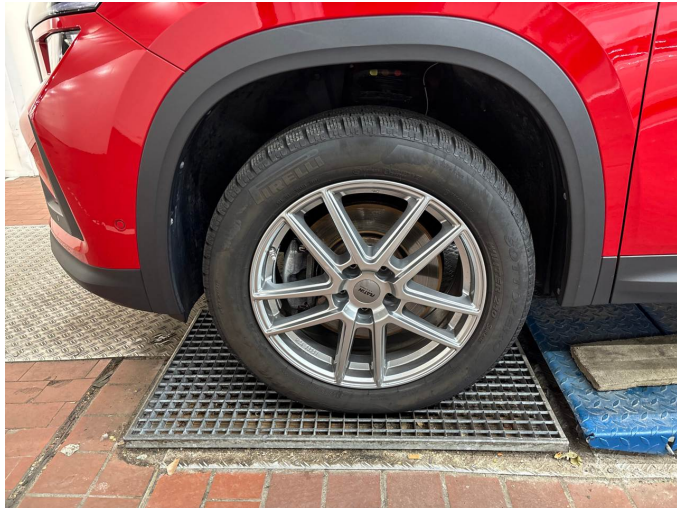
Figure 13: Mounted tyres

| # | Tyre size | Type of tyre | Manufacturer | Tread depth |
|---|---|---|---|---|
| 1) | 235/55 R18 104H | Winter tyres on Light alloy | Pirelli | 5mm / 5mm |
| 2) | 235/55 R18 104H | Winter tyres on Light alloy | Pirelli | 6mm / 6mm |

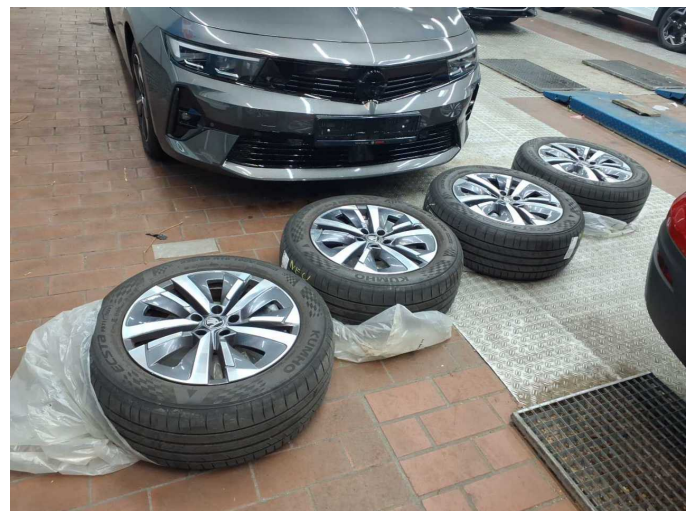
Figure 16: Additional tyres

| # | Tyre size | Type of tyre | Manufacturer | Tread depth |
|---|---|---|---|---|
| 1) | 235/55 R18 100V | Summer tyres on Light alloy | Kumho | 5mm / 5mm |
| 2) | 235/55 R18 100V | Summer tyres on Light alloy | Kumho | 5mm / 5mm |

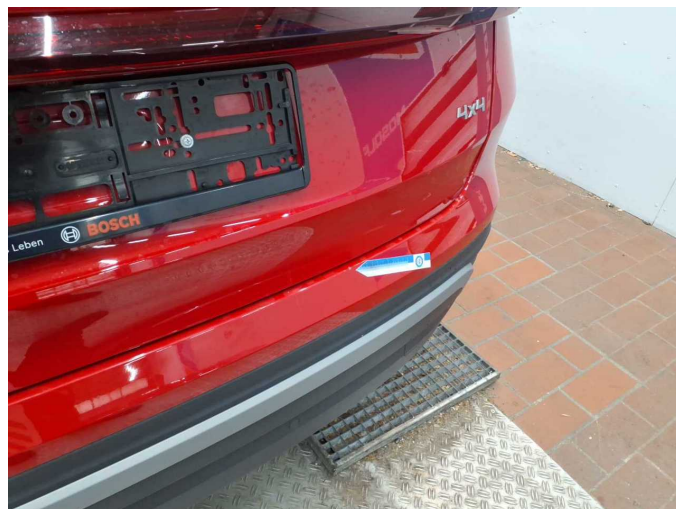
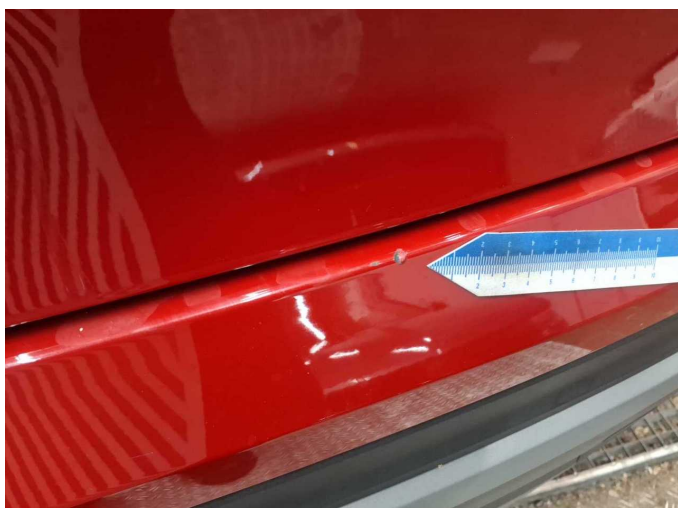
| No. | Component group | Description |
|---|---|---|
| 1 | Rear bumper | Rear bumper - Scratch(es) - Smart repair |

**Damage 1:** Rear bumper: Rear bumper - Scratch(es) - Smart repair

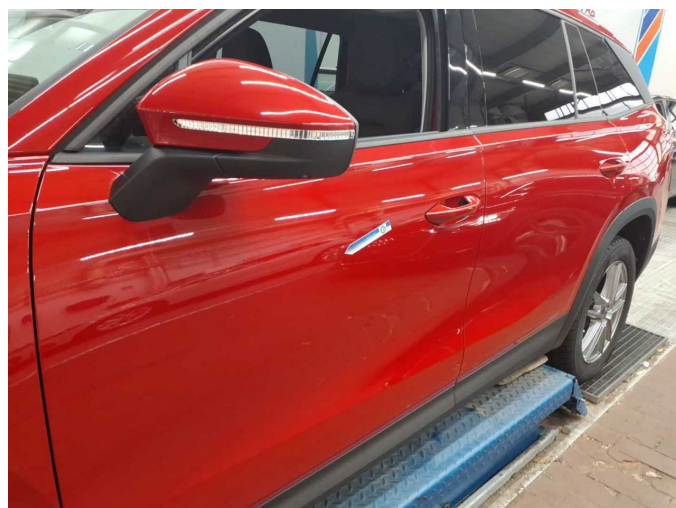
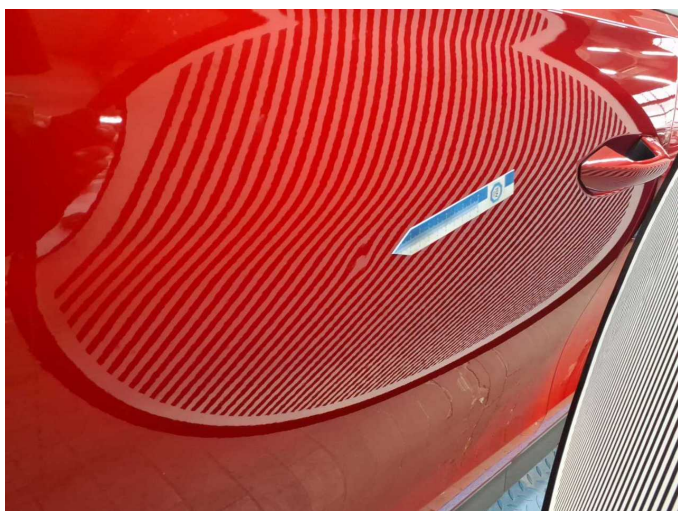
| No. | Component group | Description |
|---|---|---|
| 2 | Door - front left side | Door - dent(s) - Smart repair |

**Damage 2:** Door - front left side: Door - dent(s) - Smart repair

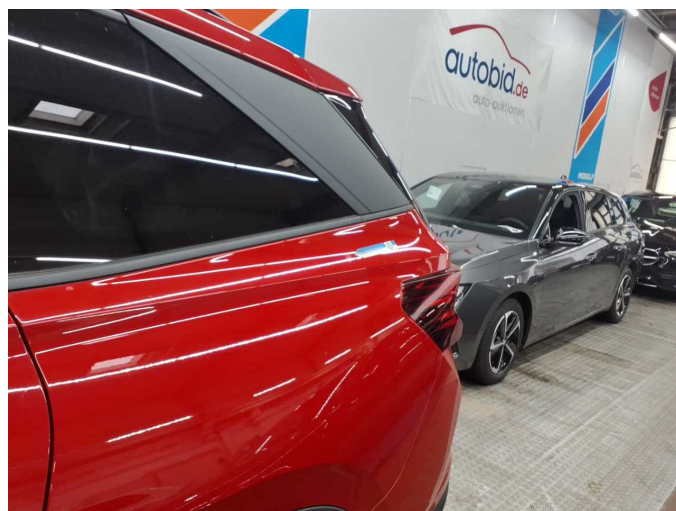
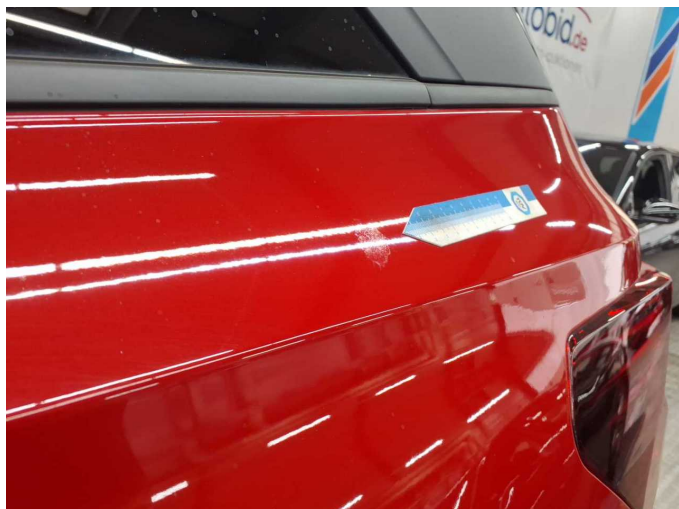
| No. | Component group | Description |
|---|---|---|
| 3 | Side panel - rear left side | Side panel (Verätzungen-Mehrkosten möglich) - Paint defect - Conditioning |

**Damage 3:** Side panel - rear left side: Side panel (Verätzungen-Mehrkosten möglich) - Paint defect - Conditioning

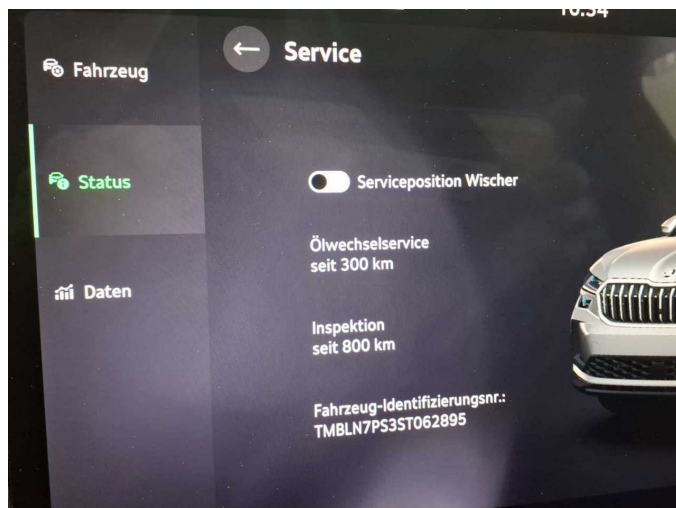
| No. | Component group | Description |
|---|---|---|
| 4 | Misc. | Inspection / maintenance - Due - Perform |

**Damage 4:** Misc.: Inspection / maintenance - Due - Perform

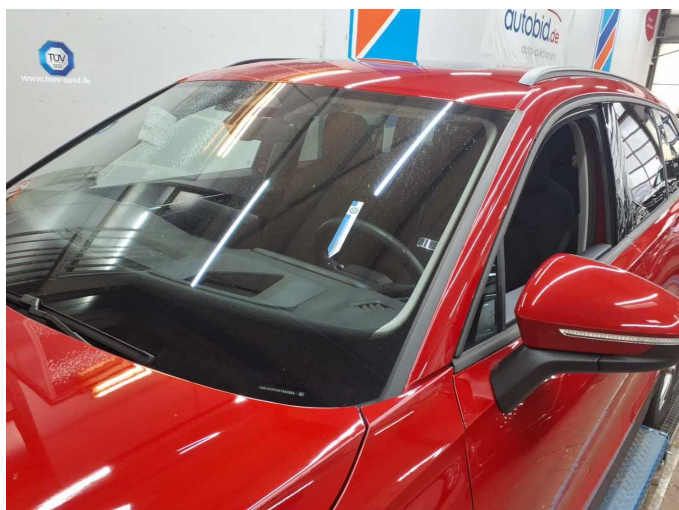
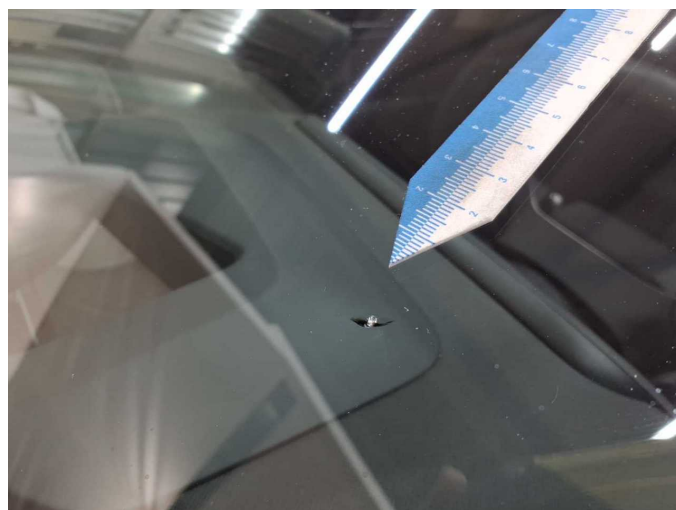
| No. | Component group | Description |
|---|---|---|
| 5 | Vehicle glazing | Windscreen with lane departure assistant - Stone chips - Replace |

**Damage 5:** Vehicle glazing: Windscreen with lane departure assistant - Stone chips - Replace
