Expertise

Protocol number: 46436649  
Order No. / Reference: 26598245  
Inspection date: 9 Jul 2026

Model: 316 CDI Sprinter 4x4 Standard HA 7G-TRONIC Plus

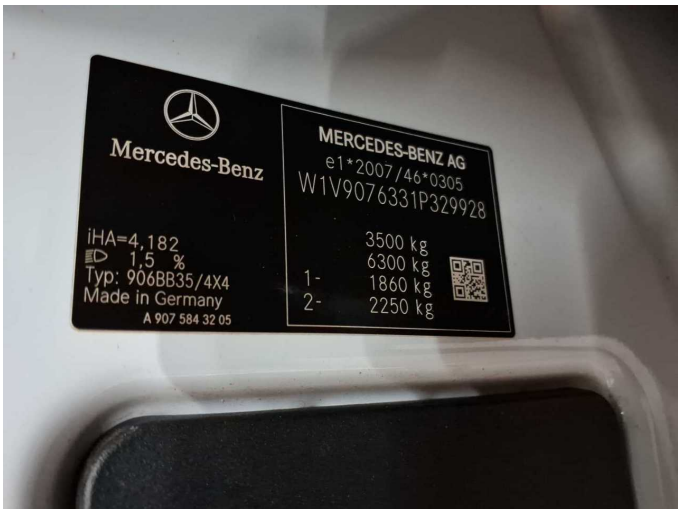
Figure 11: VIN

| VIN comparison | The vehicle identification number (VIN) was read from the vehicle and its conformity with the submitted documents was confirmed by the undersigned during the inspection. |

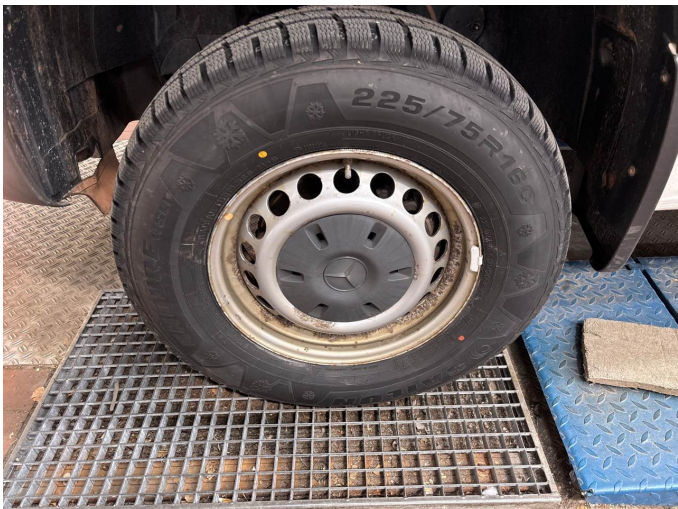
Figure 12: Mounted tyres

| Tyres | | | | |
|---|---|---|---|---|
| 1) | 225/75 R16 121R | Winter tyres on Steel | Sonstige | 7mm / 7mm |
| 2) | 225/75 R16 121R | Winter tyres on Steel | Sonstige | 7mm / 7mm |

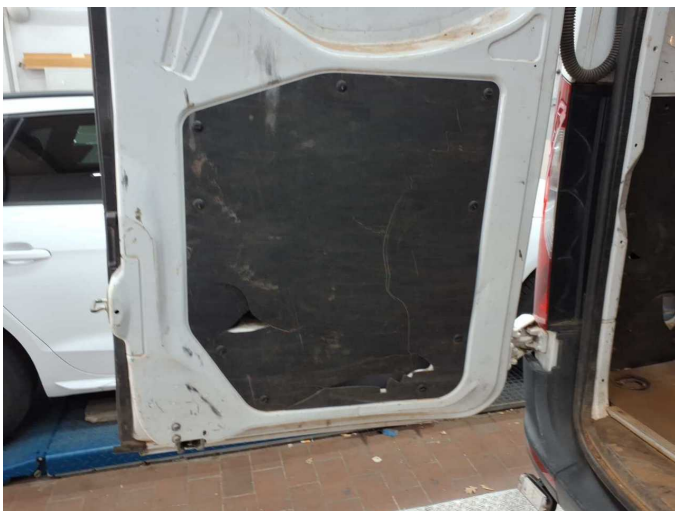
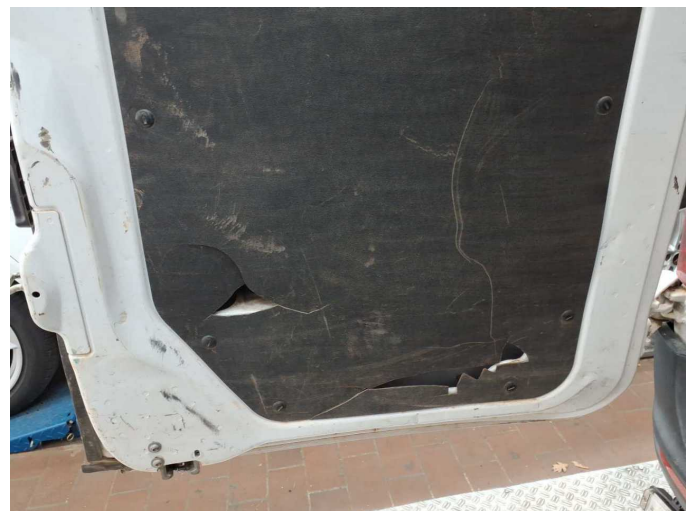
| No. | Component group | Description |
|---|---|---|
| 1 | Boot lid / rear door | Rear door - left side (Verkleidung) - Broken / torn - Replace |

**Damage 1:** Boot lid / rear door: Rear door - left side (Verkleidung) - Broken / torn - Replace

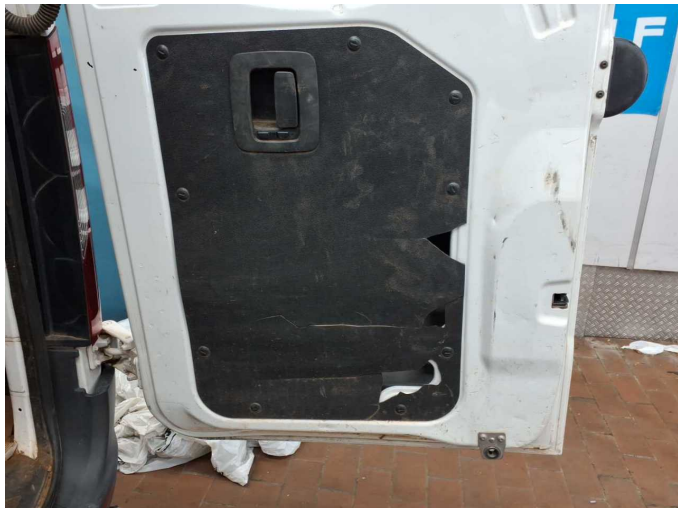
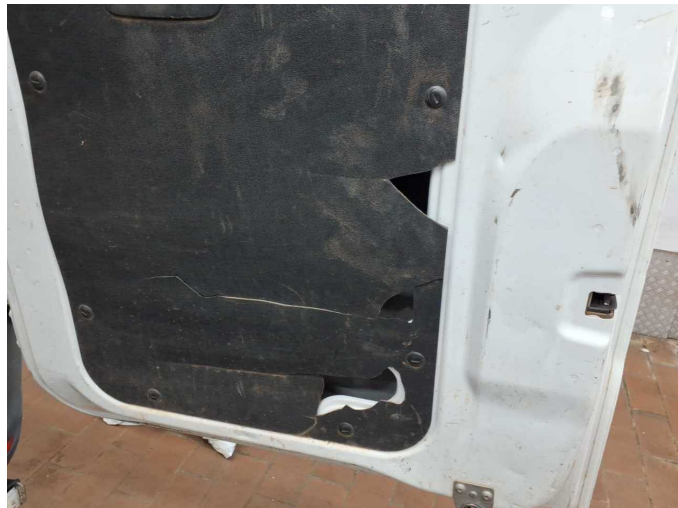
| No. | Component group | Description |
|---|---|---|
| 2 | Boot lid / rear door | Rear door - right side (Verkleidung) - Broken / torn - Replace |

**Damage 2:** Boot lid / rear door: Rear door - right side (Verkleidung) - Broken / torn - Replace

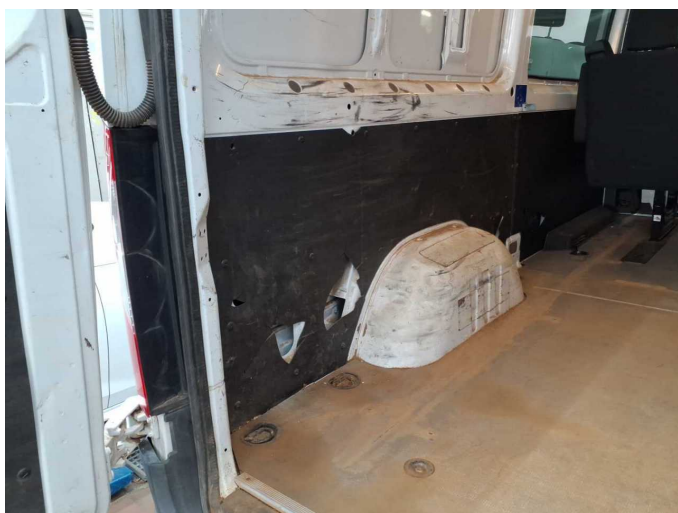
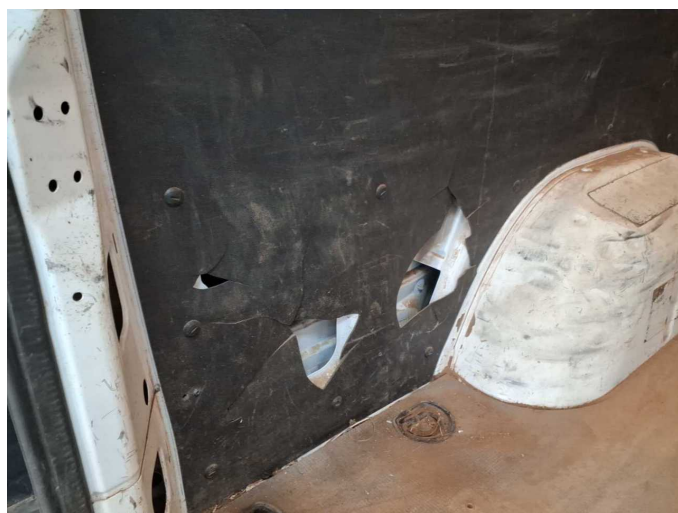
| No. | Component group | Description |
|---|---|---|
| 3 | Side panel - rear left side | Interior trim - Broken / torn - Replace |

**Damage 3:** Side panel - rear left side: Interior trim - Broken / torn - Replace

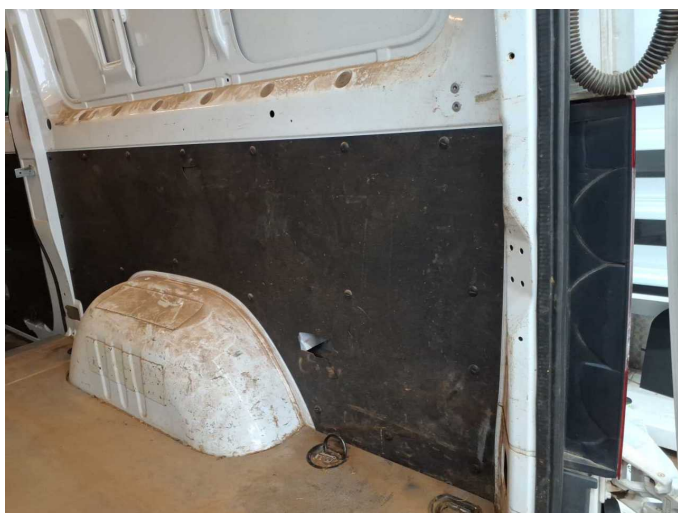
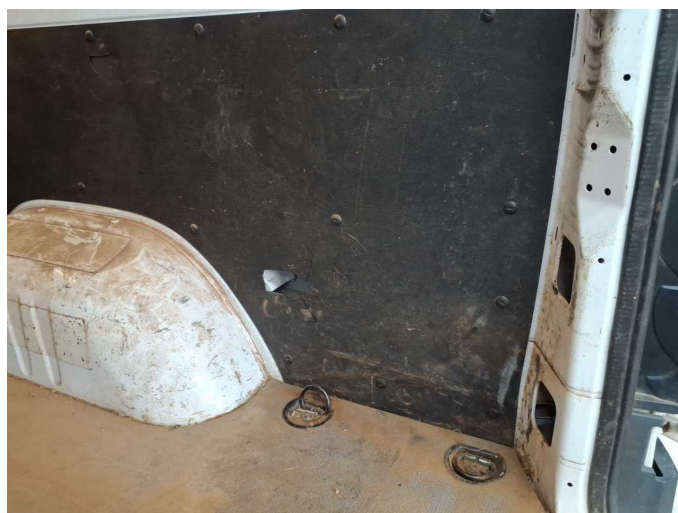
| No. | Component group | Description |
|---|---|---|
| 4 | Side panel - rear right side | Interior trim - Broken / torn - Replace |

**Damage 4:** Side panel - rear right side: Interior trim - Broken / torn - Replace

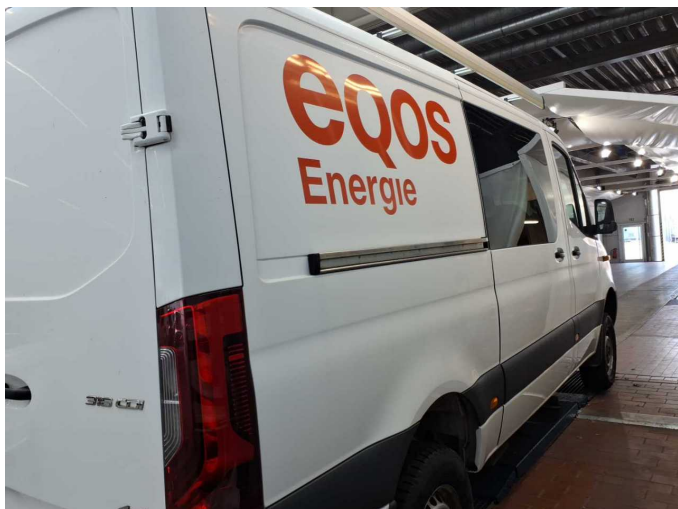
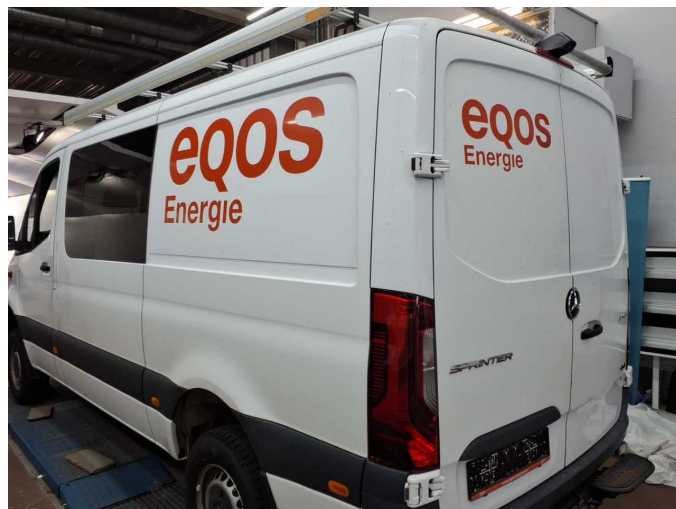
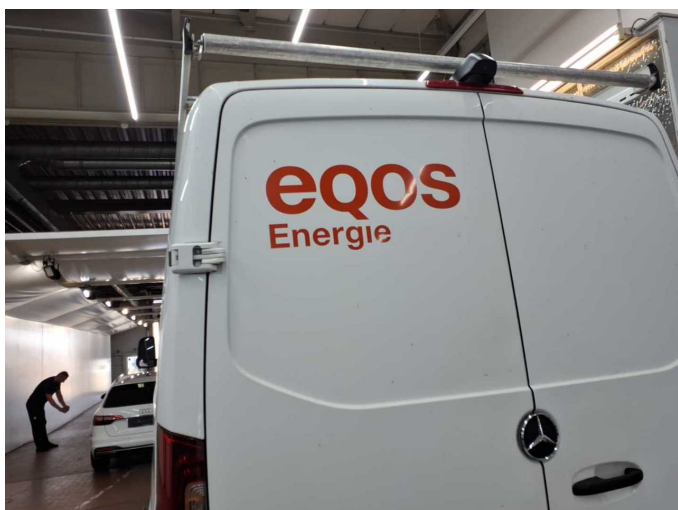
| No. | Component group | Description |
|---|---|---|
| 5 | Body | Body - Glued / labelled - De-glue / neutralise |

**Damage 5:** Body: Body - Glued / labelled - De-glue / neutralise

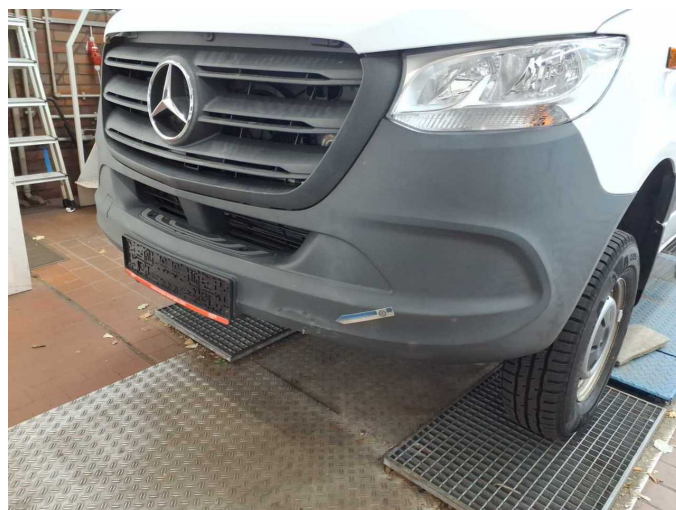
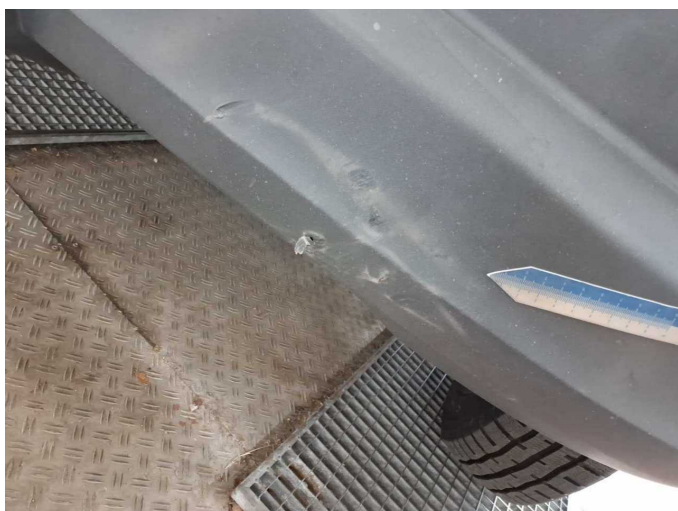
| No. | Component group | Description |
|---|---|---|
| 6 | Front bumper | Front bumper - Damaged - Replace |

**Damage 6:** Front bumper: Front bumper - Damaged - Replace
