Expertise

Protocol number: 46291226  
Order No. / Reference: 26651995  
Inspection date: 2 Jul 2026

Manufacturer: Ford

Model: Transit Connect 230 L2 S&S Trend

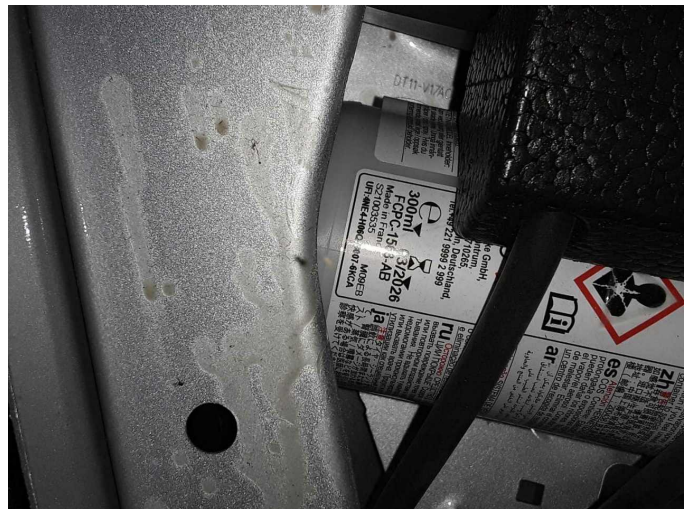
| No. | Component group | Description |
|---|---|---|
| 1 | Equipment | Tirefit filler - Expired - Replace |

**Damage 1:** Equipment: Tirefit filler - Expired - Replace

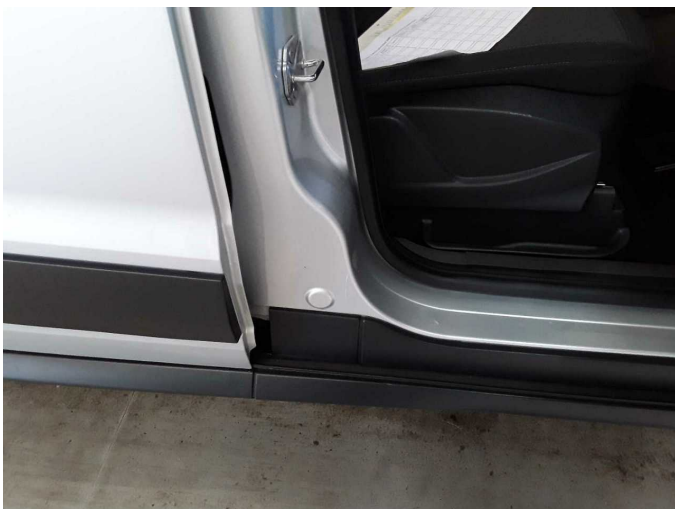
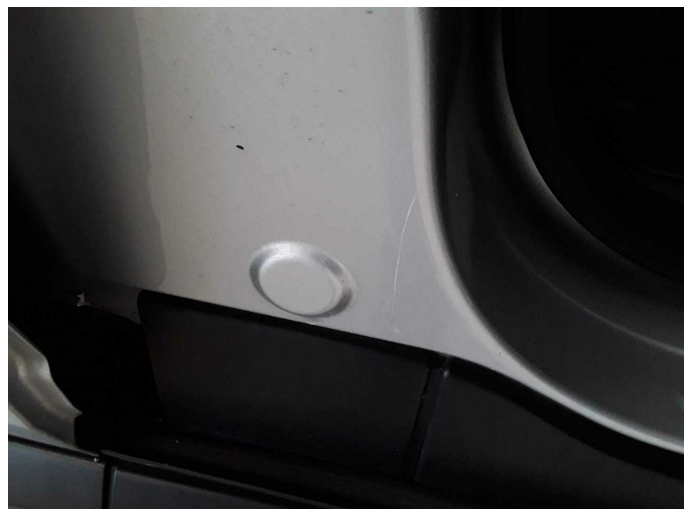
| No. | Component group | Description |
|---|---|---|
| 2 | Body | B-pillar - right side - Scratch(es) - Smart repair |

**Damage 2:** Body: B-pillar - right side - Scratch(es) - Smart repair

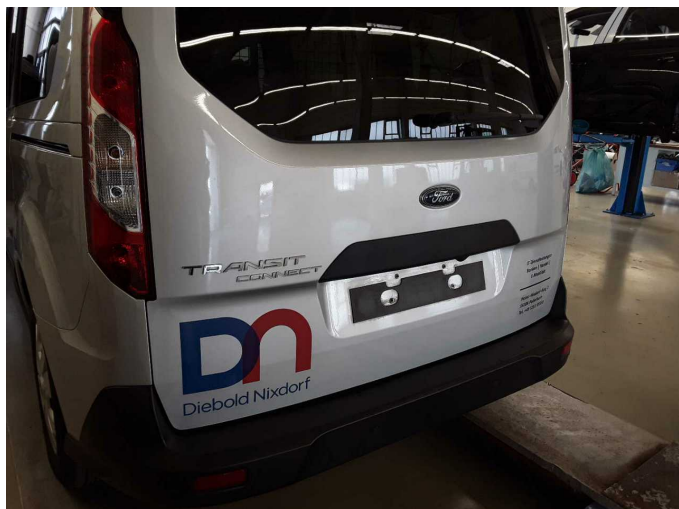
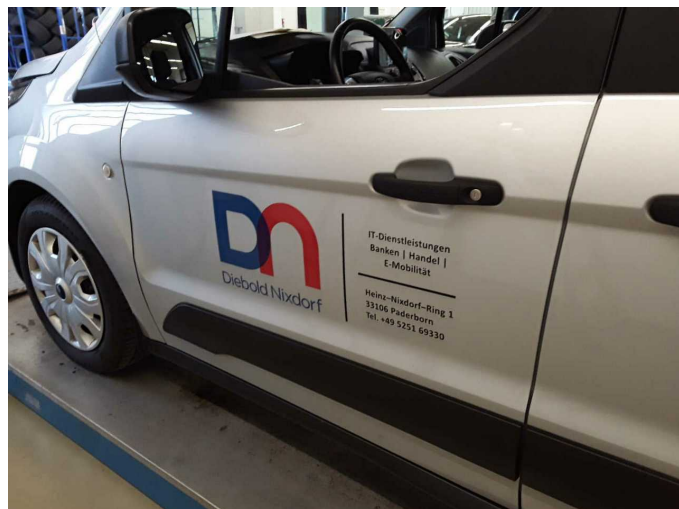
| No. | Component group | Description |
|---|---|---|
| 3 | Body | Body (Zusatzkosten können entstehen) - Glued / labelled - De-glue / neutralise |

**Damage 3:** Body: Body (Zusatzkosten können entstehen) - Glued / labelled - De-glue / neutralise

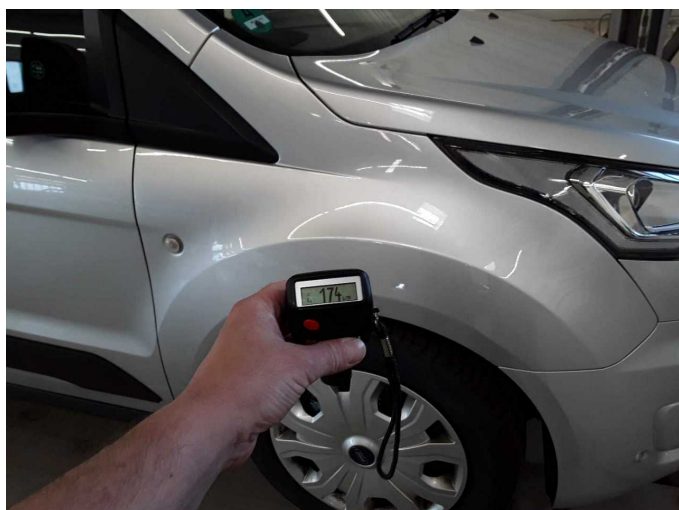
1 Mudguard - right side, Door - front right side, Professionally carried out

| Mudguard - right side | 174 µm | Door - front right side | 165 µm |

**Mudguard - right side:** 174 µm

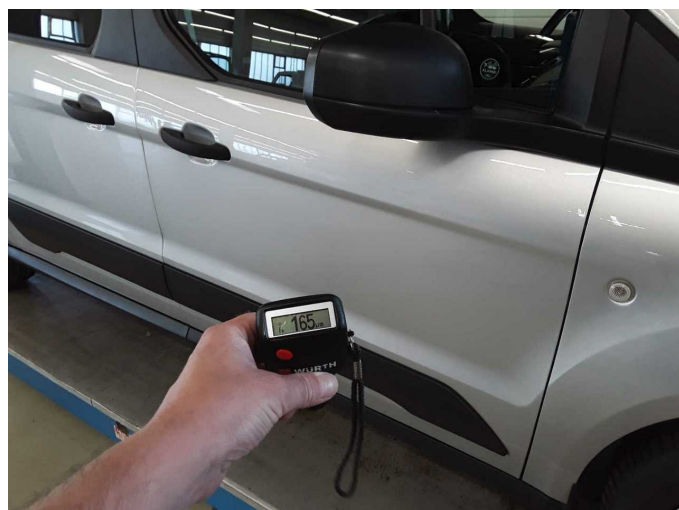
**Door - front right side:** 165 µm
