Expertise

Protocol number: 46919262  
Order No. / Reference: 26687499  
Inspection date: 5 Aug 2026

Manufacturer: Mercedes-Benz

Model: GLC-Coupe 200 d 4Matic 9G-TRONIC AMG Line

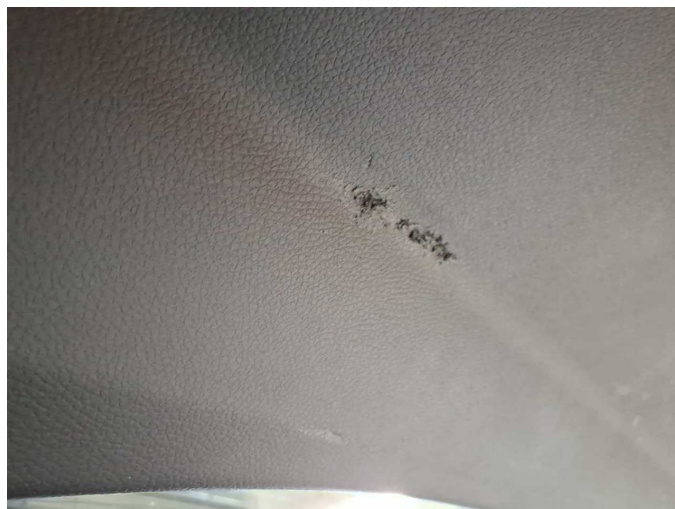
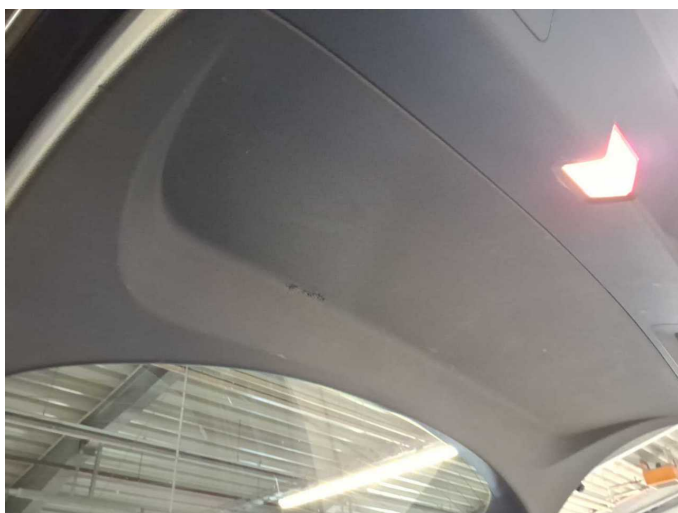
**Damage 1:** Trim / covers: Boot lid - interior trim - Scratched - Smart repair

| No. | Component group | Description |
|---|---|---|
| 1 | Trim / covers | Boot lid - interior trim - Scratched - Smart repair |

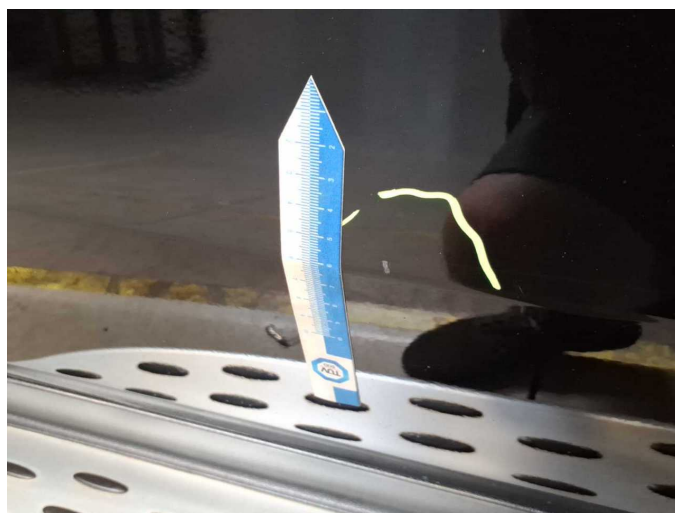
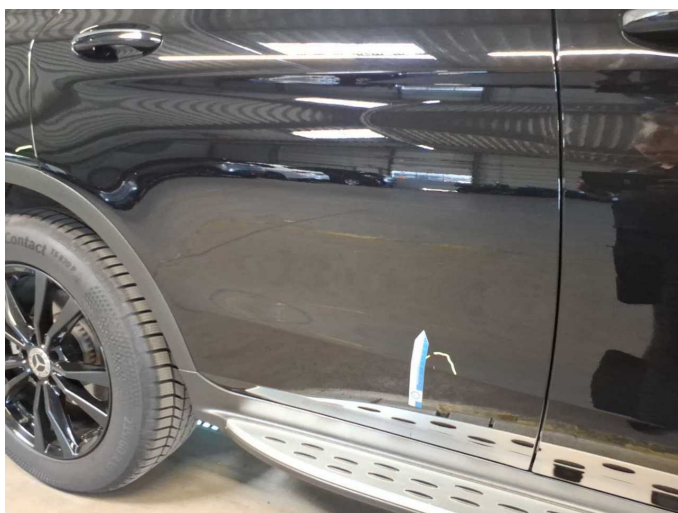
**Damage 2:** Door - rear right side: Door - Scratch(es) - Smart repair

| No. | Component group | Description |
|---|---|---|
| 2 | Door - rear right side | Door - Scratch(es) - Smart repair |

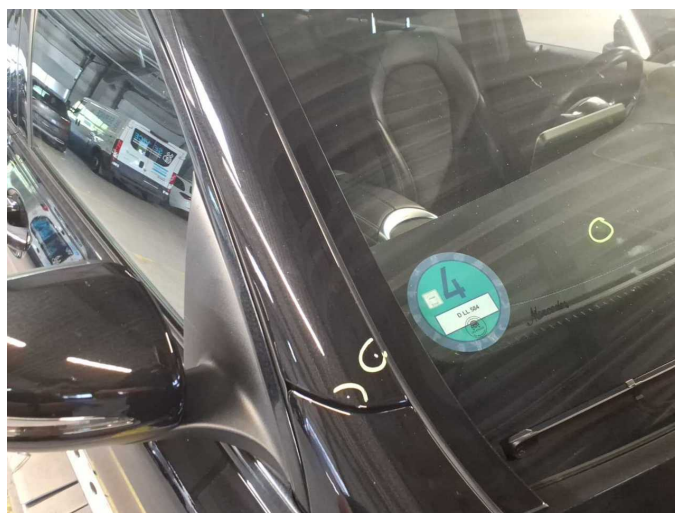
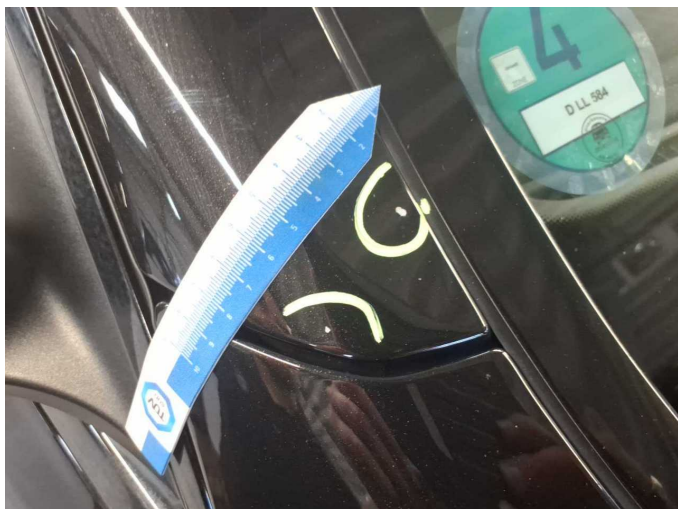
**Damage 3:** Body: A-pillar - right side - Stone chips - Smart repair

| No. | Component group | Description |
|---|---|---|
| 3 | Body | A-pillar - right side - Stone chips - Smart repair |

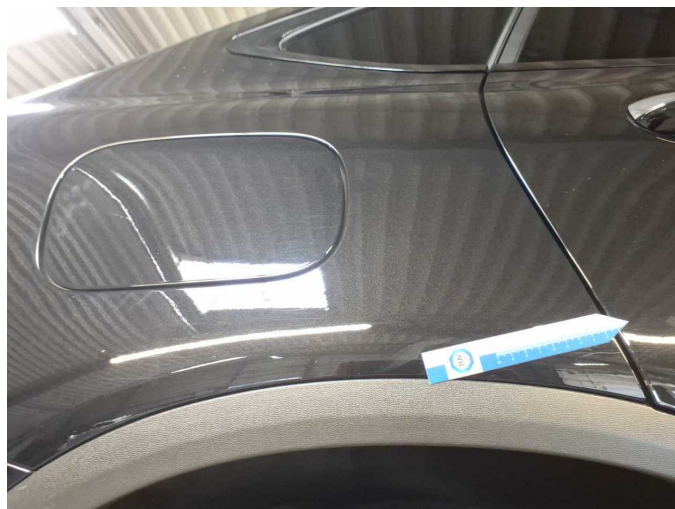
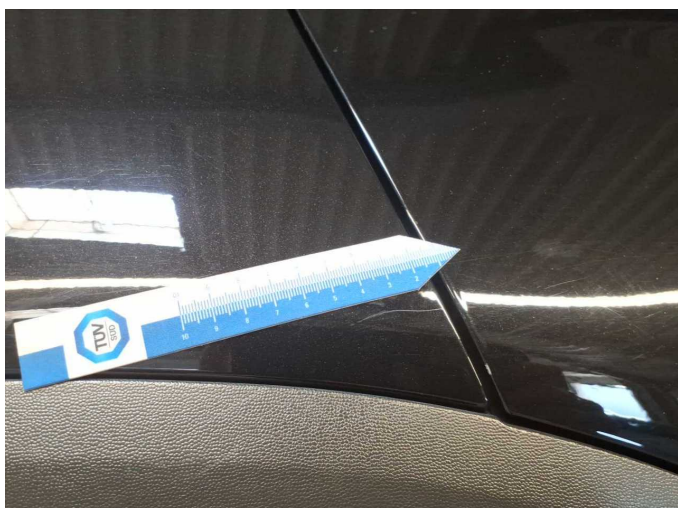
**Damage 4:** Side panel - rear right side: Side panel - Scratch(es) - Smart repair

| No. | Component group | Description |
|---|---|---|
| 4 | Side panel - rear right side | Side panel - Scratch(es) - Smart repair |

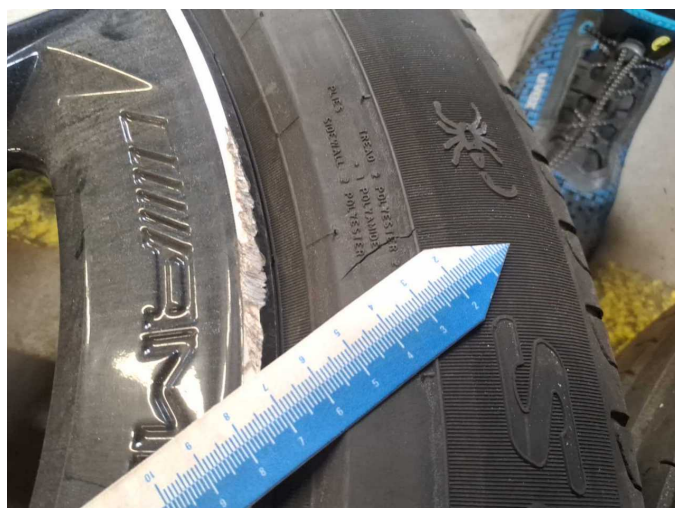
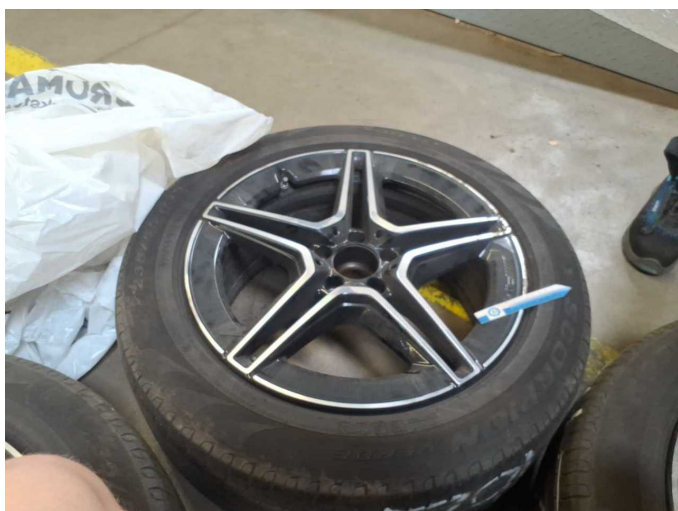
**Damage 5:** 2nd wheel set: 1 tyre - Broken / torn - Replace

| No. | Component group | Description |
|---|---|---|
| 5 | 2nd wheel set | 1 tyre - Broken / torn - Replace |

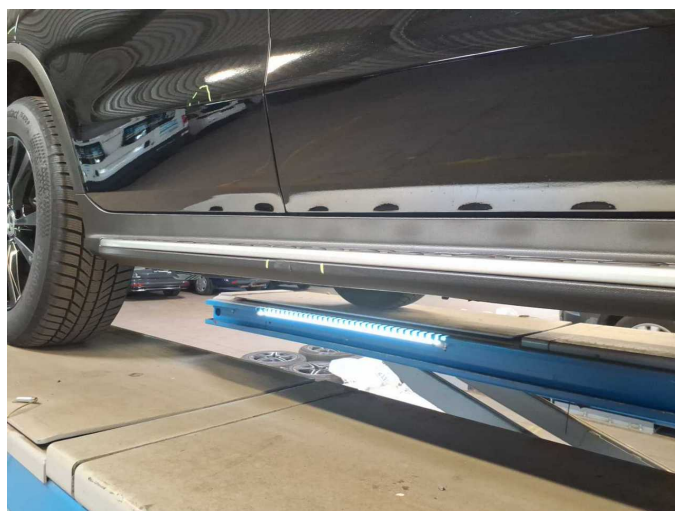
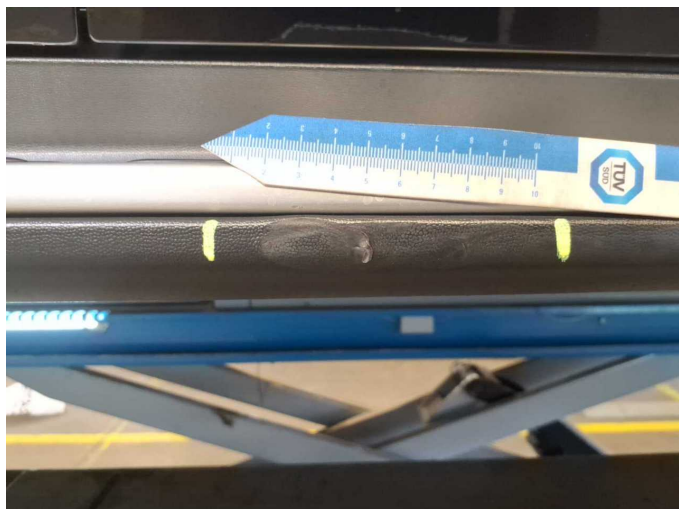
**Damage 6:** Sill - right side: Cat walk - Deformed - Replace

| No. | Component group | Description |
|---|---|---|
| 6 | Sill - right side | Cat walk - Deformed - Replace |

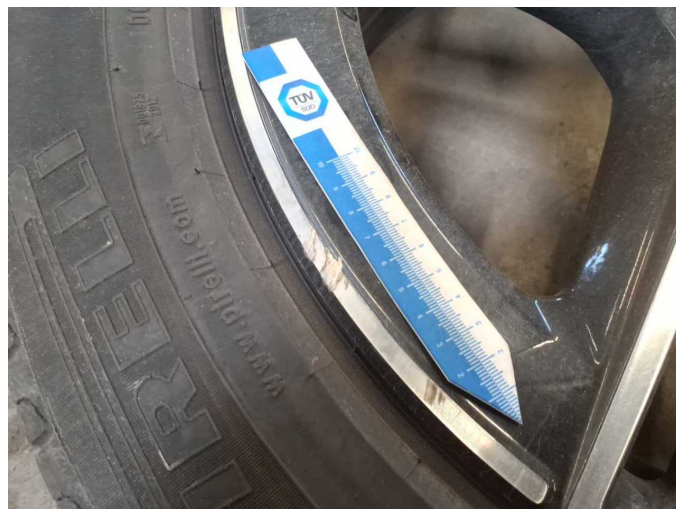
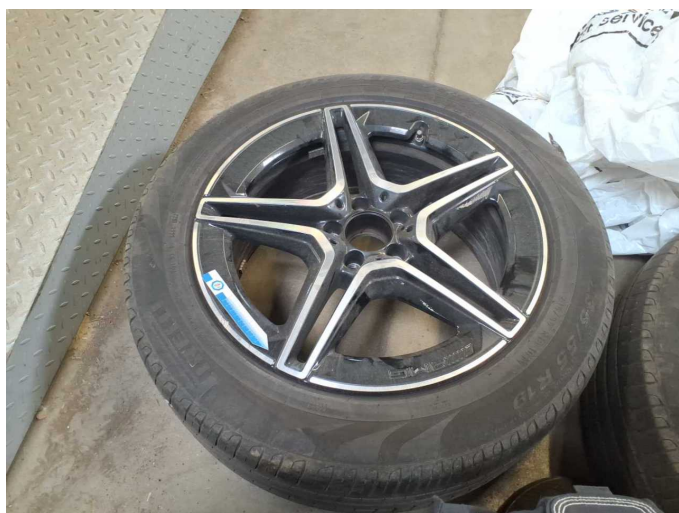
**Damage 7:** 2nd wheel set: 1 alloy rim - Scratched - Loss in value

| No. | Component group | Description |
|---|---|---|
| 7 | 2nd wheel set | 1 alloy rim - Scratched - Loss in value |

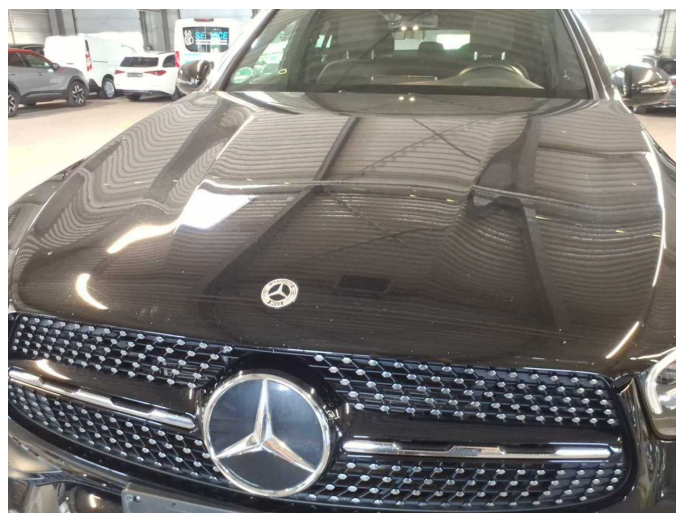
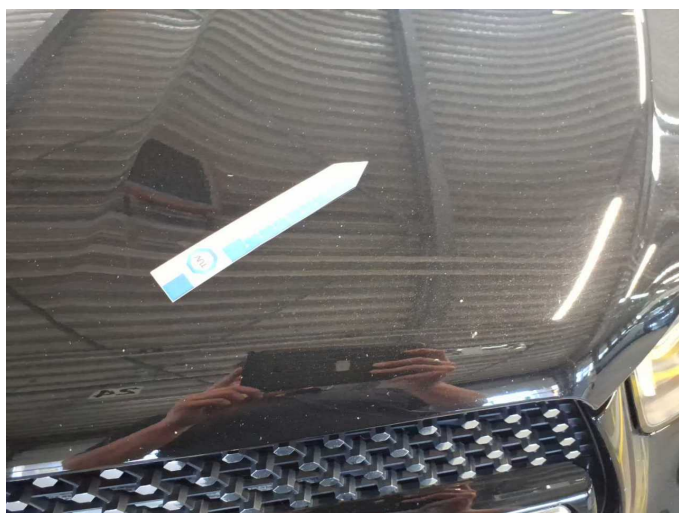
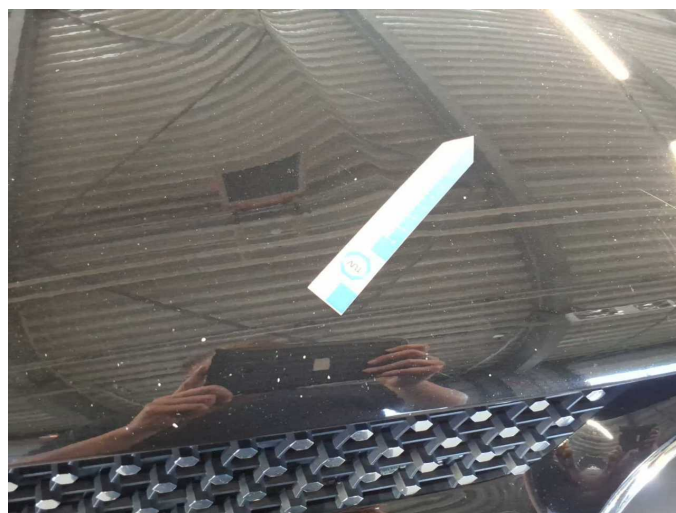
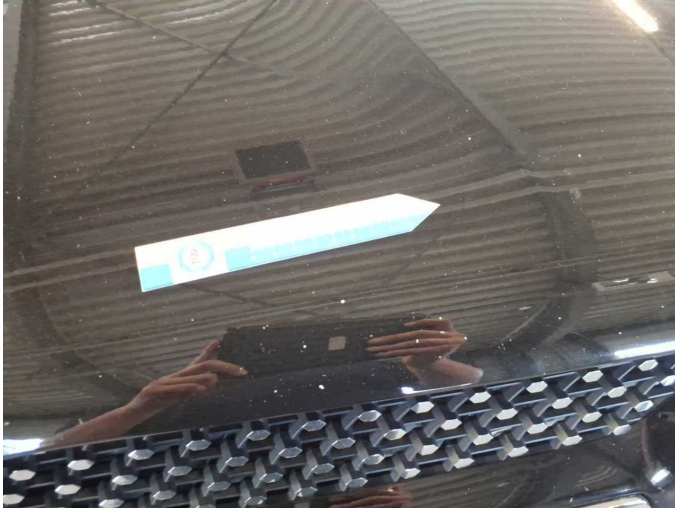
**Damage 8:** Bonnet: Bonnet (Sandstrahleffekt) - Stone chips - Paint

| No. | Component group | Description |
|---|---|---|
| 8 | Bonnet | Bonnet (Sandstrahleffekt) - Stone chips - Paint |

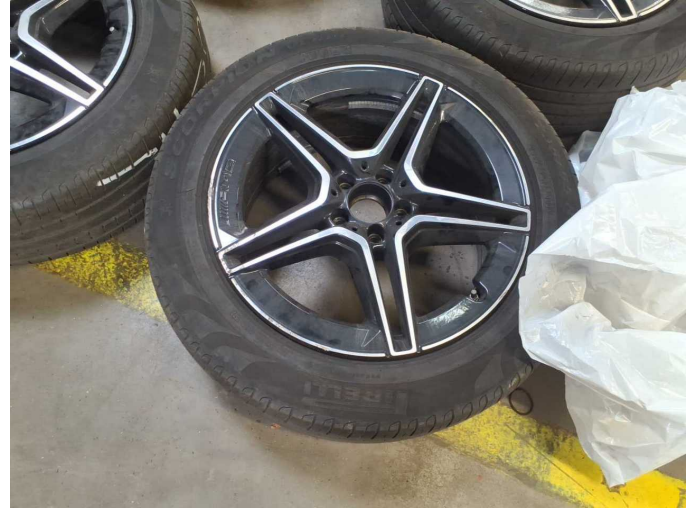
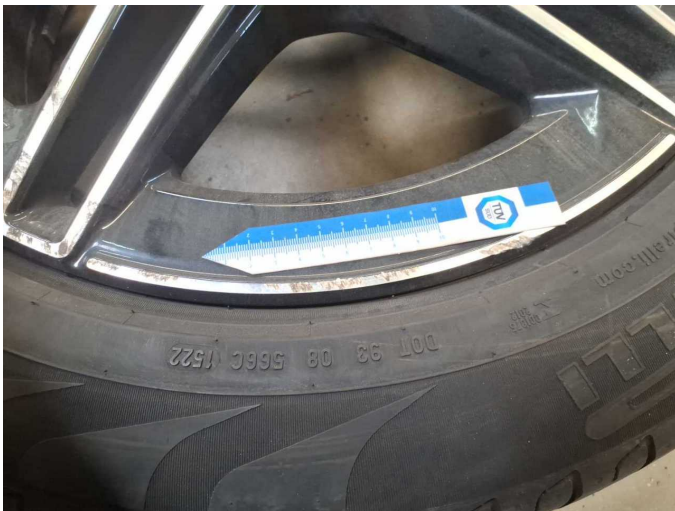
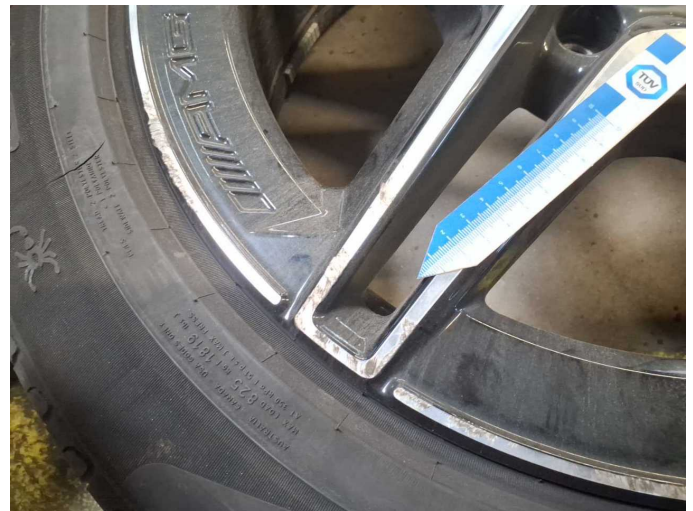
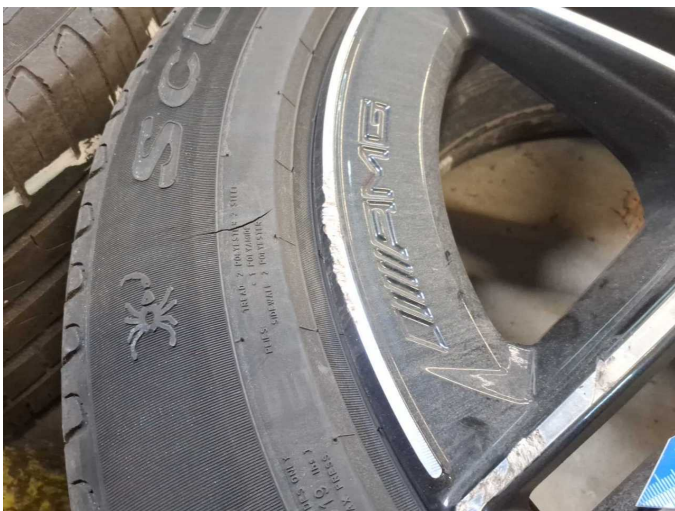
**Damage 9:** 2nd wheel set: 1 alloy rim - Scratched - Replace

| No. | Component group | Description |
|---|---|---|
| 9 | 2nd wheel set | 1 alloy rim - Scratched - Replace |

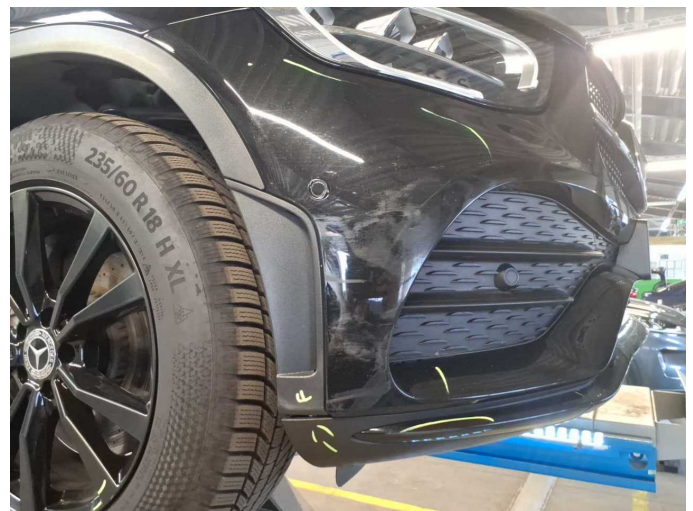
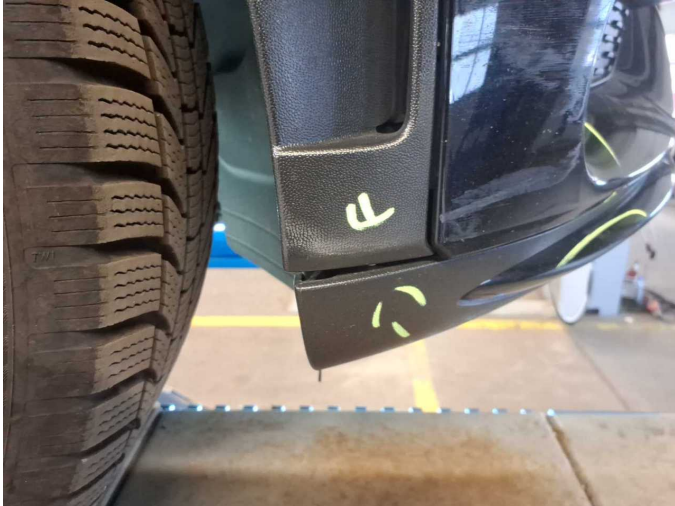
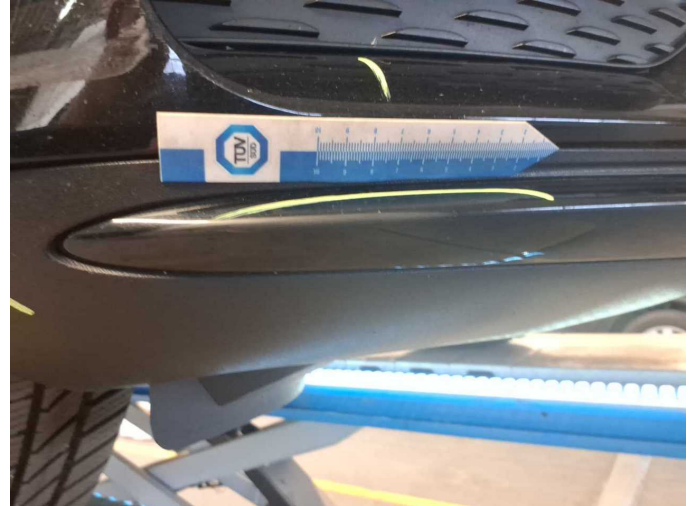
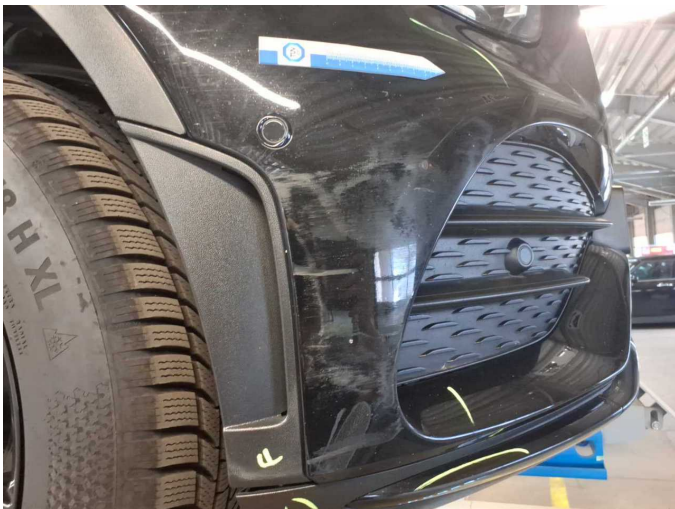
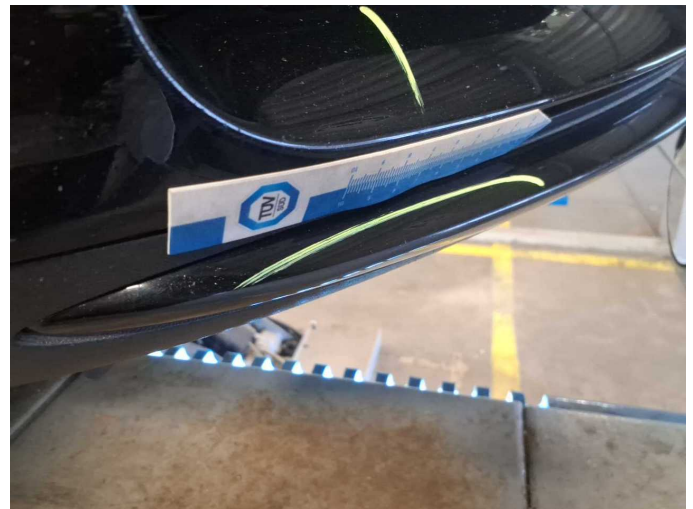
**Damage 10:** Front bumper: Front bumper (+ Blende+Leiste erneuern) - Scratched - Paint

| No. | Component group | Description |
|---|---|---|
| 10 | Front bumper | Front bumper (+ Blende+Leiste erneuern) - Scratched - Paint |

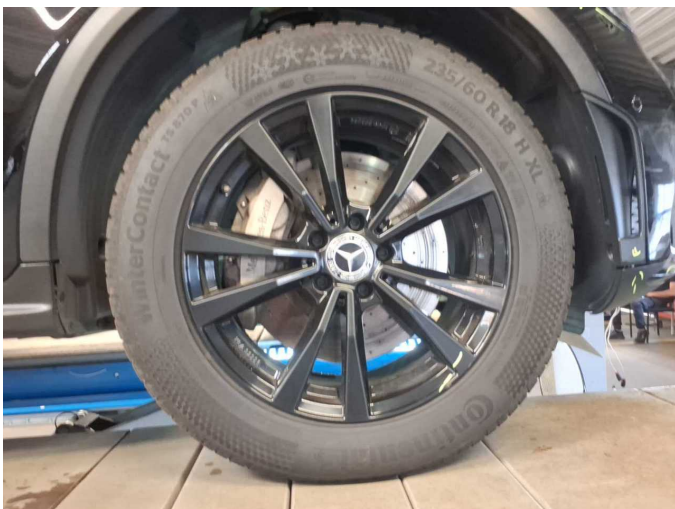
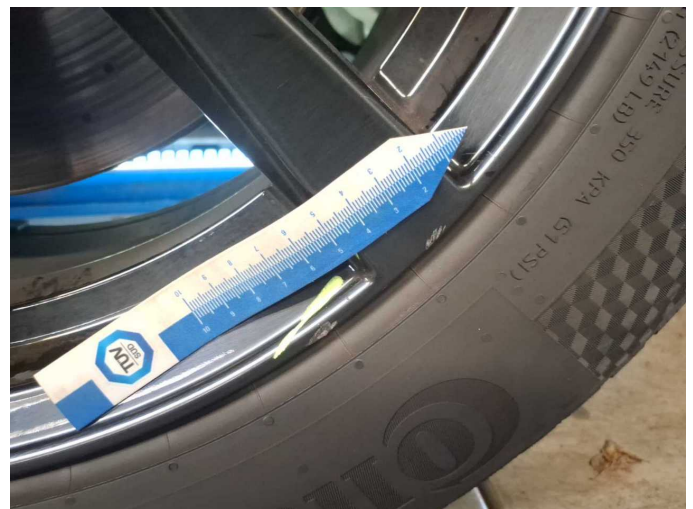
| No. | Component group | Description |
|---|---|---|
| 1 | Wheel / tyres | Alloy rim - front right side - Scratched - No deduction |

**Wear and tear 1:** Wheel / tyres: Alloy rim - front right side - Scratched - No deduction

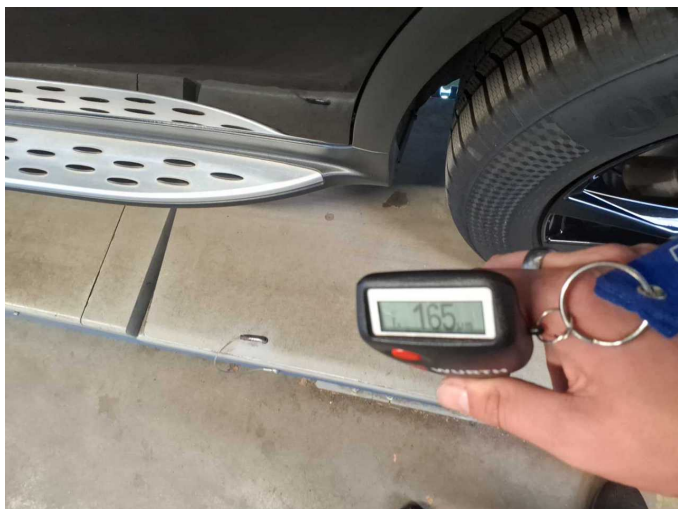
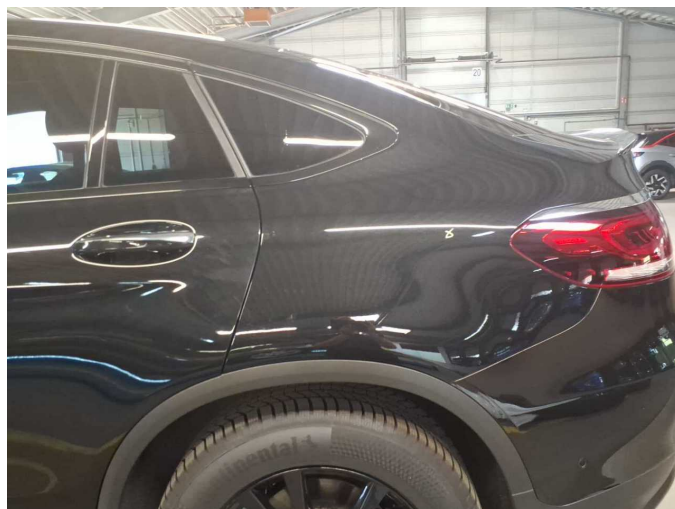
| No. | Repainting |
|---|---|
| 1 | Side panel - rear left side |

**Repainting 1:** Side panel - rear left side

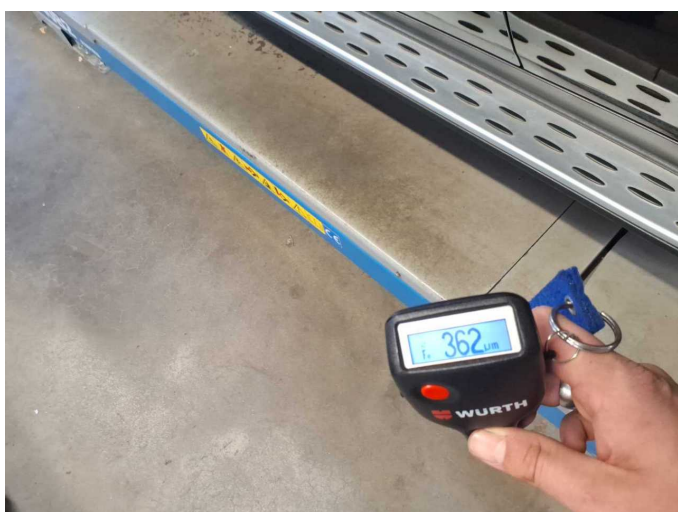
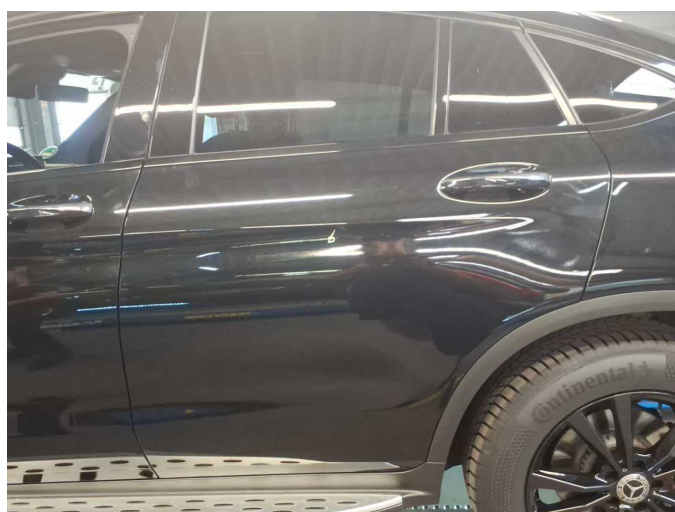
| No. | Repainting |
|---|---|
| 2 | Door - rear left side, Professionally carried out, Invoice of repair done Non-existent |

**Repainting 2:** Door - rear left side

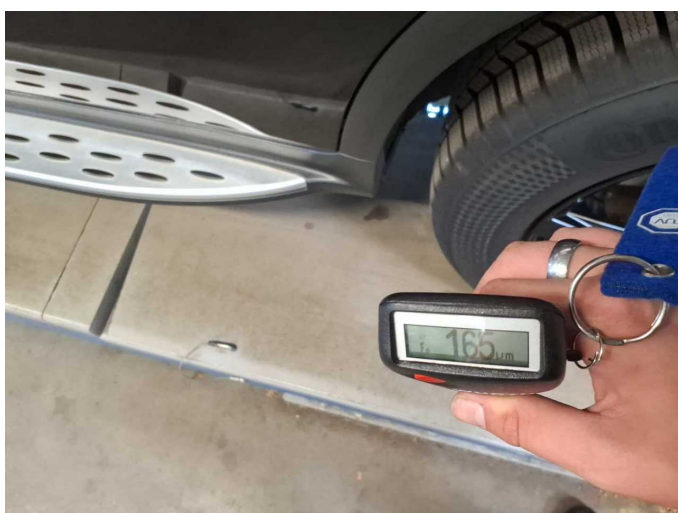
| Side panel - rear left side | 165 µm | Door - rear left side | 362 µm |

**Side panel - rear left side:** 165 µm

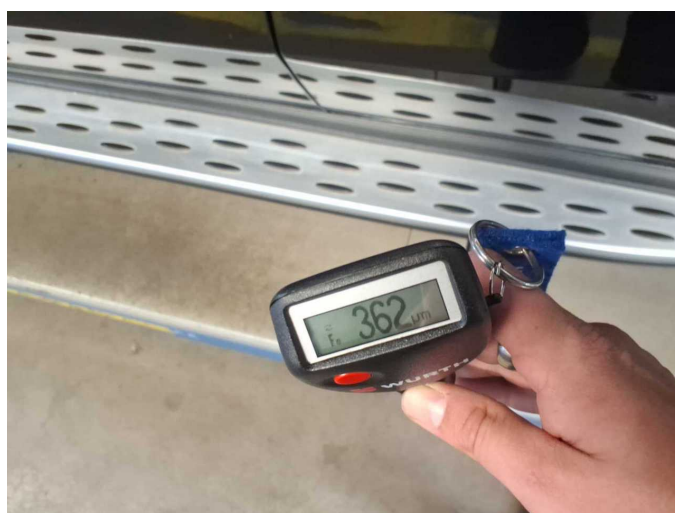
**Door - rear left side:** 362 µm
