Expertise

Protocol number: 46772699  
Order No. / Reference: 26630648  
Inspection date: 28 Jul 2026

| Manufacturer: Ford | Model: Focus Turnier 1.0 EcoBoost Hybrid TITANIUM |
| VIN: WF0PXXGCHPPD64187 | |

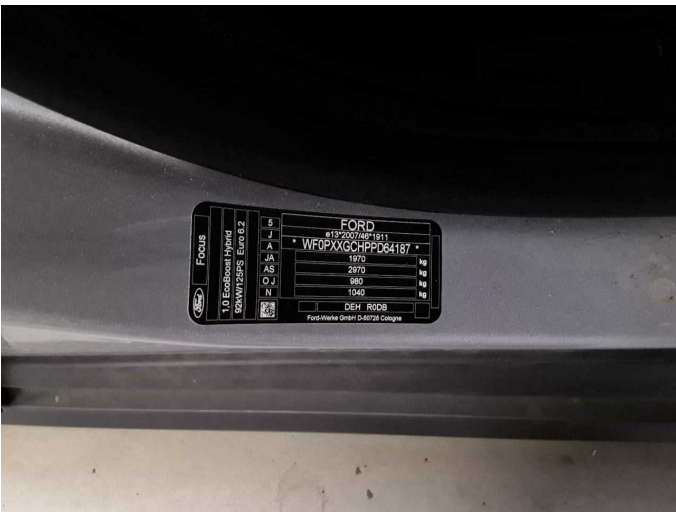
Figure 11: VIN

| VIN comparison | The vehicle identification number (VIN) was read from the vehicle and its conformity with the submitted documents was confirmed by the undersigned during the inspection. |

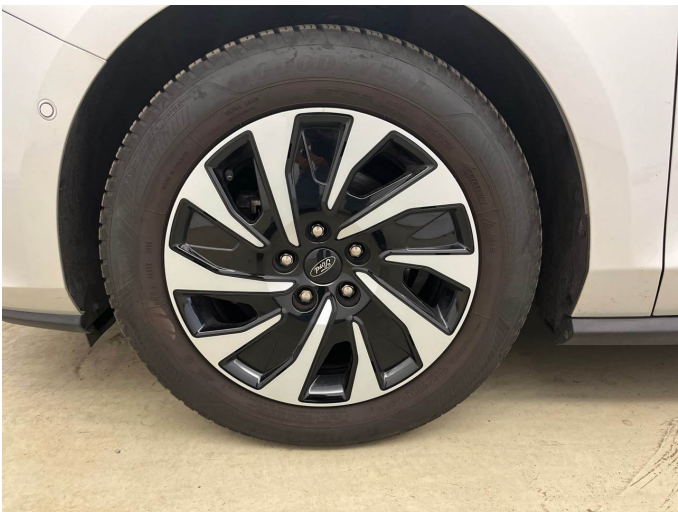
Figure 12: Mounted tyres

| # | Tyre size | Type of tyre | Manufacturer | Tread depth |
|---|---|---|---|---|
| 1) | 205/60 R16 96V | All-season tyres on Light alloy | Goodyear | 7mm / 7mm |
| 2) | 205/60 R16 96V | All-season tyres on Light alloy | Goodyear | 5mm / 5mm |

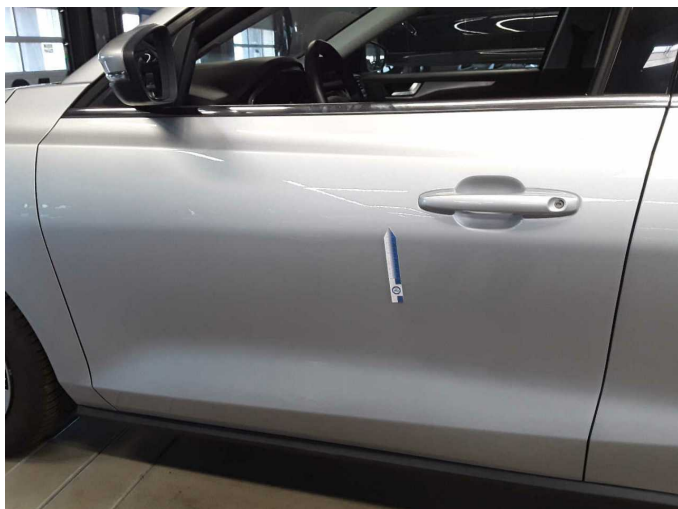
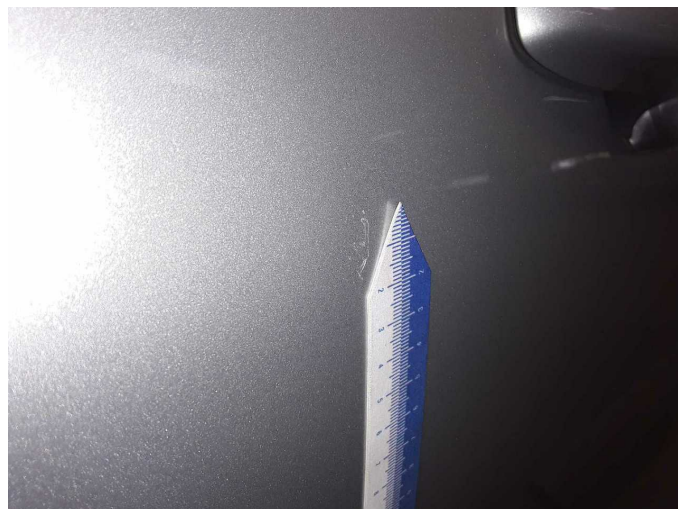
| No. | Component group | Description |
|---|---|---|
| 1 | Door - front left side | Door - Scratch(es) - Smart repair |

**Damage 1:** Door - front left side: Door - Scratch(es) - Smart repair

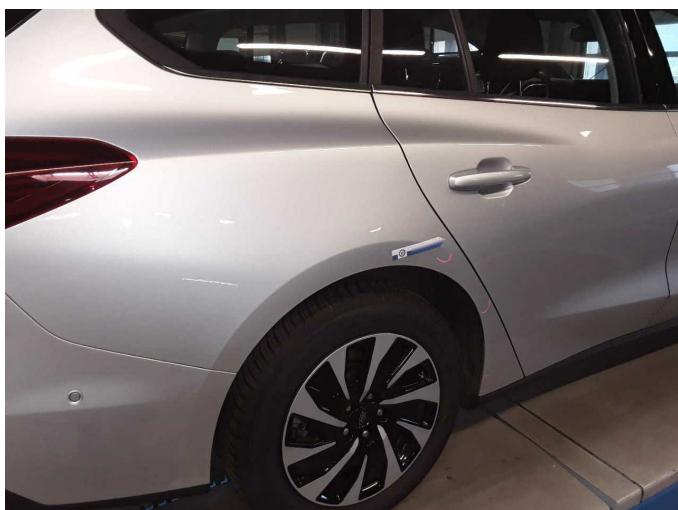
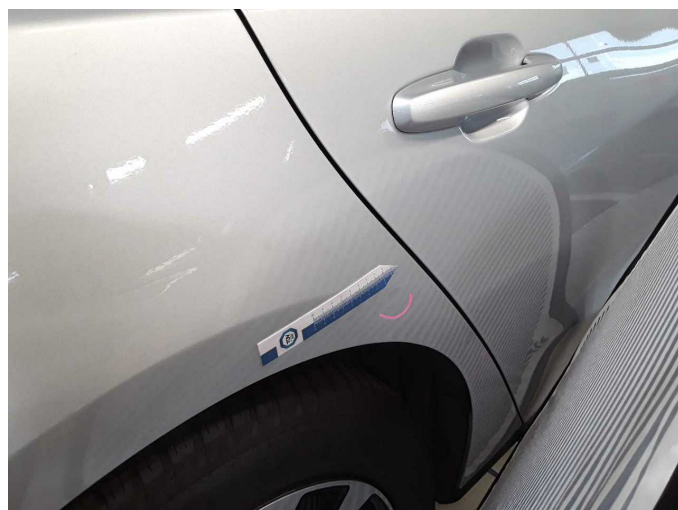
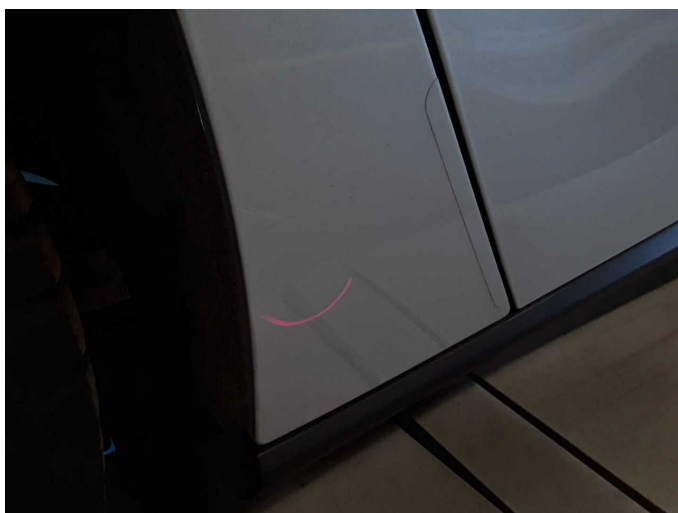
| No. | Component group | Description |
|---|---|---|
| 2 | Side panel - rear right side | Sill - Dent / paintcoat damage - Smart repair |

**Damage 2:** Side panel - rear right side: Sill - Dent / paintcoat damage - Smart repair
