Condition Report / Loss of Value Assessment II

| Process | |
|---|---|
| Date of inspection | 2026-07-07 |

| Vehicle information | | | |
|---|---|---|---|
| Type / sales designation | Q8 45 TDI quattro | Kilometres read | 28,834 km |

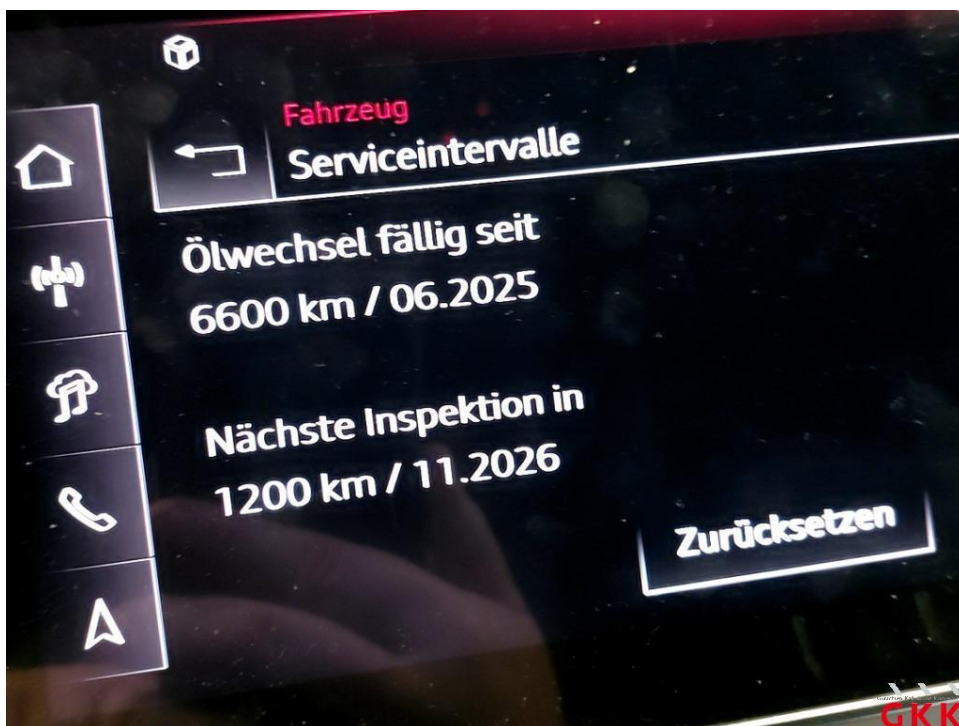
small inspection Sixt car rental, due, carry out (Image 18)

Picture 18 small inspection, Sixt car rental, due, carry out

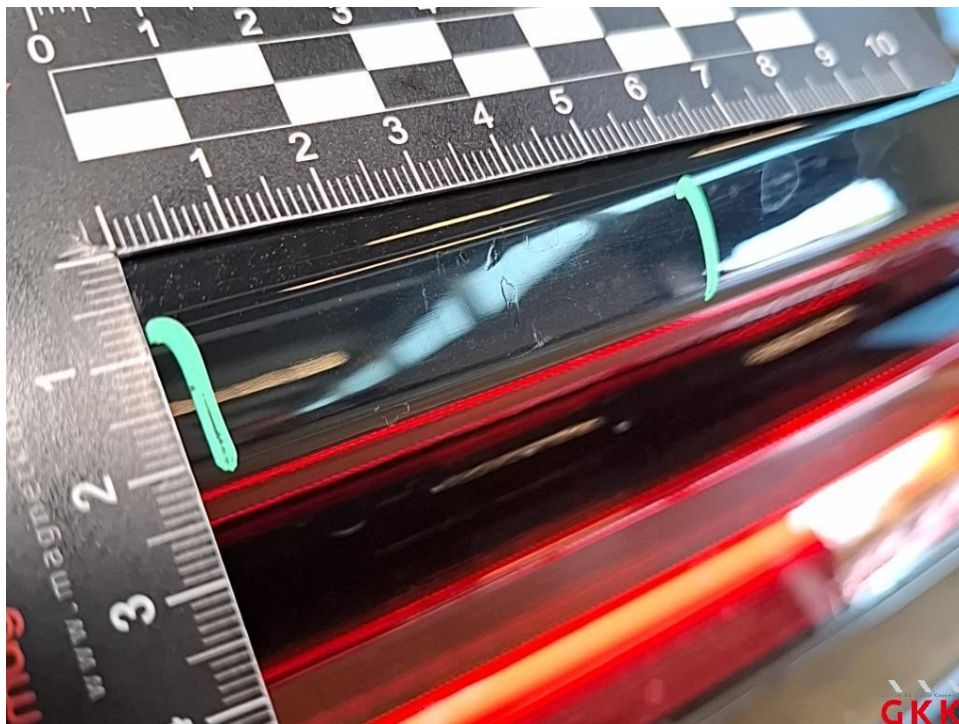
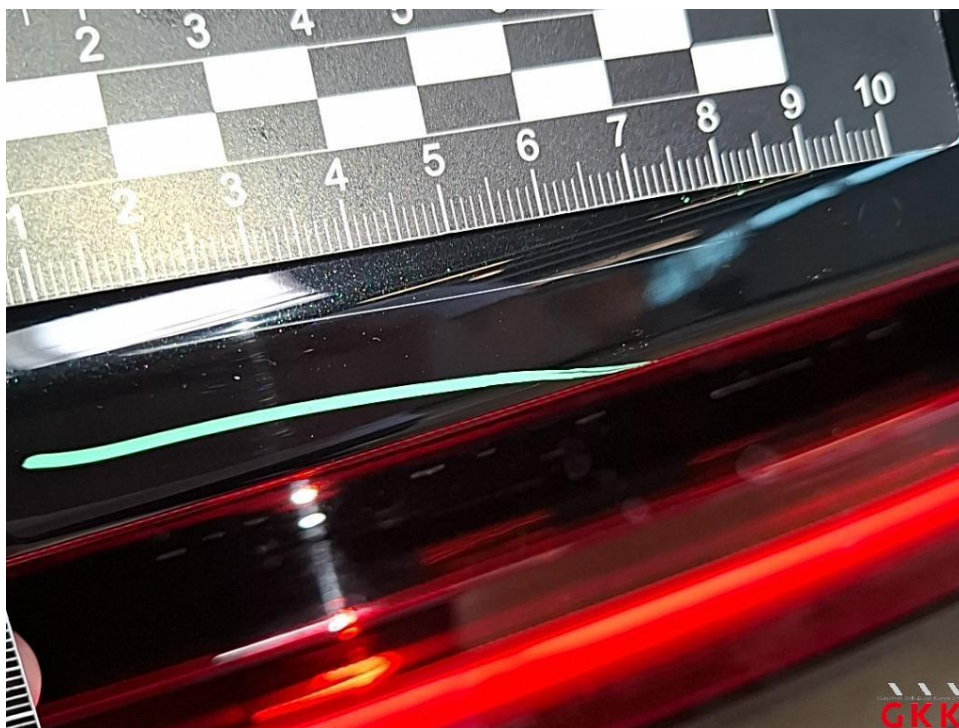
rear lid below, scratched, paint (Image 19, Image 20)

Picture 19 rear lid, below, scratched, paint

Picture 20 rear lid, below, scratched, paint

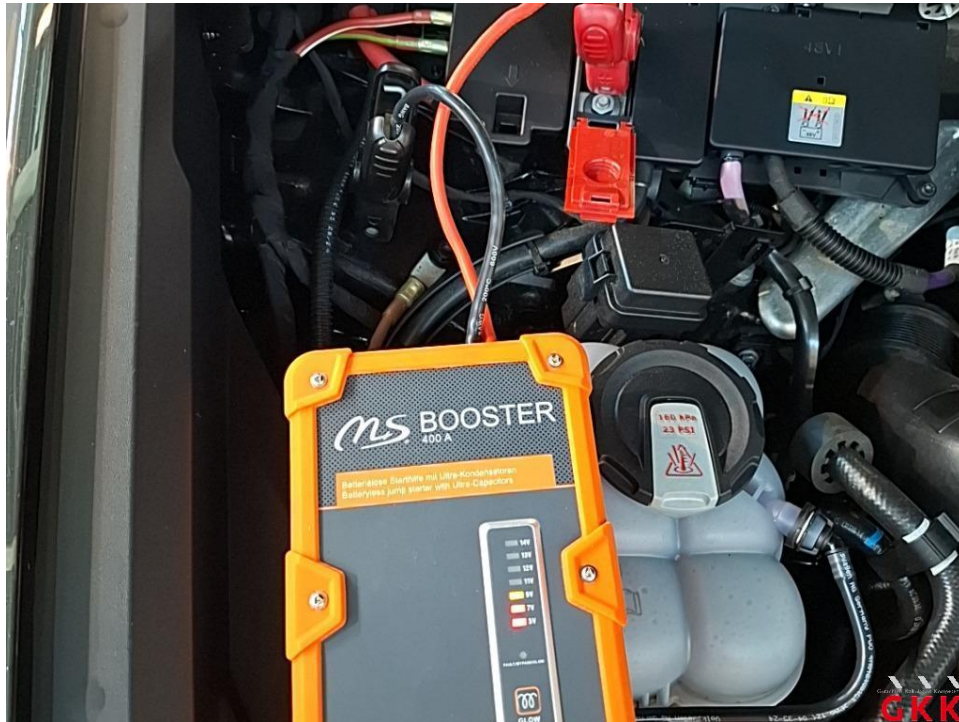
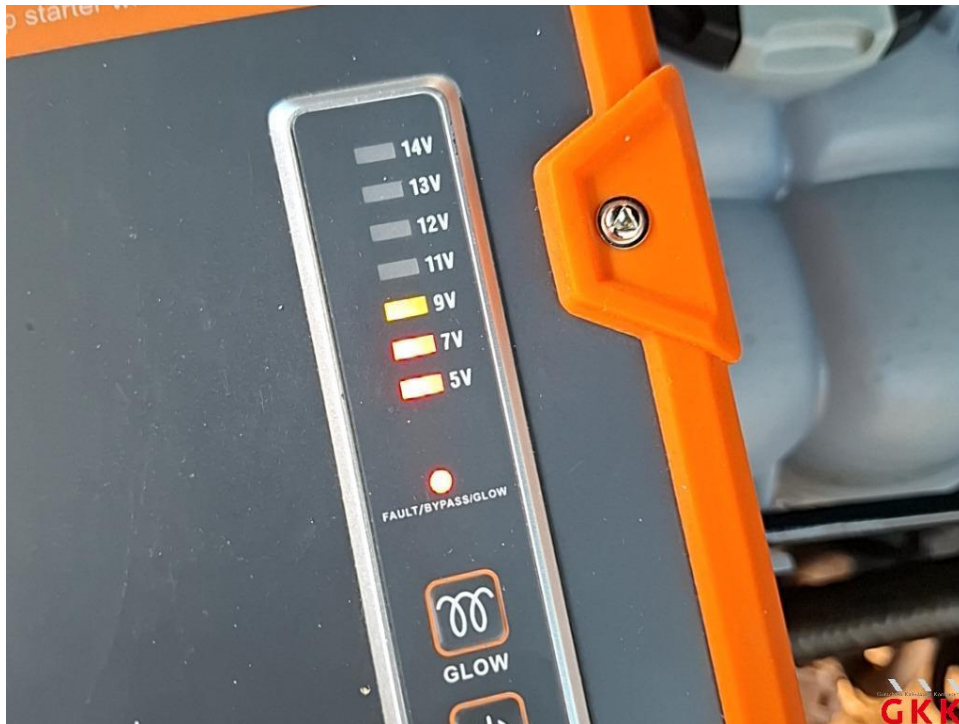
Satz Sommerräder fehlt, Batterie Tiefentladen

vehicle Battery, functioning, replace (Image 21, Image 22)

Picture 21 vehicle, Battery, functioning, replace

Picture 22 vehicle, Battery, functioning, replace

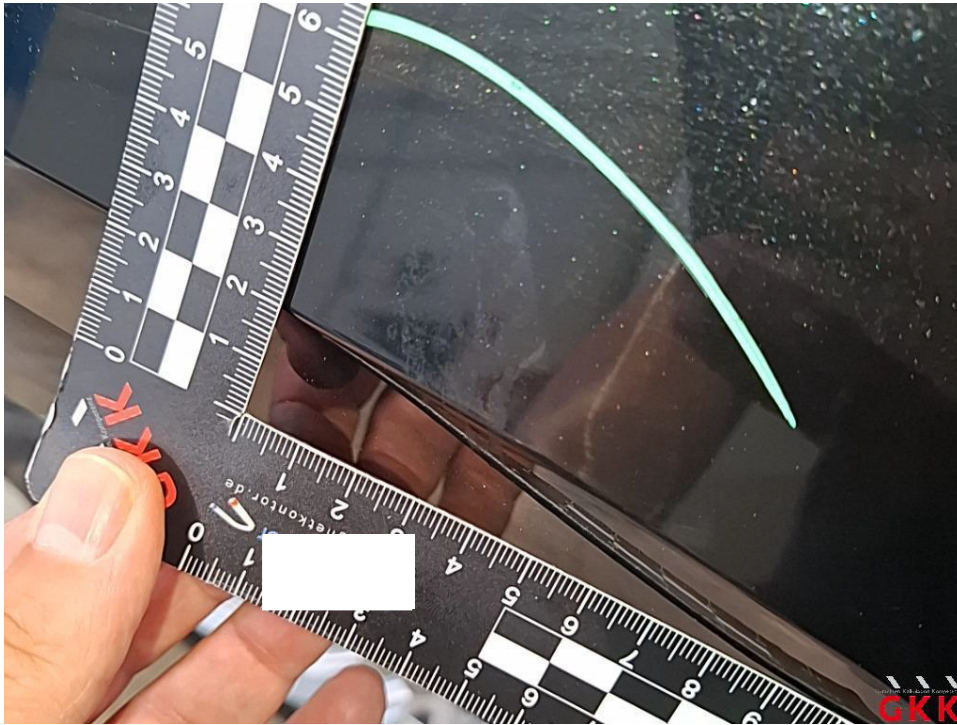
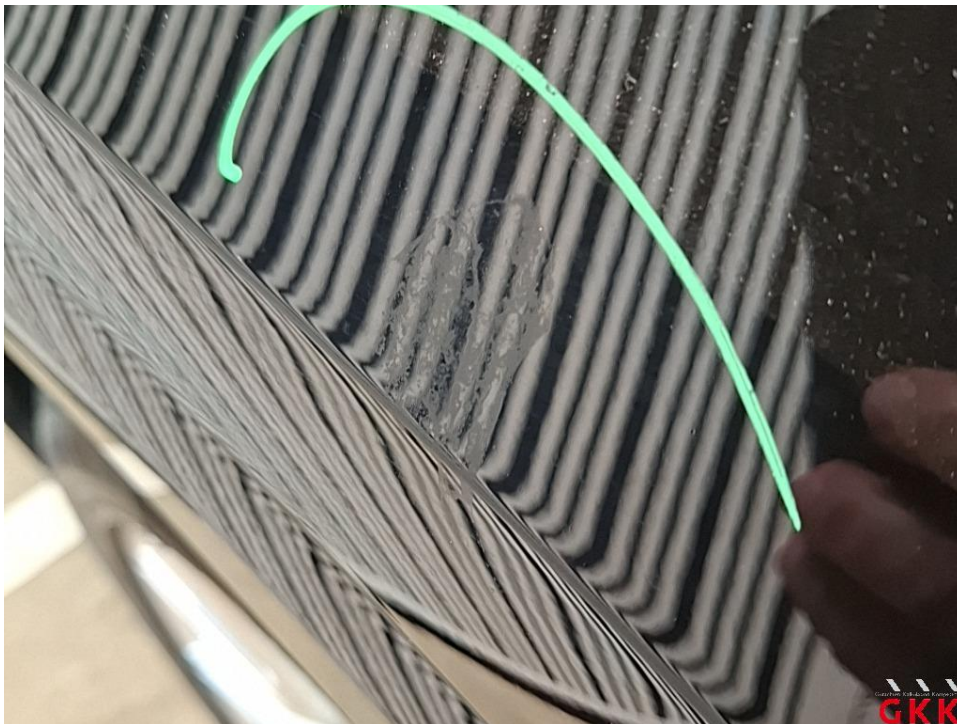
fender front right, paintwork eroded, prepare (Image 23, Image 24)

Picture 23 fender front right, paintwork eroded, prepare

Picture 24 fender front right, paintwork eroded, prepare

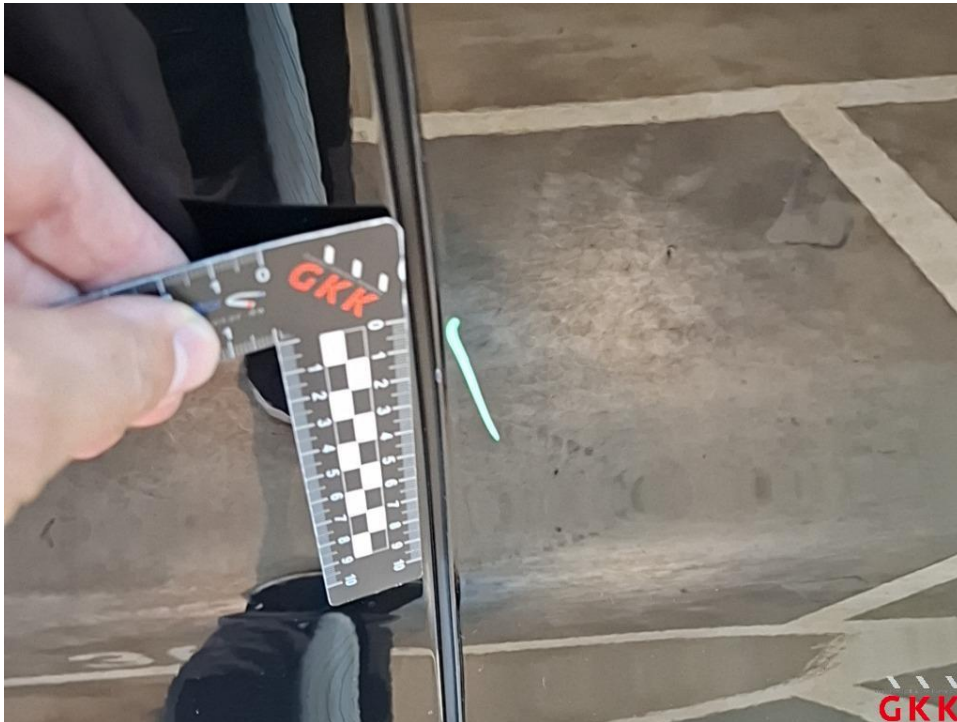
door front right edge, scratched, disassemble, grind, polish (Image 25)

Picture 25 door front right, edge, scratched, disassemble, grind, polish
