Expertise

Protocol number: 46781070  
Order No. / Reference: 26497972  
Inspection date: 28 Jul 2026

Manufacturer: Mercedes-Benz  
VIN: W1KAH0DB3PF098124

Model: C 200 d T 9G-TRONIC Avantgarde

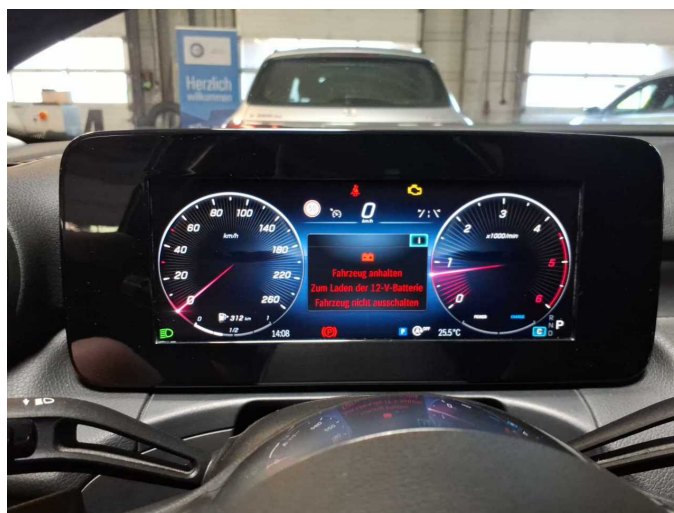
Figure 6: Instrument cluster

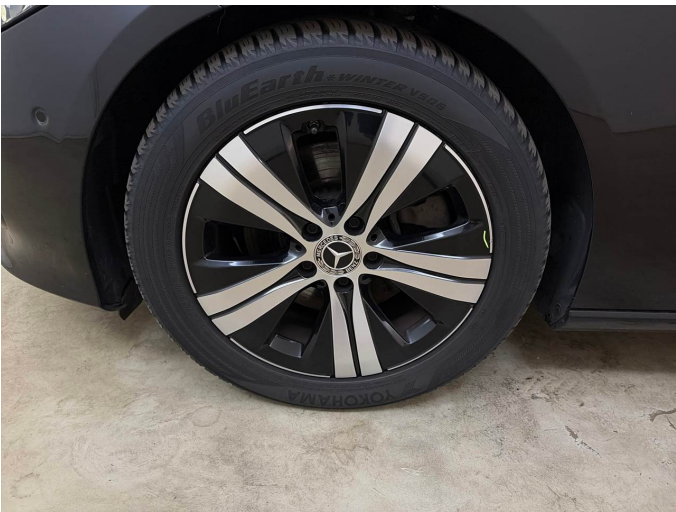
Figure 11: Mounted tyres

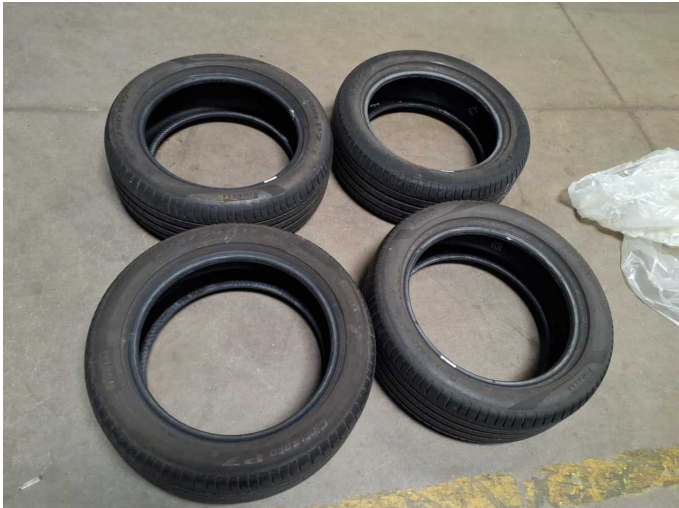
Figure 14: Additional tyres

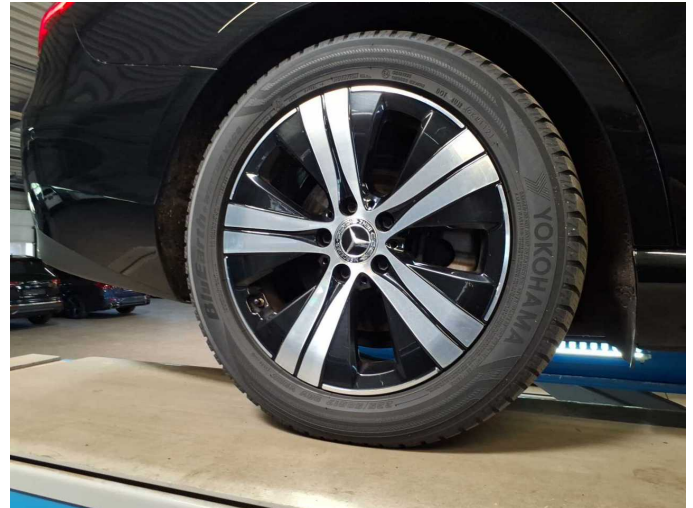
| No. | Component group | Description |
|---|---|---|
| 1 | Wheel / tyres | Tyre - right - does not meet manufacturer specifications - No deduction |

**Damage 1:** Wheel / tyres: Tyre - right - does not meet manufacturer specifications - No deduction

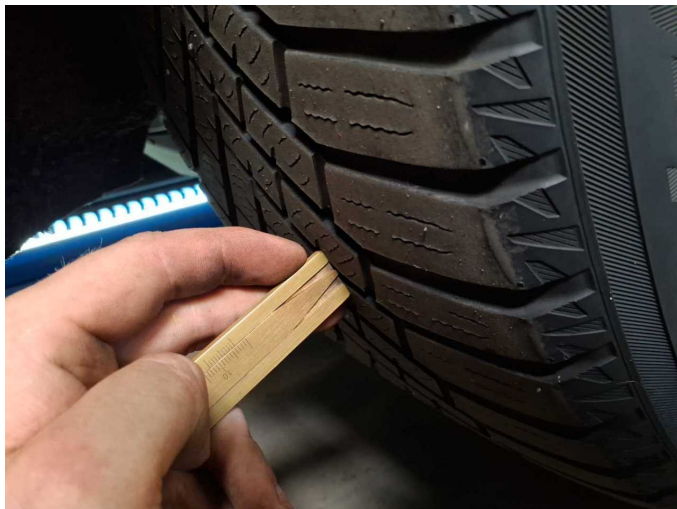
**Damage 1:** Wheel / tyres: Tyre - right - does not meet manufacturer specifications - No deduction

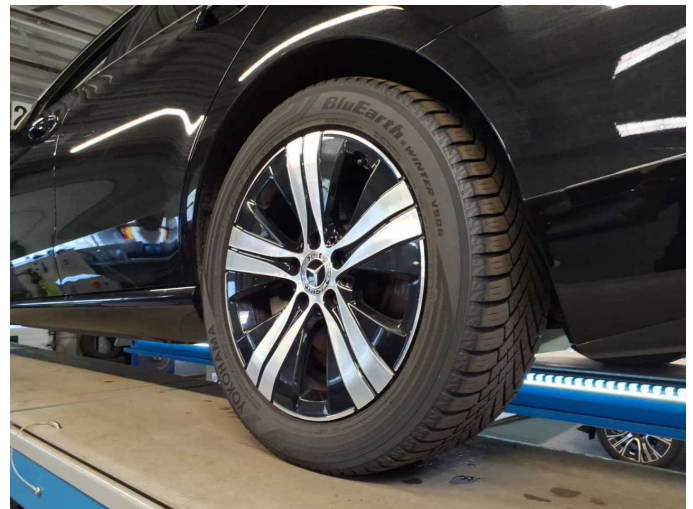
**Damage 1:** Wheel / tyres: Tyre - right - does not meet manufacturer specifications - No deduction

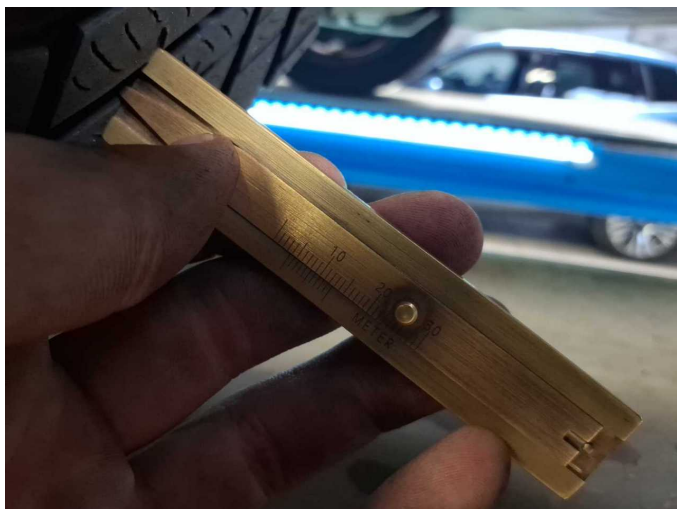
**Damage 1:** Wheel / tyres: Tyre - right - does not meet manufacturer specifications - No deduction

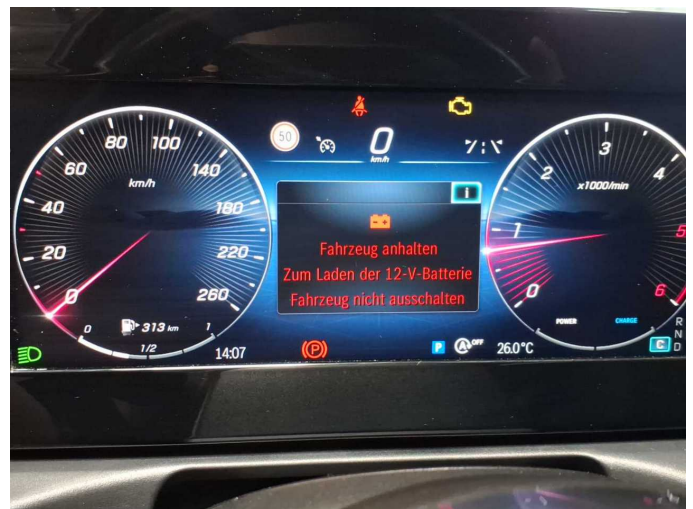
| No. | Component group | Description |
|---|---|---|
| 2 | Instrument panel | Indicator light (Batterie) - on - Perform diagnosis |

**Damage 2:** Instrument panel: Indicator light (Batterie) - on - Perform diagnosis

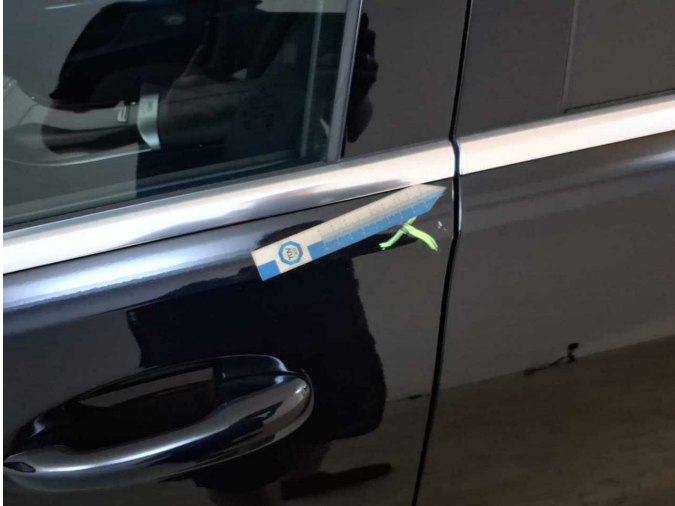
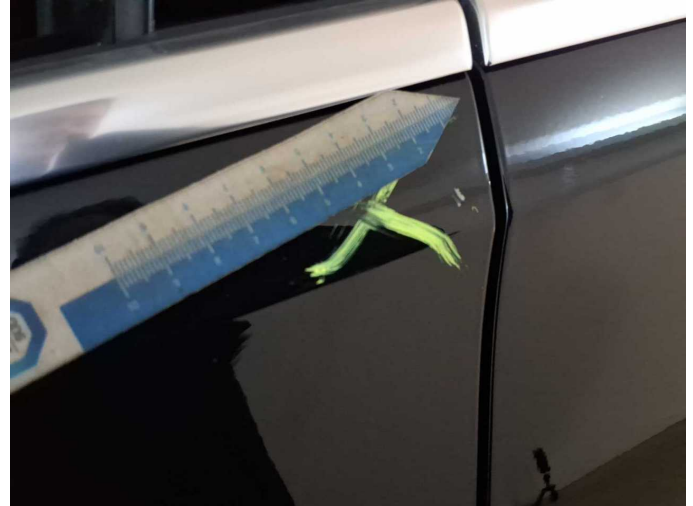
| No. | Component group | Description |
|---|---|---|
| 3 | Door - front left side | Door - Scratch(es) - Smart repair |

**Damage 3:** Door - front left side: Door - Scratch(es) - Smart repair

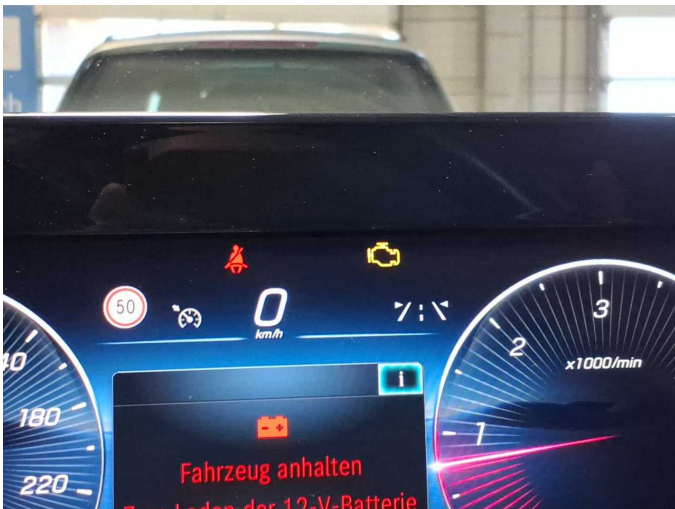
| No. | Component group | Description |
|---|---|---|
| 4 | Instrument panel | Indicator light (Motor) - on - Perform diagnosis |

**Damage 4:** Instrument panel: Indicator light (Motor) - on - Perform diagnosis

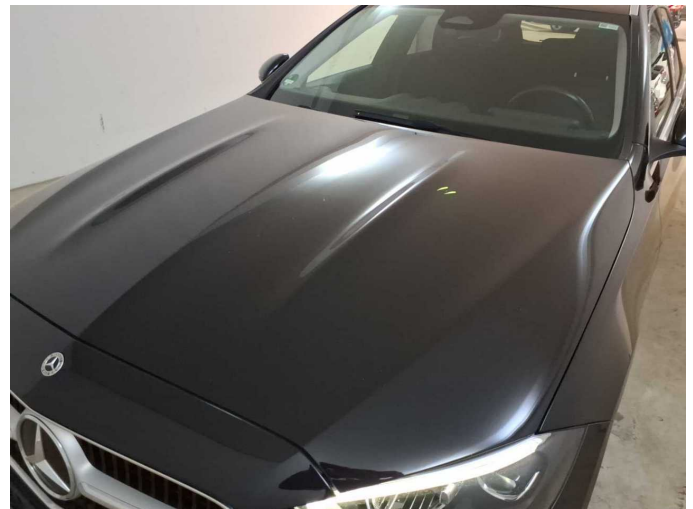
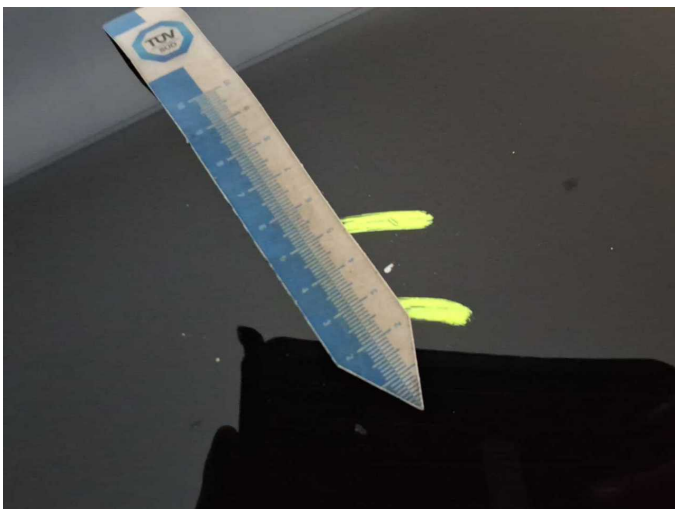
| No. | Component group | Description |
|---|---|---|
| 5 | Bonnet | Bonnet - Stone chips - Paint |

**Damage 5:** Bonnet: Bonnet - Stone chips - Paint

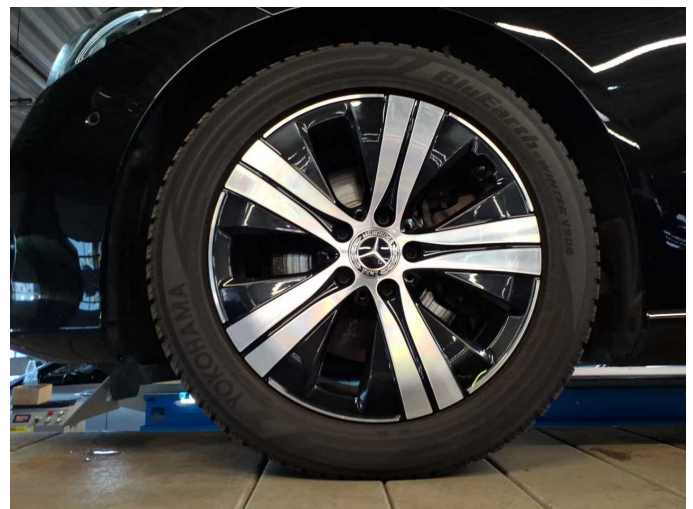
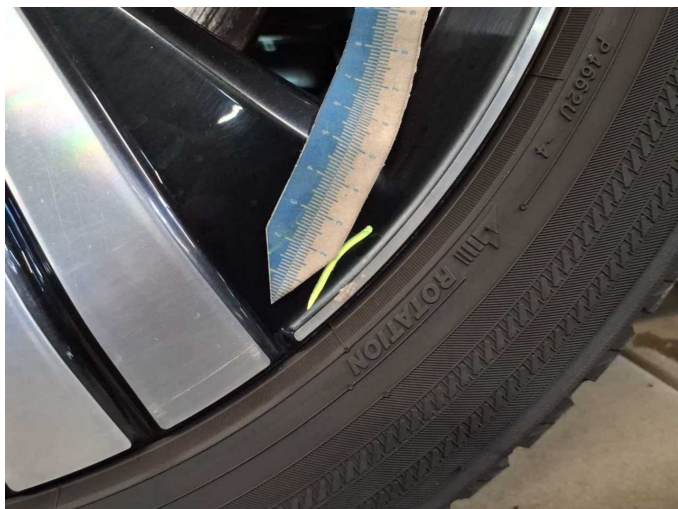
| No. | Component group | Description |
|---|---|---|
| 1 | Wheel / tyres | Alloy rim - front left side - Scratch(es) - No deduction |

**Wear and tear 1:** Wheel / tyres: Alloy rim - front left side - Scratch(es) - No deduction

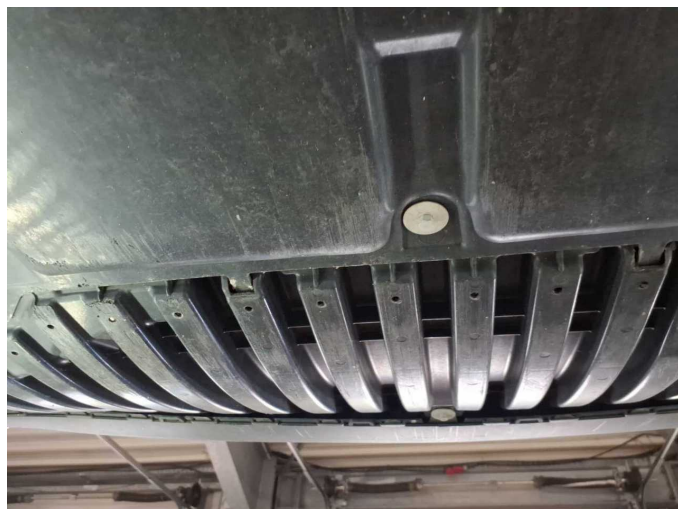
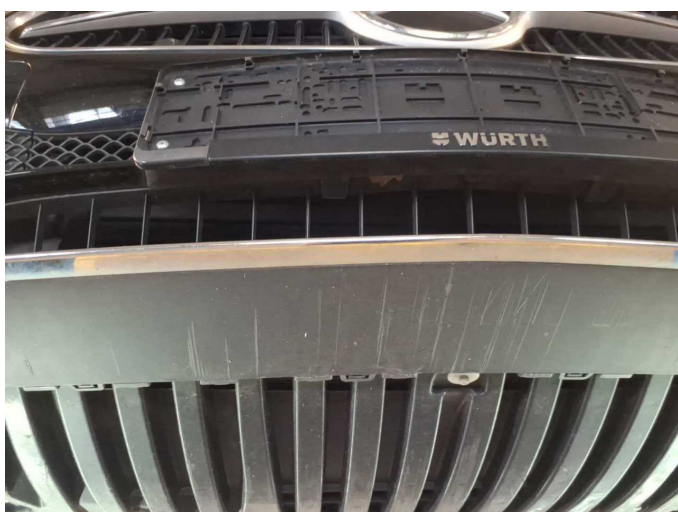
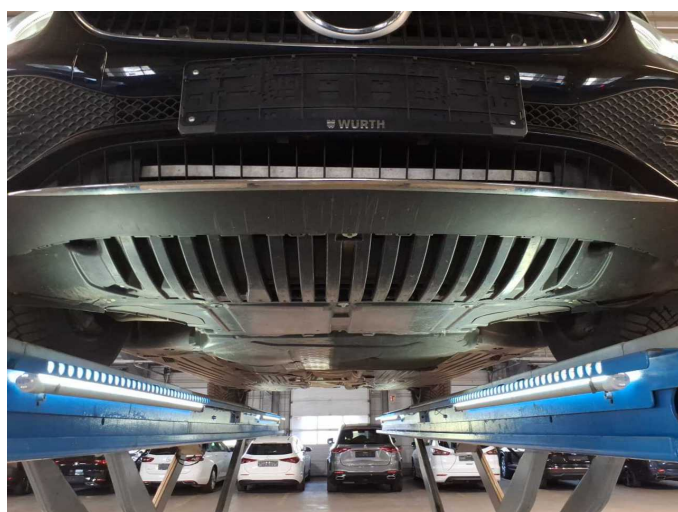
| No. | Component group | Description |
|---|---|---|
| 2 | Body | Underbody panelling - Scratched - No deduction |

**Wear and tear 2:** Body: Underbody panelling - Scratched - No deduction
