Expertise

Protocol number: 46599052  
Order No. / Reference: 26703616  
Inspection date: 20 Jul 2026

Manufacturer: Mercedes-Benz

Model: C 220 d T 9G-TRONIC Avantgarde

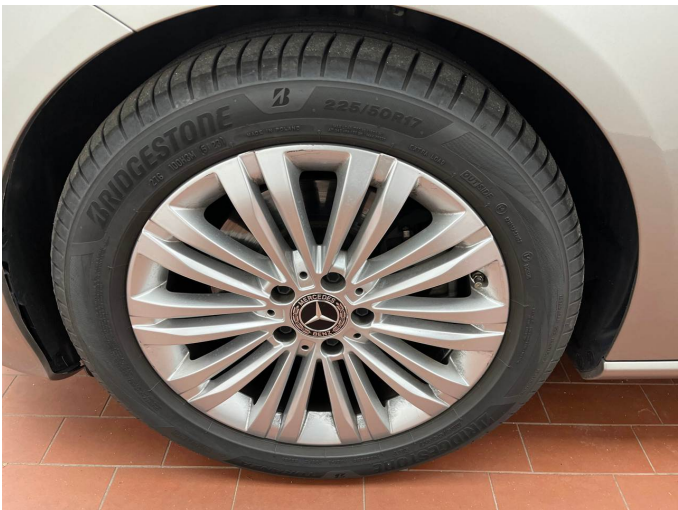
Figure 12: Mounted tyres

| # | Tyre size | Type of tyre | Manufacturer | Tread depth |
|---|---|---|---|---|
| 1) | 225/50 R17 98Y | Summer tyres on Light alloy | Bridgestone | 6mm / 6mm |
| 2) | 225/50 R17 98Y | Summer tyres on Light alloy | Bridgestone | 6mm / 6mm |

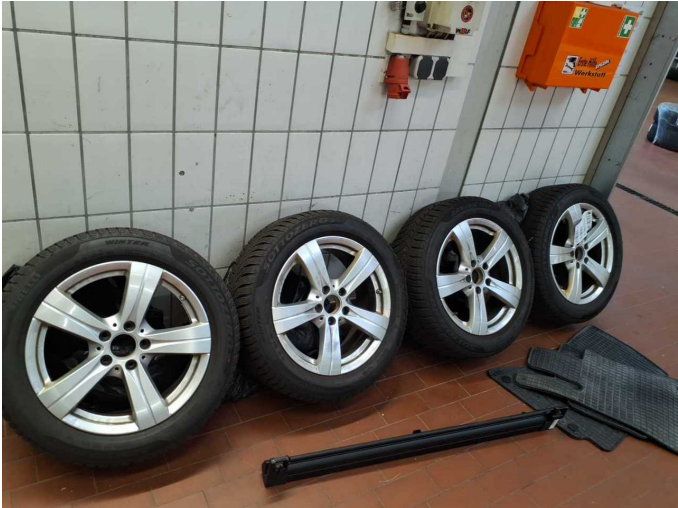
Figure 16: Additional tyres

| # | Tyre size | Type of tyre | Manufacturer | Tread depth |
|---|---|---|---|---|
| 1) | 225/50 R17 98H | Winter tyres on Light alloy | Pirelli | 6mm / 6mm |
| 2) | 225/50 R17 98H | Winter tyres on Light alloy | Pirelli | 7mm / 7mm |

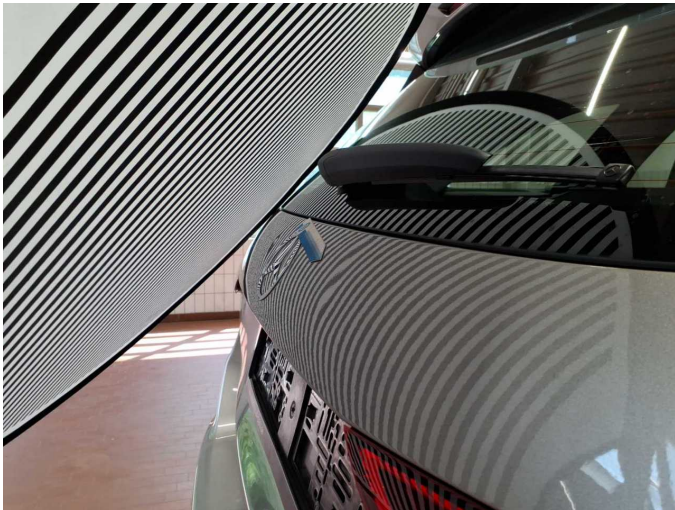
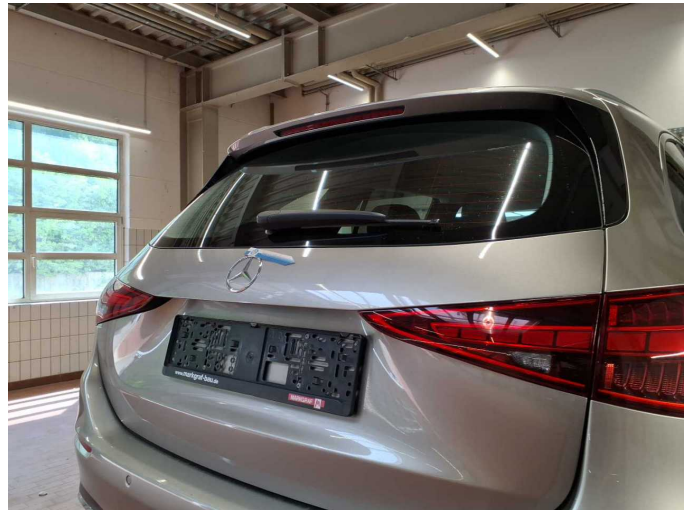
| No. | Component group | Description |
|---|---|---|
| 1 | Boot lid / rear door | Boot lid - dent(s) - Smooth repair work |

Damage 1: Boot lid / rear door: Boot lid - dent(s) - Smooth repair work

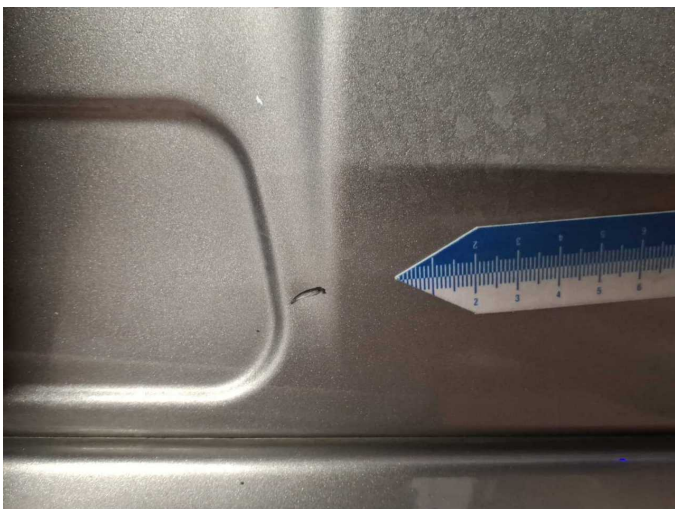
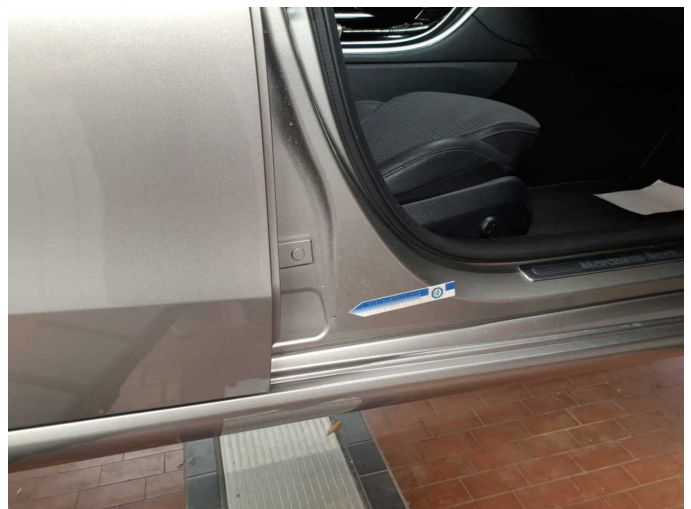
| No. | Component group | Description |
|---|---|---|
| 2 | Body | B-pillar - right side - Scratch(es) - Smart repair |

Damage 2: Body: B-pillar - right side - Scratch(es) - Smart repair

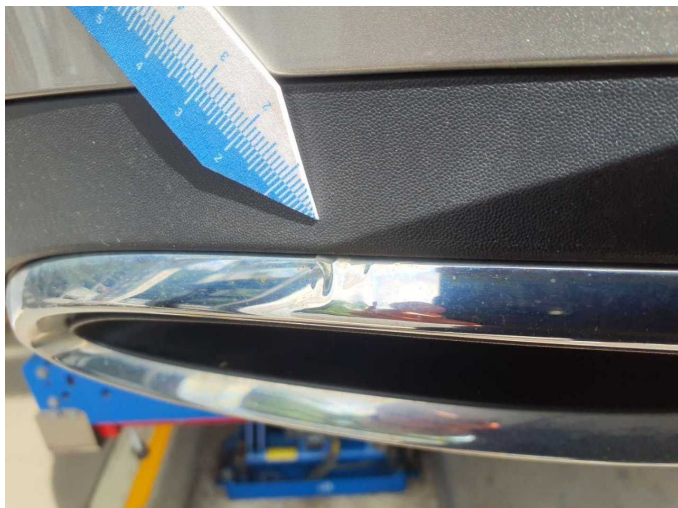
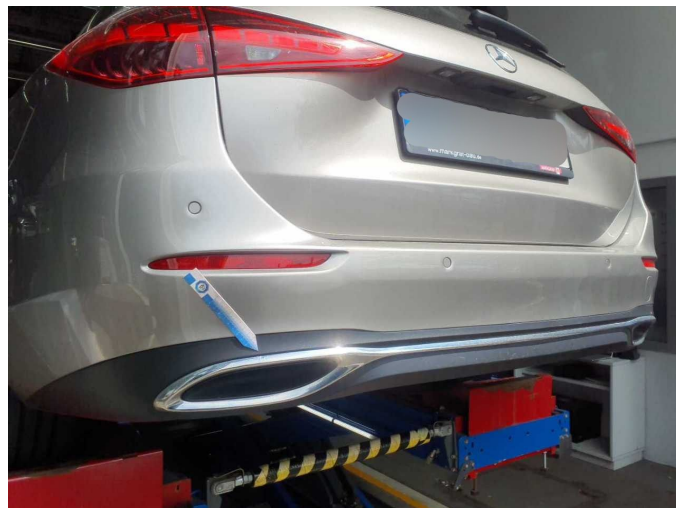
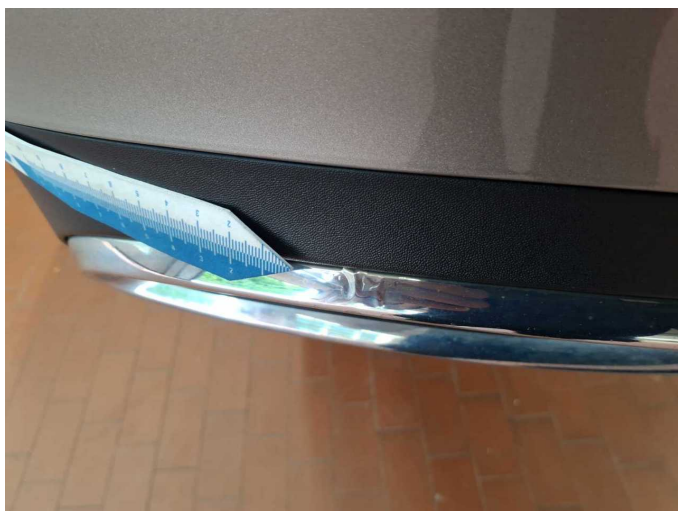
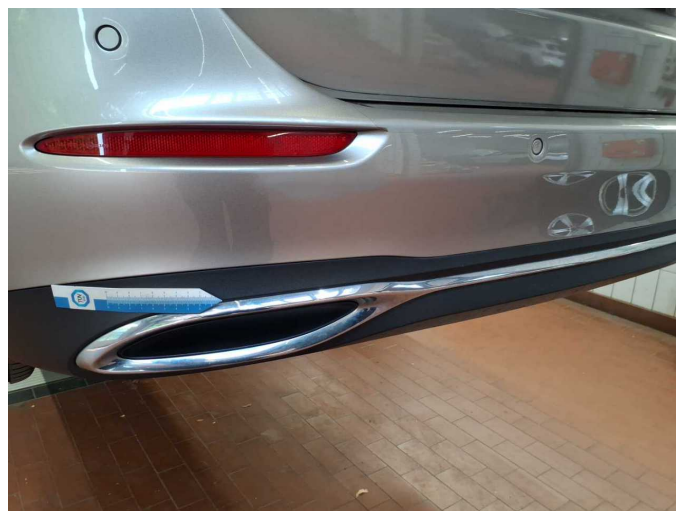
| No. | Component group | Description |
|---|---|---|
| 3 | Rear bumper | Rear bumper (Blende) - Paint defect - Replace |

**Damage 3:** Rear bumper: Rear bumper (Blende) - Paint defect - Replace

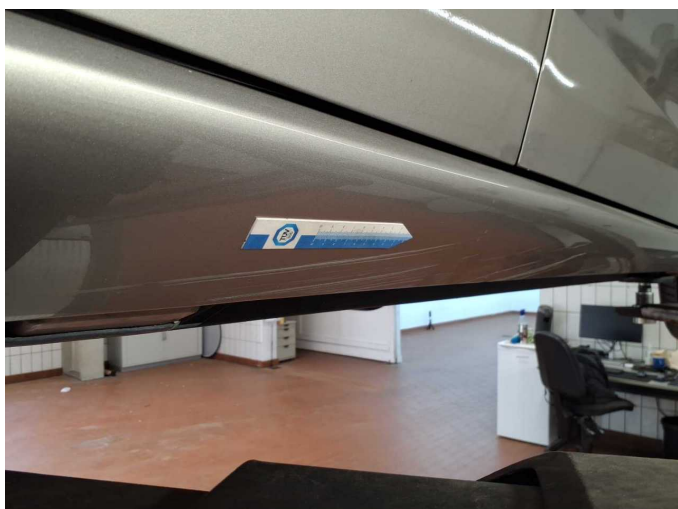
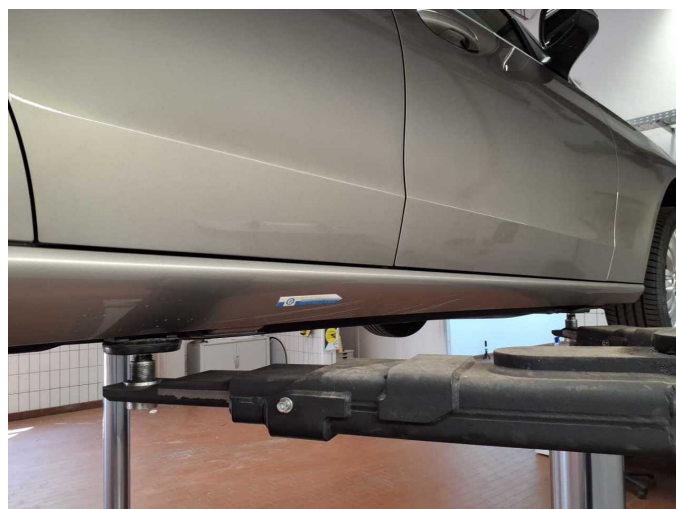
| No. | Component group | Description |
|---|---|---|
| 4 | Sill - right side | Trim - Scratched - Paint |

**Damage 4:** Sill - right side: Trim - Scratched - Paint

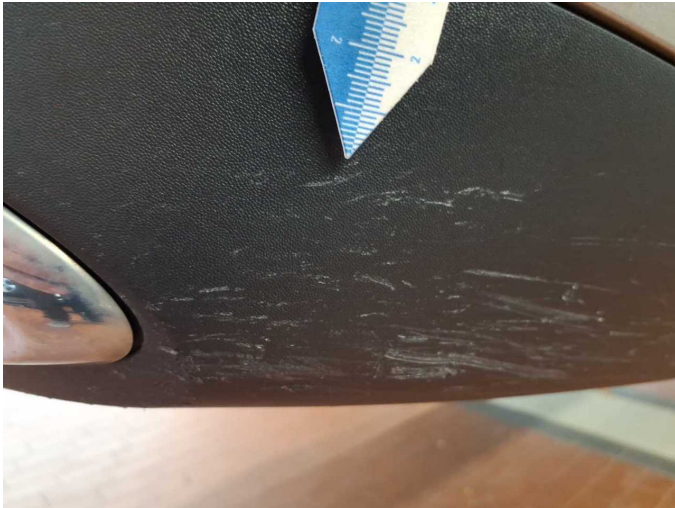
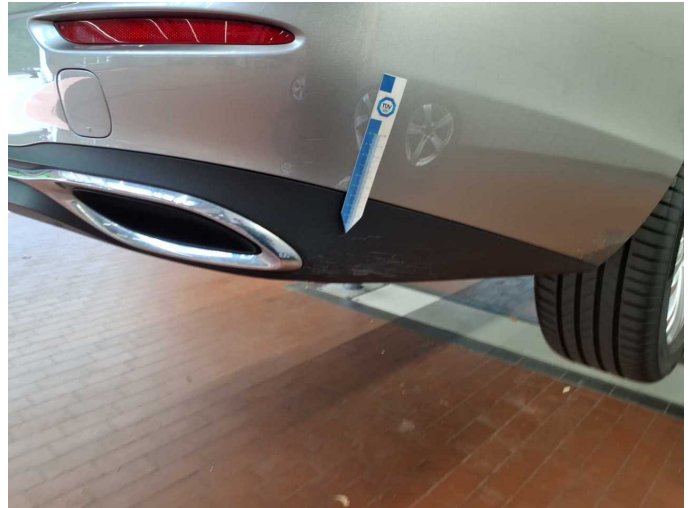
| No. | Component group | Description |
|---|---|---|
| 1 | Rear bumper | Spoiler - Abrasion - No deduction |

**Wear and tear 1:** Rear bumper: Spoiler - Abrasion - No deduction

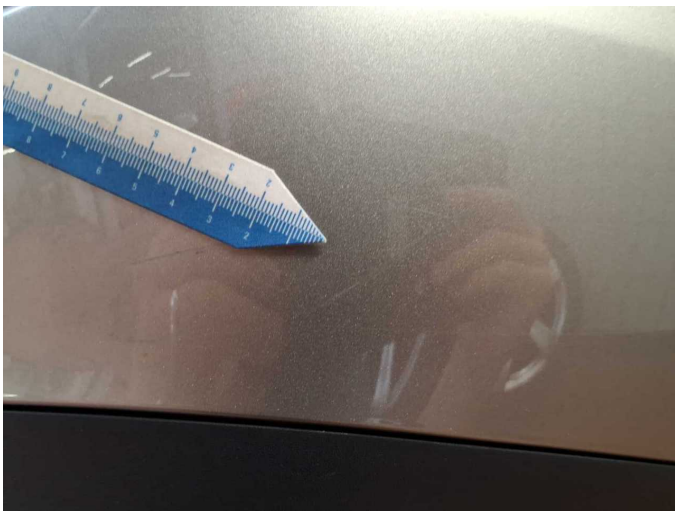
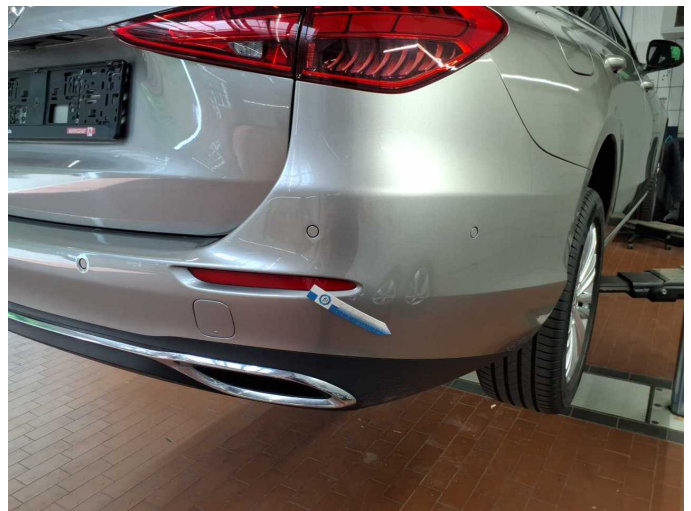
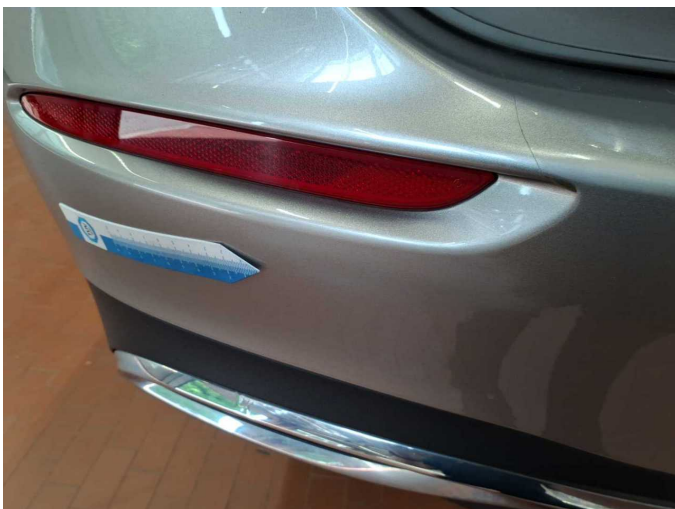
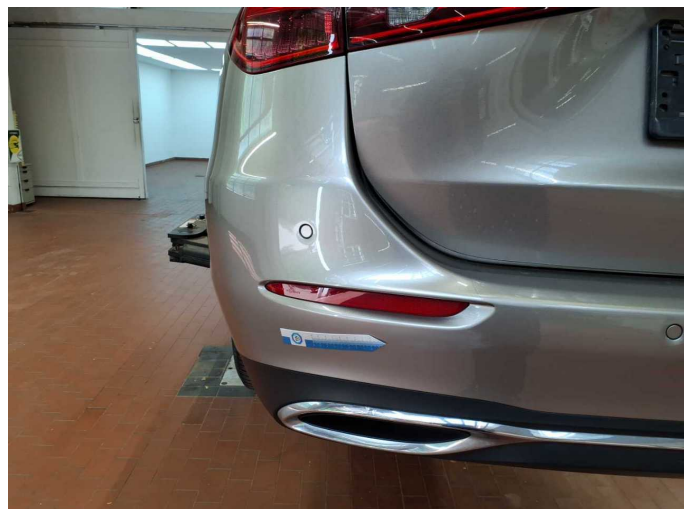
| No. | Component group | Description |
|---|---|---|
| 2 | Rear bumper | Rear bumper - Scratched - No deduction |

**Wear and tear 2:** Rear bumper: Rear bumper - Scratched - No deduction
