Expertise

Protocol number: 46123601  
Order No. / Reference: 26543882  
Inspection date: 24 Jun 2026

| Manufacturer: Ford | Model: Focus Turnier 1.0 EcoBoost Start-Stopp-System TITANIUM X |
| VIN: WF0PXXGCHPNG34672 | |

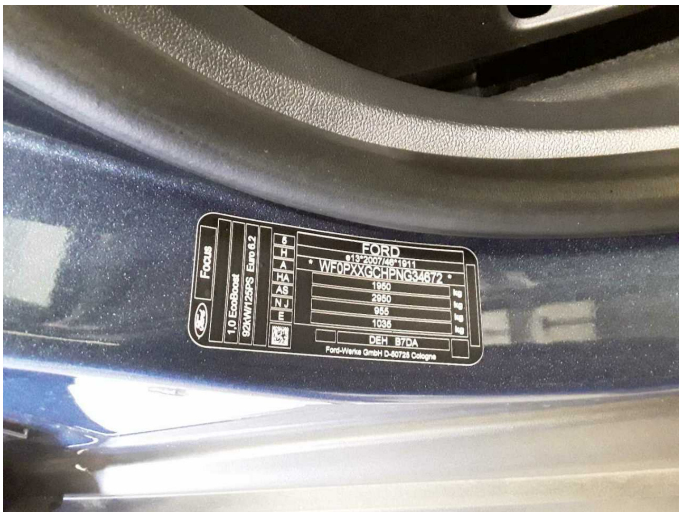
Figure 12: VIN

| VIN comparison | The vehicle identification number (VIN) was read from the vehicle and its conformity with the submitted documents was confirmed by the undersigned during the inspection. |

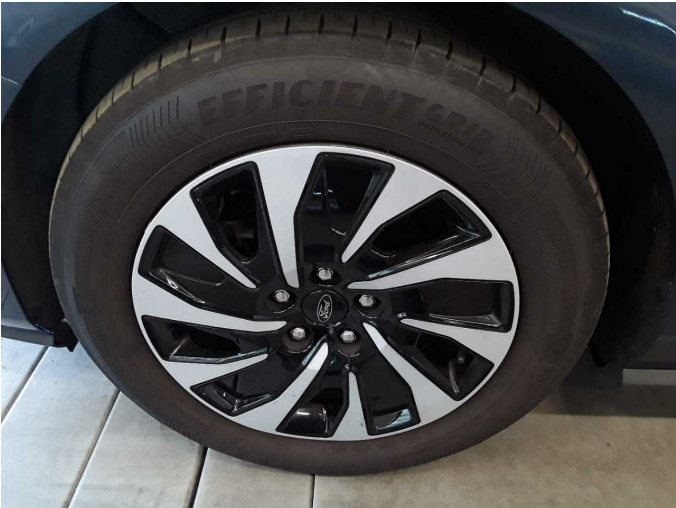
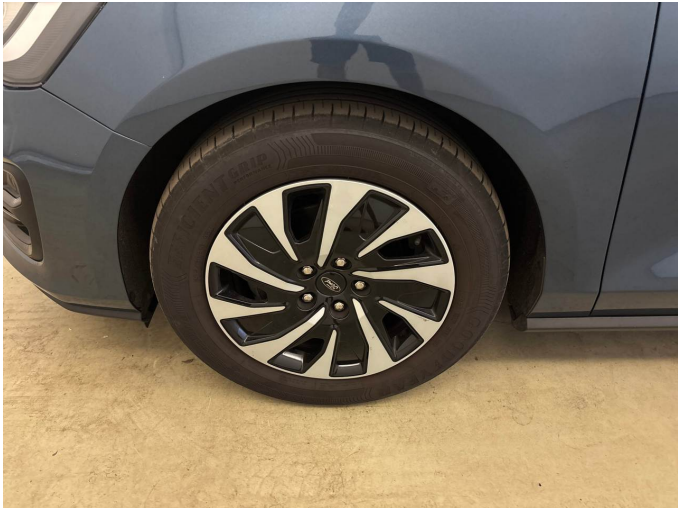
| Tyres | | | | |
|---|---|---|---|---|
| 1) | 205/60 R16 92V | Summer tyres on Steel rim with wheel cover | Goodyear | 4mm / 4mm |
| 2) | 205/60 R16 92V | Summer tyres on Steel rim with wheel cover | Goodyear | 4mm / 4mm |

Figure 13: Mounted tyres

Figure 14: Mounted tyres

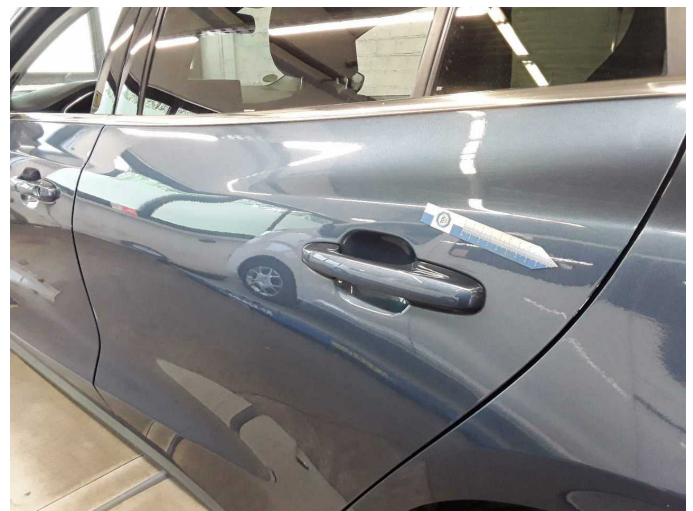
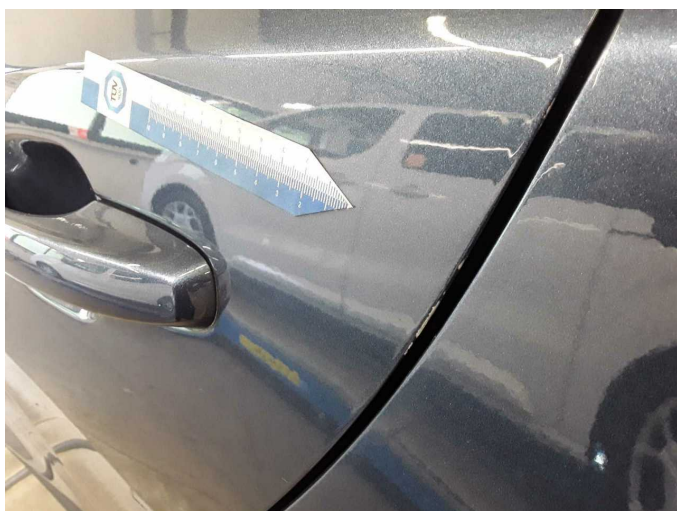
| No. | Component group | Description |
|---|---|---|
| 1 | Door - rear left side | Door - Scratch(es) - Smart repair |

Damage 1: Door - rear left side: Door - Scratch(es) - Smart repair

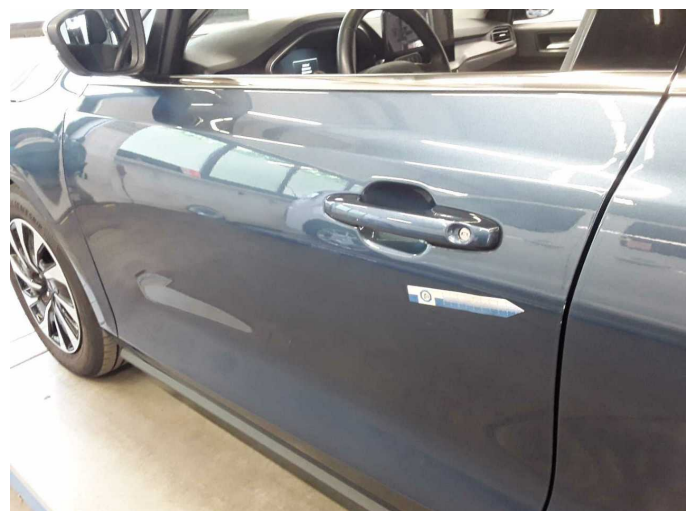
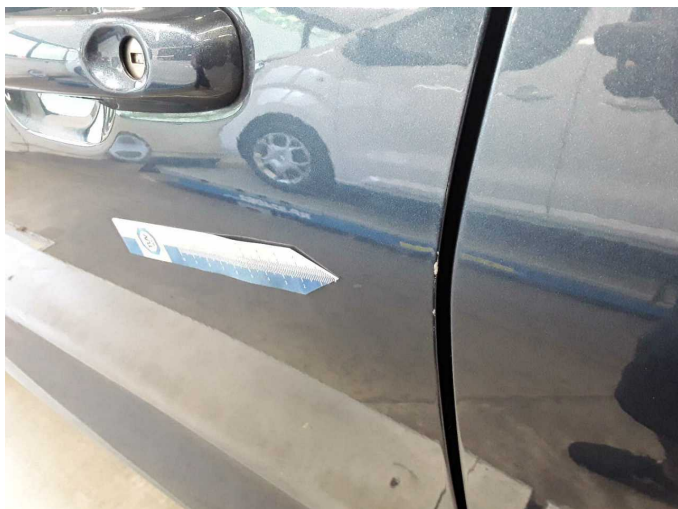
| No. | Component group | Description |
|---|---|---|
| 2 | Door - front left side | Door - Scratch(es) - Smart repair |

Damage 2: Door - front left side: Door - Scratch(es) - Smart repair

**Damage 2:** Door - front left side: Door - Scratch(es) - Smart repair

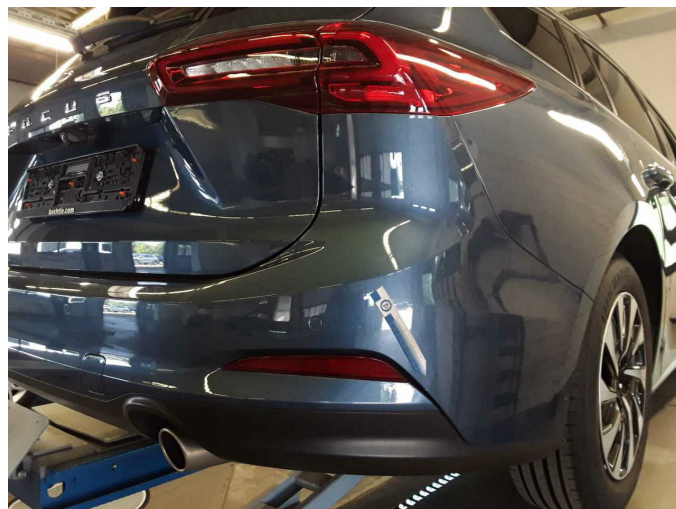
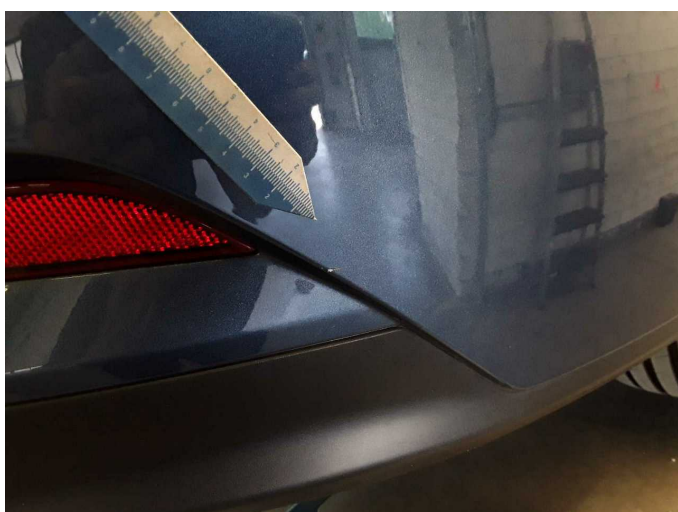
| No. | Component group | Description |
|---|---|---|
| 3 | Rear bumper | Rear bumper - Scratch(es) - Smart repair |

**Damage 3:** Rear bumper: Rear bumper - Scratch(es) - Smart repair

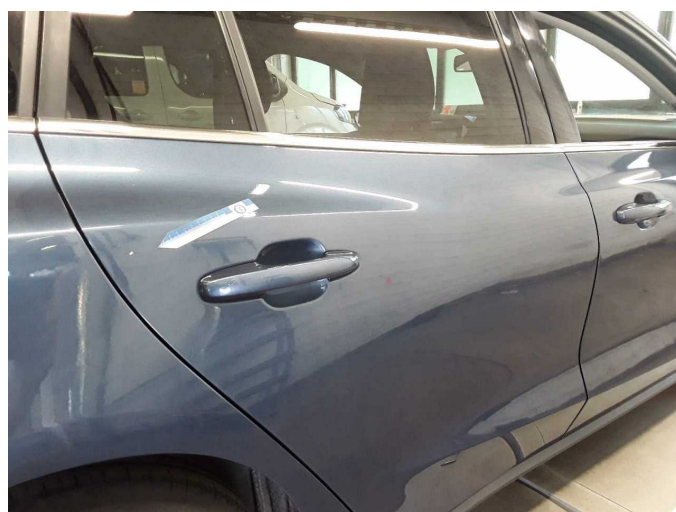
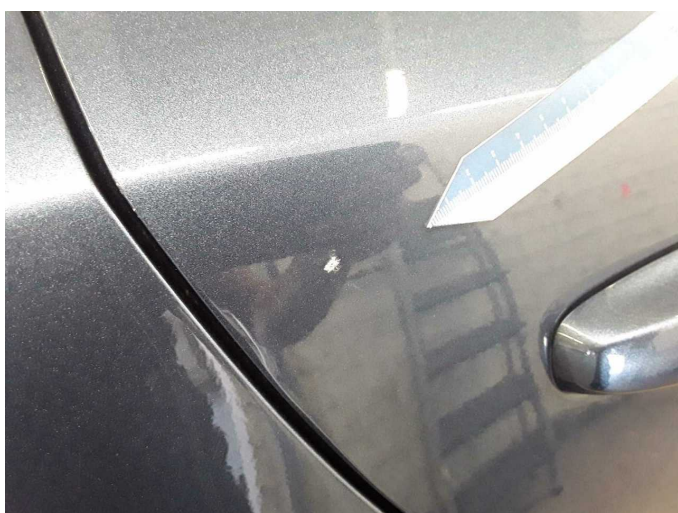
| No. | Component group | Description |
|---|---|---|
| 4 | Door - rear right side | Door - Scratch(es) - Paint |

**Damage 4:** Door - rear right side: Door - Scratch(es) - Paint

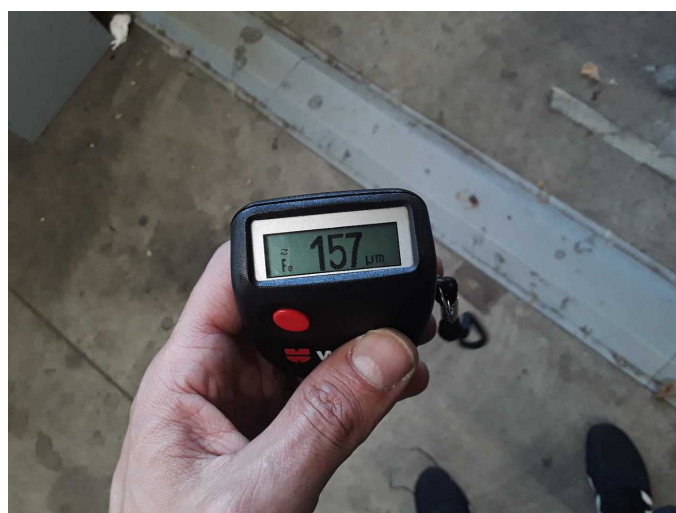
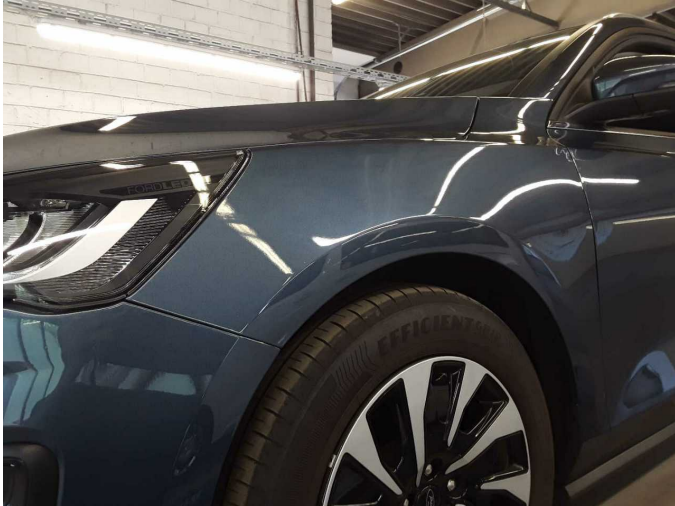
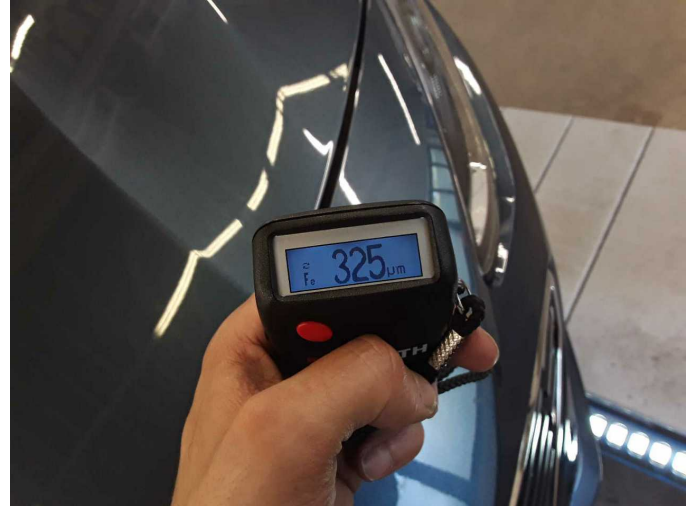
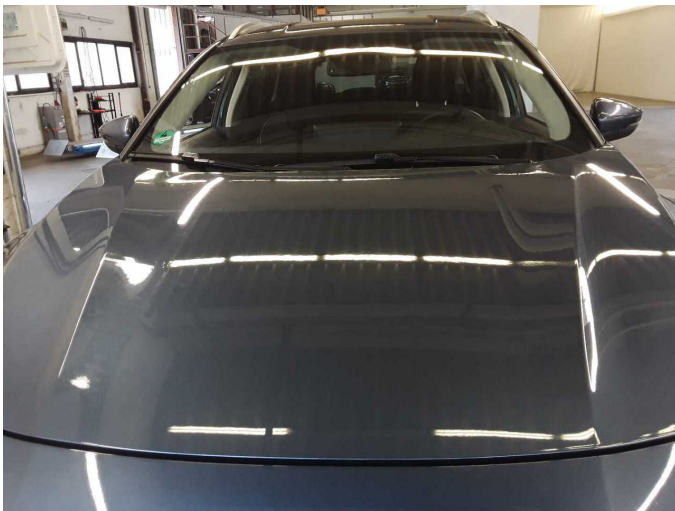
| No. | Repainting |
|---|---|
| 1 | Mudguard - left side, Bonnet, Professionally carried out, Invoice of repair done Non-existent |

| Bonnet | 325 µm | Door - front left side | 157 µm |

**Repainting 1:** Mudguard - left side, Bonnet
