Expertise

Protocol number: 46326309  
Order No. / Reference: 26605115  
Inspection date: 3 Jul 2026

Manufacturer: Mercedes-Benz

Model: GLB 200 d 8G-DCT Progressive

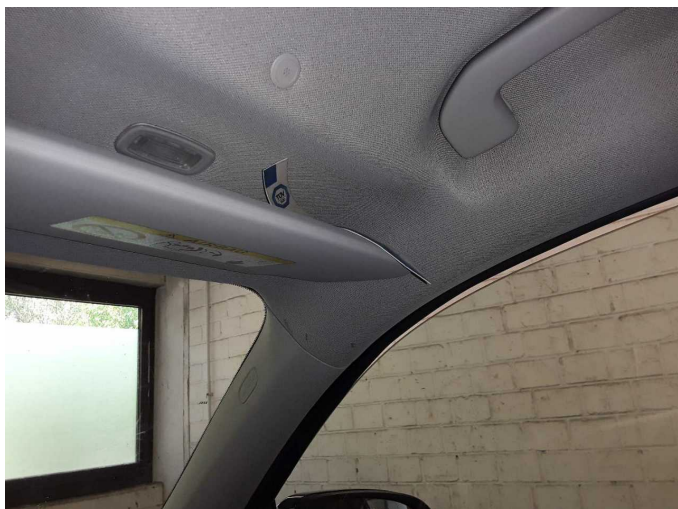
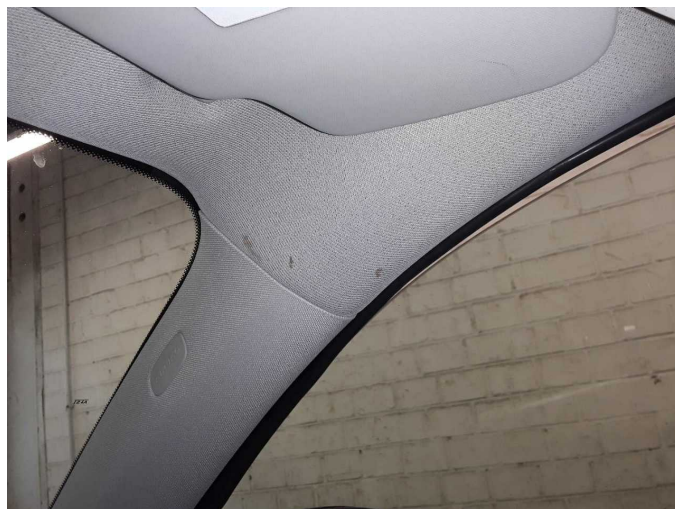
| No. | Component group | Description |
|---|---|---|
| 1 | Trim / covers | Roof lining - Soiled - Clean |

**Damage 1:** Trim / covers: Roof lining - Soiled - Clean

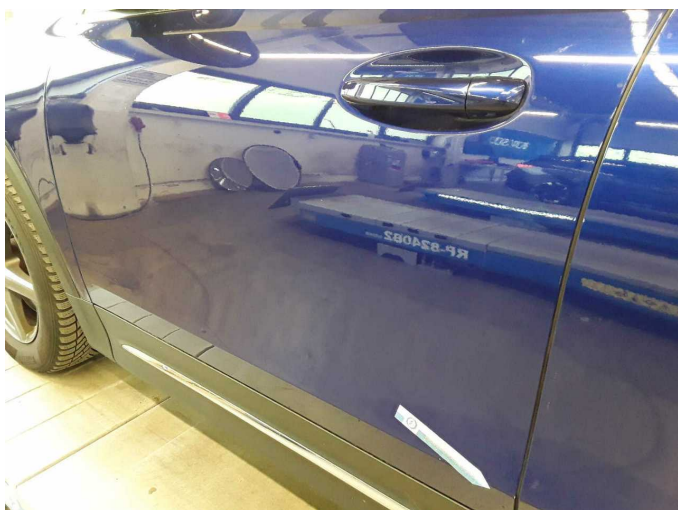
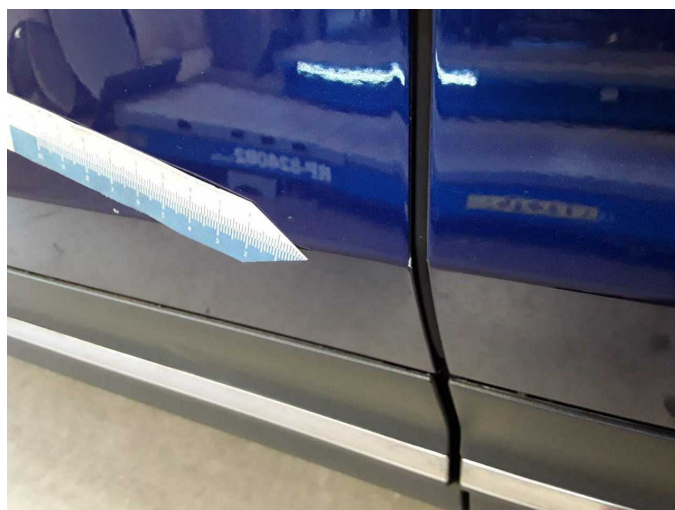
| No. | Component group | Description |
|---|---|---|
| 2 | Door - front left side | Door - Scratch(es) - Smart repair |

**Damage 2:** Door - front left side: Door - Scratch(es) - Smart repair

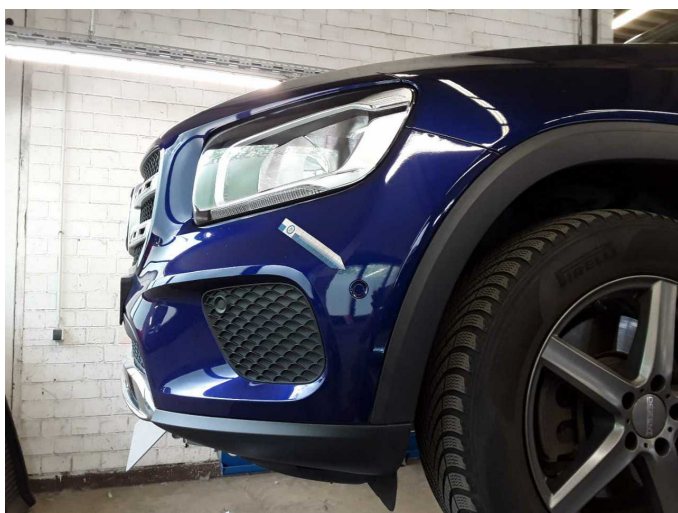
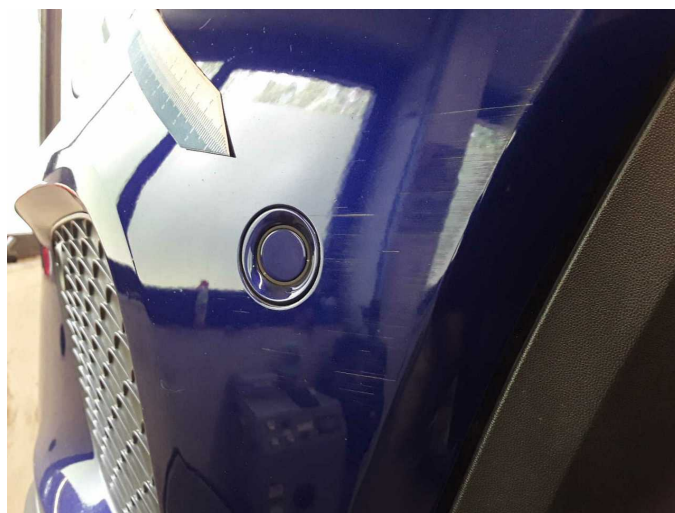
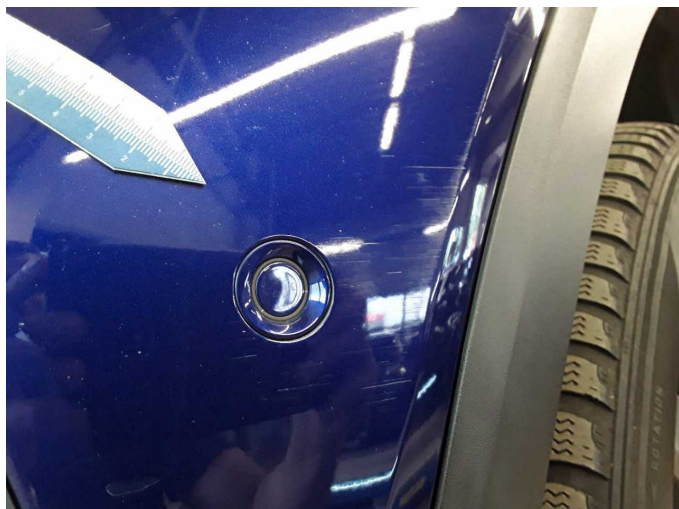
| No. | Component group | Description |
|---|---|---|
| 3 | Front bumper | Front bumper - Scratch(es) - Smart repair |

**Damage 3:** Front bumper: Front bumper - Scratch(es) - Smart repair

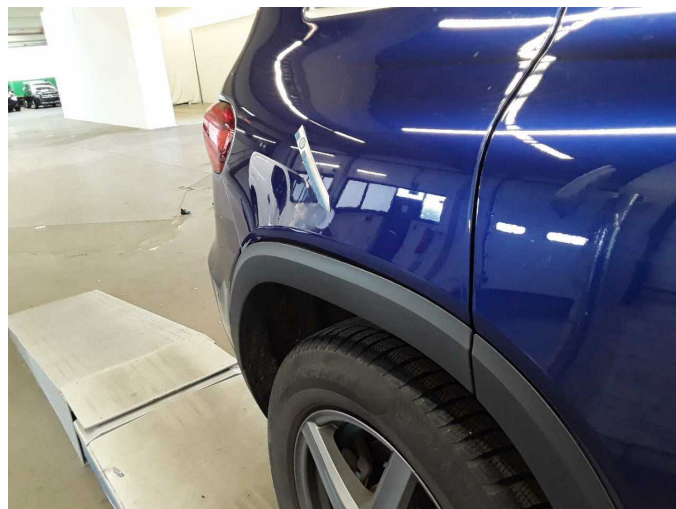
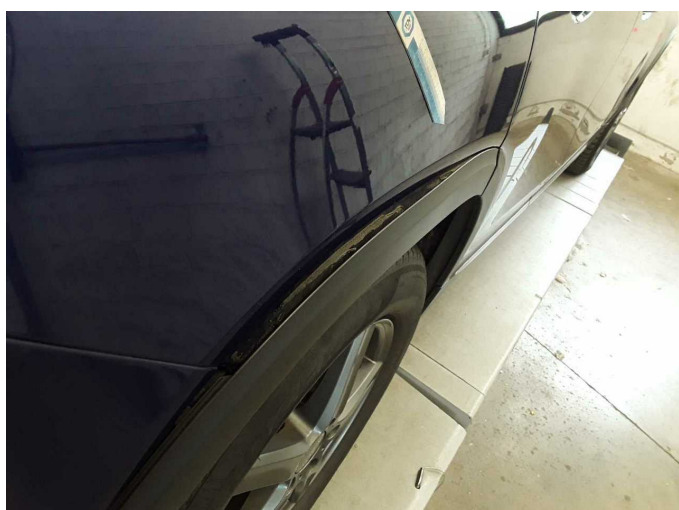
| No. | Component group | Description |
|---|---|---|
| 4 | Side panel - rear right side | Wheel arch - Damaged - Replace |

**Damage 4:** Side panel - rear right side: Wheel arch - Damaged - Replace

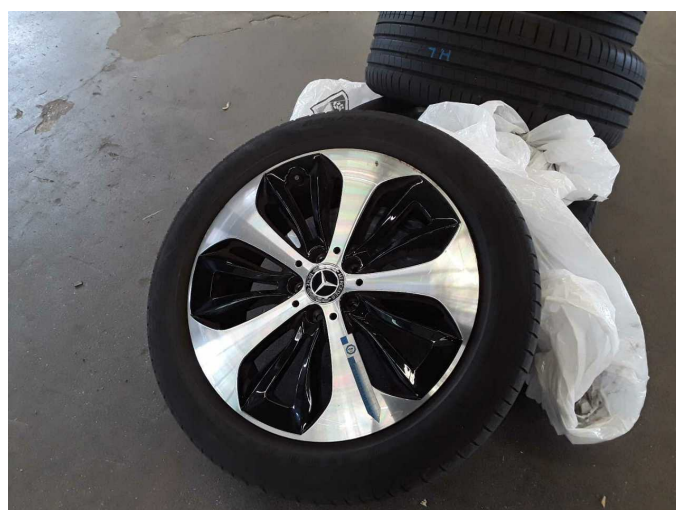
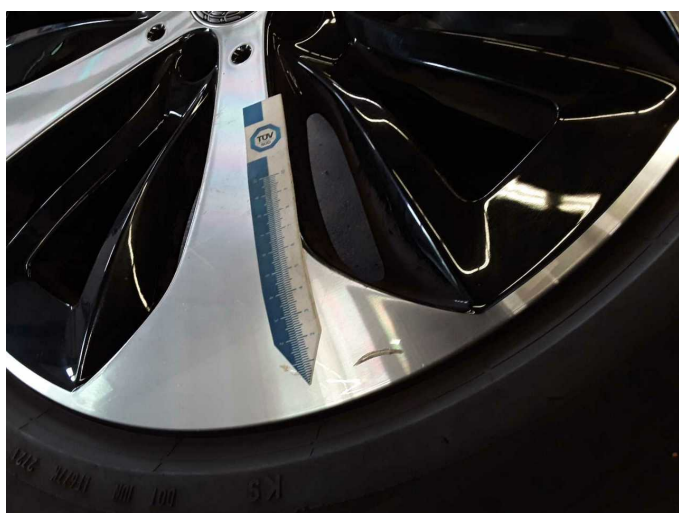
| No. | Component group | Description |
|---|---|---|
| 5 | 2nd wheel set | 1 alloy rim - Scratched - Loss in value |

**Damage 5:** 2nd wheel set: 1 alloy rim - Scratched - Loss in value

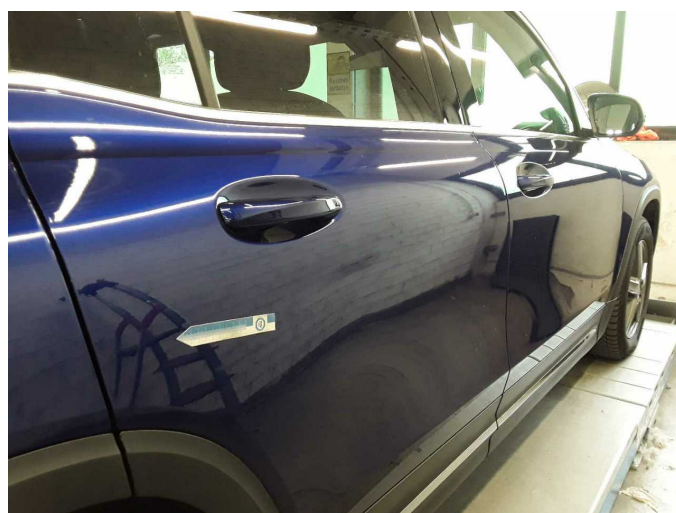
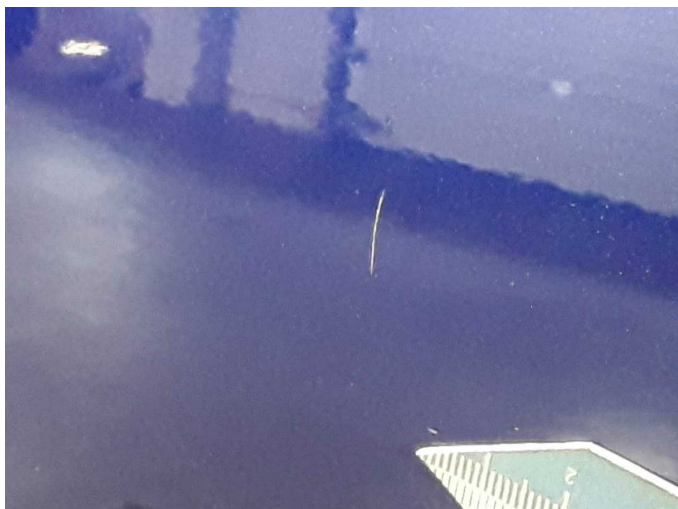
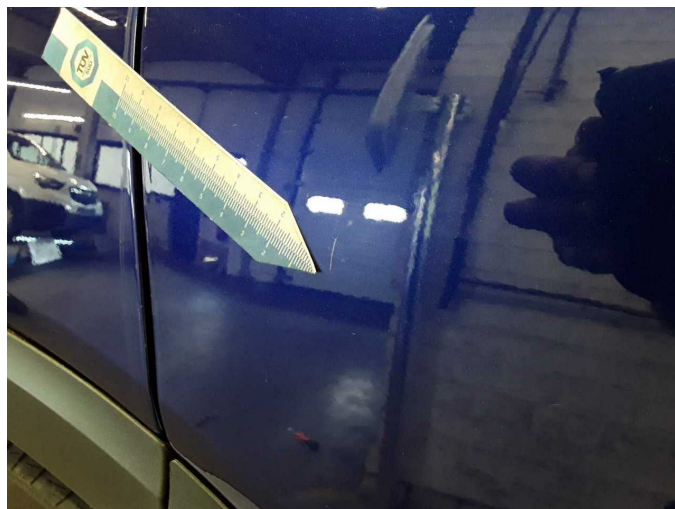
| No. | Component group | Description |
|---|---|---|
| 6 | Door - rear right side | Door - Scratch(es) - Paint |

**Damage 6:** Door - rear right side: Door - Scratch(es) - Paint

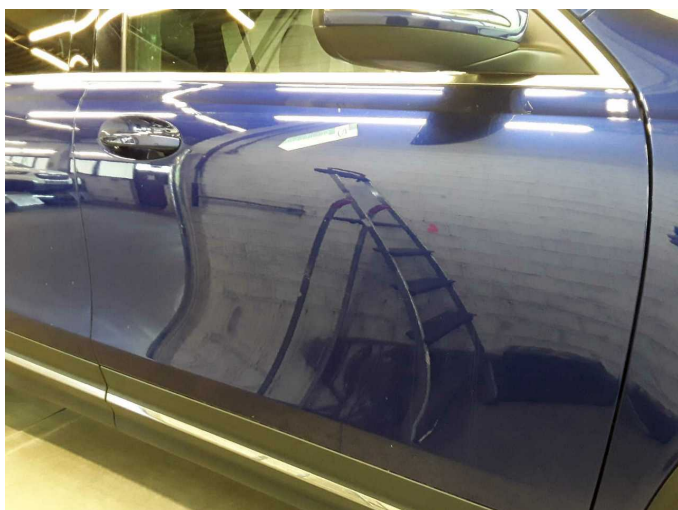
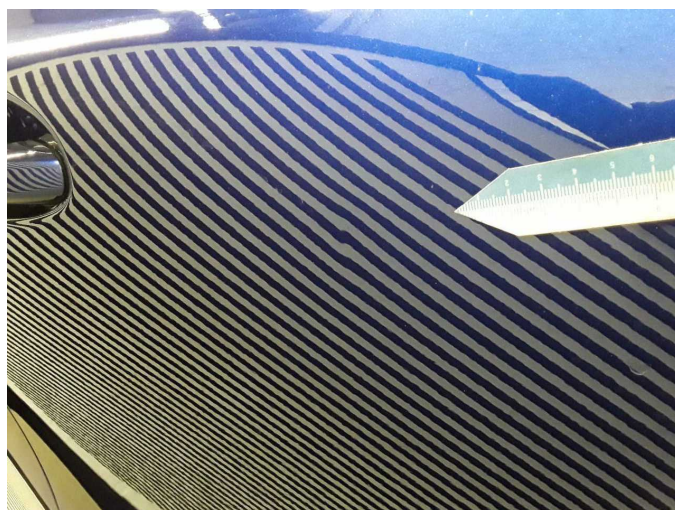
| No. | Component group | Description |
|---|---|---|
| 5 | Door - front right side | Door - dent(s) - No deduction |

**Wear and tear 5:** Door - front right side: Door - dent(s) - No deduction

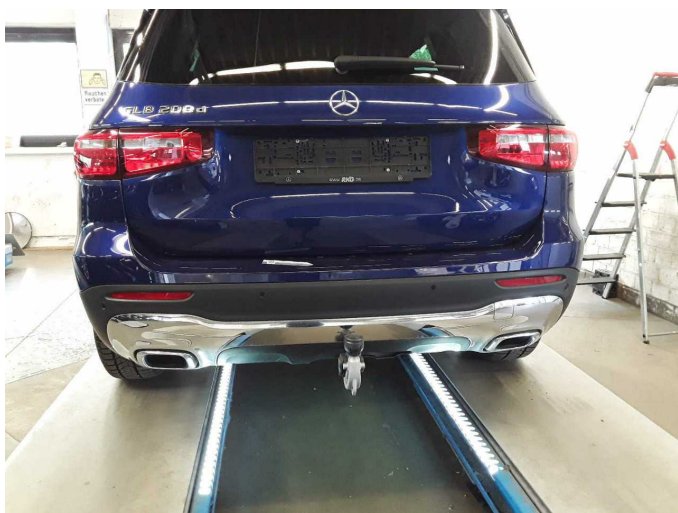
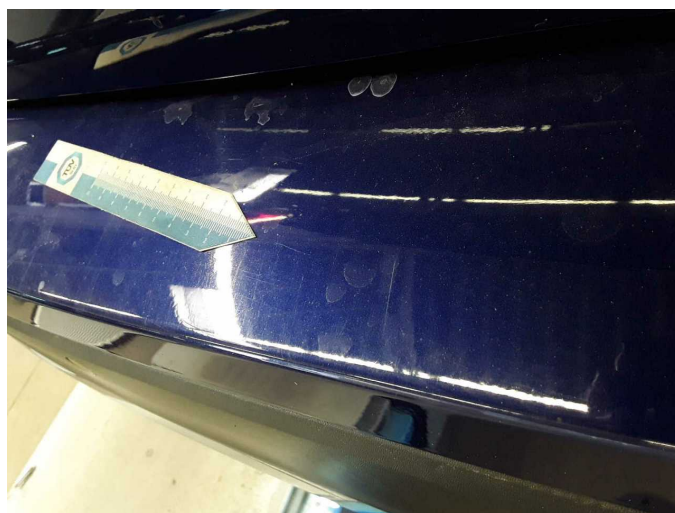
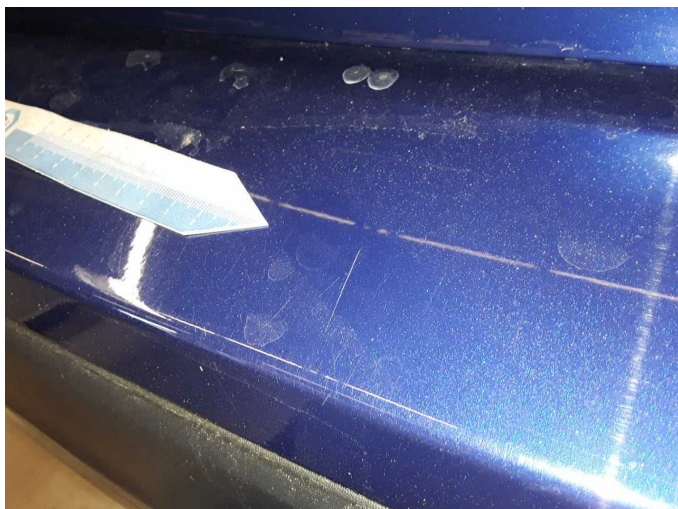
| No. | Component group | Description |
|---|---|---|
| 6 | Rear bumper | Rear bumper (Verladebereich) - Scratch(es) - No deduction |

**Wear and tear 6:** Rear bumper: Rear bumper (Verladebereich) - Scratch(es) - No deduction

**Wear and tear 6:** Rear bumper: Rear bumper (Verladebereich) -  
Scratch(es) - No deduction
