Expertise

Protocol number: 45378983
Order No. / Reference: 26243698
Inspection date: 18 Apr 2026

Model: Superb Combi 2.0 TDI DSG Premium Edition

Brief expert findings

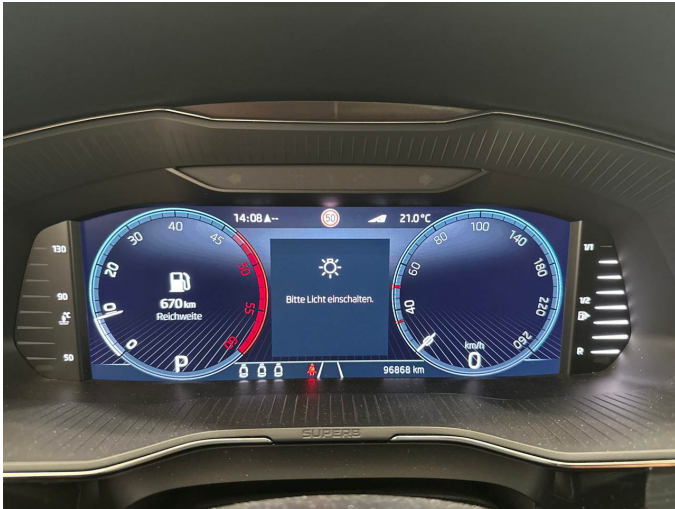
Figure 7: Instrument cluster

Mileage (Read) 96,868 km

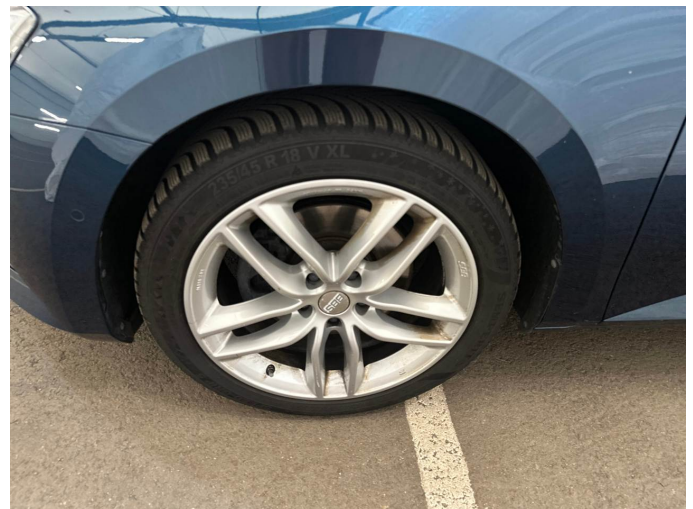
Figure 12: Mounted tyres

#	Tyre size	Type of tyre	Manufacturer	Tread depth
1)	235/45 R18 98V	Winter tyres on Light alloy	Semperit	6mm / 6mm
2)	235/45 R18 98V	Winter tyres on Light alloy	Semperit	7mm / 5mm

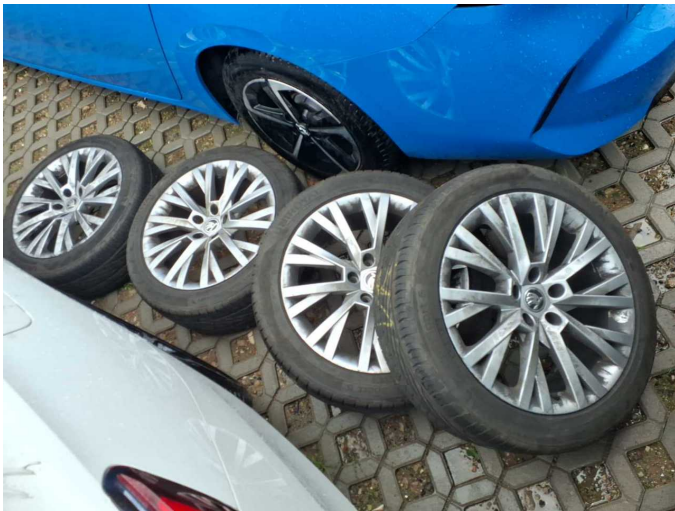
Figure 15: Additional tyres

#	Tyre size	Type of tyre	Manufacturer	Tread depth
1)	235/45 R18 98Y	Summer tyres on Light alloy	Uniroyal	7mm / 7mm
2)	235/45 R18 98Y	Summer tyres on Light alloy	Uniroyal	7mm / 7mm

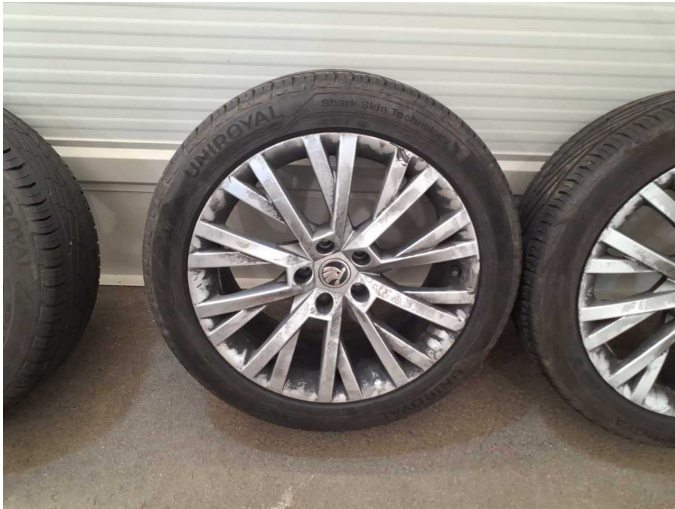
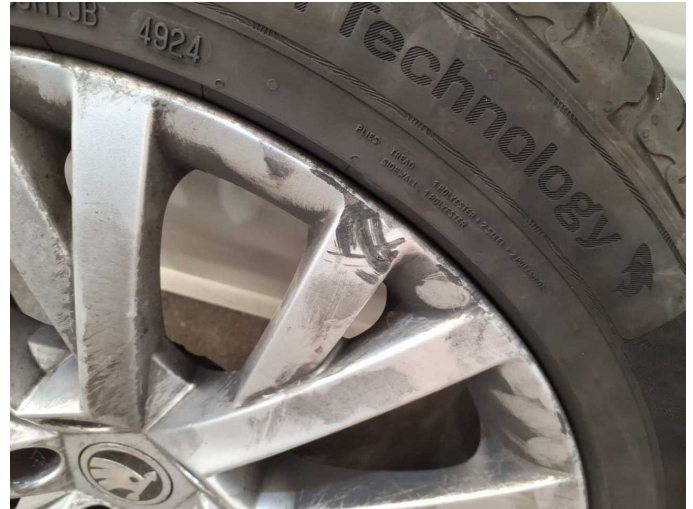
Damage 1: 2nd wheel set: 1 alloy rim - Scratched - Loss in value

No.	Component group	Description
1	2nd wheel set	1 alloy rim - Scratched - Loss in value
2	Rear bumper	Rear bumper - Scratched - Paint
3	Front bumper	Front bumper - Scratched - Repair and paint

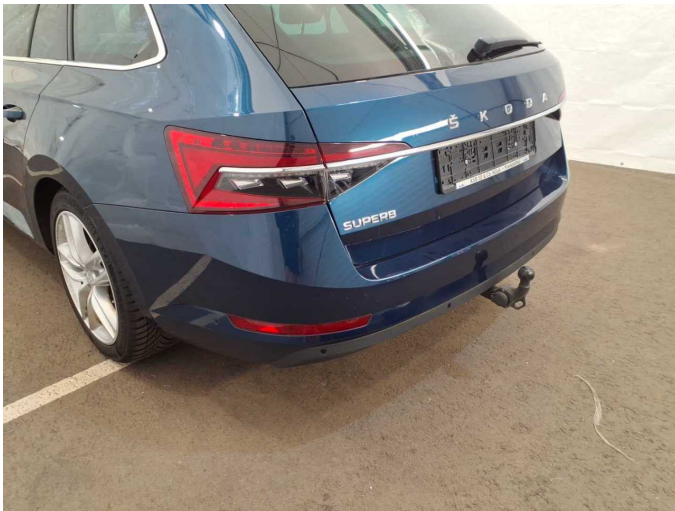
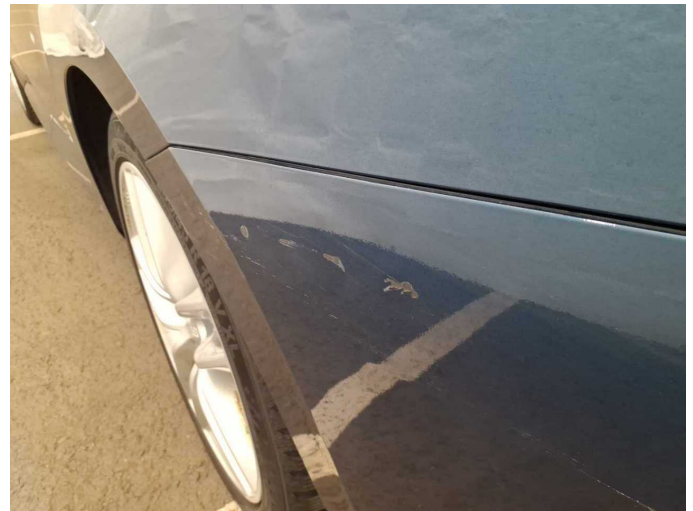
Damage 2: Rear bumper: Rear bumper - Scratched - Paint

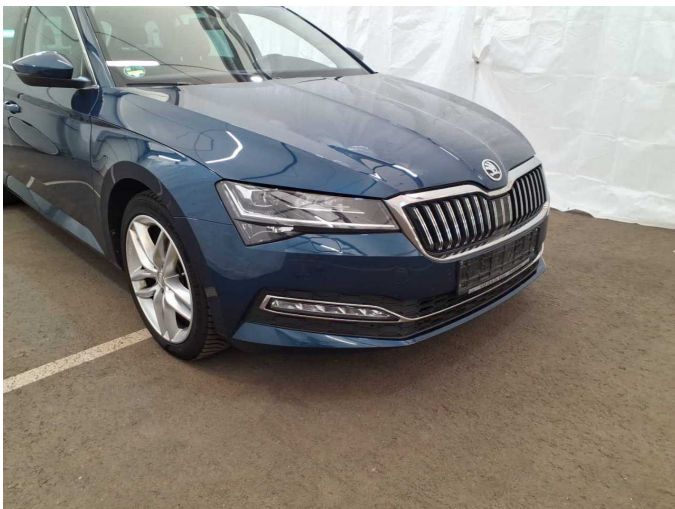
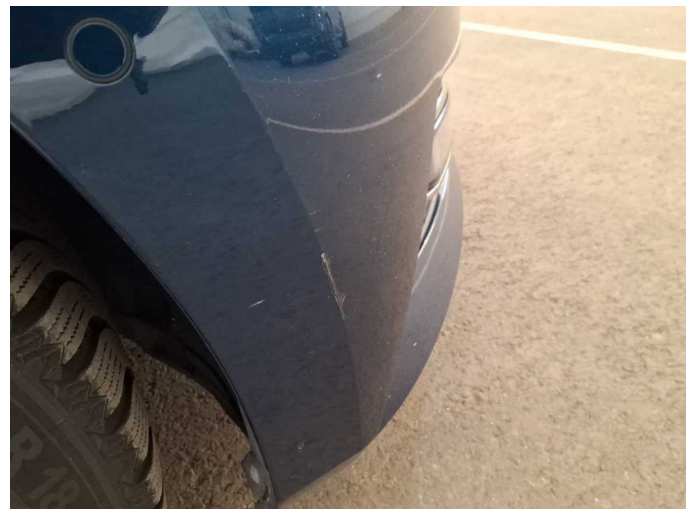
Damage 3: Front bumper: Front bumper - Scratched - Repair and paint
