Expertise

Protocol number: 46314790
Order No. / Reference: 26325649
Inspection date: 1 Jul 2026

Model: A6 40 TDI S tronic

VIN: WAUZZZF22RN033914

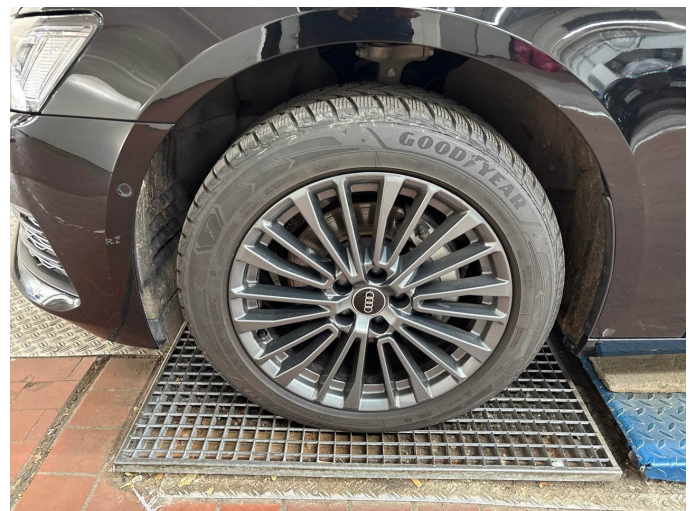
#	Tyre size	Type of tyre	Manufacturer	Tread depth
1)	225/55 R18 102V	Winter tyres on Light alloy	Goodyear	7mm / 7mm
2)	225/55 R18 102V	Winter tyres on Light alloy	Goodyear	6mm / 6mm

Figure 12: Mounted tyres

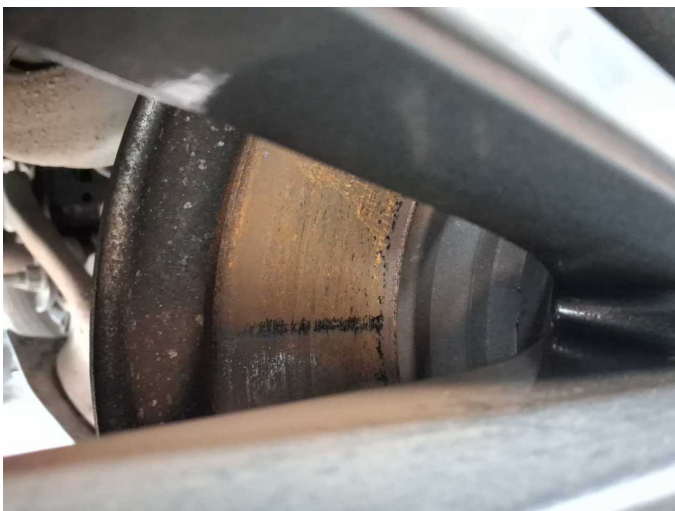
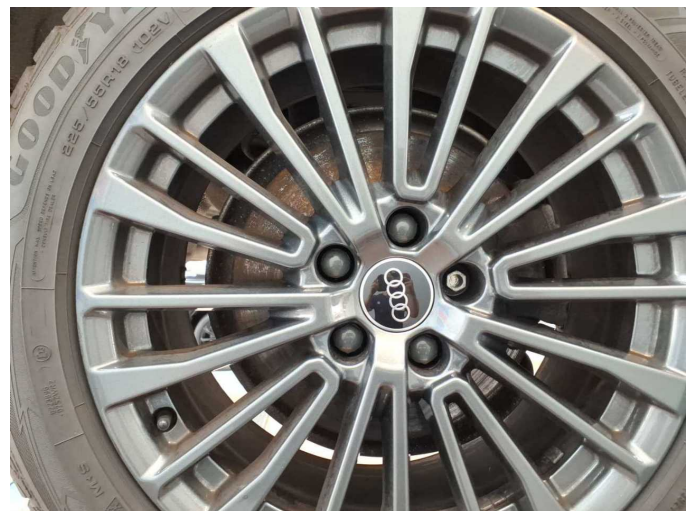
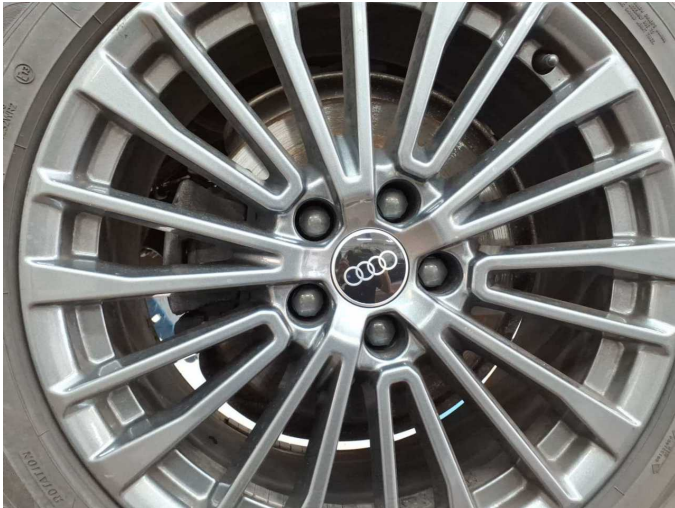
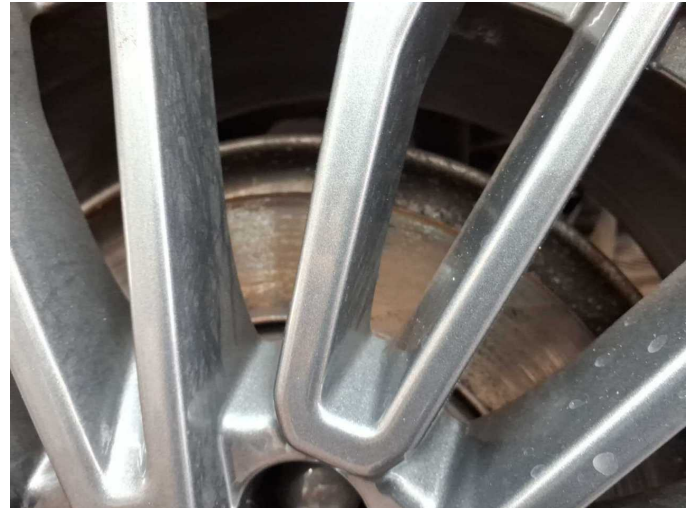
Damage 1: Braking system: Brake discs - rear (Freibremsen) - Corrosion

Wenn sich die Bremsscheiben nicht freibremsten lassen entstehen Mehrkosten.

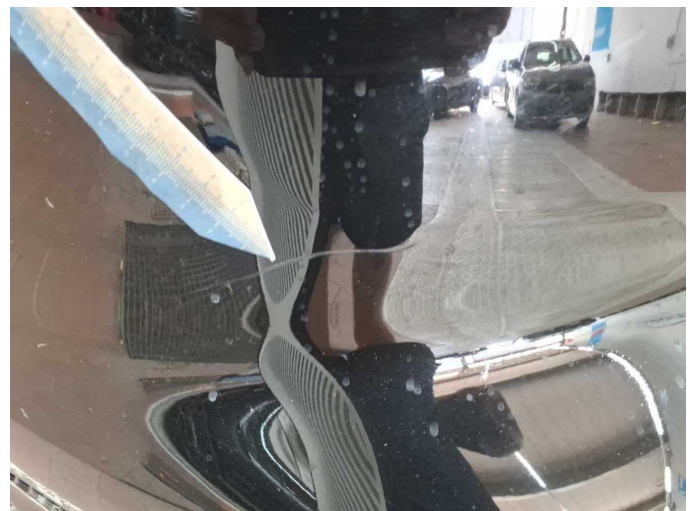
Damage 2: Rear bumper: Rear bumper - Scratch(es) - Smart repair

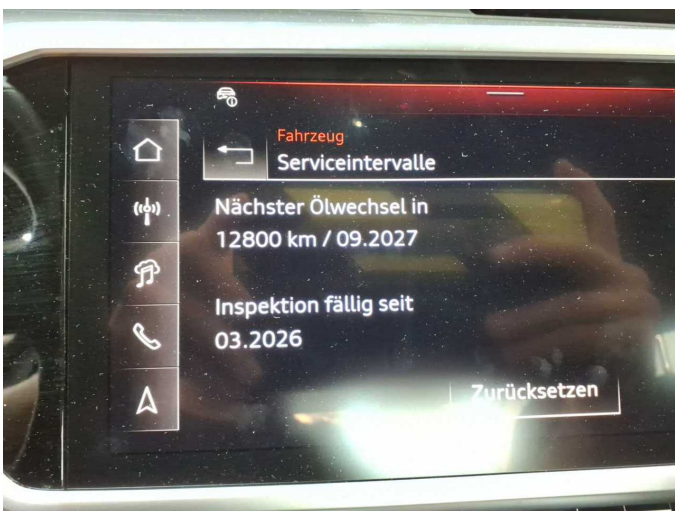
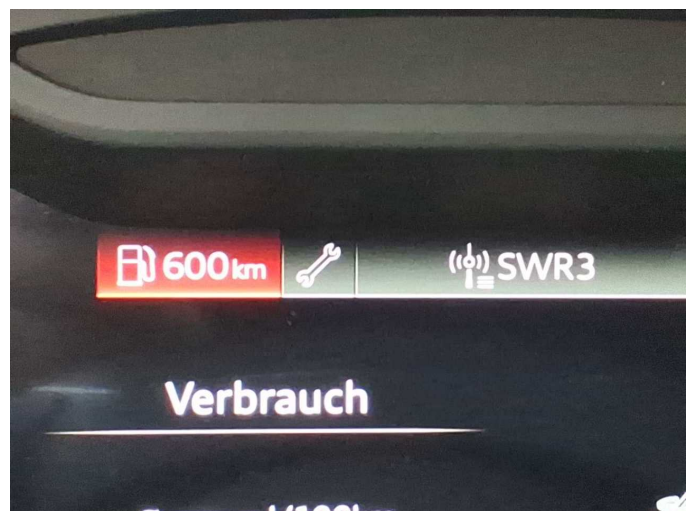
Damage 3: Misc.: Inspection / maintenance - Due - Perform

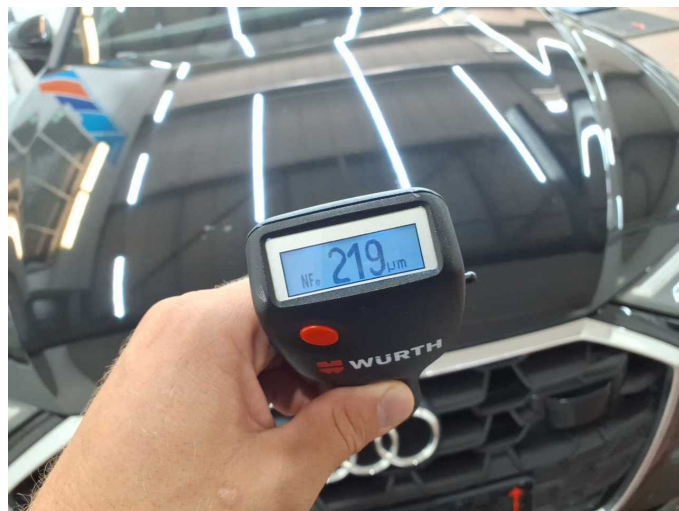
No.	Repainting
1	Bonnet, Professionally carried out, Invoice of repair done Non-existent

Bonnet	219 µm
--------	--------

Repainting 1: Bonnet
