Expertise

Protocol number: 46511706  
Order No. / Reference: 26561838  
Inspection date: 9 Jul 2026

Manufacturer: Volkswagen

Model: Touran 2.0 TDI SCR DSG Highline

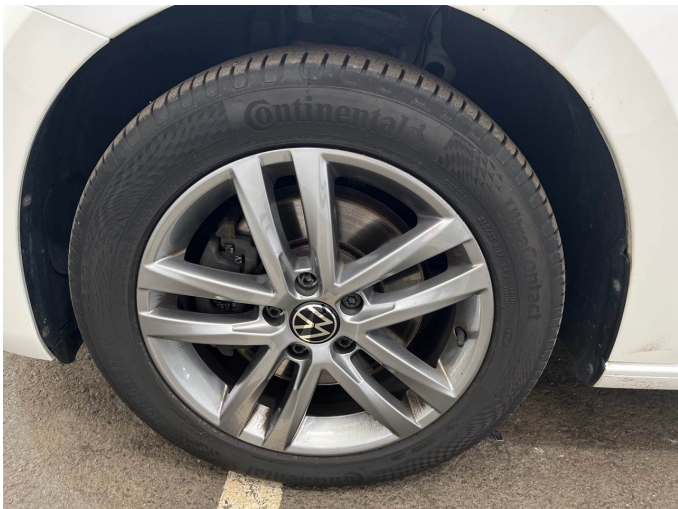
| # | Tyre size | Type of tyre | Manufacturer | Tread depth |
|---|---|---|---|---|
| 1) | 215/55 R17 94V | Summer tyres on Light alloy | Continental | 6mm / 6mm |
| 2) | 215/55 R17 94V | Summer tyres on Light alloy | Continental | 4mm / 4mm |

Figure 12: Mounted tyres

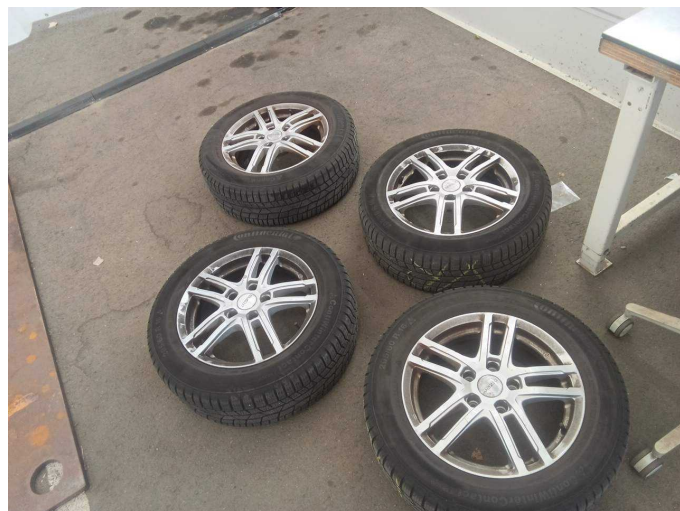
| # | Tyre size | Type of tyre | Manufacturer | Tread depth |
|---|---|---|---|---|
| 1) | 205/60 R16 96H | Winter tyres on Light alloy | Continental | 6mm / 6mm |
| 2) | 205/60 R16 96H | Winter tyres on Light alloy | Continental | 6mm / 6mm |

Figure 15: Additional tyres

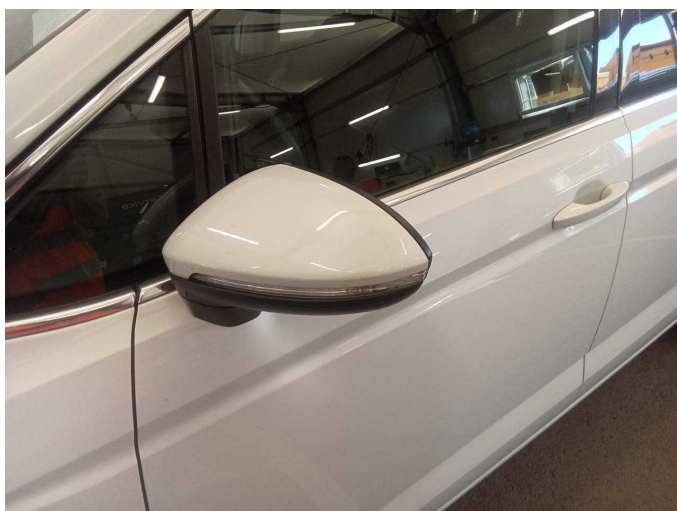
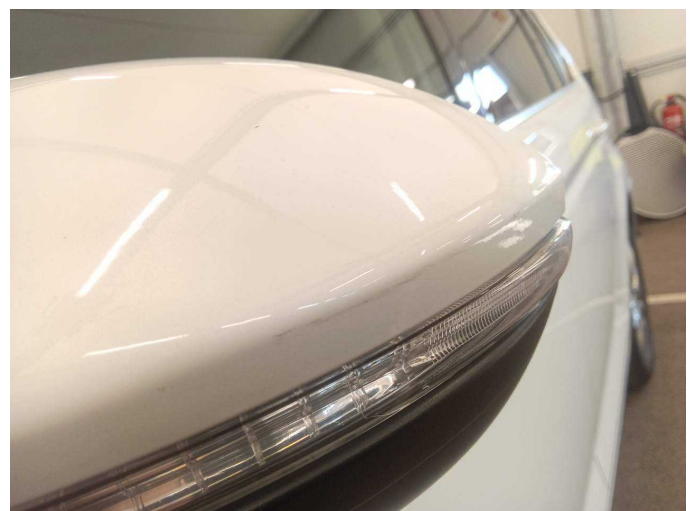
| No. | Component group | Description |
|---|---|---|
| 1 | Wing mirror - left side | Cap - Scratch(es) - Smart repair |

**Damage 1:** Wing mirror - left side: Cap - Scratch(es) - Smart repair

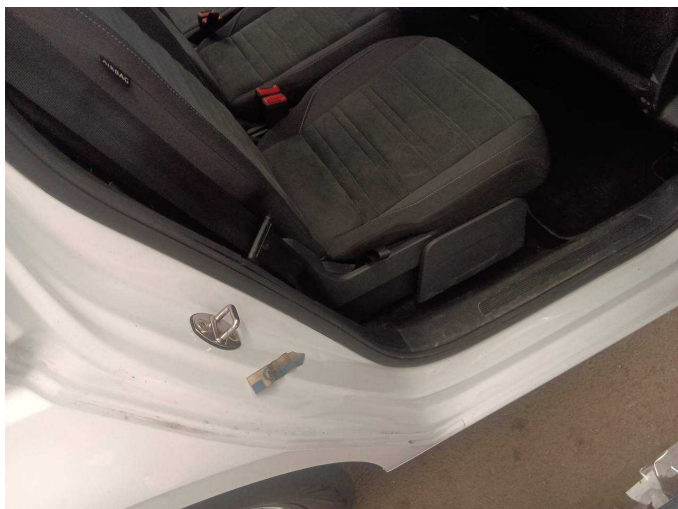
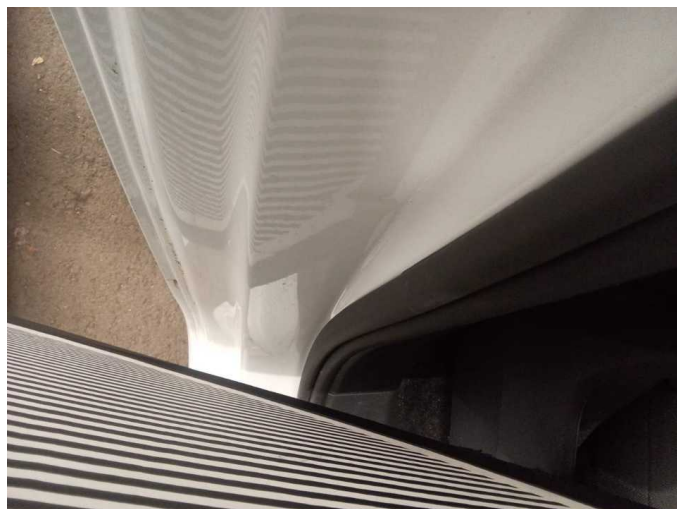
| No. | Component group | Description |
|---|---|---|
| 2 | Side panel - rear right side | Sill - dent(s) - Smooth repair work |

**Damage 2:** Side panel - rear right side: Sill - dent(s) - Smooth repair work

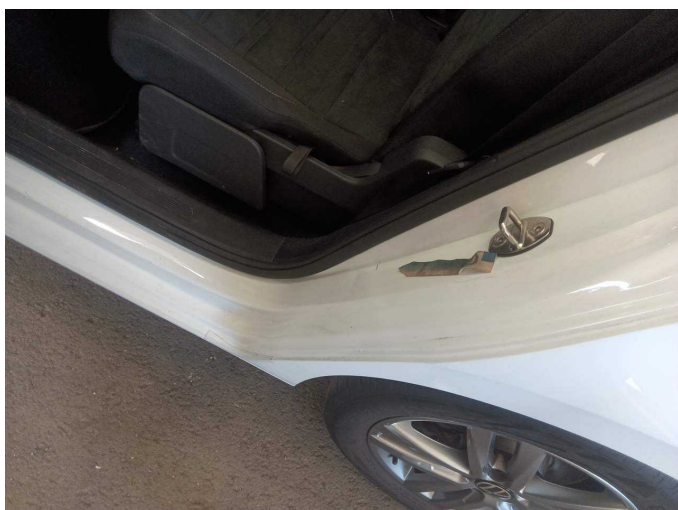
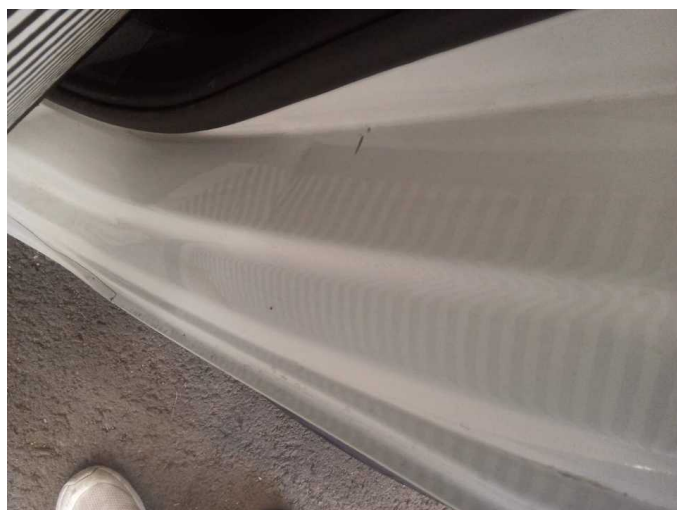
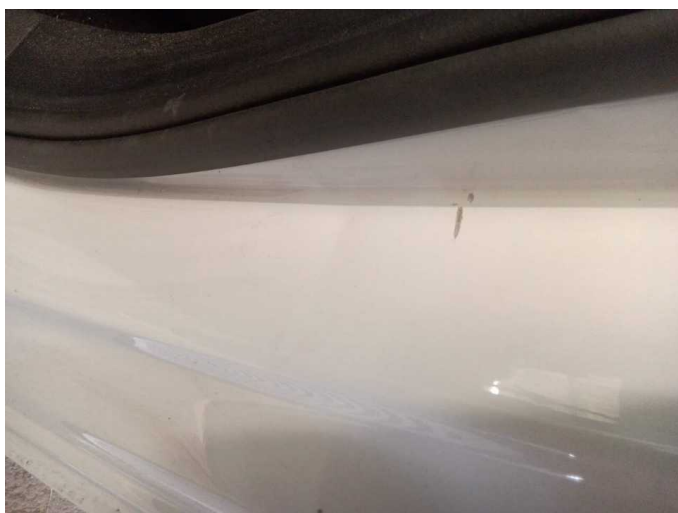
| No. | Component group | Description |
|---|---|---|
| 3 | Side panel - rear left side | Sill - Dent / paintcoat damage - Smart repair |

**Damage 3:** Side panel - rear left side: Sill - Dent / paintcoat damage - Smart repair

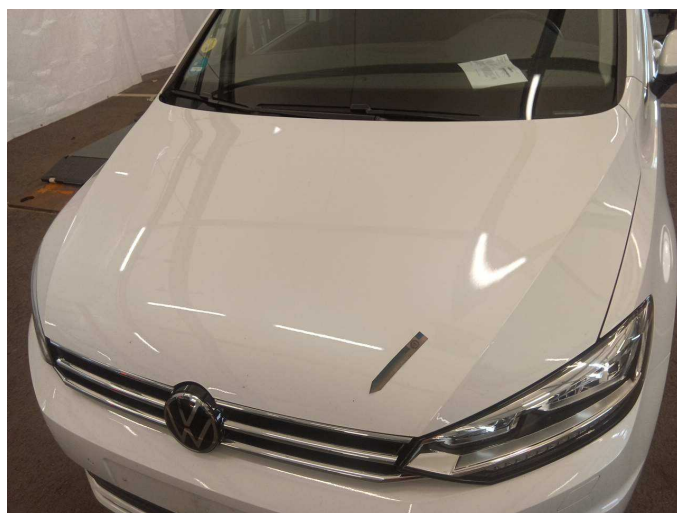
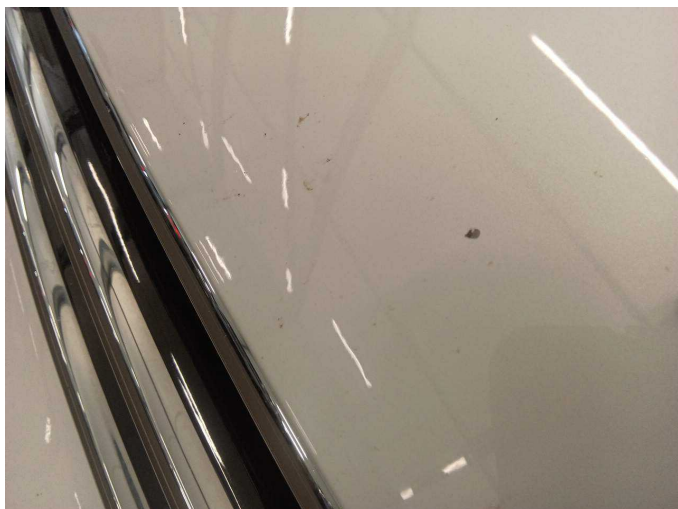
| No. | Component group | Description |
|---|---|---|
| 1 | Bonnet | Bonnet - Stone chips - No deduction |

**Wear and tear 1:** Bonnet: Bonnet - Stone chips - No deduction

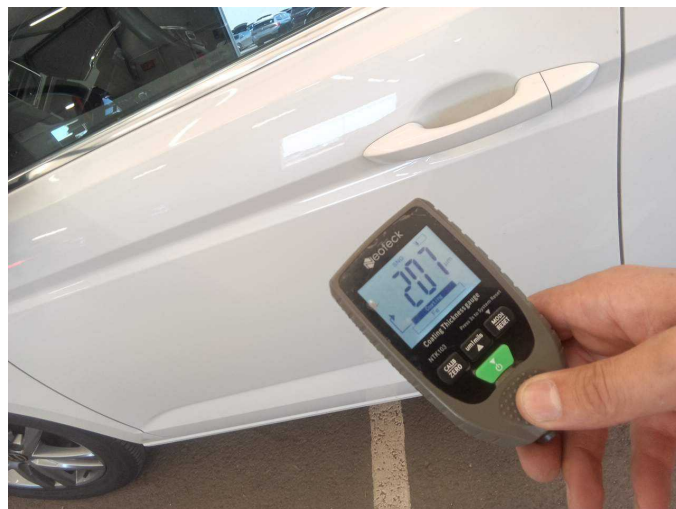
1 Door - front left side, Professionally carried out, Invoice of repair done Non-existent

Door - front left side 207 µm

**Repainting 1:** Door - front left side
