Expertise

Protocol number: 46423657  
Order No. / Reference: 26657457  
Inspection date: 8 Jul 2026

Model: C 300 e T 9G-TRONIC Avantgarde

VIN: W1KAH5EB6PF121262

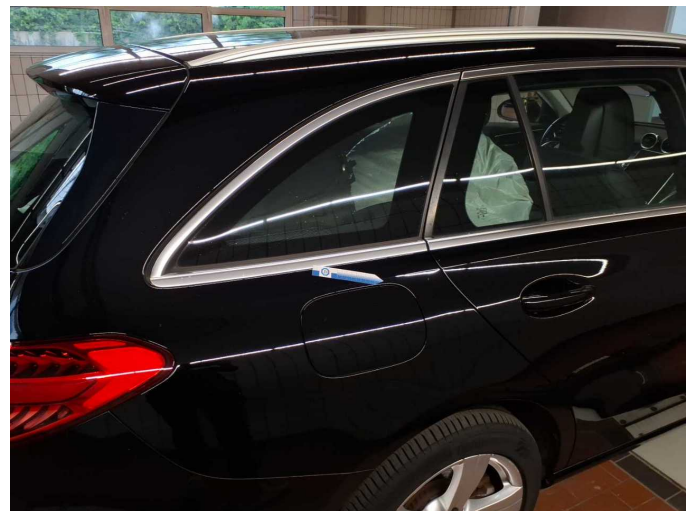
| No. | Component group | Description |
|---|---|---|
| 1 | Side panel - rear right side | Side panel - Scratch(es) - Smart repair |

Damage 1: Side panel - rear right side: Side panel - Scratch(es) - Smart repair

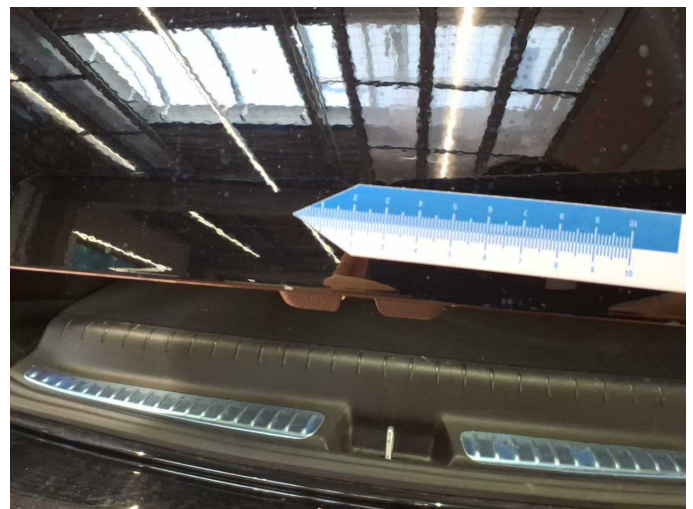
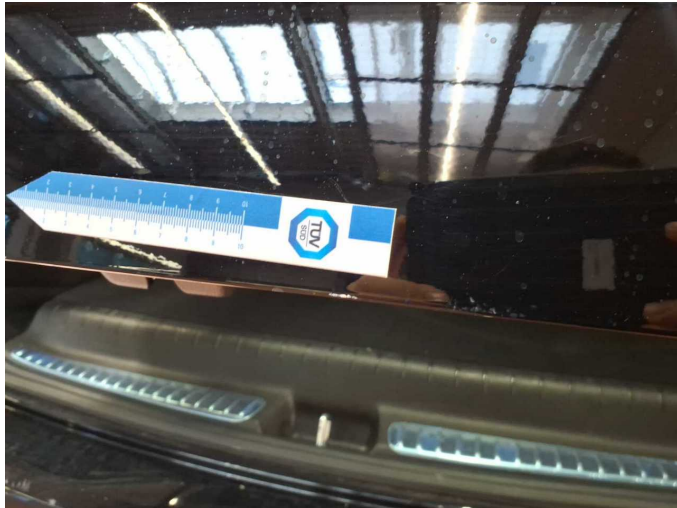
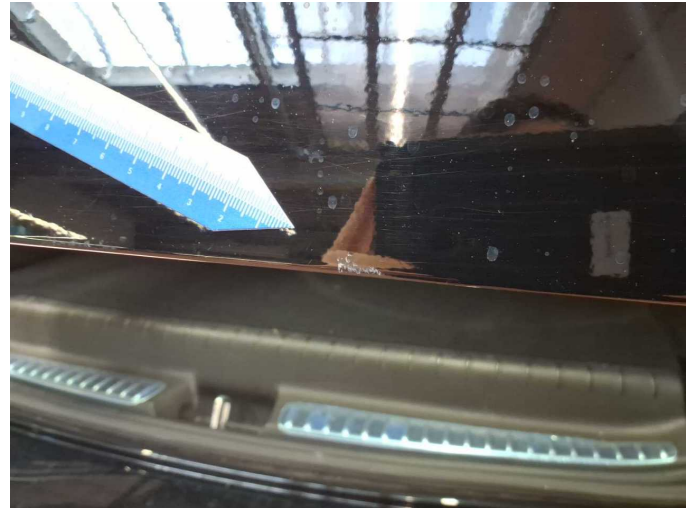
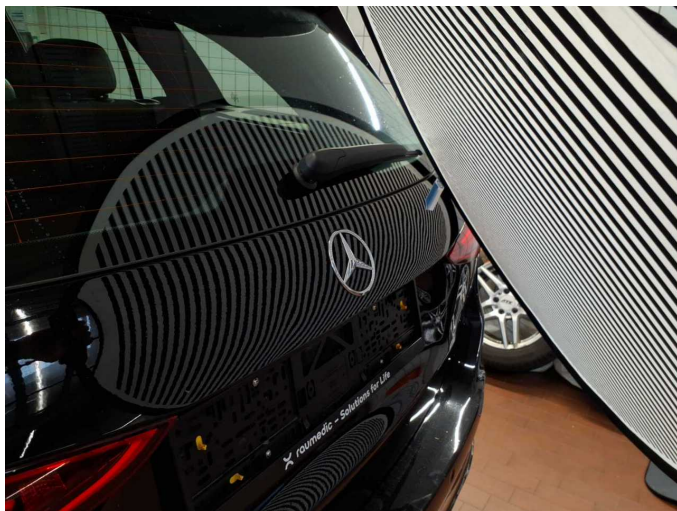
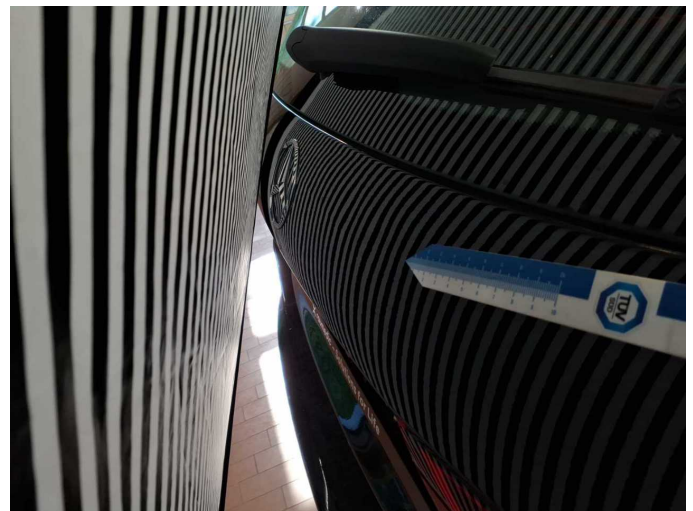
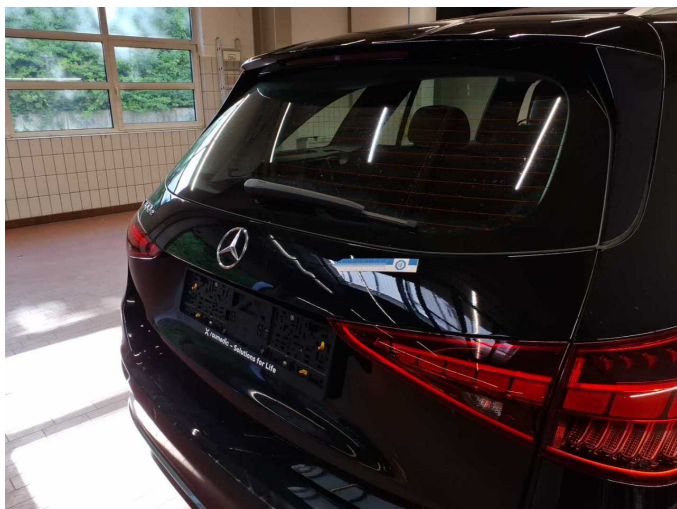
| No. | Component group | Description |
|---|---|---|
| 2 | Boot lid / rear door | Boot lid - Dent / paintcoat damage - Smart repair |

Damage 2: Boot lid / rear door: Boot lid - Dent / paintcoat damage - Smart repair

**Damage 2:** Boot lid / rear door: Boot lid - Dent / paintcoat damage - Smart repair

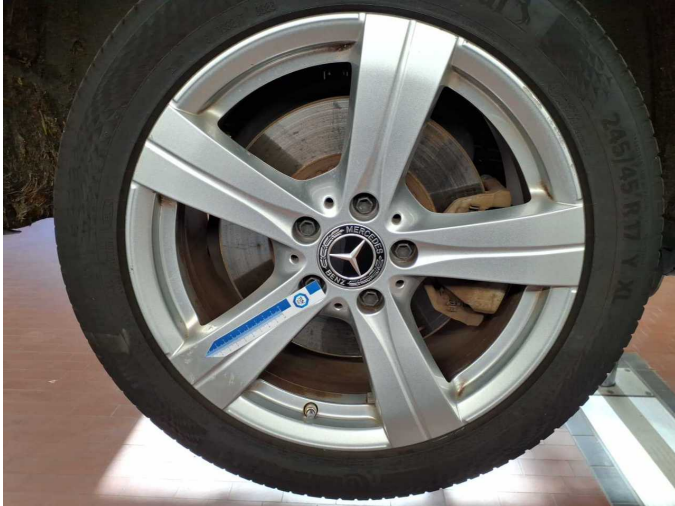
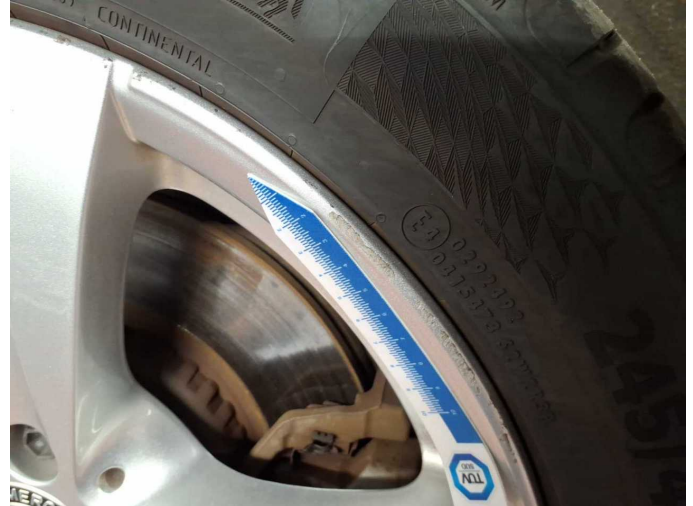
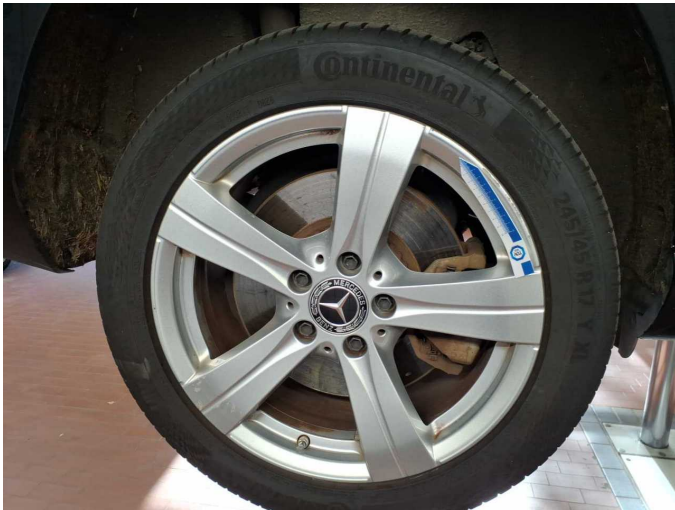
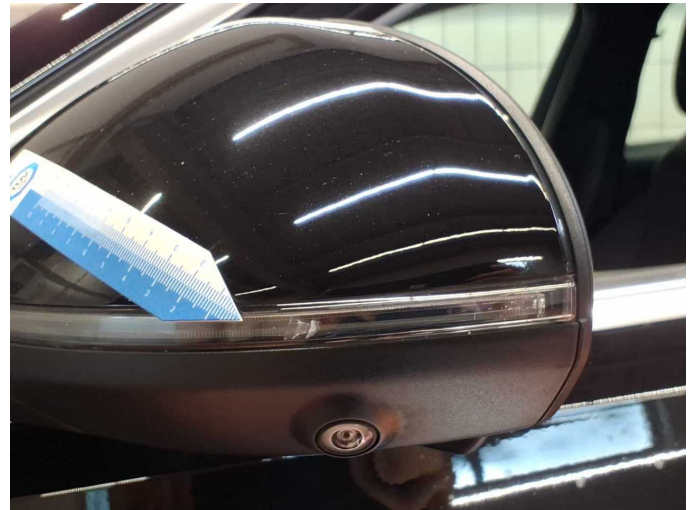
| No. | Component group | Description |
|---|---|---|
| 3 | Wheel / tyres | Alloy rim - rear right side - Scratch(es) - Loss in value |

**Damage 3:** Wheel / tyres: Alloy rim - rear right side - Scratch(es) - Loss in value

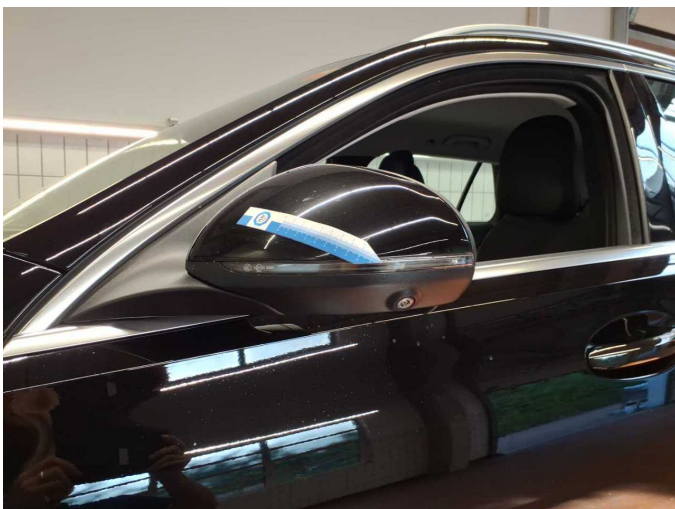
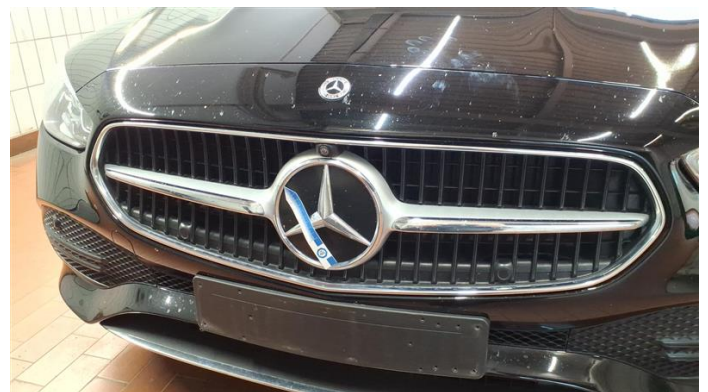
| No. | Component group | Description |
|---|---|---|
| 4 | Indicator - front | Mirror - left side - Scratch(es) - Replace |

**Damage 4:** Indicator - front: Mirror - left side - Scratch(es) - Replace

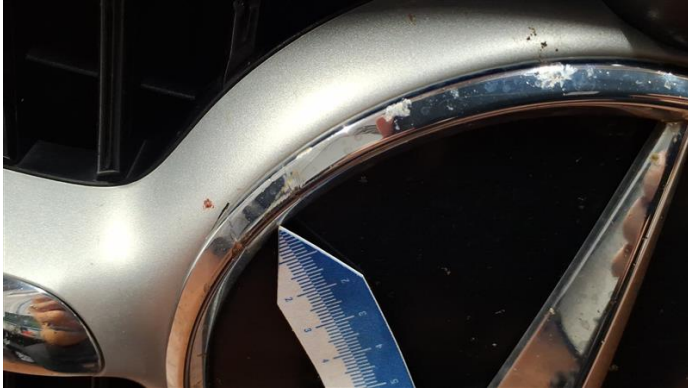
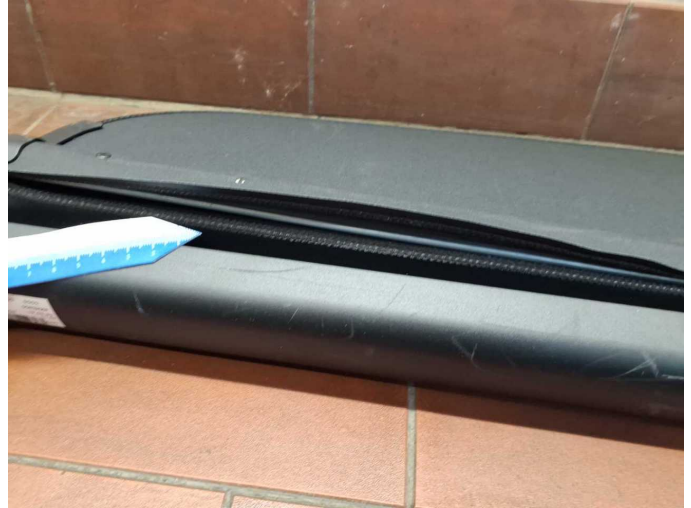
| No. | Component group | Description |
|---|---|---|
| 5 | Front bumper | Grille (Stern) - Broken / torn - Replace |

**Damage 5:** Front bumper: Grille (Stern) - Broken / torn - Replace

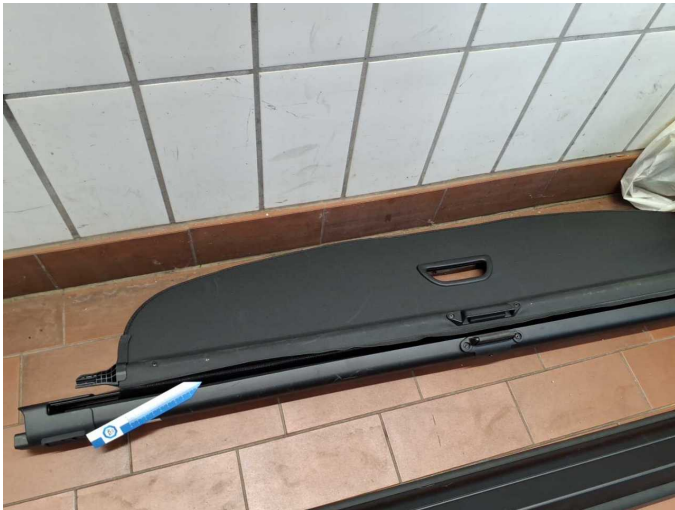
| No. | Component group | Description |
|---|---|---|
| 6 | Interior | Boot cover / roller cover - Broken / torn - Replace |

**Damage 6:** Interior: Boot cover / roller cover - Broken / torn - Replace

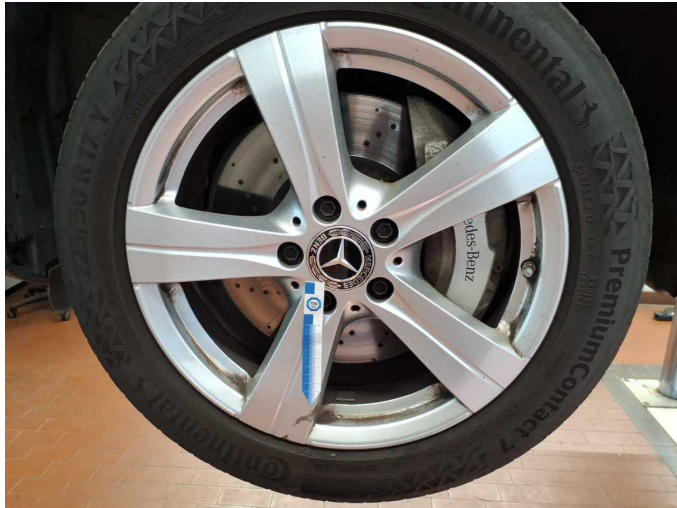
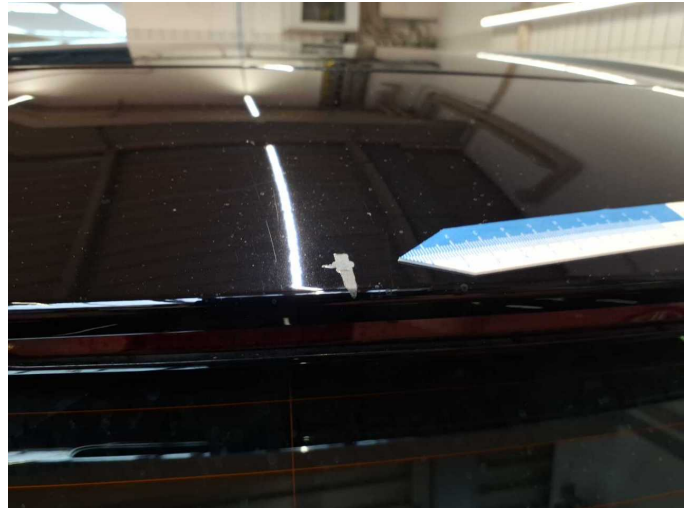
| No. | Component group | Description |
|---|---|---|
| 8 | Wheel / tyres | Alloy rim - front left side (Hoher Materialabtrag) - Scratched - Replace |

**Damage 8:** Wheel / tyres: Alloy rim - front left side (Hoher Materialabtrag) - Scratched - Replace

**Damage 8:** Wheel / tyres: Alloy rim - front left side (Hoher Materialabtrag)  
- Scratched - Replace

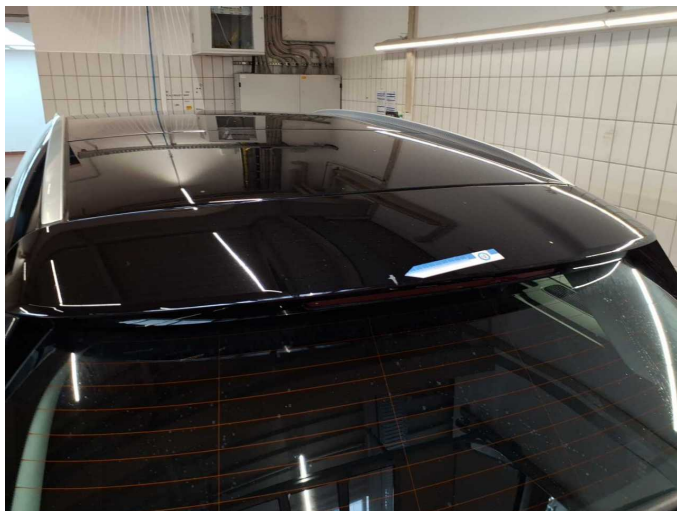
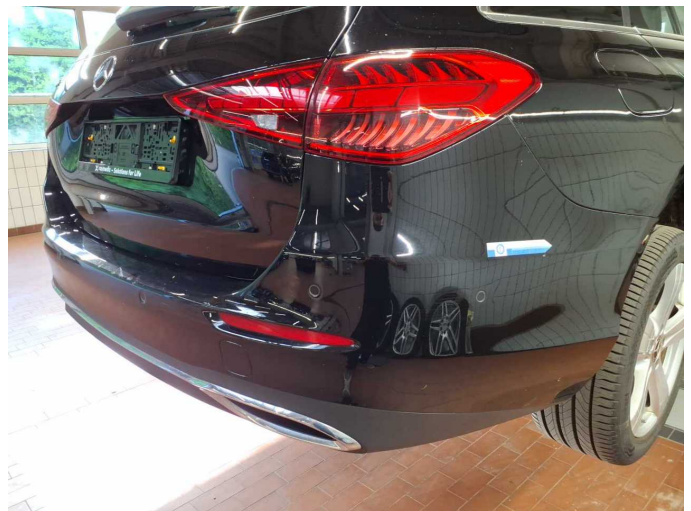
| No. | Component group | Description |
|---|---|---|
| 9 | Boot lid / rear door | Rear spoiler - Scratch(es) - Paint |

**Damage 9:** Boot lid / rear door: Rear spoiler - Scratch(es) - Paint

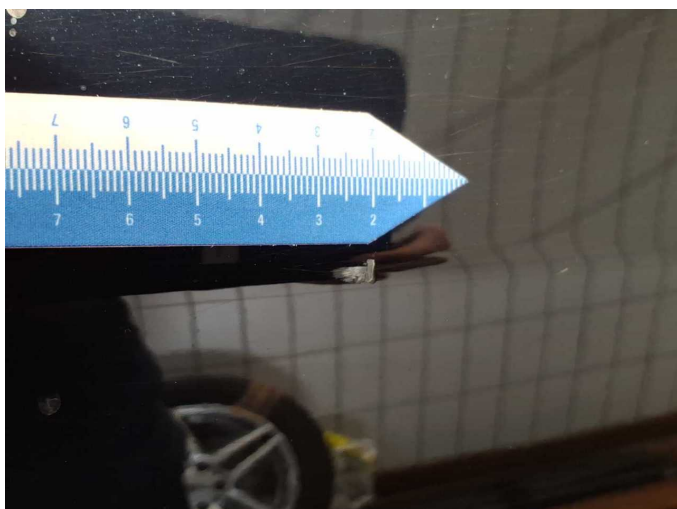
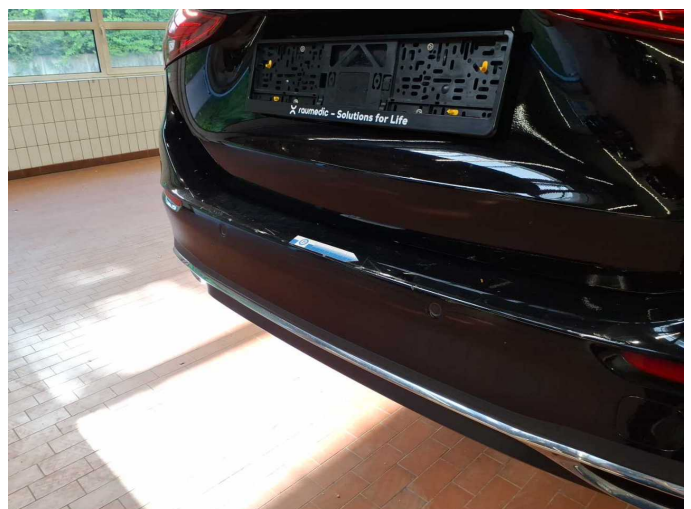
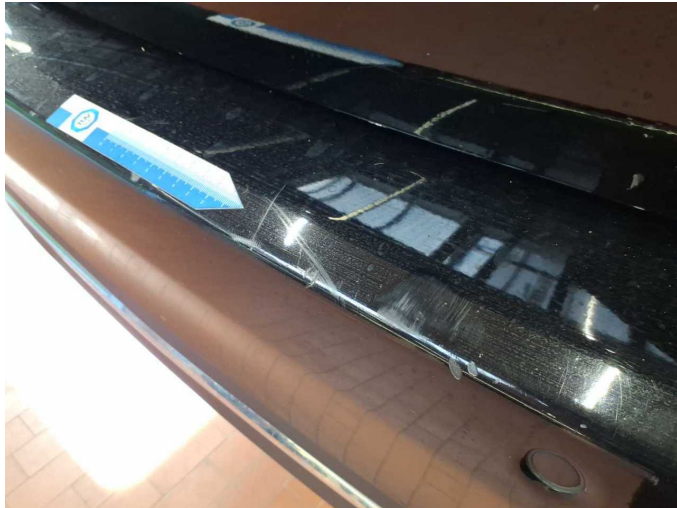
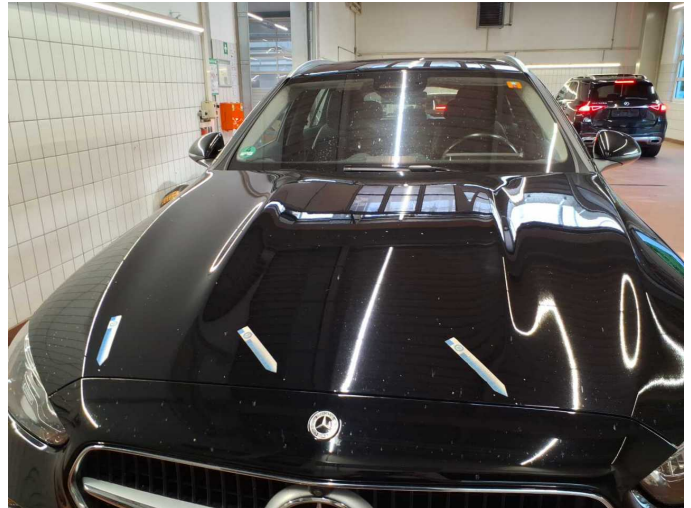
| No. | Component group | Description |
|---|---|---|
| 10 | Rear bumper | Rear bumper - Scratch(es) - Paint |

**Damage 10:** Rear bumper: Rear bumper - Scratch(es) - Paint

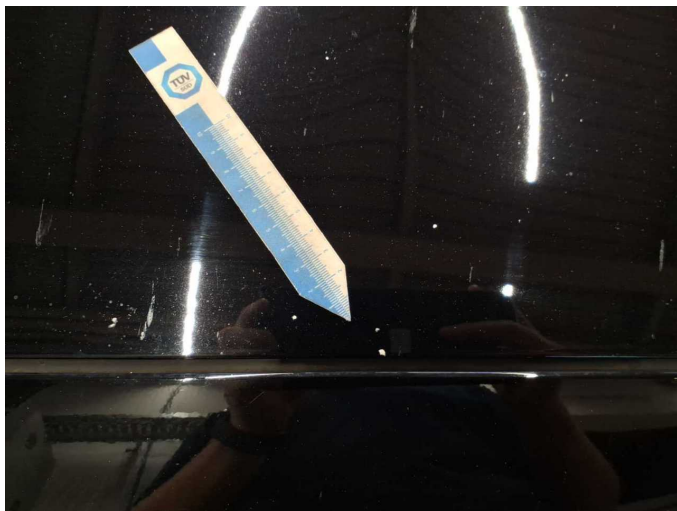
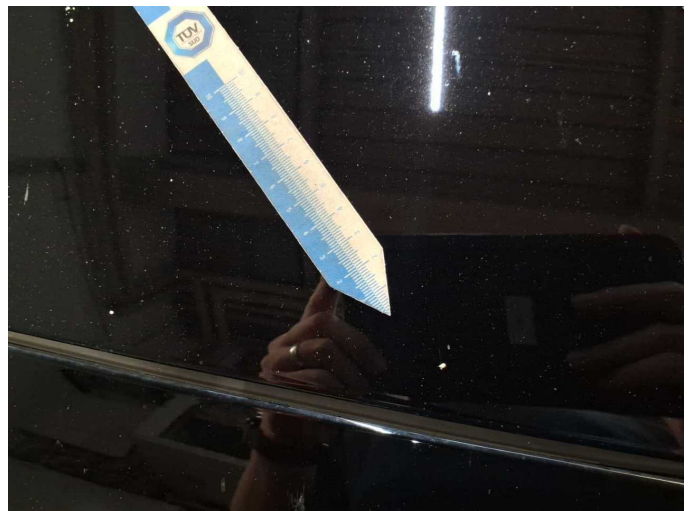
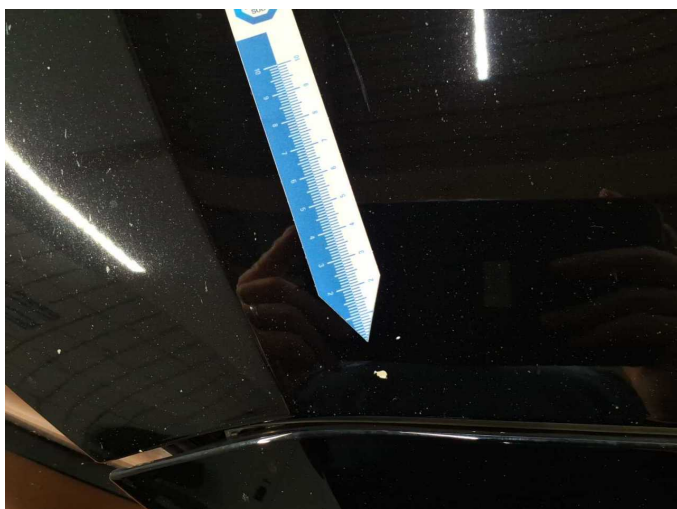
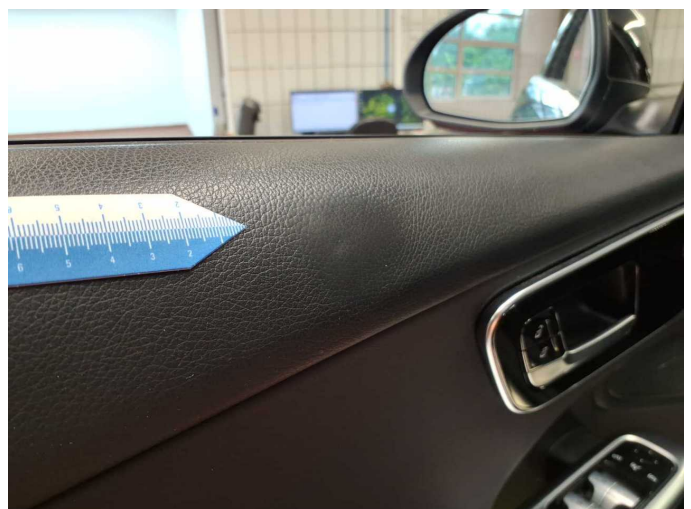
| No. | Component group | Description |
|---|---|---|
| 11 | Bonnet | Bonnet - Stone chips - Paint |

**Damage 11:** Bonnet: Bonnet - Stone chips - Paint

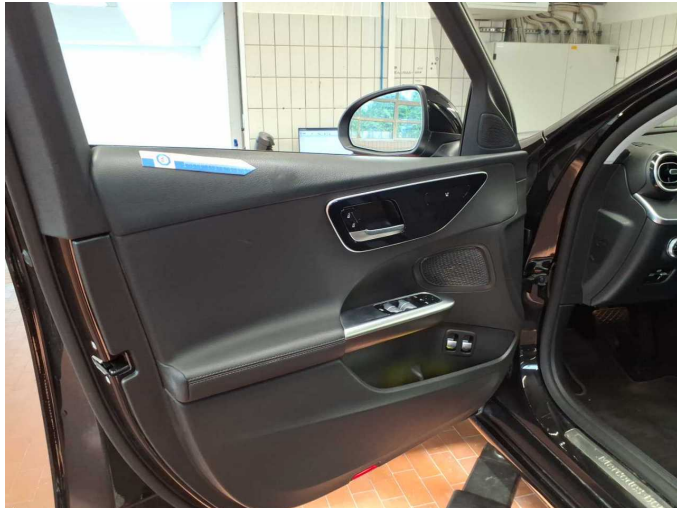
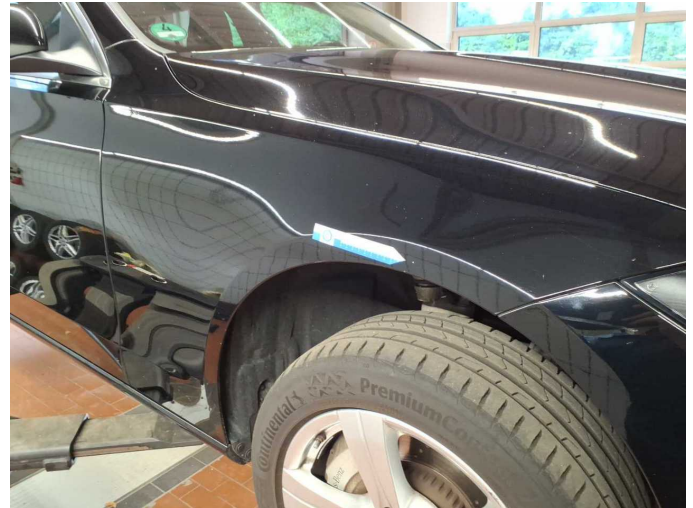
| No. | Component group | Description |
|---|---|---|
| 1 | Trim / covers | Door trim - front left side - dent(s) - No deduction |

**Wear and tear 1:** Trim / covers: Door trim - front left side - dent(s) - No deduction

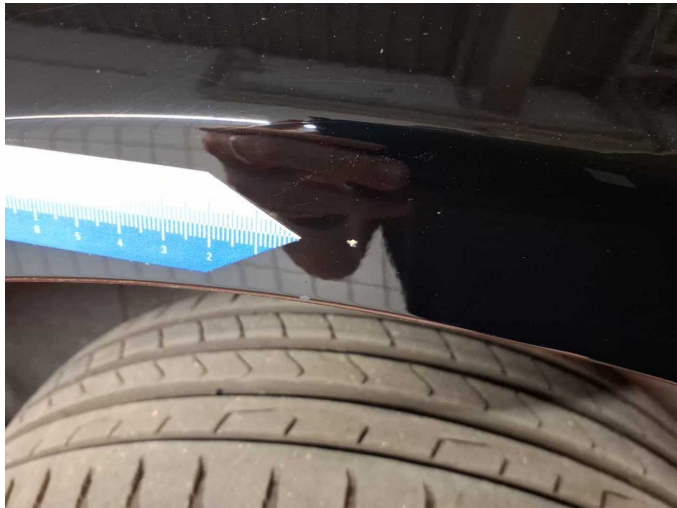
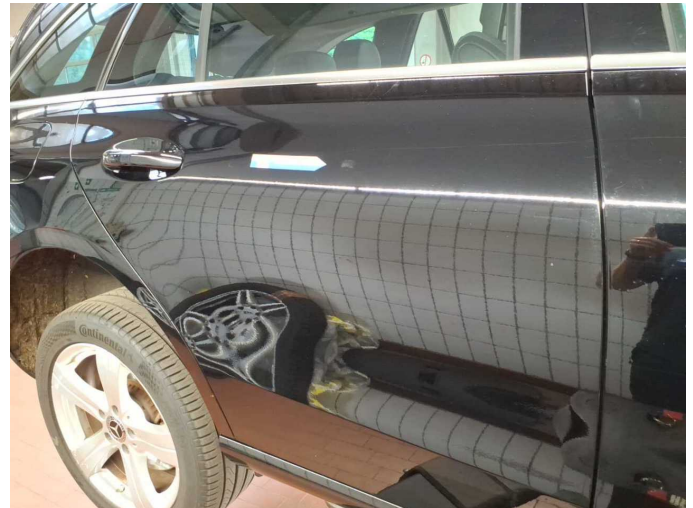
| No. | Component group | Description |
|---|---|---|
| 2 | Mudguard - right side | Mudguard - right side - Stone chips - No deduction |

**Wear and tear 2:** Mudguard - right side: Mudguard - right side - Stone chips - No deduction

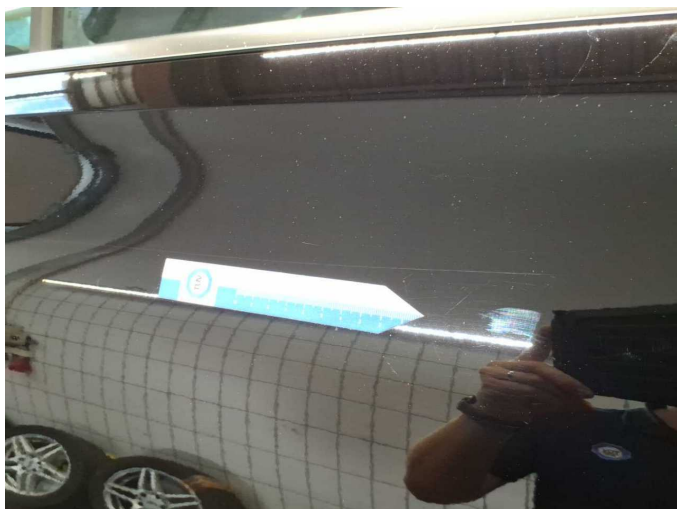
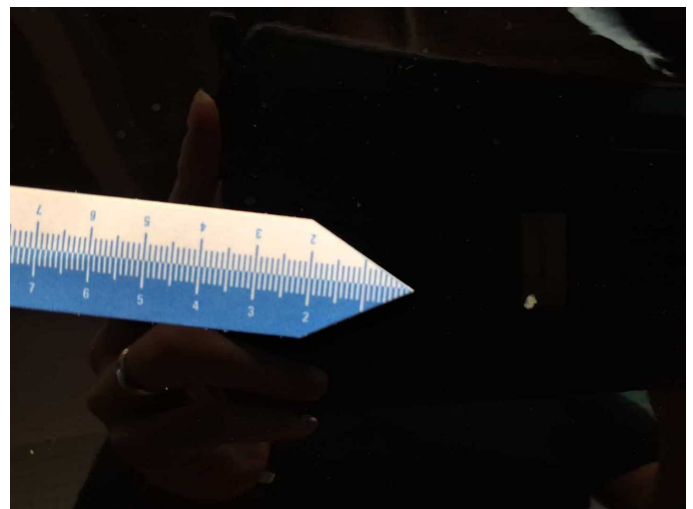
| No. | Component group | Description |
|---|---|---|
| 3 | Door - rear right side | Door - Scratch(es) - No deduction |

**Wear and tear 3:** Door - rear right side: Door - Scratch(es) - No deduction

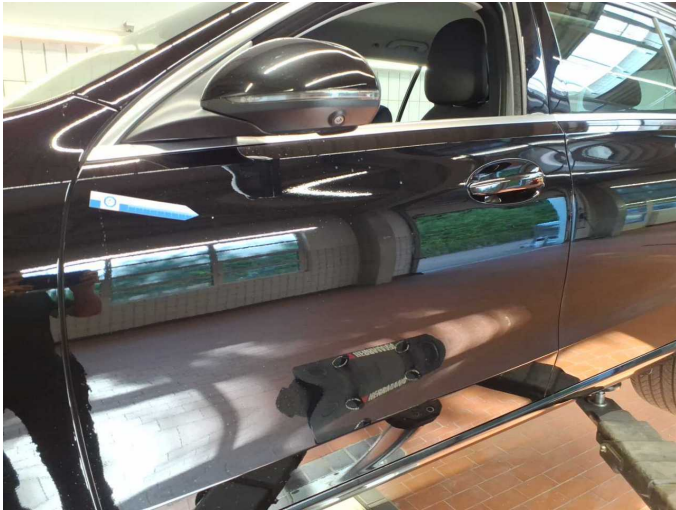
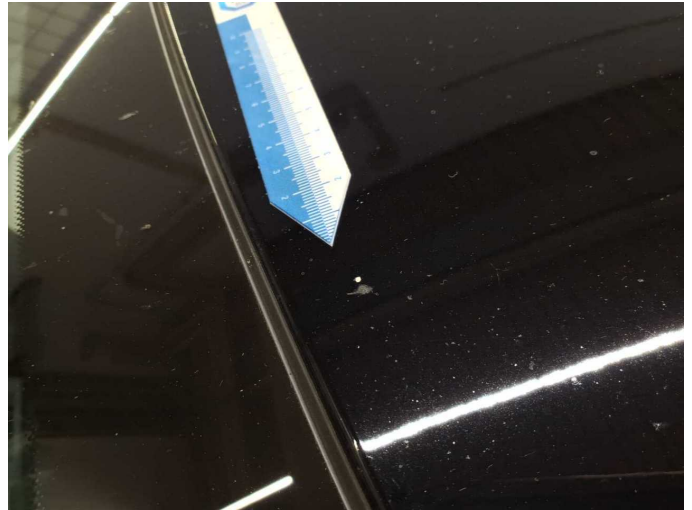
| No. | Component group | Description |
|---|---|---|
| 6 | Door - front left side | Door - Scratch(es) - No deduction |

**Wear and tear 6:** Door - front left side: Door - Scratch(es) - No deduction

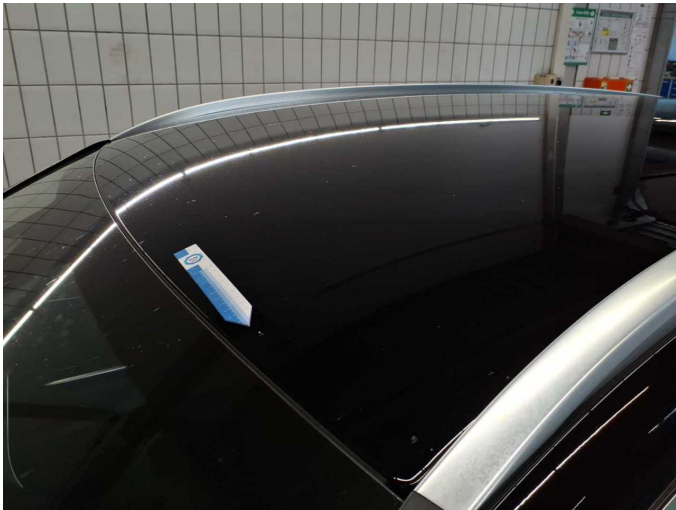
| No. | Component group | Description |
|---|---|---|
| 7 | Roof | Roof - Stone chips - No deduction |

**Wear and tear 7:** Roof: Roof - Stone chips - No deduction

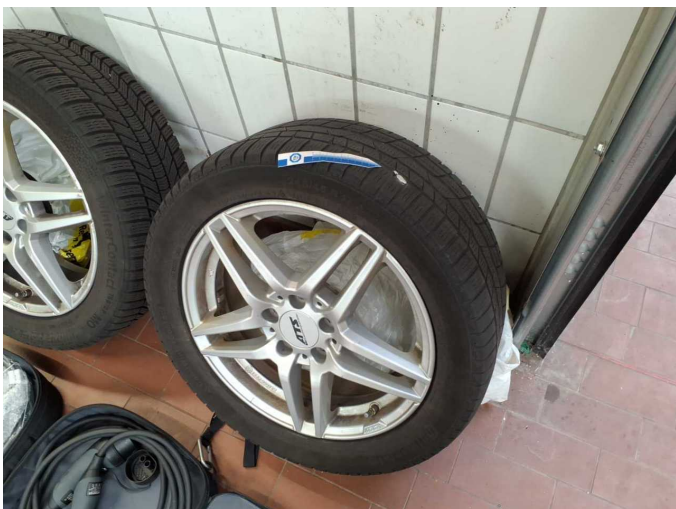
| No. | Component group | Description |
|---|---|---|
| 8 | 2nd wheel set | 1 tyre (Fremdkörper/Kein Teil der Serienausstattung) - Broken / torn - No deduction |

**Wear and tear 8:** 2nd wheel set: 1 tyre (Fremdkörper/Kein Teil der Serienausstattung) - Broken / torn - No deduction
