Expertise

Protocol number: 46884624  
Order No. / Reference: 26847823  
Inspection date: 4 Aug 2026

Manufacturer: Mercedes-Benz

Model: A 180 d 8G-DCT Lim. Progressive Advanced

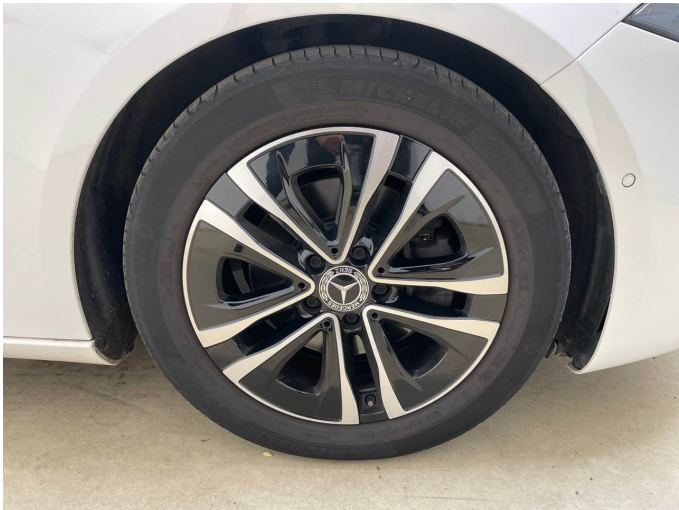
Figure 12: Mounted tyres

| # | Tyre size | Type of tyre | Manufacturer | Tread depth |
|---|---|---|---|---|
| 1) | 205/55 R17 91W | Summer tyres on Light alloy | Michelin | 4mm / 4mm |
| 2) | 205/55 R17 91W | Summer tyres on Light alloy | Michelin | 5mm / 5mm |

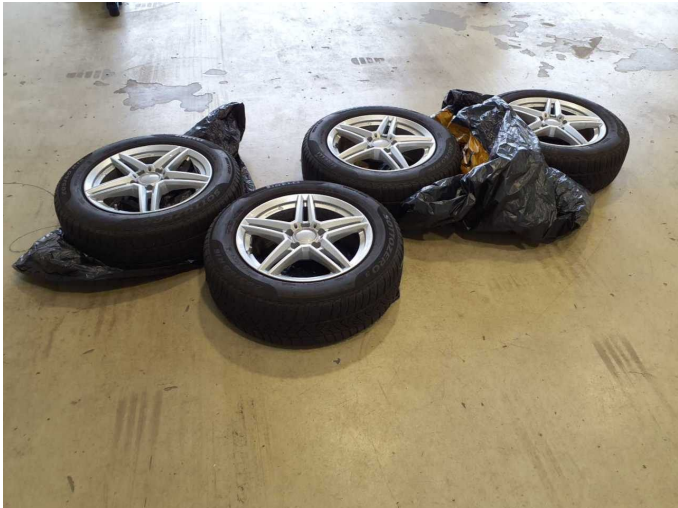
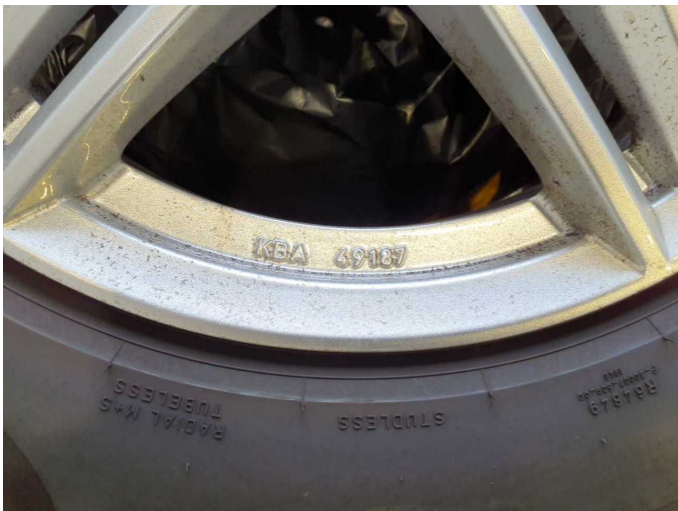
Figure 14: Additional tyres

| # | Tyre size | Type of tyre | Manufacturer | Tread depth |
|---|---|---|---|---|
| 1) | 205/60 R16 92H | Winter tyres on Light alloy | Pirelli | 3mm / 3mm |
| 2) | 205/60 R16 92H | Winter tyres on Light alloy | Pirelli | 4mm / 4mm |

| No. | Component group | Description |
|---|---|---|
| 2 | 2nd wheel set | Tyres - complete set - does not meet manufacturer specifications - No deduction |

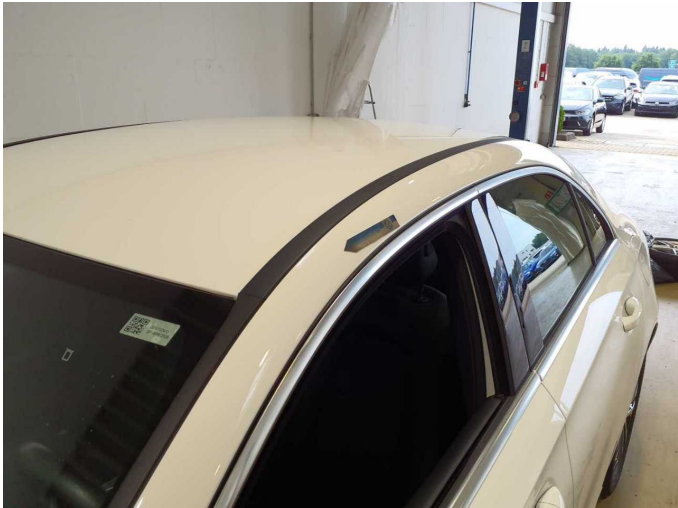
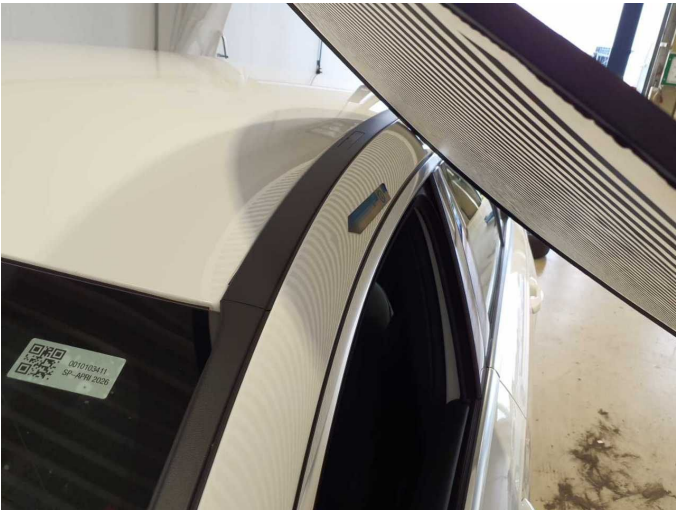
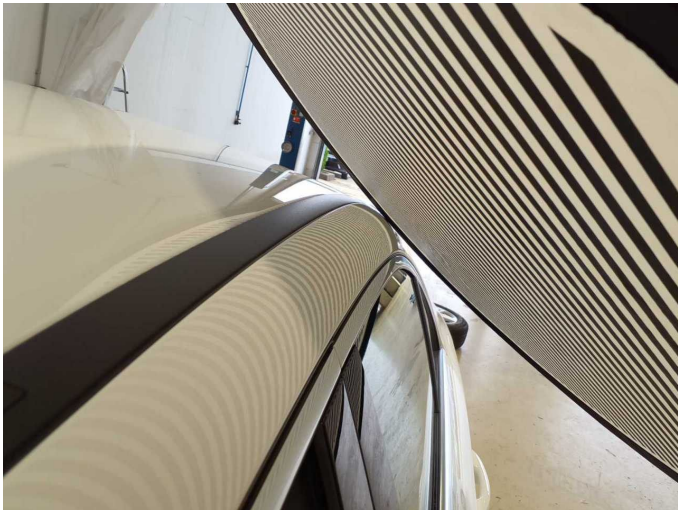
Damage 1: Roof: Roof rail - left side - dent(s) - Smooth repair work

| No. | Component group | Description |
|---|---|---|
| 1 | Roof | Roof rail - left side - dent(s) - Smooth repair work |

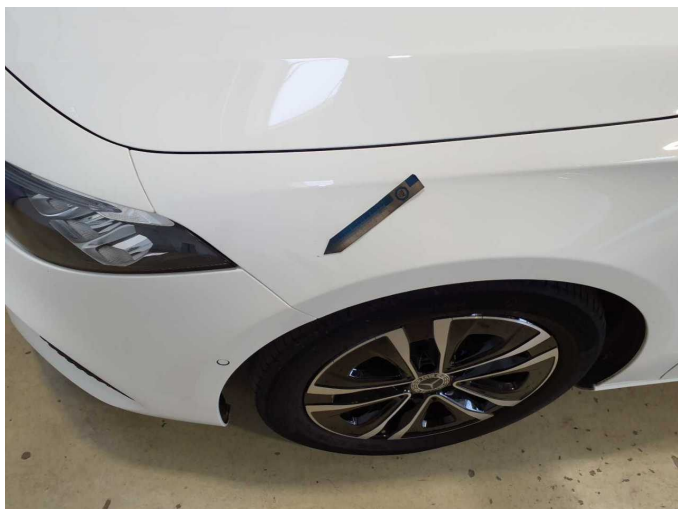
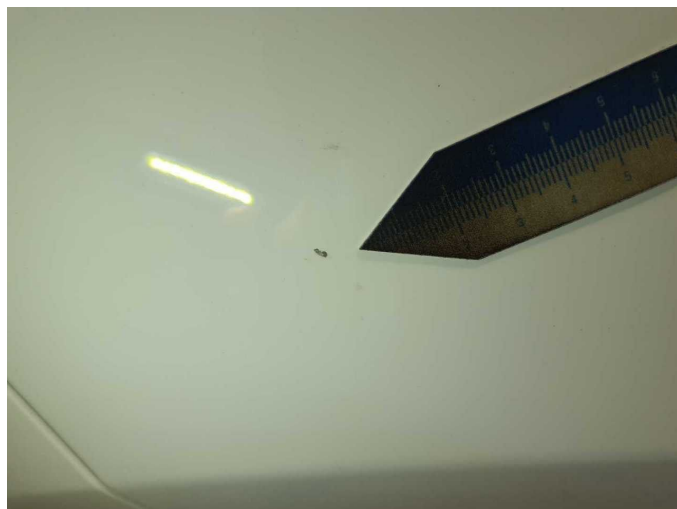
**Damage 2:** Mudguard - left side: Mudguard - left side - Stone chips - Smart repair

| No. | Component group | Description |
|---|---|---|
| 2 | Mudguard - left side | Mudguard - left side - Stone chips - Smart repair |

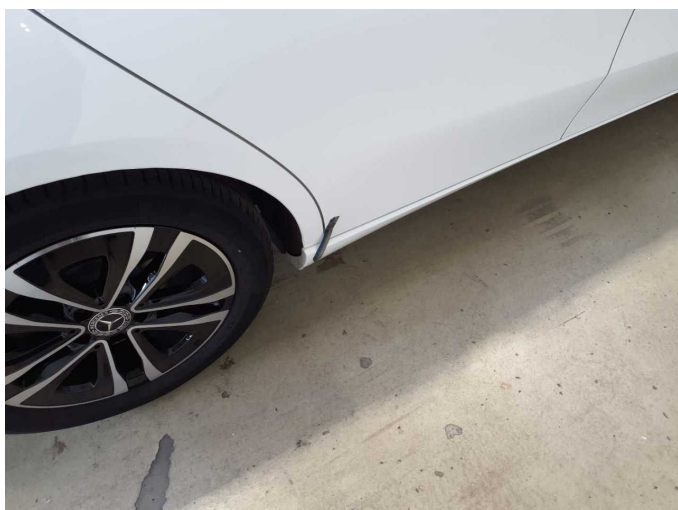
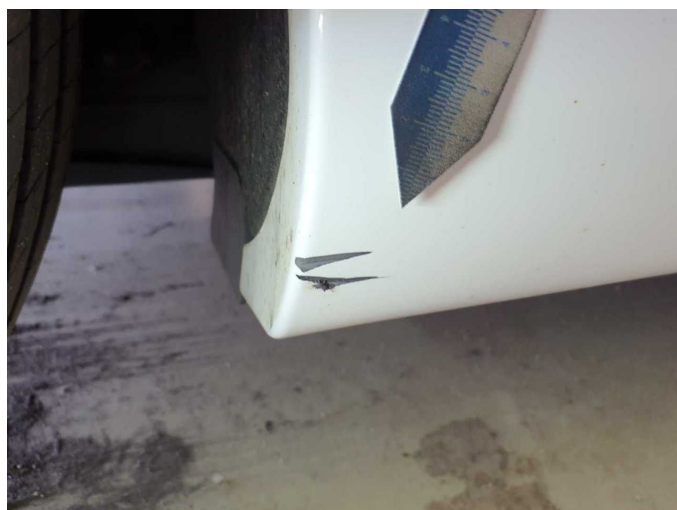
**Damage 3:** Sill - right side: Trim - Scratch(es) - Smart repair

| No. | Component group | Description |
|---|---|---|
| 3 | Sill - right side | Trim - Scratch(es) - Smart repair |

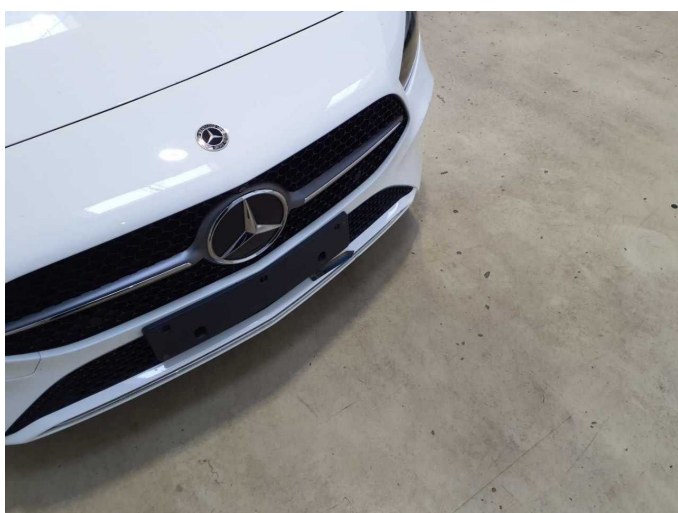
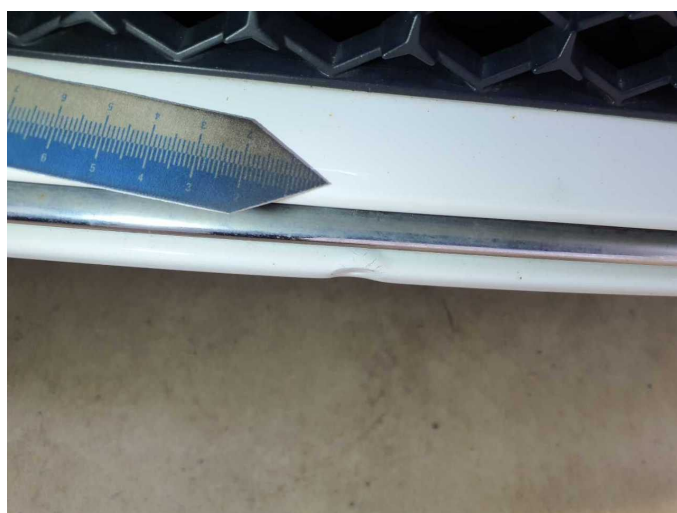
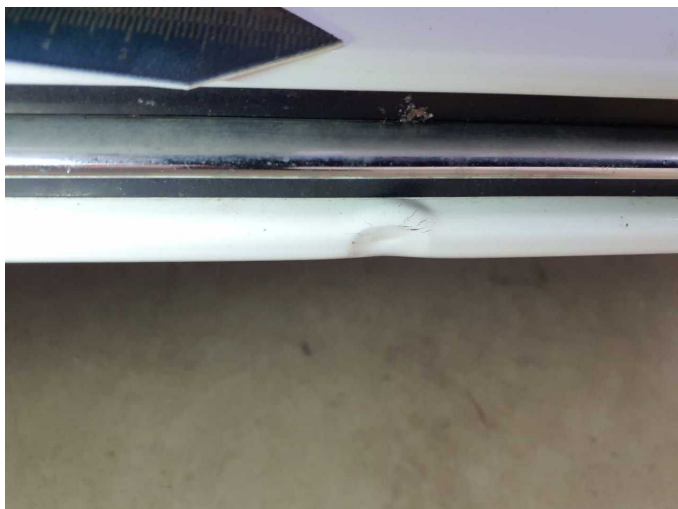
**Damage 4:** Front bumper: Front bumper - Dent / paintcoat damage - Repair and paint

| No. | Component group | Description |
|---|---|---|
| 4 | Front bumper | Front bumper - Dent / paintcoat damage - Repair and paint |

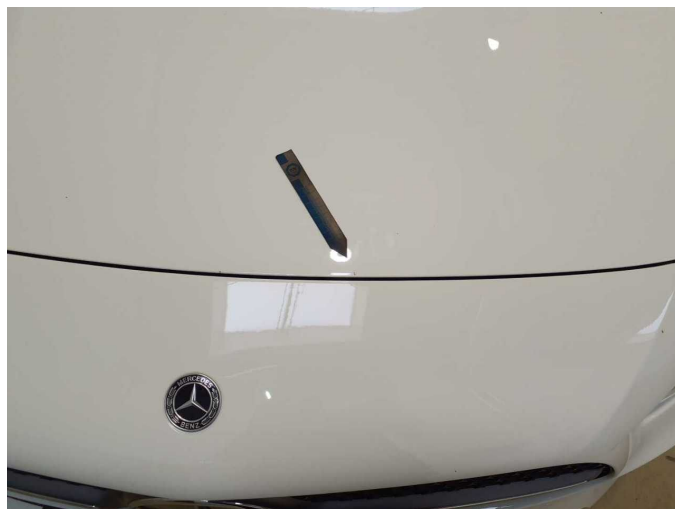
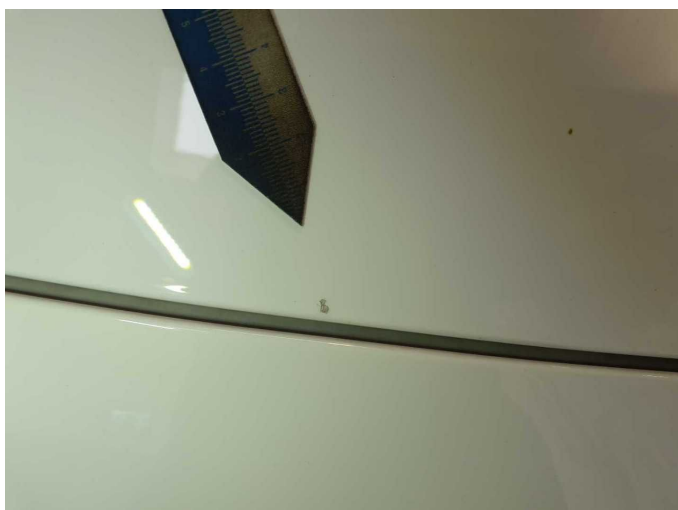
**Wear and tear 6:** Bonnet: Bonnet - Stone chips - Cover / polish

| No. | Component group | Description |
|---|---|---|
| 6 | Bonnet | Bonnet - Stone chips - Cover / polish |
