Expertise

Protocol number: 46830749  
Order No. / Reference: 26694440  
Inspection date: 15 Jul 2026

Manufacturer: Volkswagen

Model: Touran 2.0 TDI SCR DSG Comfortline

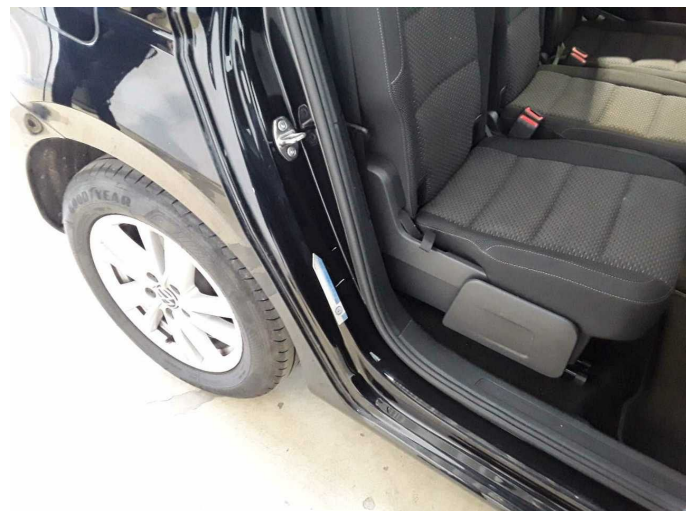
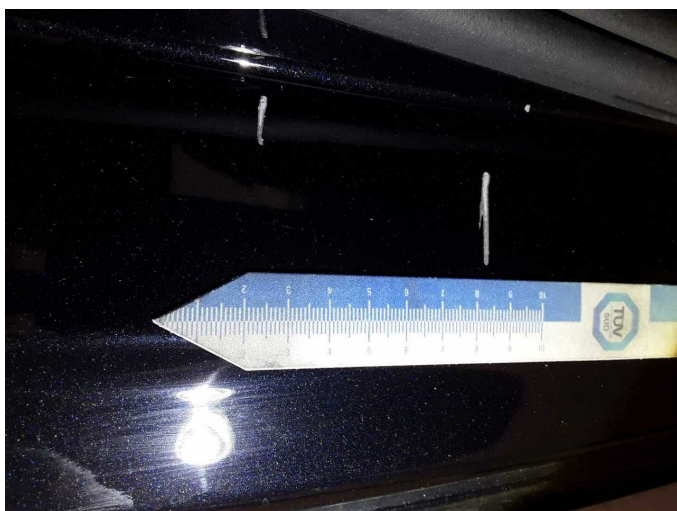
| No. | Component group | Description |
|---|---|---|
| 2 | Side panel - rear right side | Sill - Scratch(es) - Smart repair |

**Damage 2:** Side panel - rear right side: Sill - Scratch(es) - Smart repair

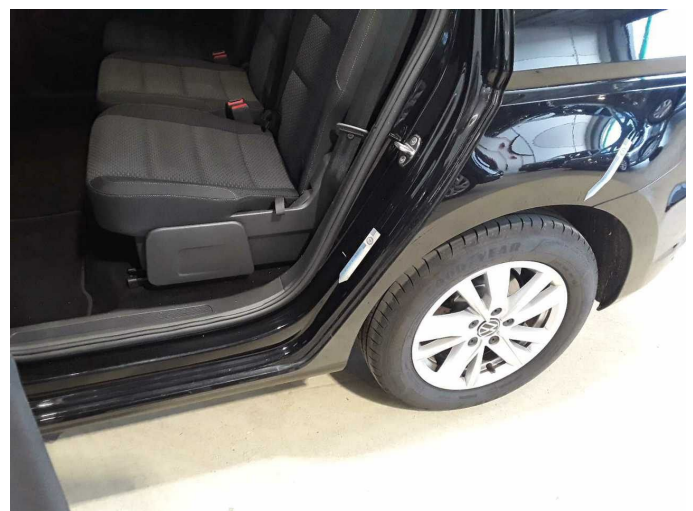
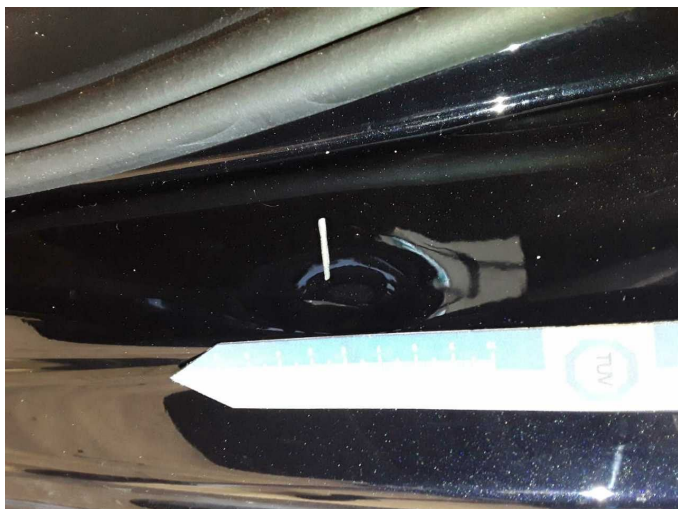
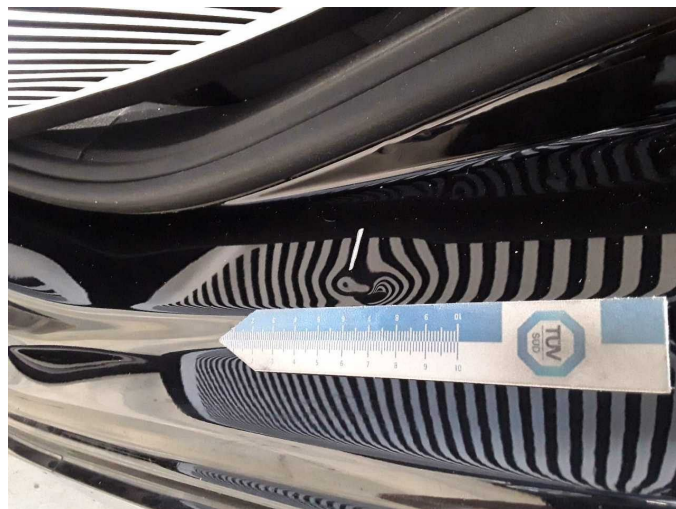
| No. | Component group | Description |
|---|---|---|
| 3 | Side panel - rear left side | Sill - Dent / paintcoat damage - Smart repair |

**Damage 3:** Side panel - rear left side: Sill - Dent / paintcoat damage - Smart repair

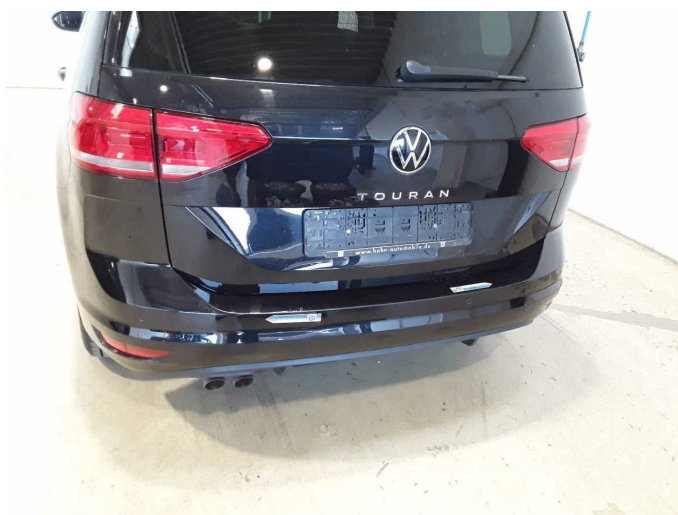
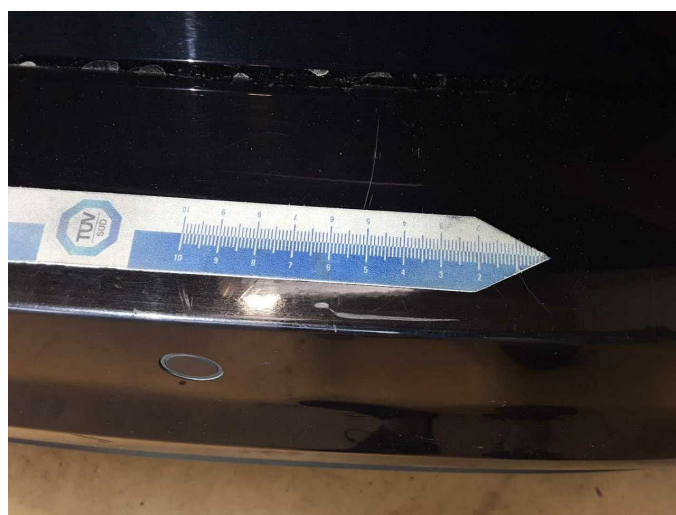
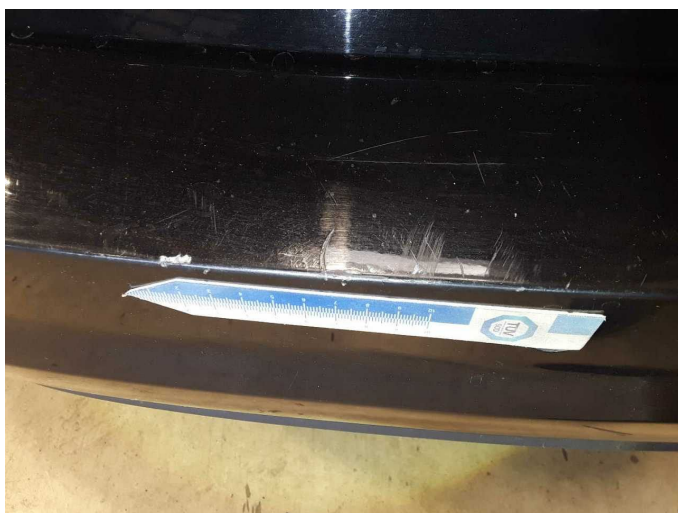
| No. | Component group | Description |
|---|---|---|
| 4 | Rear bumper | Rear bumper - Scratch(es) - Smart repair |

**Damage 4:** Rear bumper: Rear bumper - Scratch(es) - Smart repair

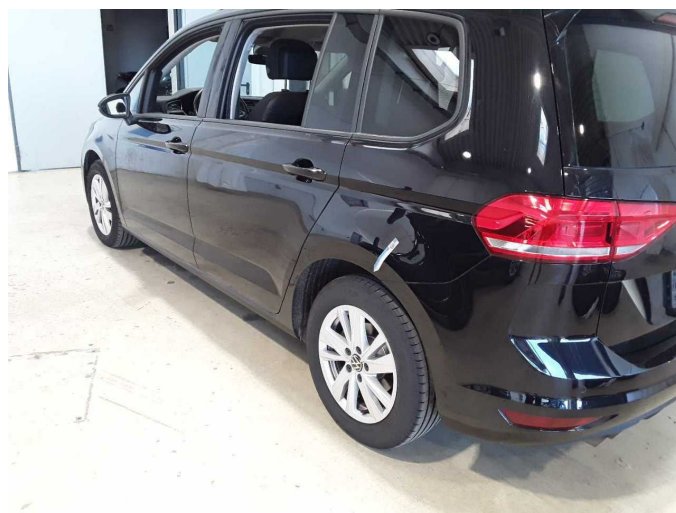
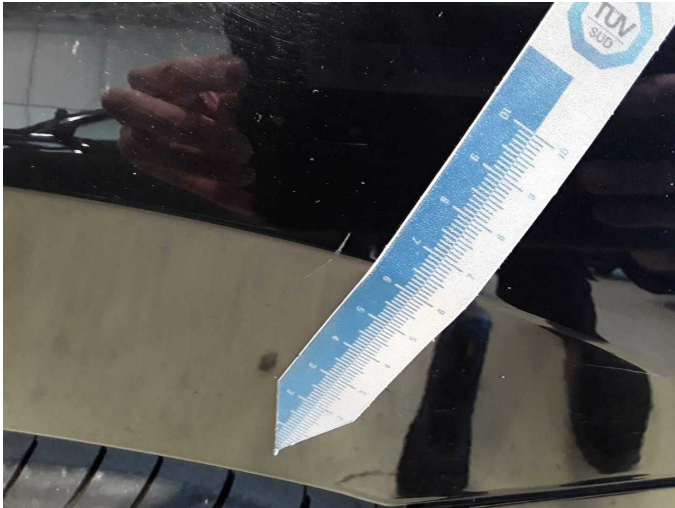
| No. | Component group | Description |
|---|---|---|
| 5 | Side panel - rear left side | Side panel - Scratch(es) - Smart repair |

**Damage 5:** Side panel - rear left side: Side panel - Scratch(es) - Smart repair

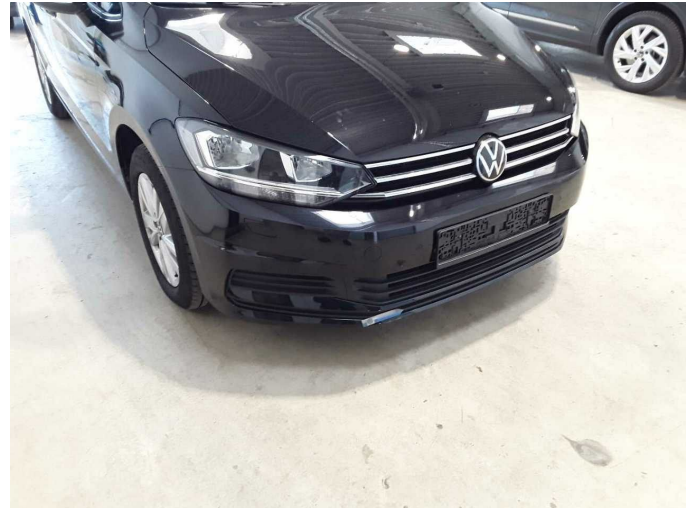
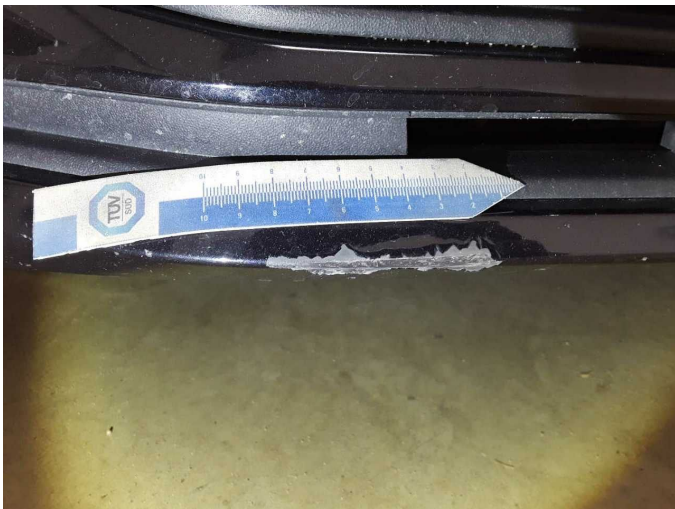
| No. | Component group | Description |
|---|---|---|
| 6 | Front bumper | Front bumper - Scratch(es) - Paint |

**Damage 6:** Front bumper: Front bumper - Scratch(es) - Paint
