Expertise

Protocol number: 45902692
Order No. / Reference: 26316554-1
Inspection date: 11 May 2026

Manufacturer: Audi

Model: A6 Limo 55 TFSI quattro S tronic S line

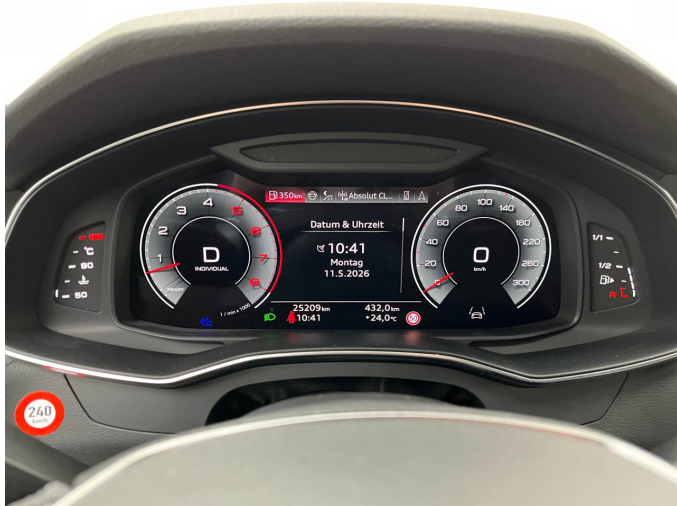
Figure 7: Instrument cluster

Mileage (Read) 25,209 km

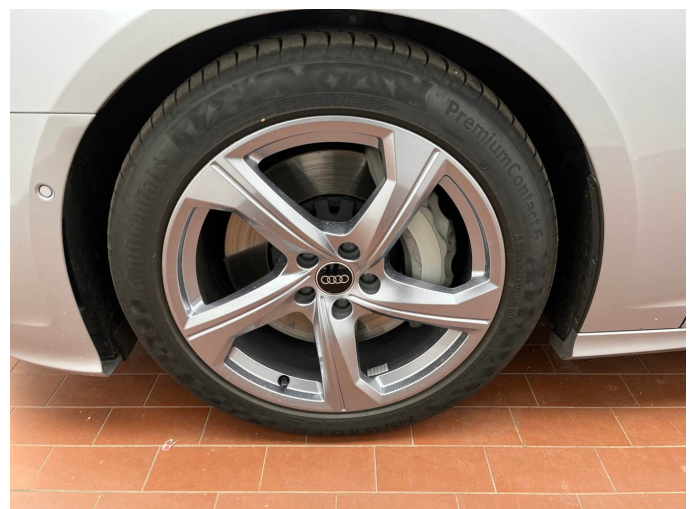
Figure 12: Mounted tyres

#	Tyre size	Type of tyre	Manufacturer	Tread depth
1)	245/45 R19 102Y	Summer tyres on Light alloy	Continental	5mm / 5mm
2)	245/45 R19 102Y	Summer tyres on Light alloy	Continental	6mm / 6mm

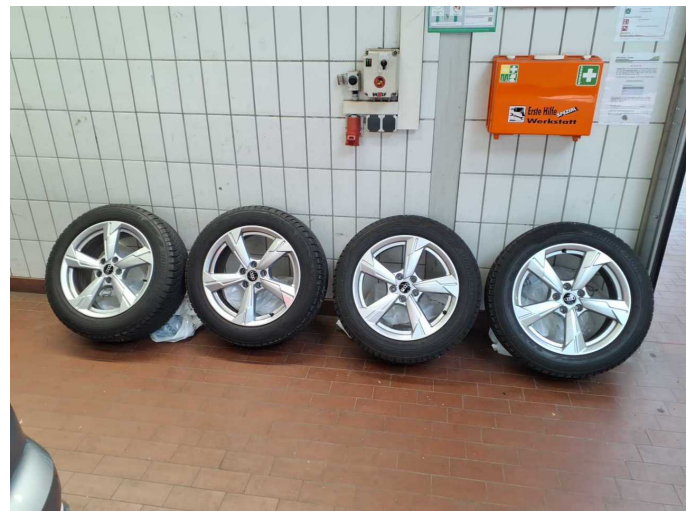
Figure 16: Additional tyres

#	Tyre size	Type of tyre	Manufacturer	Tread depth
1)	225/55 R18 102V	Winter tyres on Light alloy	Bridgestone	6mm / 6mm
2)	225/55 R18 102V	Winter tyres on Light alloy	Bridgestone	6mm / 6mm

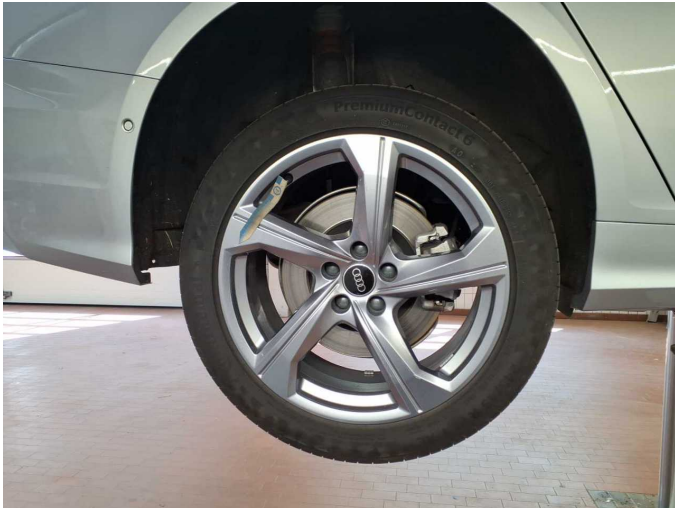
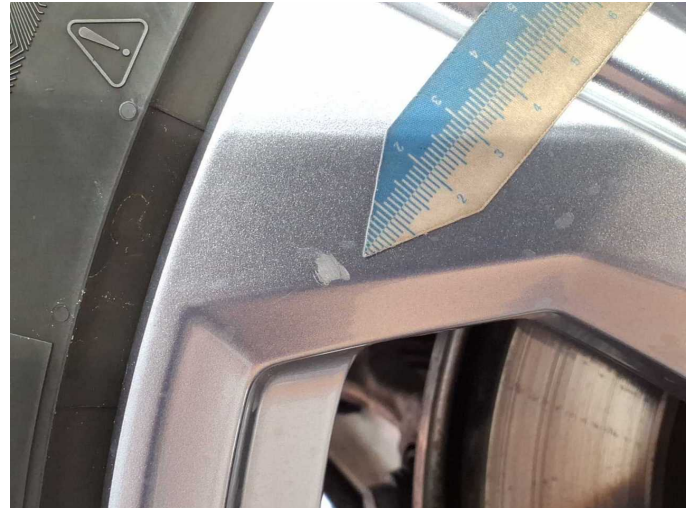
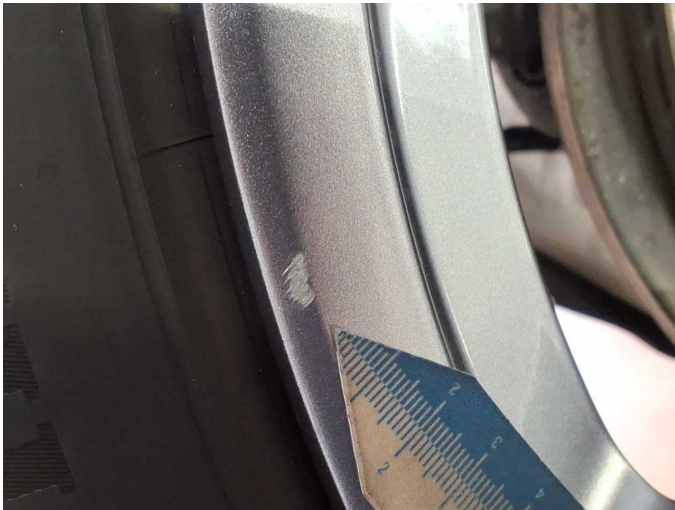
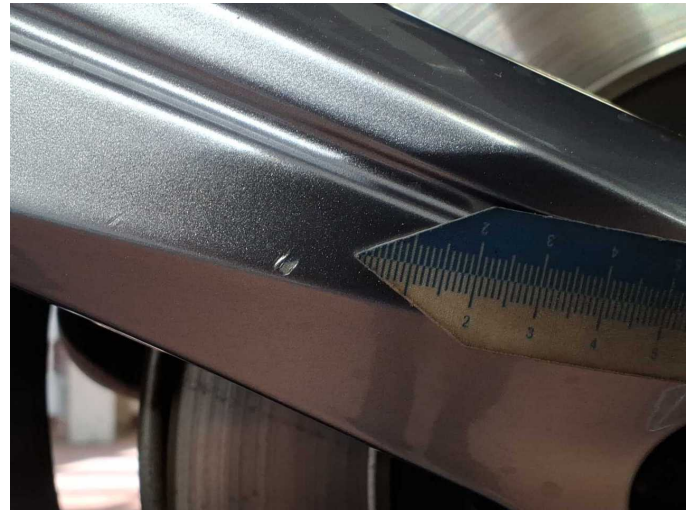
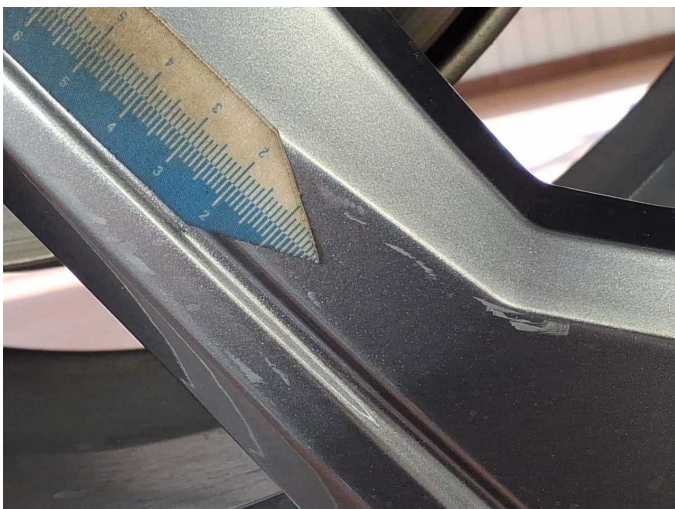
Damage 1: Wheel / tyres: Alloy rim - rear right side - Scratch(es) - Loss in value

No.	Component group	Description
1	Wheel / tyres	Alloy rim - rear right side - Scratch(es) - Loss in value
2	Wheel / tyres	Alloy rim - rear left side - Scratch(es) - Loss in value

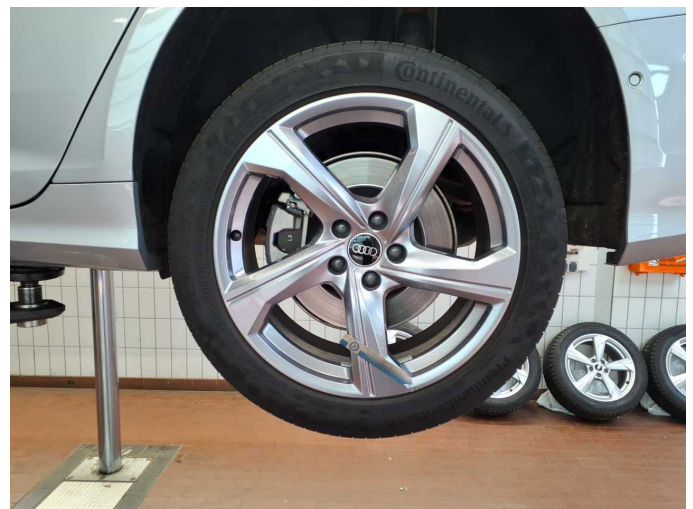
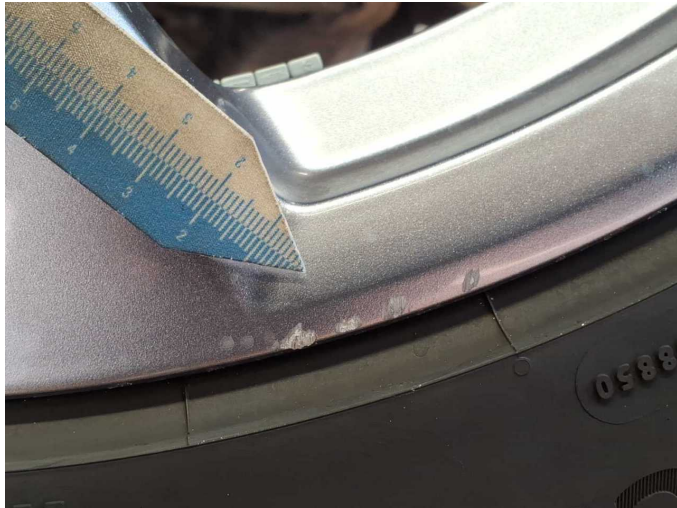
Damage 2: Wheel / tyres: Alloy rim - rear left side - Scratch(es) - Loss in value

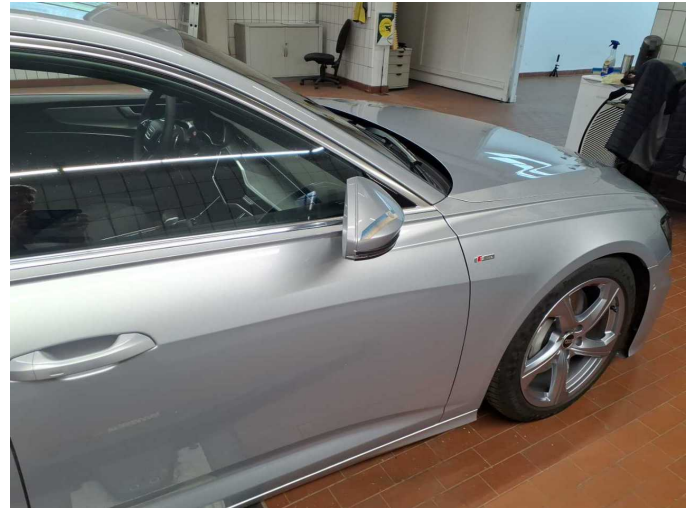
Wear and tear 4: Wing mirror - right side: Cap - Scratch(es) - No deduction

No.	Component group	Description
1	Front bumper	Front bumper - Stone chips - No deduction
2	Vehicle glazing	Windscreen - Stone chips - No deduction
3	Body	Body - Scratch(es) - No deduction
4	Wing mirror - right side	Cap - Scratch(es) - No deduction
