Expertise

Protocol number: 46160430
Order No. / Reference: 26489343
Inspection date: 25 Jun 2026

Manufacturer: Volkswagen

Model: Passat Variant 2.0 TDI SCR DSG Business

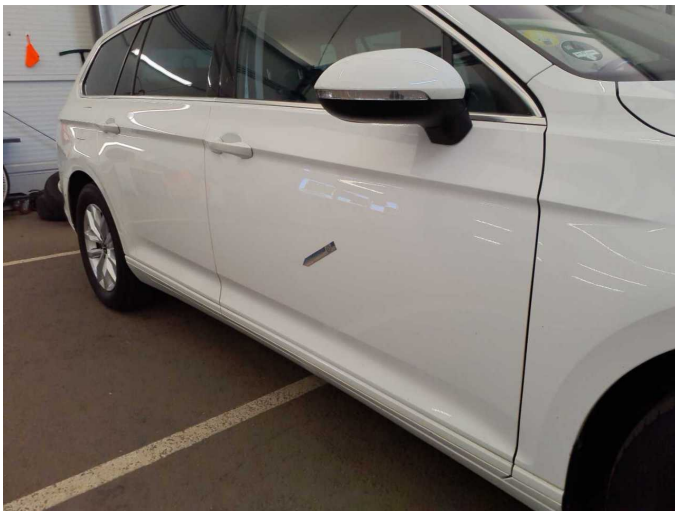
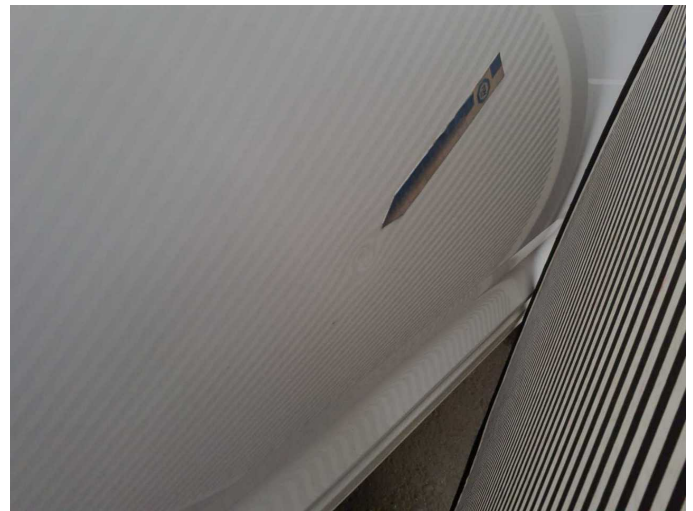
| No. | Component group | Description |
|---|---|---|
| 1 | Door - front right side | Door - dent(s) - Smart repair |

Damage 1: Door - front right side: Door - dent(s) - Smart repair

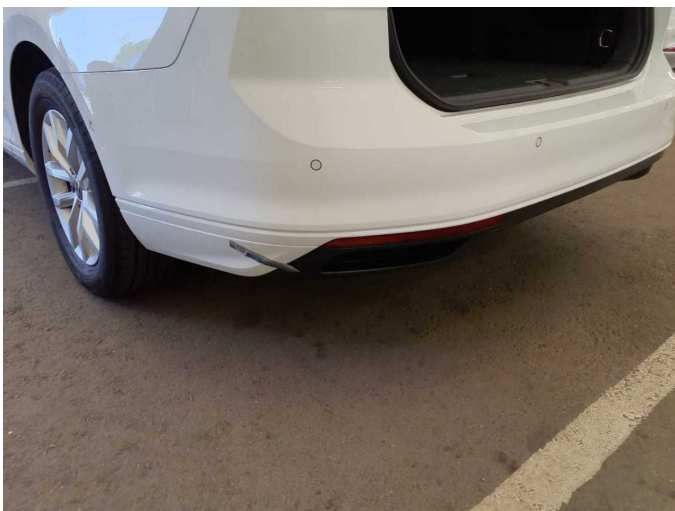
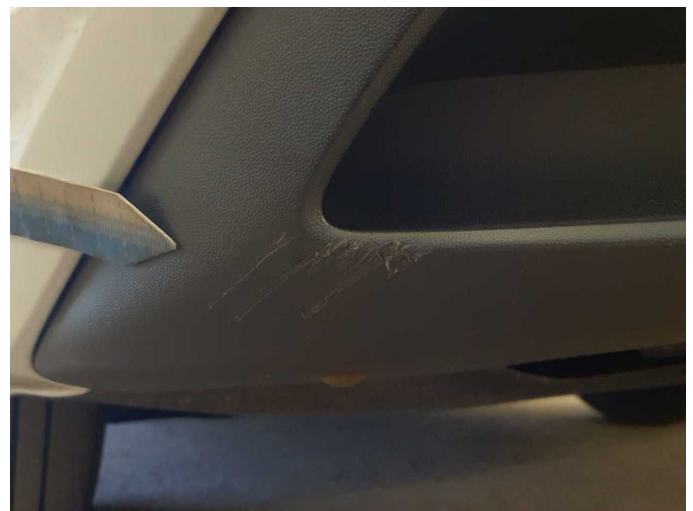
| No. | Component group | Description |
|---|---|---|
| 2 | Rear bumper | Spoiler - Scratch(es) - Replace |

Damage 2: Rear bumper: Spoiler - Scratch(es) - Replace

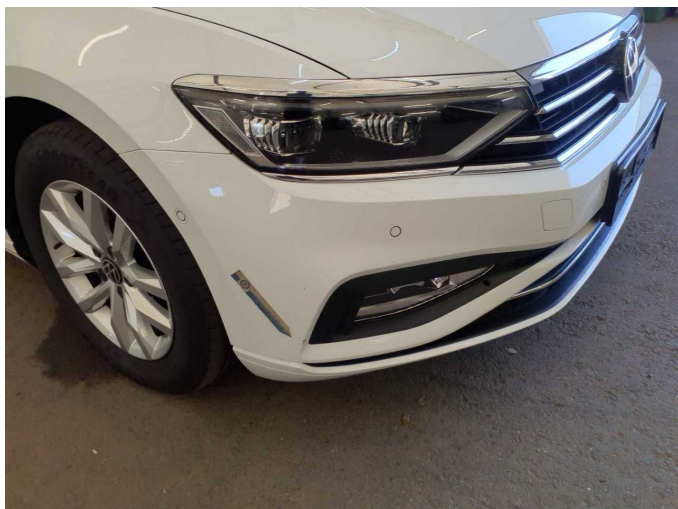
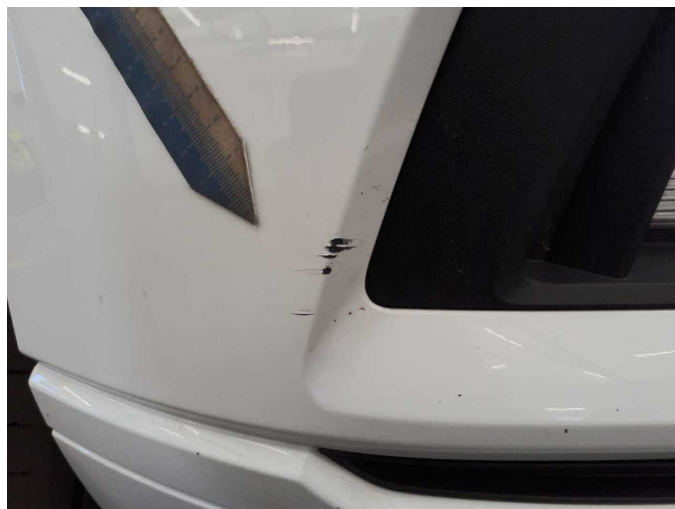
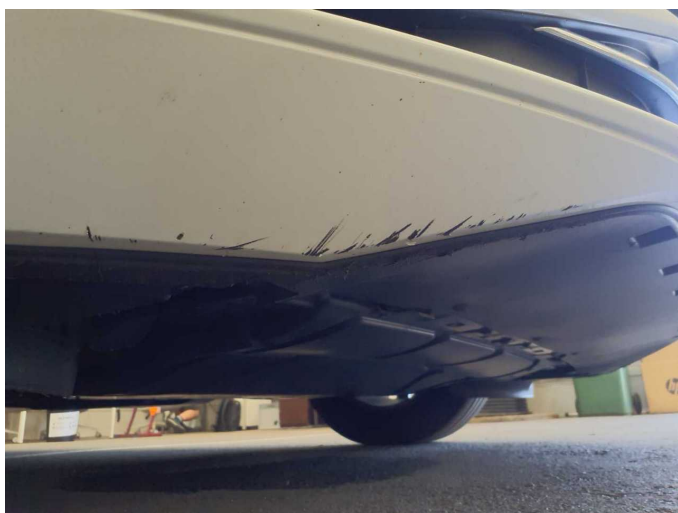
| No. | Component group | Description |
|---|---|---|
| 3 | Front bumper | Front bumper - Scratch(es) - Paint |

Damage 3: Front bumper: Front bumper - Scratch(es) - Paint
