Expertise

Protocol number: 46689914  
Order No. / Reference: 26591750  
Inspection date: 21 Jul 2026

Manufacturer: Mercedes-Benz  
VIN: W1K2052151G073983

Model: C 220 d 4Matic T 9G-TRONIC Avantgarde

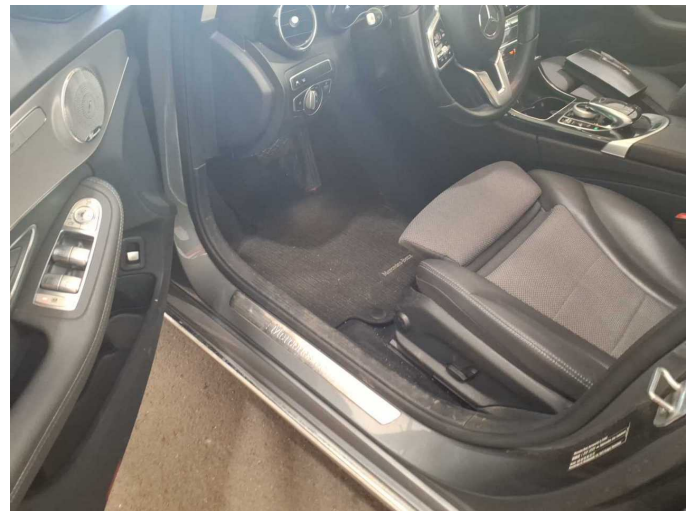
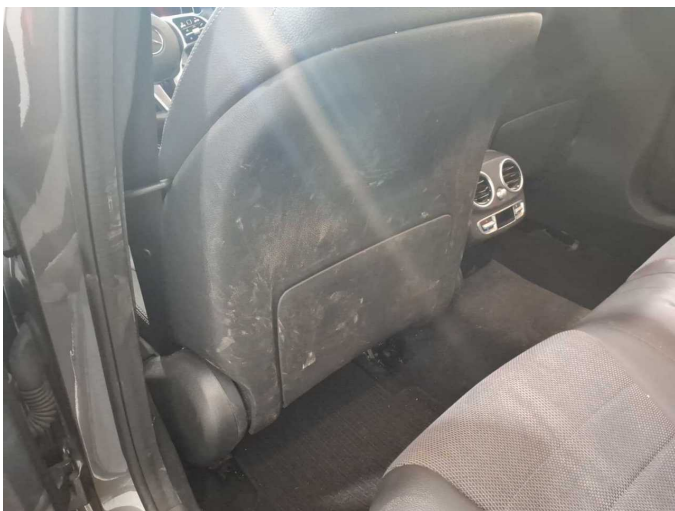
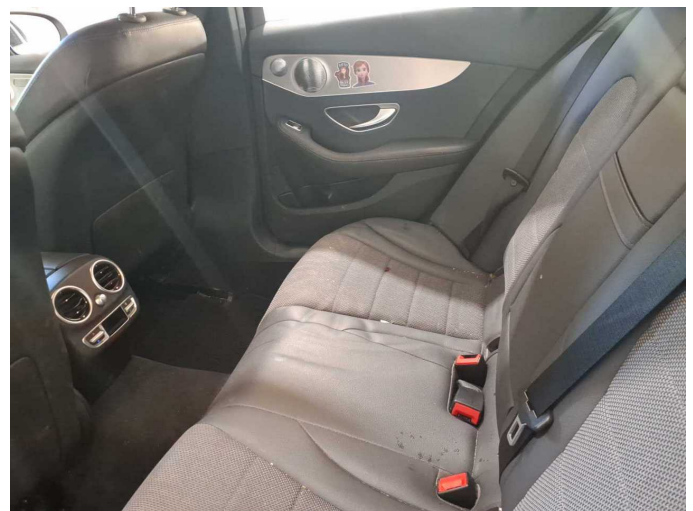
| No. | Component group | Description |
|---|---|---|
| 1 | Interior | Interior - Soiled - Clean |

Damage 1: Interior: Interior - Soiled - Clean

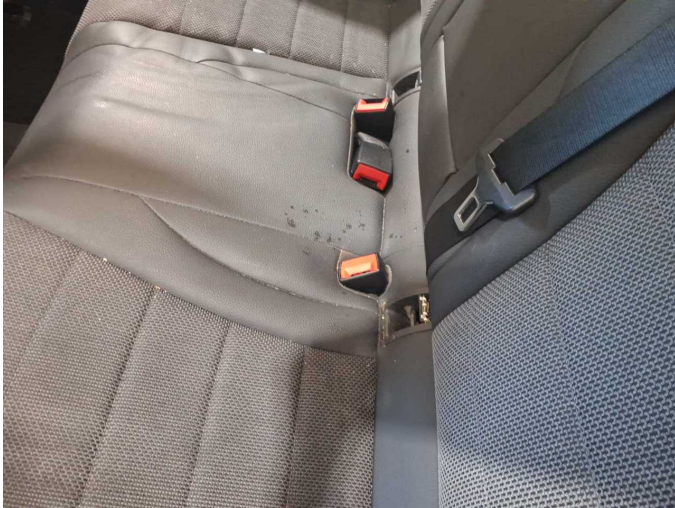
**Damage 1:** Interior: Interior - Soiled - Clean

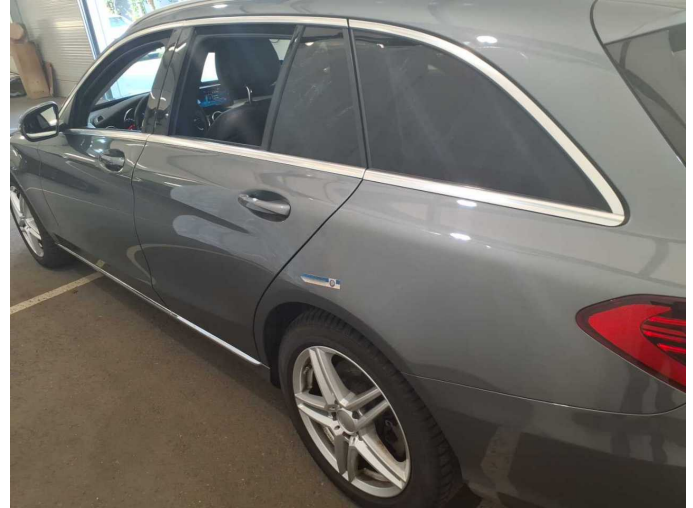
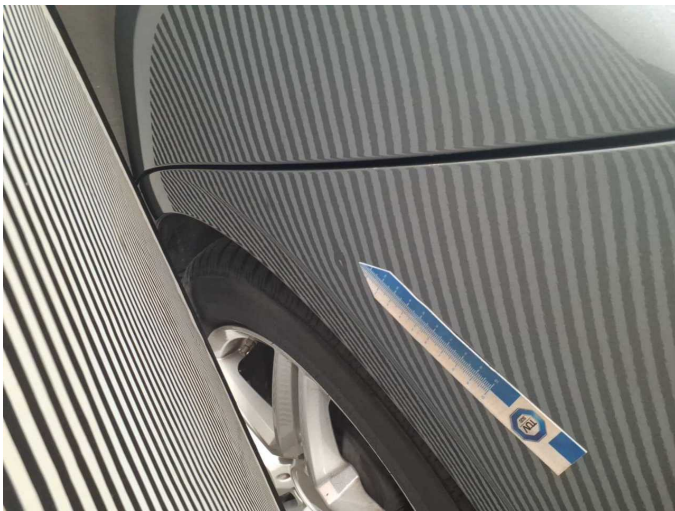
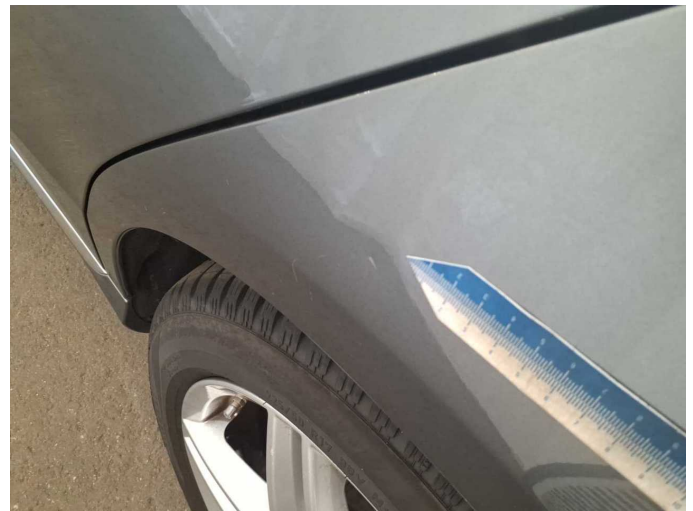
| No. | Component group | Description |
|---|---|---|
| 2 | Side panel - rear left side | Side panel - Dent / paintcoat damage - Smart repair |

**Damage 2:** Side panel - rear left side: Side panel - Dent / paintcoat damage - Smart repair

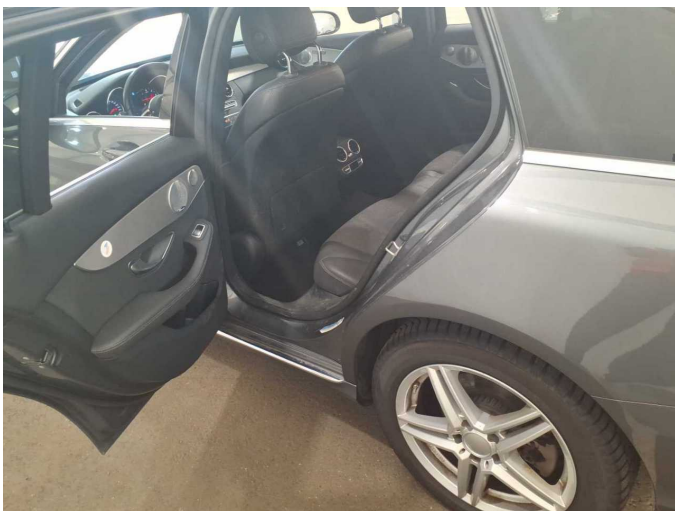
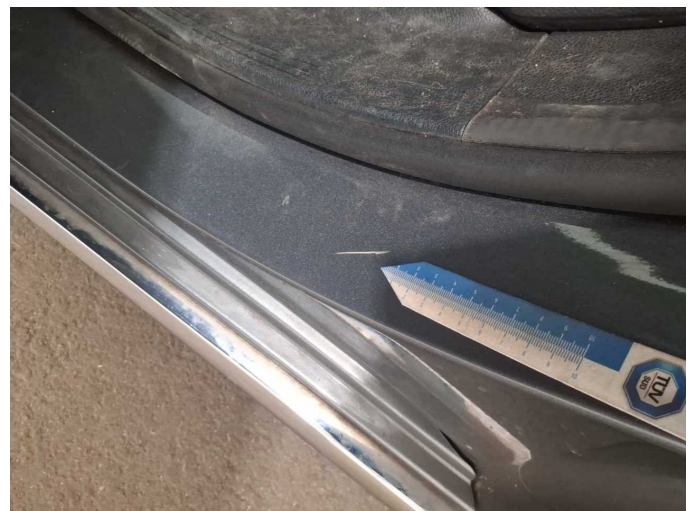
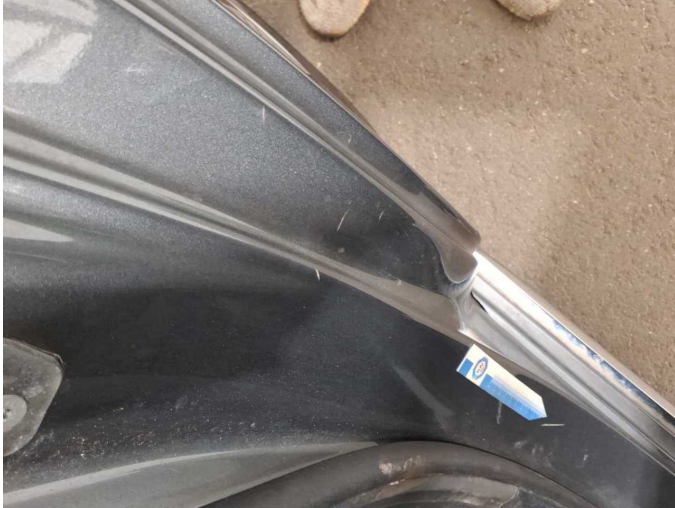
| No. | Component group | Description |
|---|---|---|
| 3 | Side panel - rear left side | Sill - Scratch(es) - Smart repair |

**Damage 3:** Side panel - rear left side: Sill - Scratch(es) - Smart repair

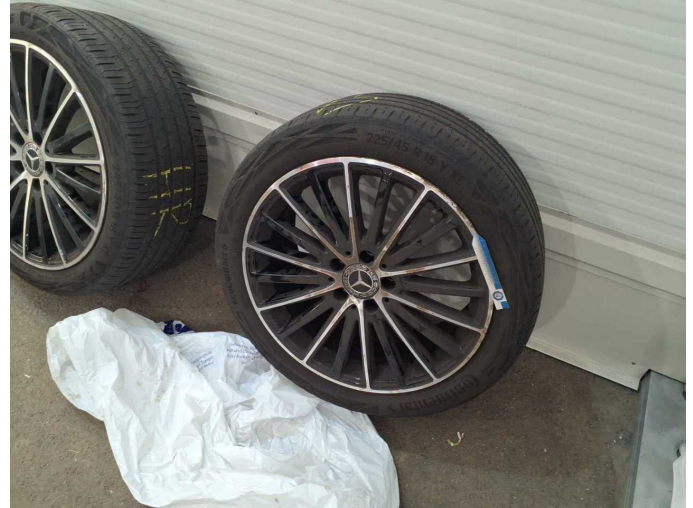
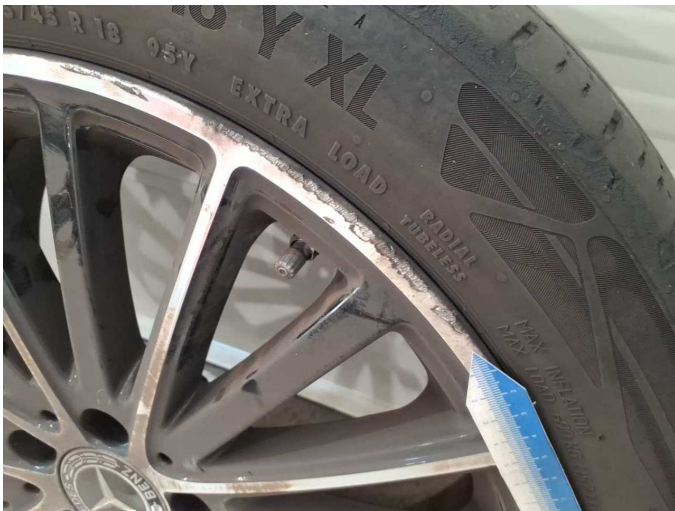
| No. | Component group | Description |
|---|---|---|
| 4 | 2nd wheel set | 1 alloy rim (Felge 1. Achse) - Scratch(es) - Loss in value |

**Damage 4:** 2nd wheel set: 1 alloy rim (Felge 1. Achse) - Scratch(es) - Loss in value

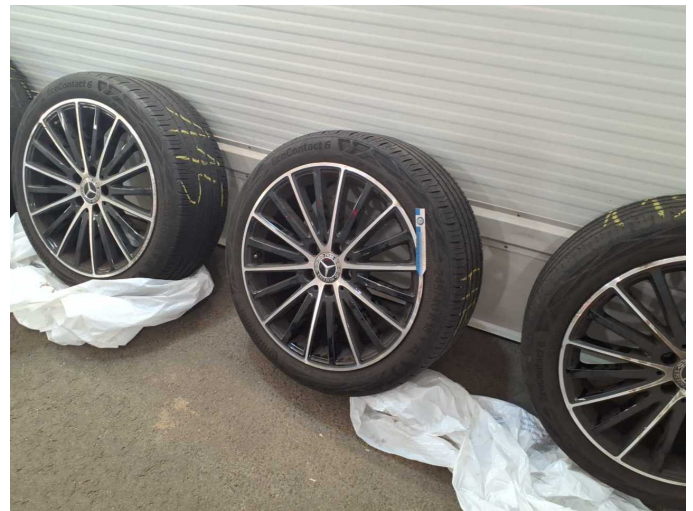
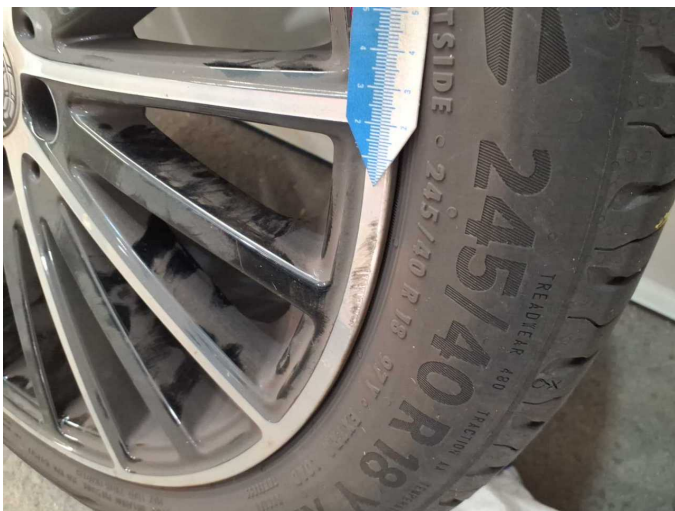
| No. | Component group | Description |
|---|---|---|
| 5 | 2nd wheel set | 1 alloy rim (Felge 2. Achse) - Scratch(es) - Loss in value |

**Damage 5:** 2nd wheel set: 1 alloy rim (Felge 2. Achse) - Scratch(es) - Loss in value

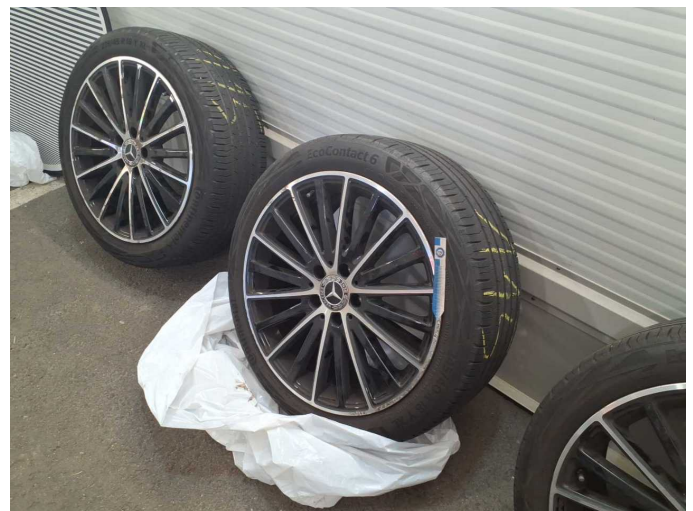
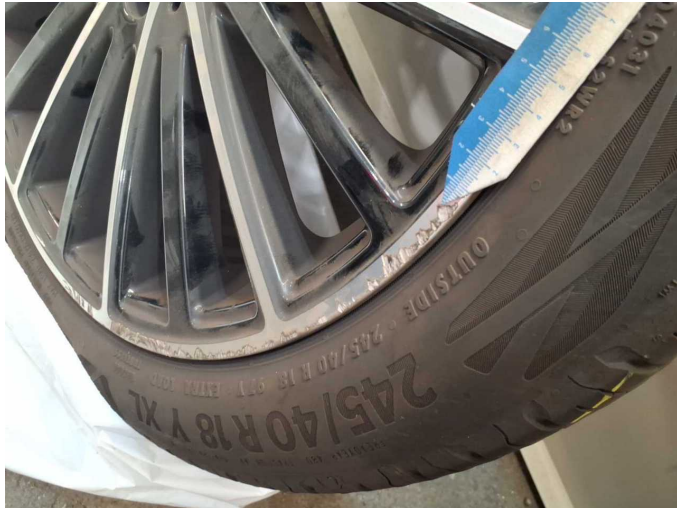
| No. | Component group | Description |
|---|---|---|
| 6 | 2nd wheel set | 1 alloy rim (Mit Materialabtrag, Felge 2. Achse) - Scratched - Replace |

**Damage 6:** 2nd wheel set: 1 alloy rim (Mit Materialabtrag, Felge 2. Achse) - Scratched - Replace

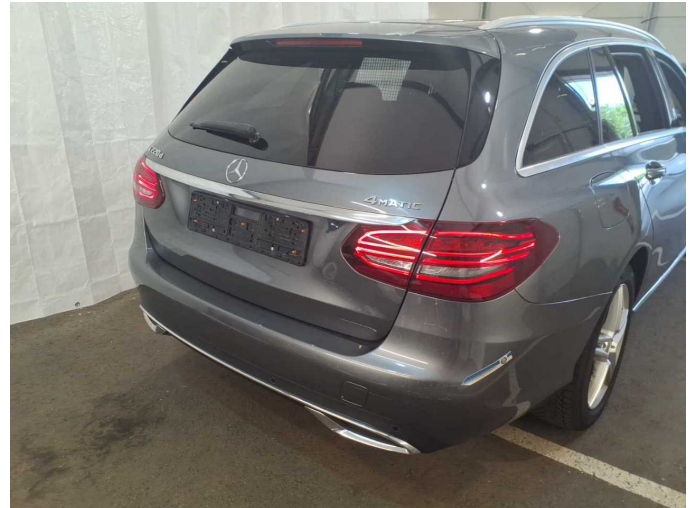
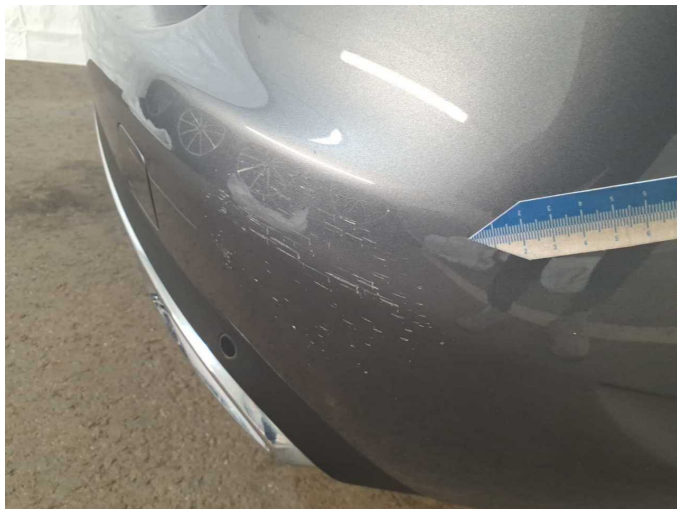
| No. | Component group | Description |
|---|---|---|
| 7 | Rear bumper | Rear bumper - Scratched - Paint |

**Damage 7:** Rear bumper: Rear bumper - Scratched - Paint
