## Expertise

Protocol number: 46201076  
Order No. / Reference: 26521235  
Inspection date: 19 Jun 2026

Manufacturer: Volkswagen

Model: Touran 2.0 TDI SCR DSG Highline

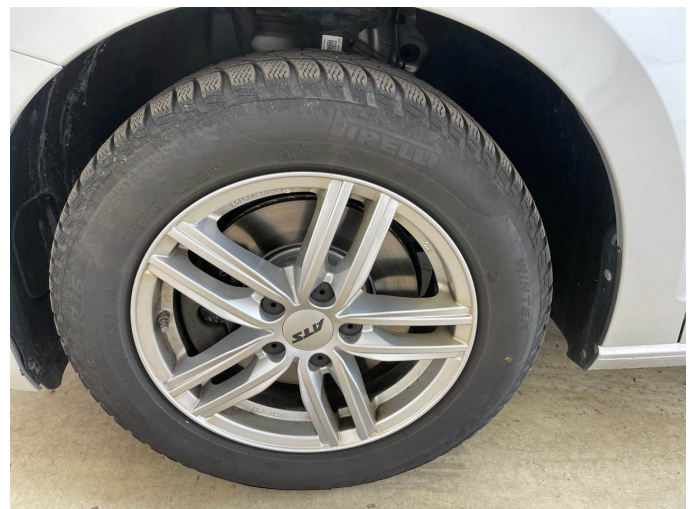
Figure 12: Mounted tyres

Mounted tyres				
#	Tyre size	Type of tyre	Manufacturer	Tread depth
1)	205/60 R16 96H	Winter tires (with run-flat tires) on Light alloy	Pirelli	5mm / 5mm
2)	205/60 R16 96H	Winter tires (with run-flat tires) on Light alloy	Pirelli	5mm / 5mm

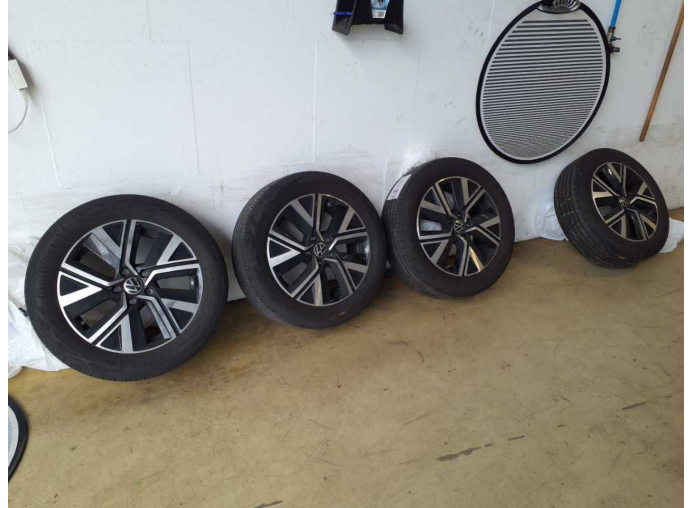
Figure 14: Additional tyres

Additional tyres				
#	Tyre size	Type of tyre	Manufacturer	Tread depth
1)	215/55 R17 94V	Summer tires (with run-flat tires) on Light alloy	Continental	5mm / 5mm
2)	215/55 R17 94V	Summer tires (with run-flat tires) on Light alloy	Continental	5mm / 5mm

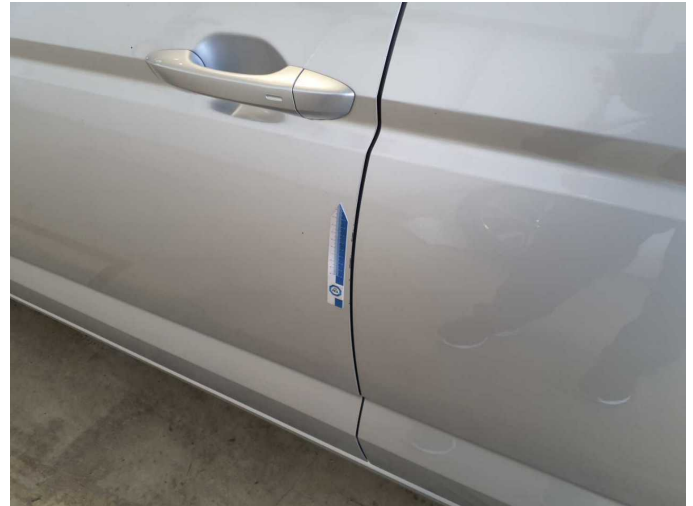
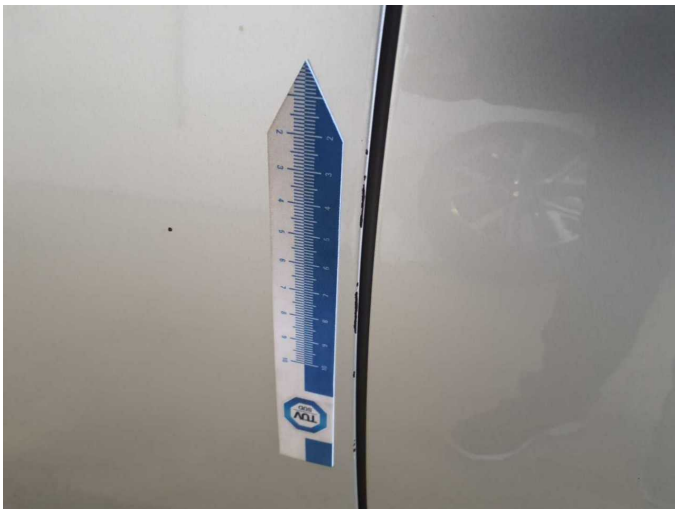
Damage 1: Door - front left side: Door edge - Scratched - Smart repair

No.	Component group	Description
1	Door - front left side	Door edge - Scratched - Smart repair
2	Rear bumper	Rear bumper - Scratched - Paint
3	Front bumper	Front bumper - Scratched - Repair and paint
4	Door - front right side	Door - dent(s) - Repair and paint
5	Roof	Roof - Corrosion - Repair and paint

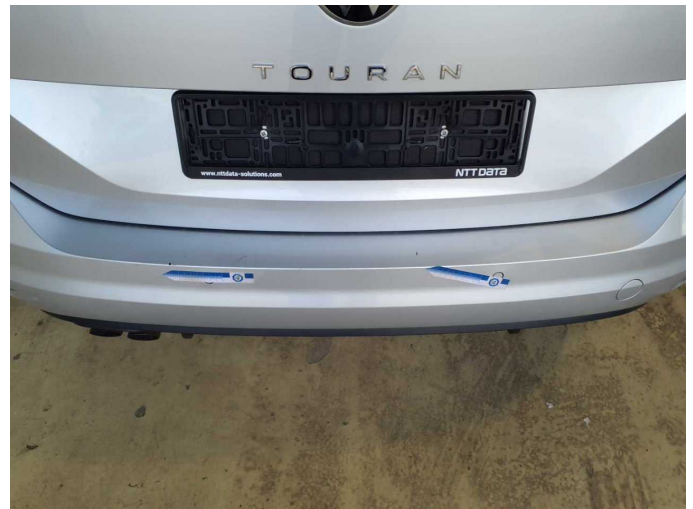
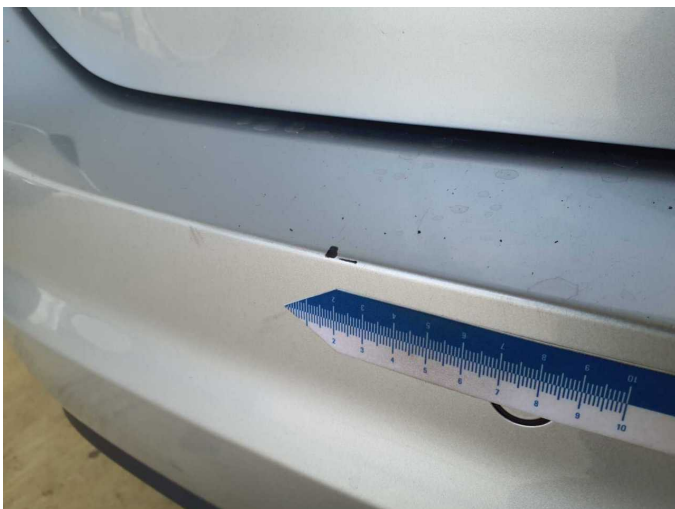
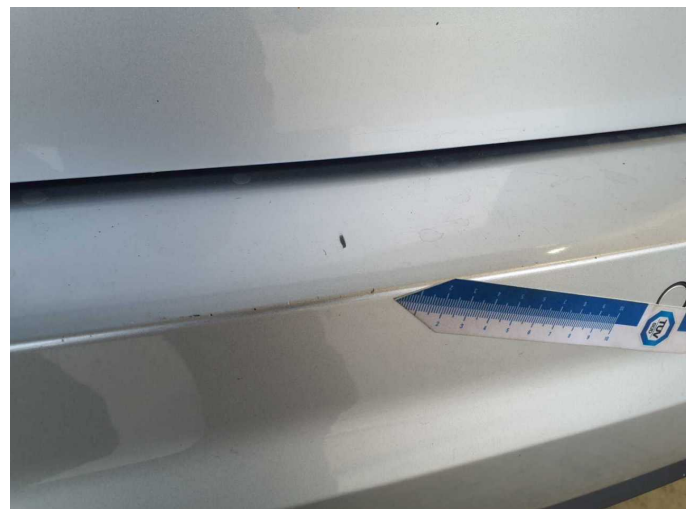
Damage 2: Rear bumper: Rear bumper - Scratched - Paint

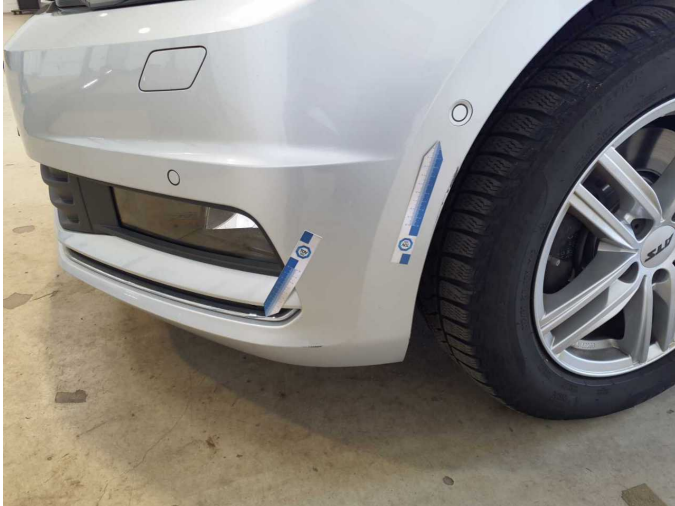
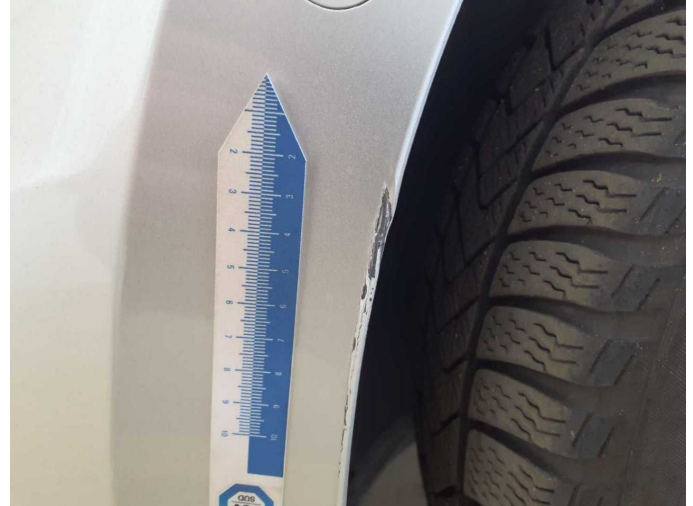
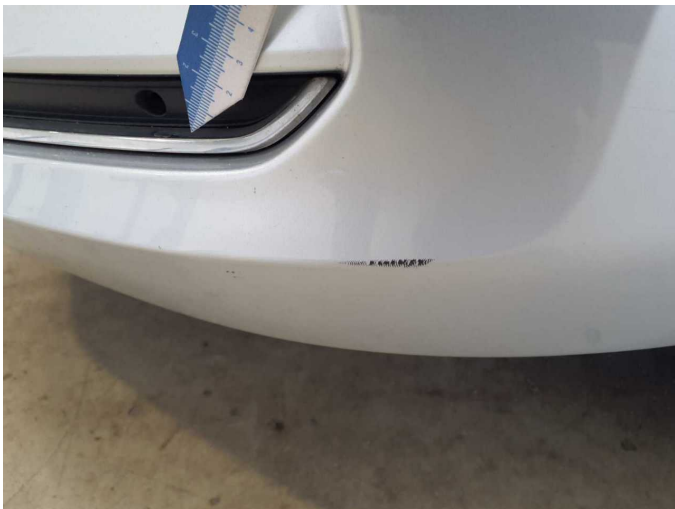
**Damage 3:** Front bumper: Front bumper - Scratched - Repair and paint

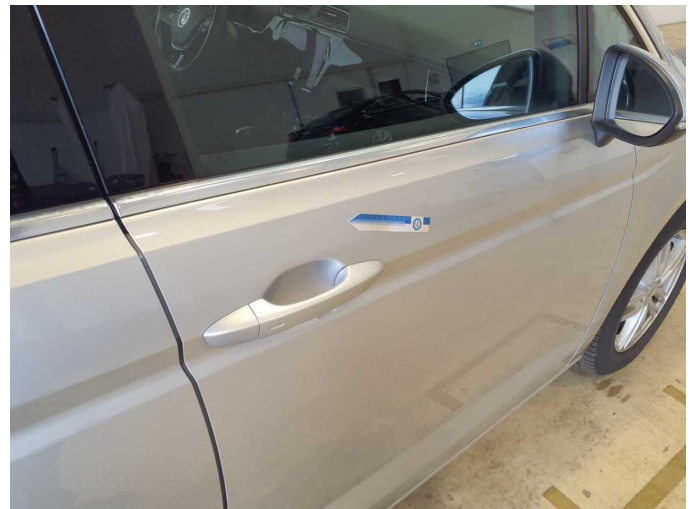
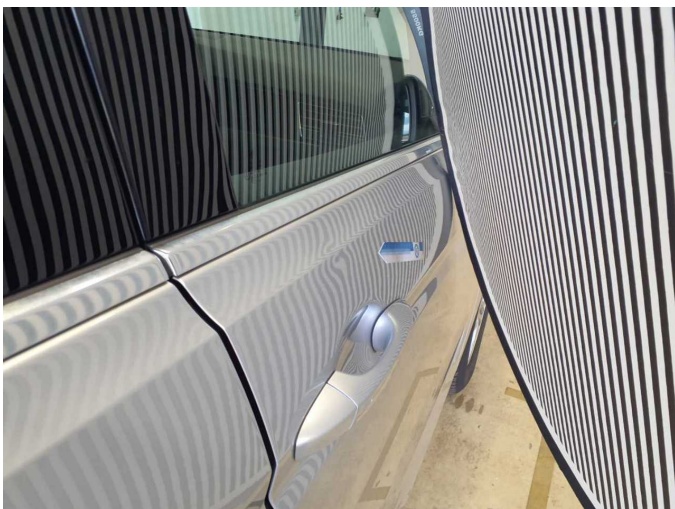
**Damage 4:** Door - front right side: Door - dent(s) - Repair and paint

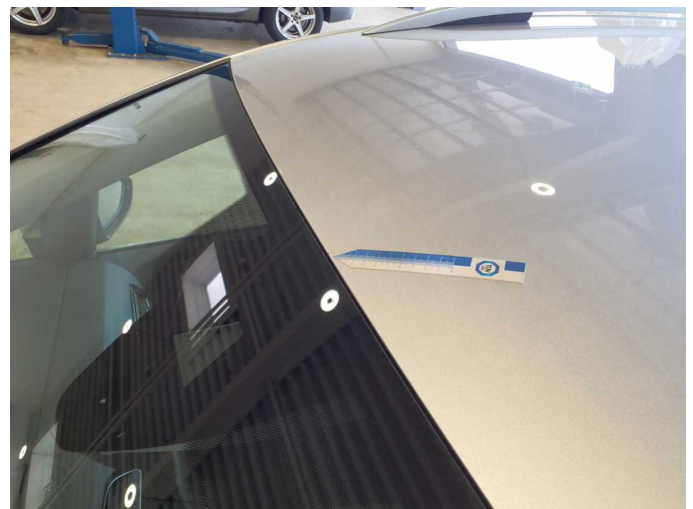
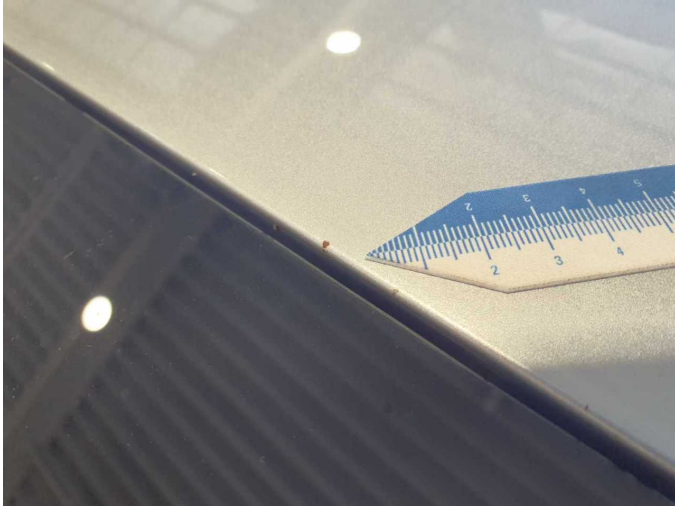
**Damage 5:** Roof: Roof - Corrosion - Repair and paint

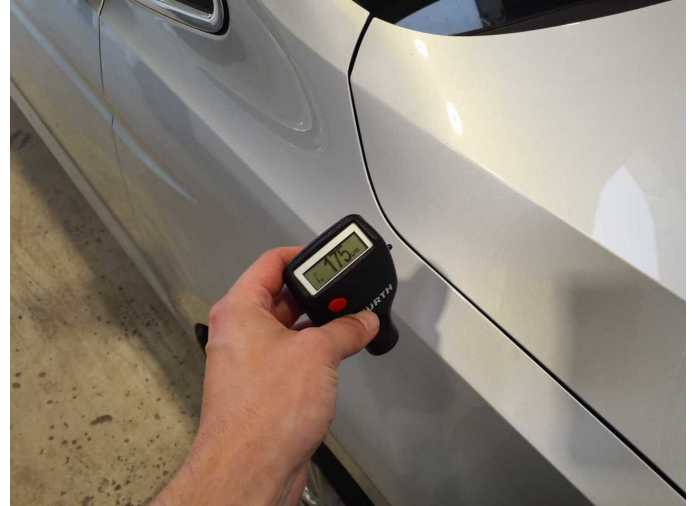
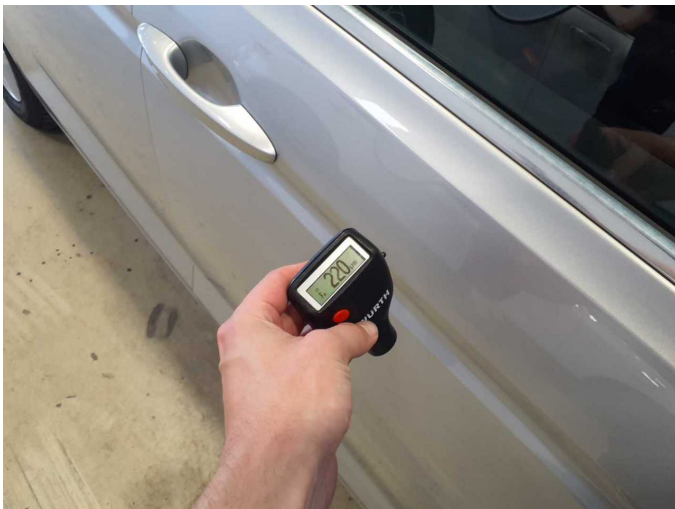
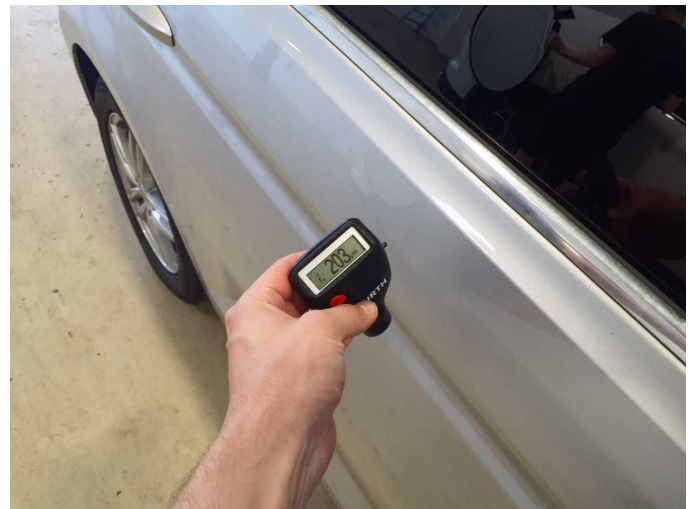
**Repainting 1:** Mudguard - right side, Door - rear right side, Door - front right side

1	Mudguard - right side, Door - rear right side, Door - front right side, Professionally carried out, Invoice of repair done Non-existent
---	---

Mudguard - right side	175 µm	Door - rear right side	203 µm
Door - front right side	220 µm
