Expertise

Protocol number: 46506368  
Order No. / Reference: 26689231  
Inspection date: 14 Jul 2026

Manufacturer: Opel

Model: Grandland 1.5 D Automatik Elegance

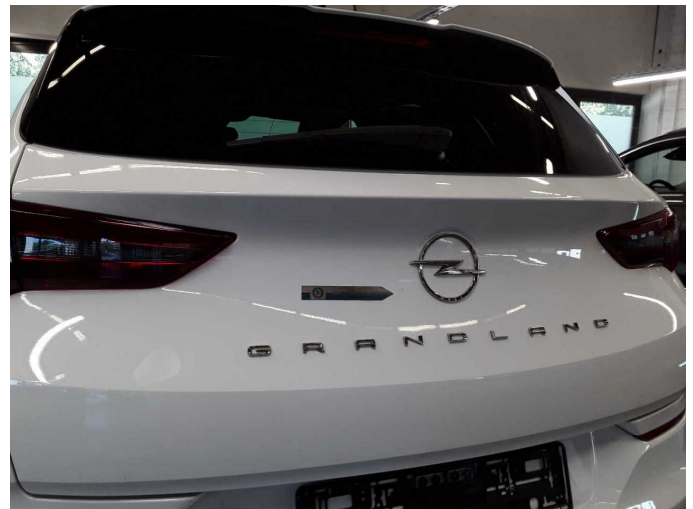
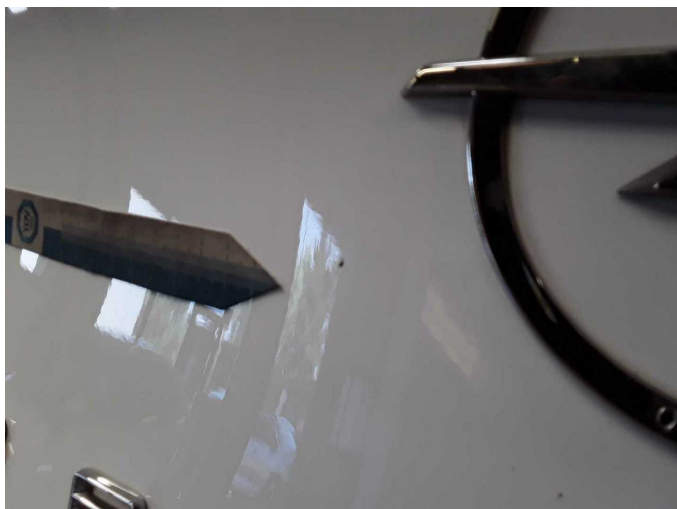
| No. | Component group | Description |
|---|---|---|
| 1 | Boot lid / rear door | Boot lid - Scratch(es) - No deduction |

Damage 1: Boot lid / rear door: Boot lid - Scratch(es) - No deduction

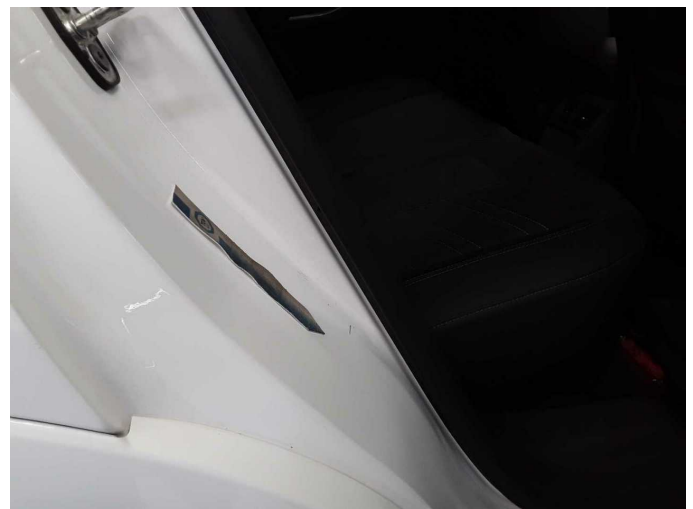
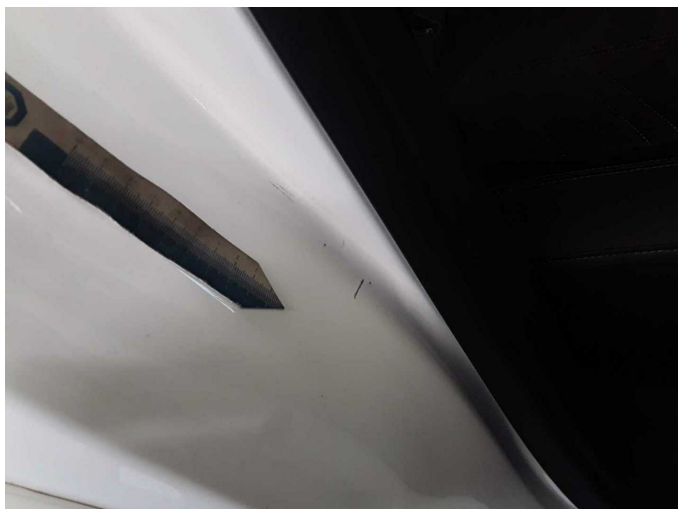
| No. | Component group | Description |
|---|---|---|
| 2 | Side panel - rear right side | Sill - Scratch(es) - Smart repair |

Damage 2: Side panel - rear right side: Sill - Scratch(es) - Smart repair

**Damage 2:** Side panel - rear right side: Sill - Scratch(es) - Smart repair

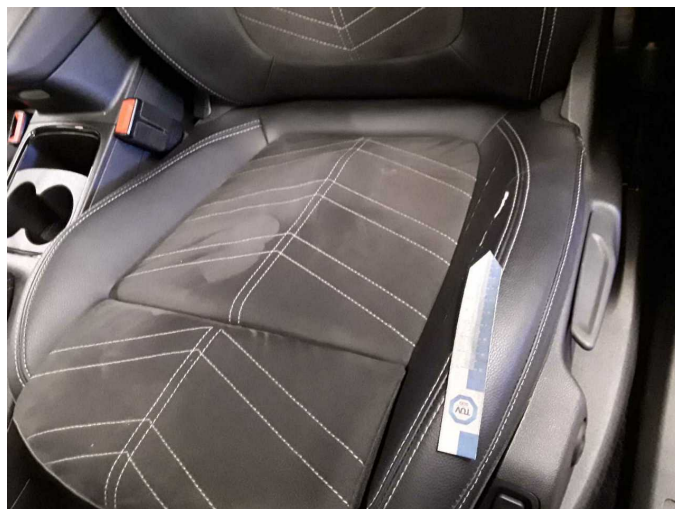
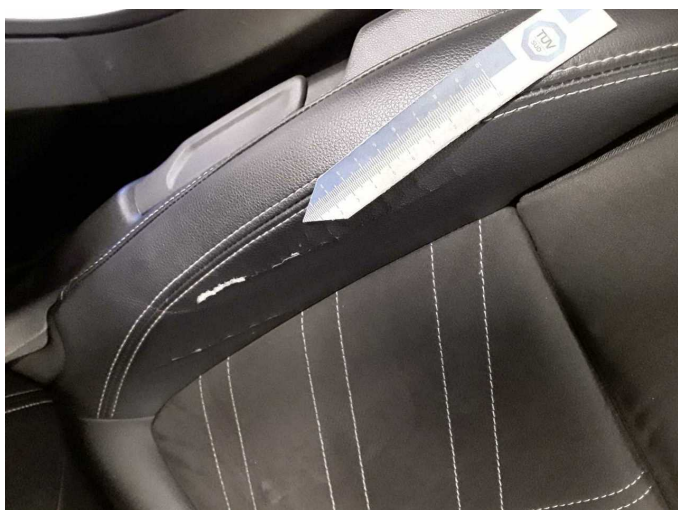
| No. | Component group | Description |
|---|---|---|
| 3 | Seat - front | Seat cover - left side - Damaged - Smart repair |

**Damage 3:** Seat - front: Seat cover - left side - Damaged - Smart repair

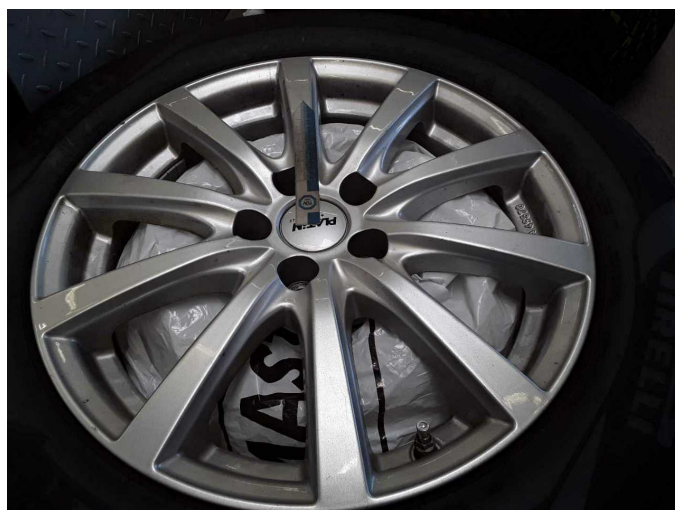
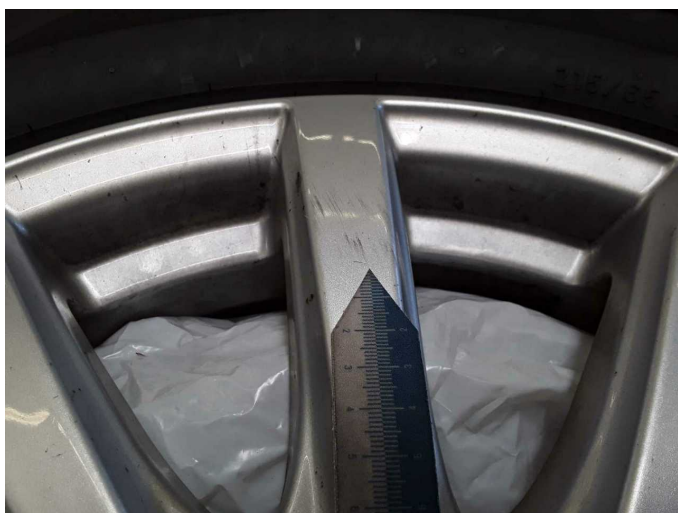
| No. | Component group | Description |
|---|---|---|
| 1 | 2nd wheel set | 2 alloy rims - Scratch(es) - No deduction |

**Wear and tear 1:** 2nd wheel set: 2 alloy rims - Scratch(es) - No deduction

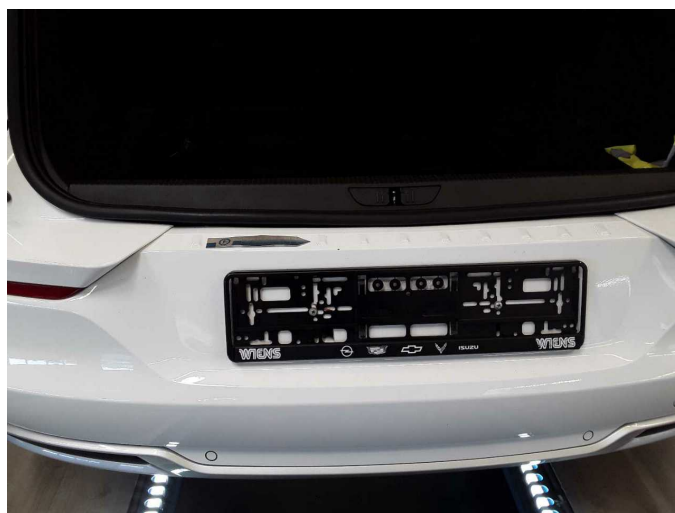
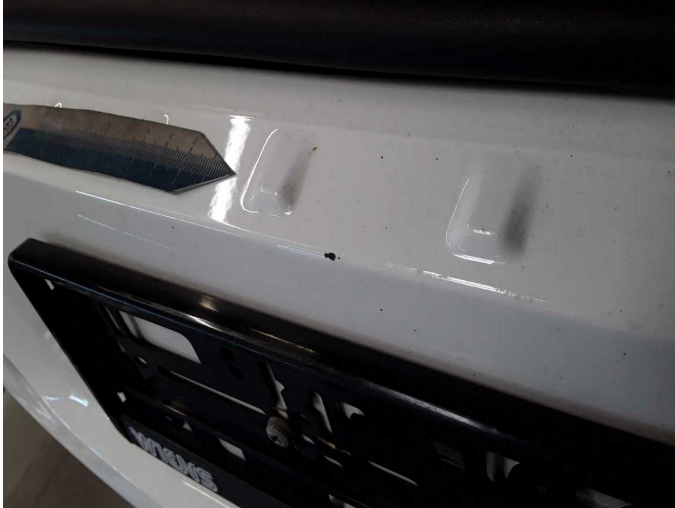
| No. | Component group | Description |
|---|---|---|
| 2 | Rear bumper | Rear bumper - Scratch(es) - No deduction |

**Wear and tear 2:** Rear bumper: Rear bumper - Scratch(es) - No deduction
