Expertise

Protocol number: 46440076  
Order No. / Reference: 26694795  
Inspection date: 10 Jul 2026

Manufacturer: Volvo

Model: XC90 T8 AWD Plug-in Hybrid Core

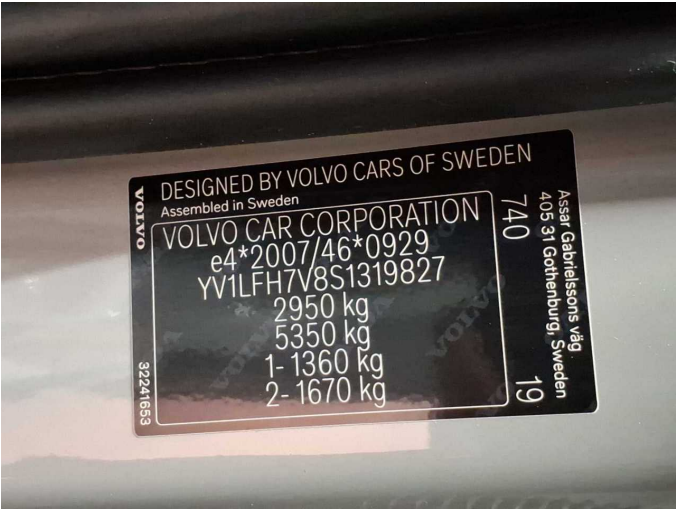
Figure 11: VIN

| VIN comparison | The vehicle identification number (VIN) was read from the vehicle and its conformity with the submitted documents was confirmed by the undersigned during the inspection. |

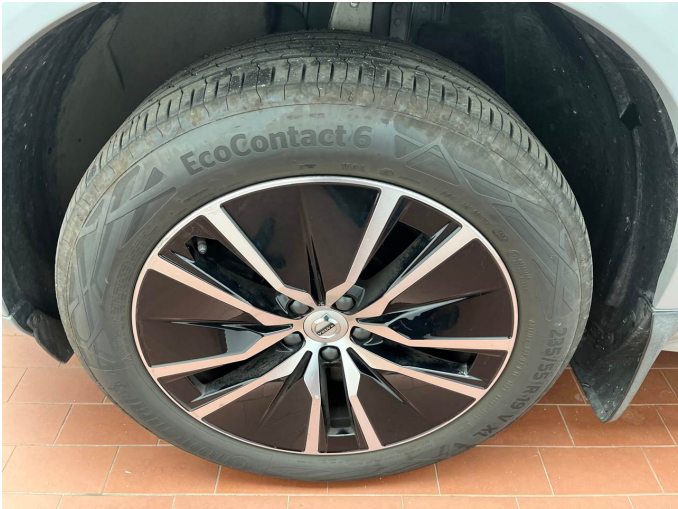
Figure 12: Mounted tyres

| # | Tyre size | Type of tyre | Manufacturer | Tread depth |
|---|---|---|---|---|
| 1) | 235/55 R19 105V | Summer tyres on Light alloy | Continental | 5mm / 5mm |
| 2) | 235/55 R19 105V | Summer tyres on Light alloy | Continental | 5mm / 5mm |

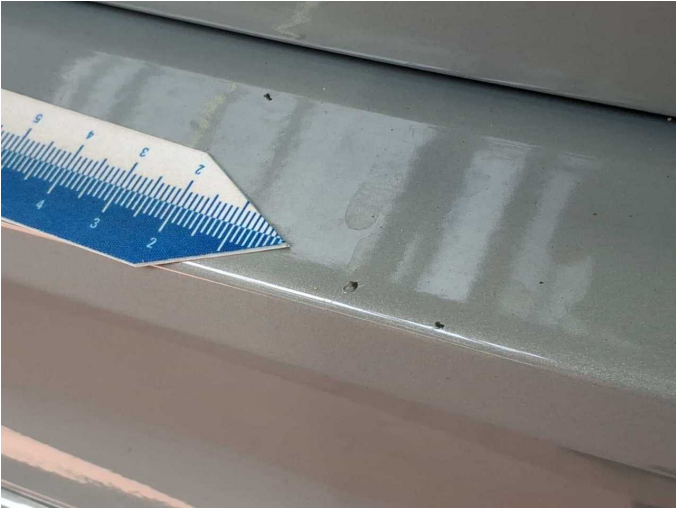
| No. | Component group | Description |
|---|---|---|
| 1 | Rear bumper | Rear bumper - Scratch(es) - Smart repair |

Damage 1: Rear bumper: Rear bumper - Scratch(es) - Smart repair

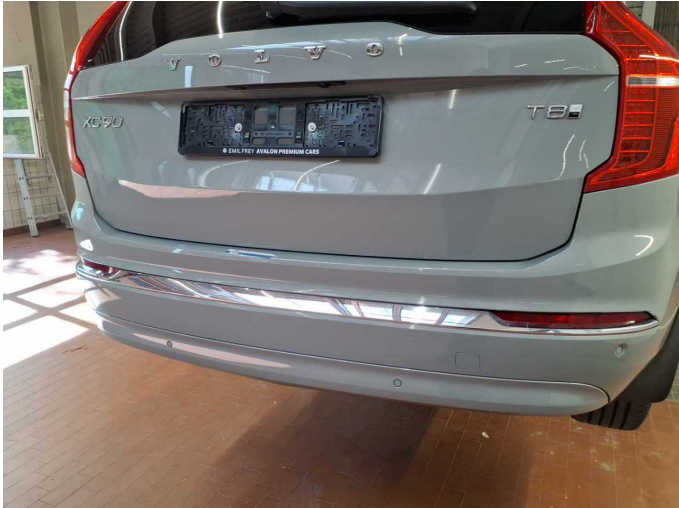
Damage 1: Rear bumper: Rear bumper - Scratch(es) - Smart repair

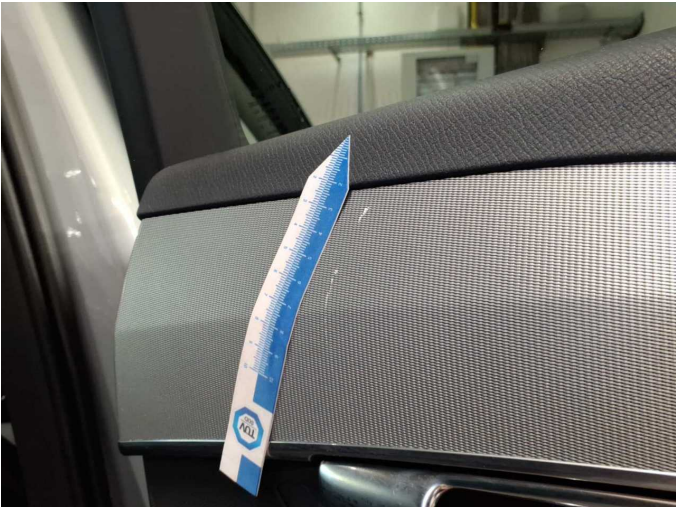
| No. | Component group | Description |
|---|---|---|
| 1 | Trim / covers | Door trim - rear right side - Scratch(es) - No deduction |

Wear and tear 1: Trim / covers: Door trim - rear right side - Scratch(es) - No deduction

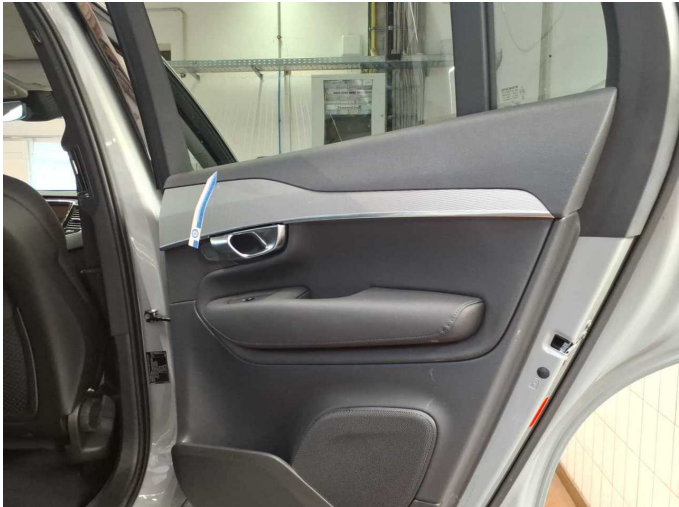
Wear and tear 1: Trim / covers: Door trim - rear right side - Scratch(es) - No deduction

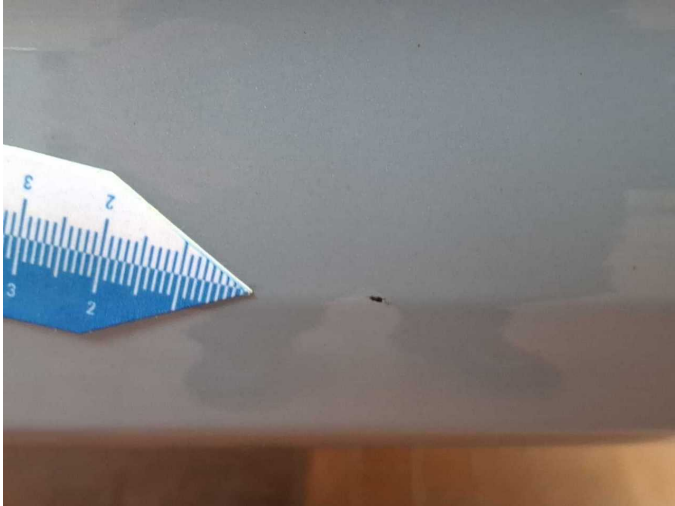
| No. | Component group | Description |
|---|---|---|
| 2 | Rear bumper | Spoiler - Scratch(es) - No deduction |

**Wear and tear 2:** Rear bumper: Spoiler - Scratch(es) - No deduction

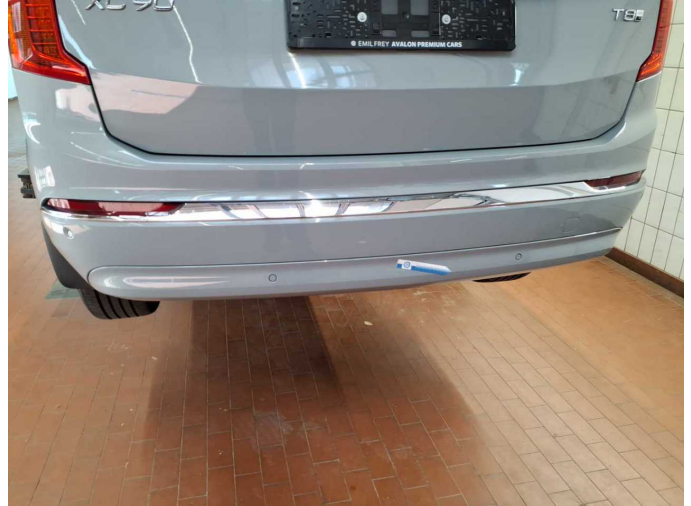
**Wear and tear 2:** Rear bumper: Spoiler - Scratch(es) - No deduction

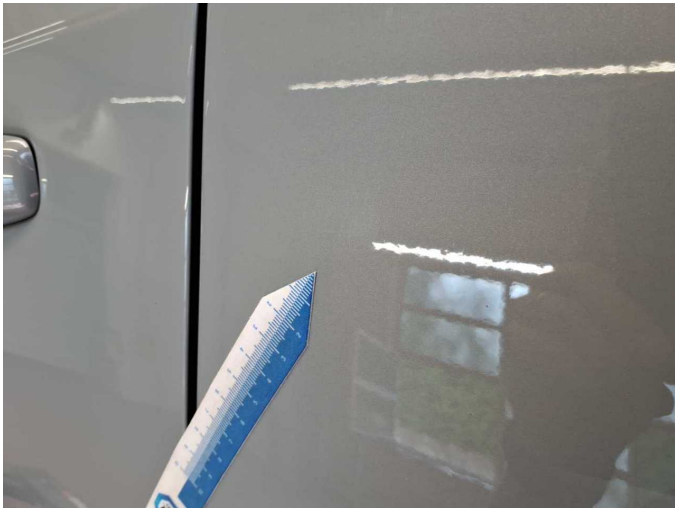
| No. | Component group | Description |
|---|---|---|
| 3 | Side panel - rear left side | Side panel - Scratch(es) - No deduction |

**Wear and tear 3:** Side panel - rear left side: Side panel - Scratch(es) - No deduction

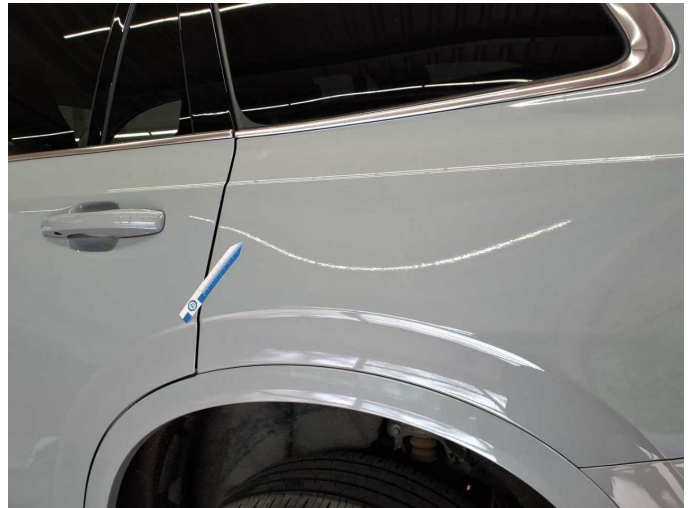
**Wear and tear 3:** Side panel - rear left side: Side panel - Scratch(es) - No deduction
