Expertise

Protocol number: 46406680  
Order No. / Reference: 26550242  
Inspection date: 8 Jul 2026

Model: GLC-Coupe 300 de 4Matic 9G-TRONIC

VIN: W1N2533111G005224

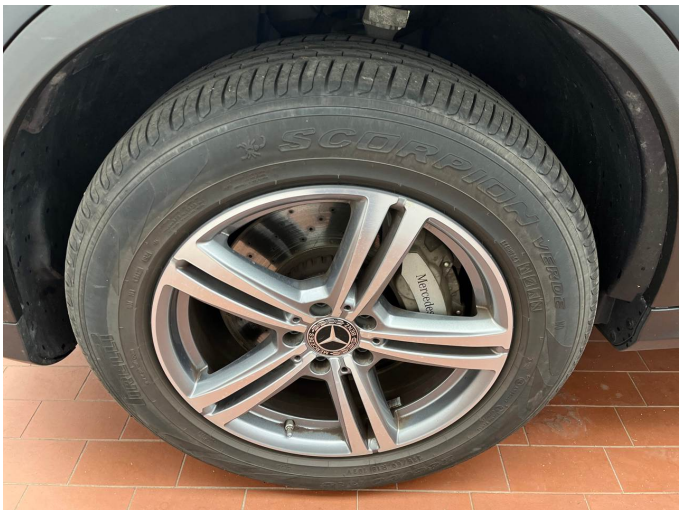
Figure 12: Mounted tyres

| # | Tyre size | Type of tyre | Manufacturer | Tread depth |
|---|---|---|---|---|
| 1) | 235/60 R18 103V | Summer tyres on Light alloy | Pirelli | 5mm / 5mm |
| 2) | 235/60 R18 103V | Summer tyres on Light alloy | Pirelli | 5mm / 5mm |

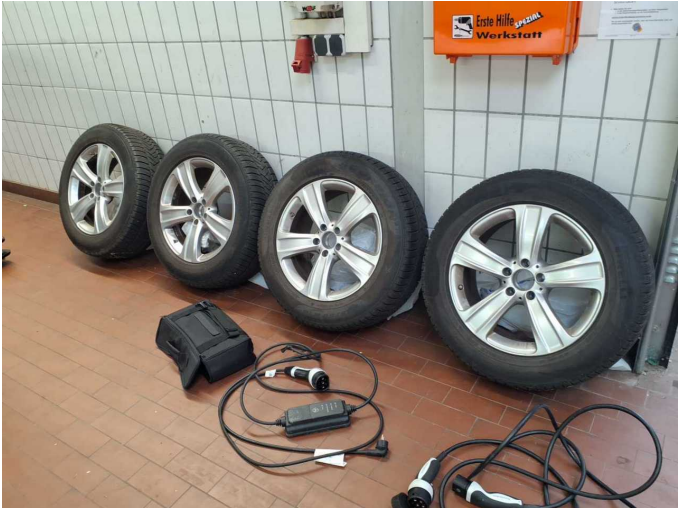
Figure 16: Additional tyres

| # | Tyre size | Type of tyre | Manufacturer | Tread depth |
|---|---|---|---|---|
| 1) | 235/60 R18 103H | Winter tyres on Light alloy | Pirelli | 6mm / 6mm |
| 2) | 235/60 R18 103H | Winter tyres on Light alloy | Pirelli | 6mm / 6mm |

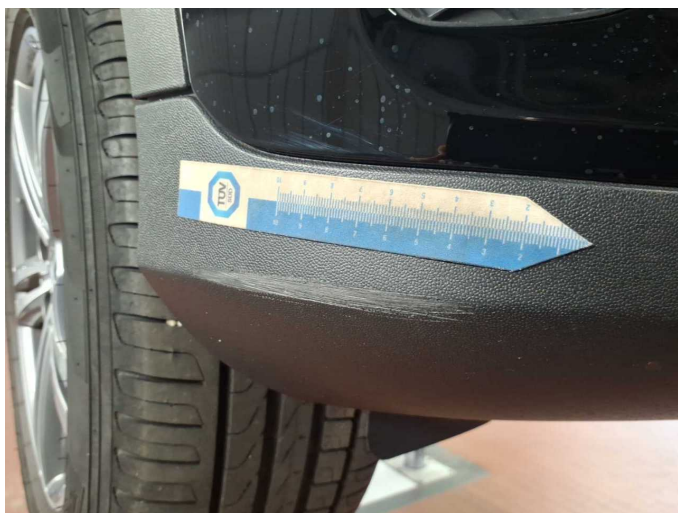
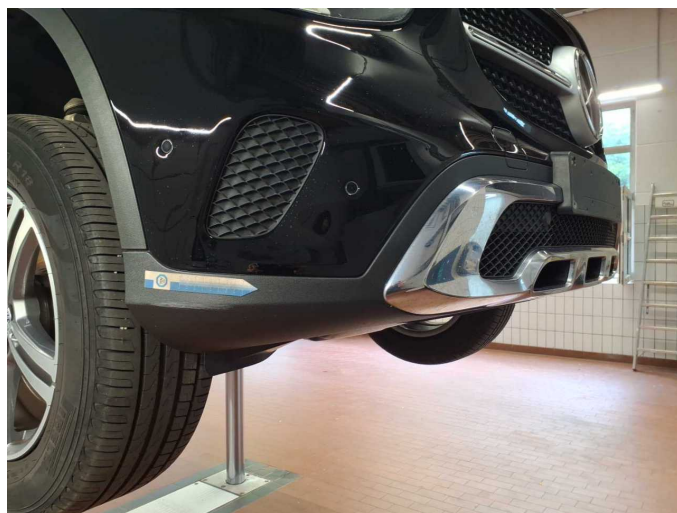
| No. | Component group | Description |
|---|---|---|
| 1 | Front bumper | Spoiler - Scratch(es) - Loss in value |

Damage 1: Front bumper: Spoiler - Scratch(es) - Loss in value

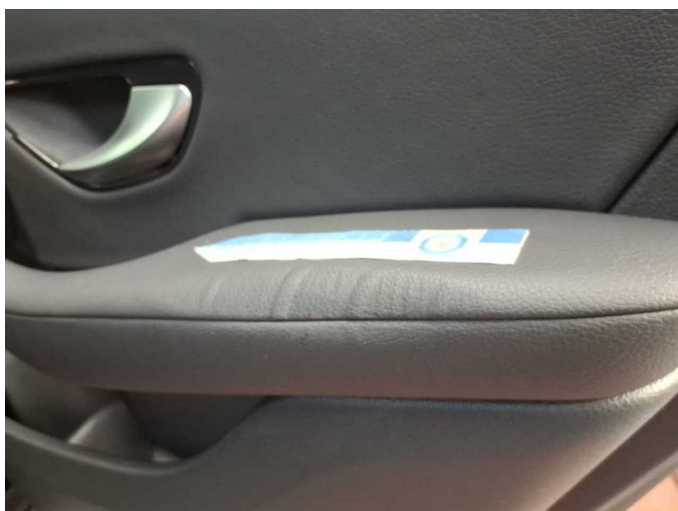
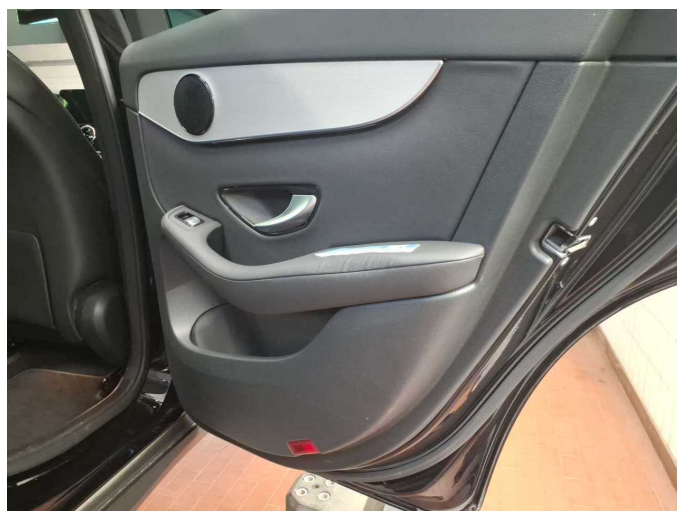
| No. | Component group | Description |
|---|---|---|
| 2 | Trim / covers | Door trim - rear right side - dent(s) - Loss in value |

Damage 2: Trim / covers: Door trim - rear right side - dent(s) - Loss in value

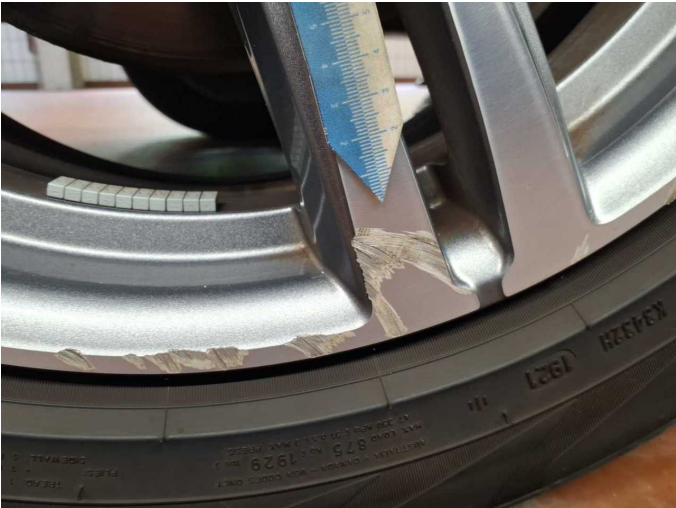
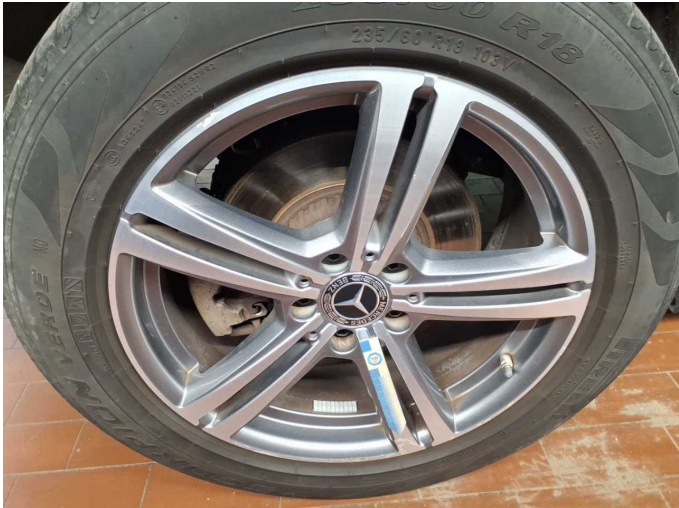
| No. | Component group | Description |
|---|---|---|
| 3 | Wheel / tyres | Alloy rim - rear right side - Scratched - Replace |

Damage 3: Wheel / tyres: Alloy rim - rear right side - Scratched - Replace

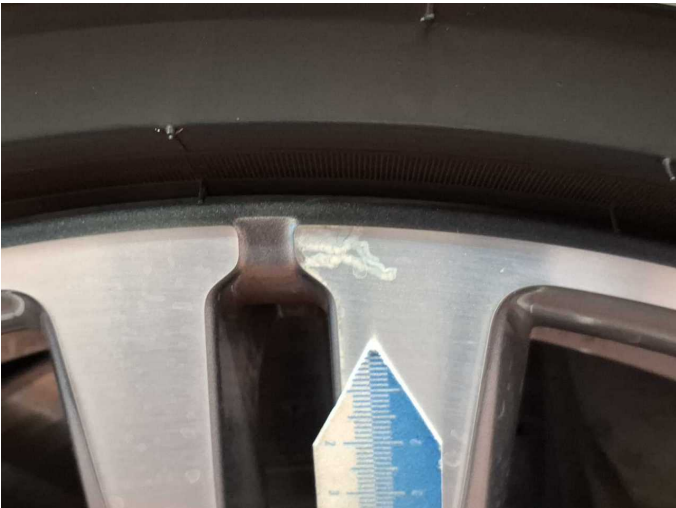
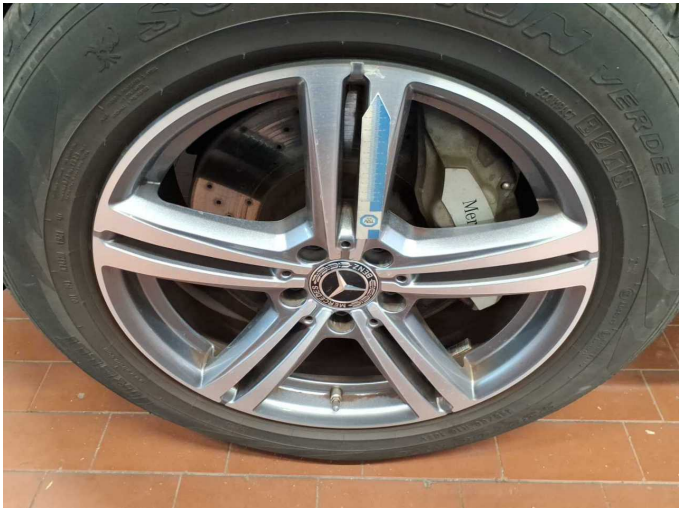
| No. | Component group | Description |
|---|---|---|
| 4 | Wheel / tyres | Alloy rim - front left side - Corrosion - Replace |

Damage 4: Wheel / tyres: Alloy rim - front left side - Corrosion - Replace

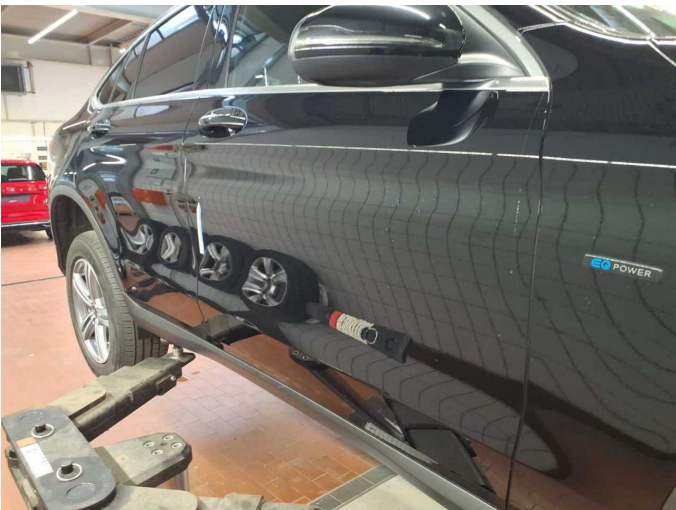
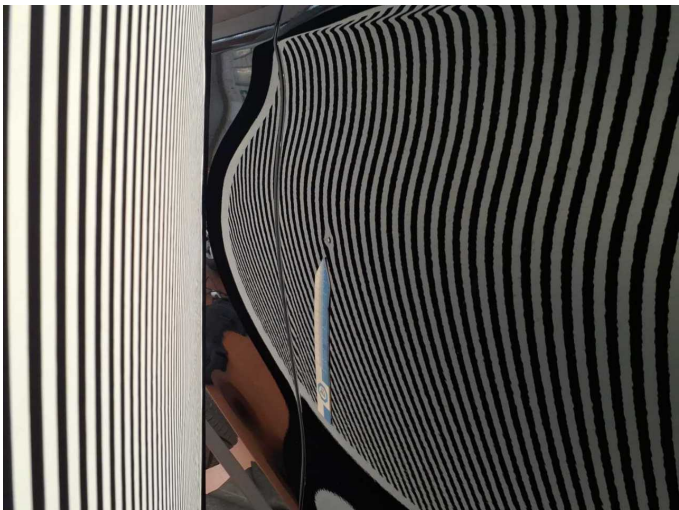
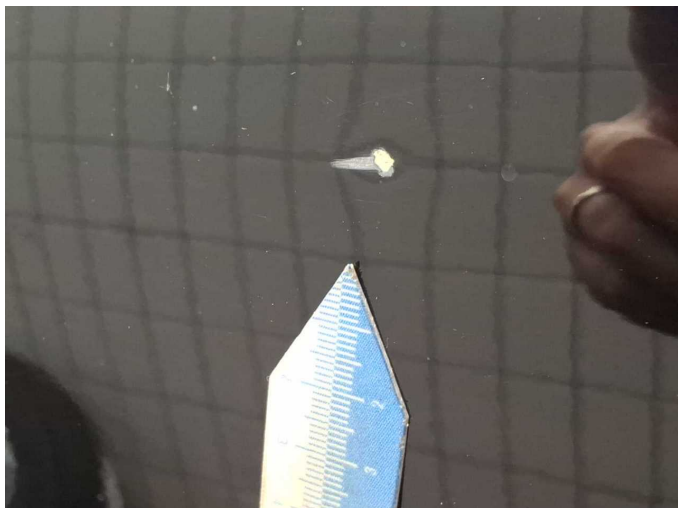
| No. | Component group | Description |
|---|---|---|
| 5 | Door - front right side | Door - Dent / paintcoat damage - Repair and paint |

Damage 5: Door - front right side: Door - Dent / paintcoat damage - Repair and paint

**Damage 5:** Door - front right side: Door - Dent / paintcoat damage - Repair and paint

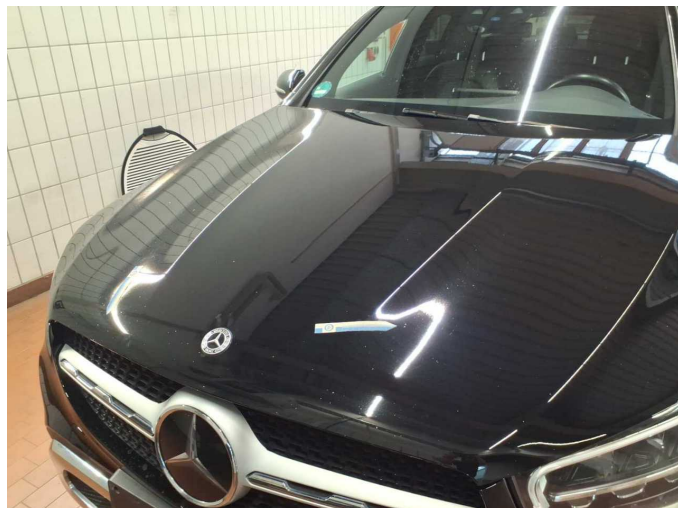
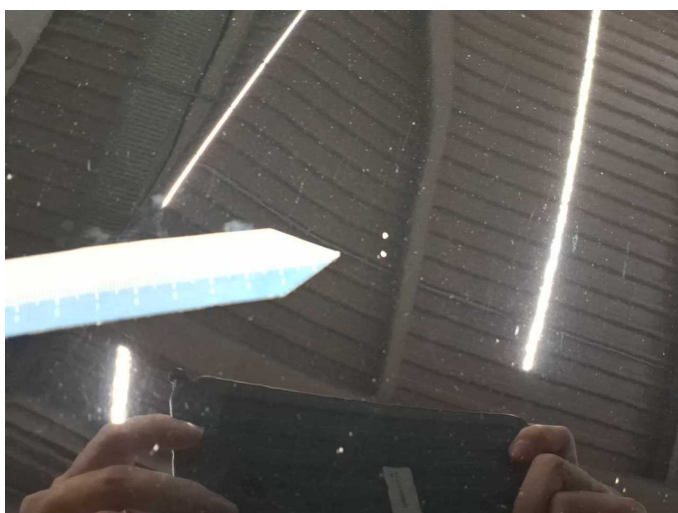
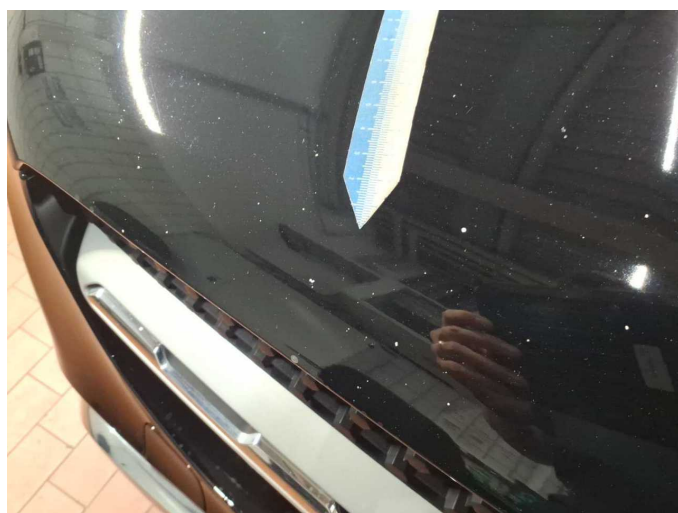
| No. | Component group | Description |
|---|---|---|
| 6 | Bonnet | Bonnet - Stone chips - Paint |

**Damage 6:** Bonnet: Bonnet - Stone chips - Paint

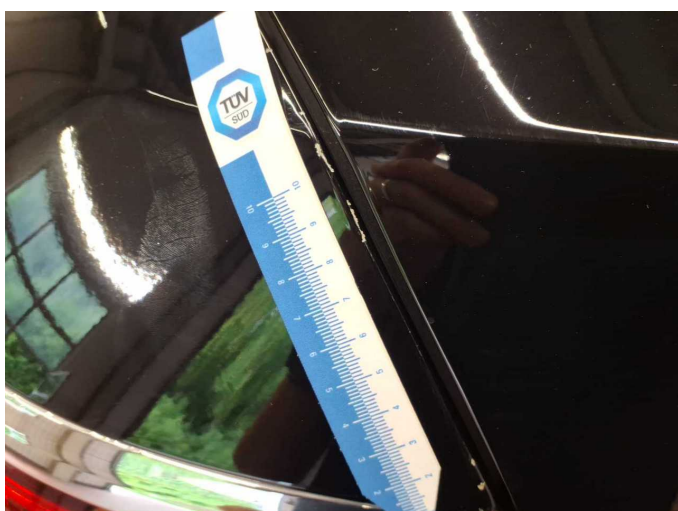
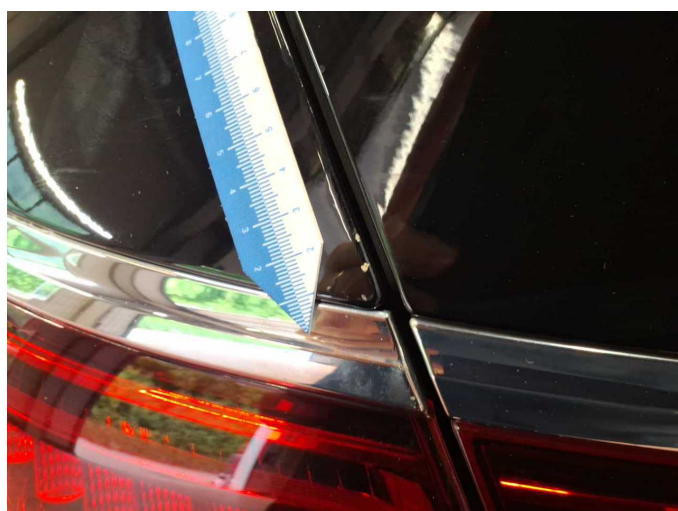
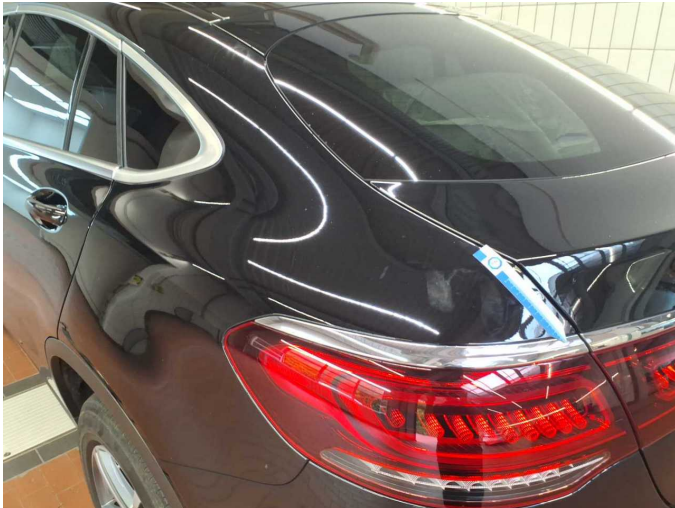
| No. | Component group | Description |
|---|---|---|
| 7 | Side panel - rear left side | Side panel - Scratch(es) - Paint |

**Damage 7:** Side panel - rear left side: Side panel - Scratch(es) - Paint

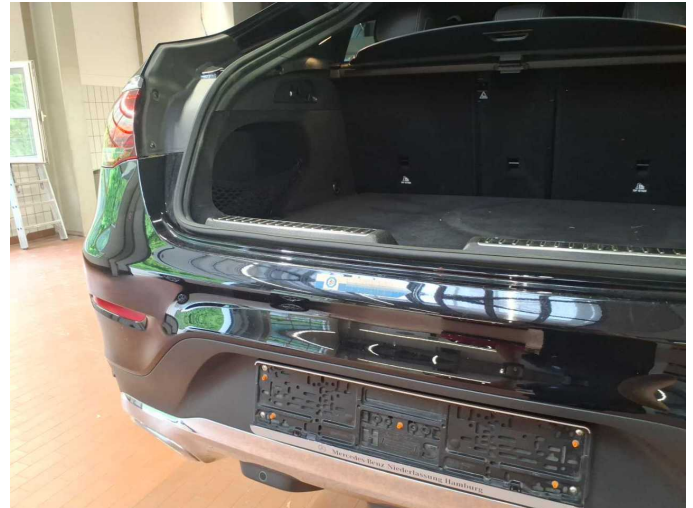
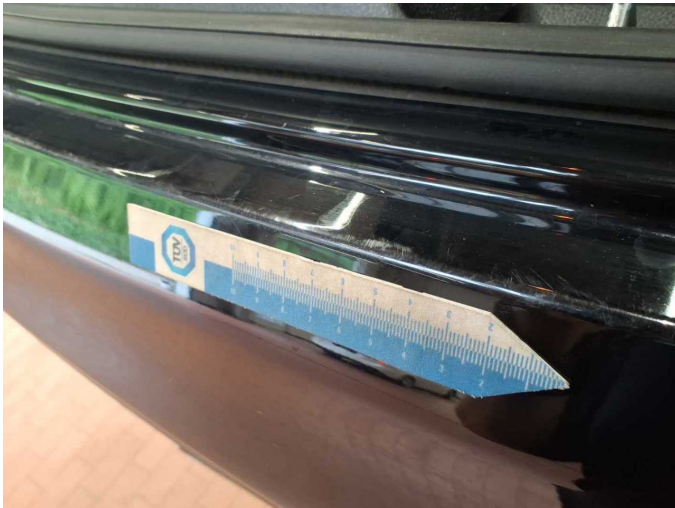
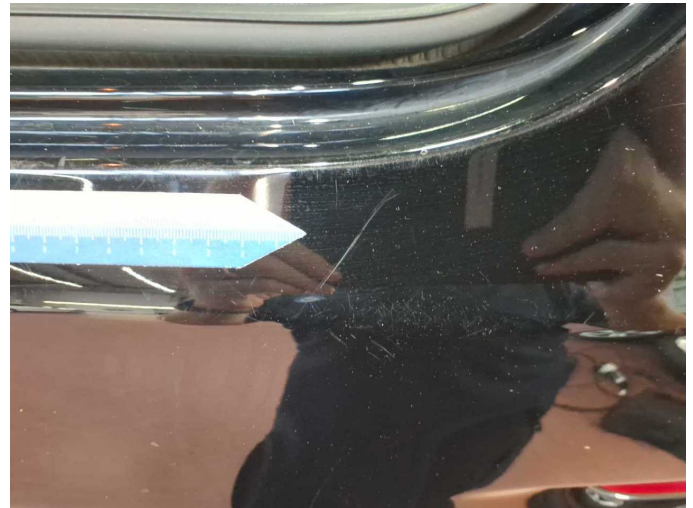
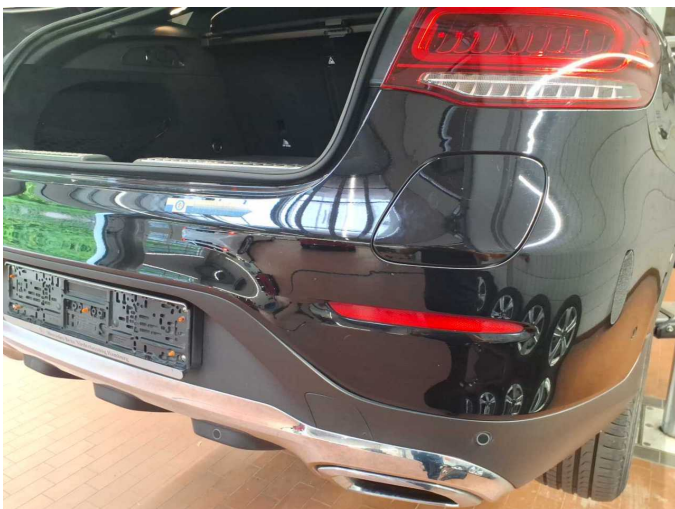
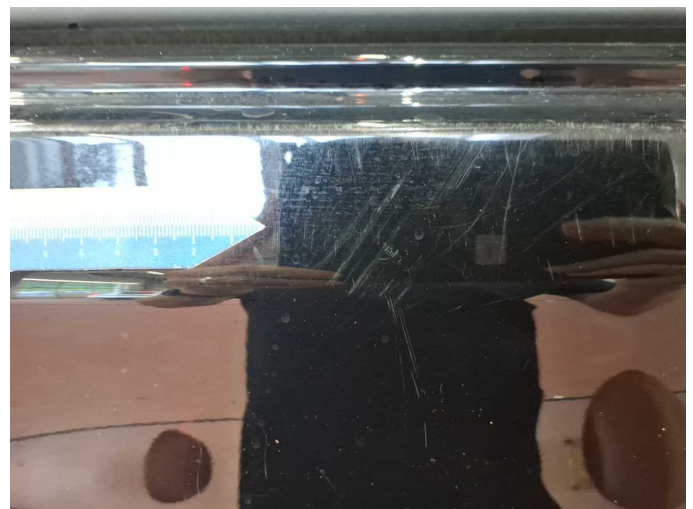
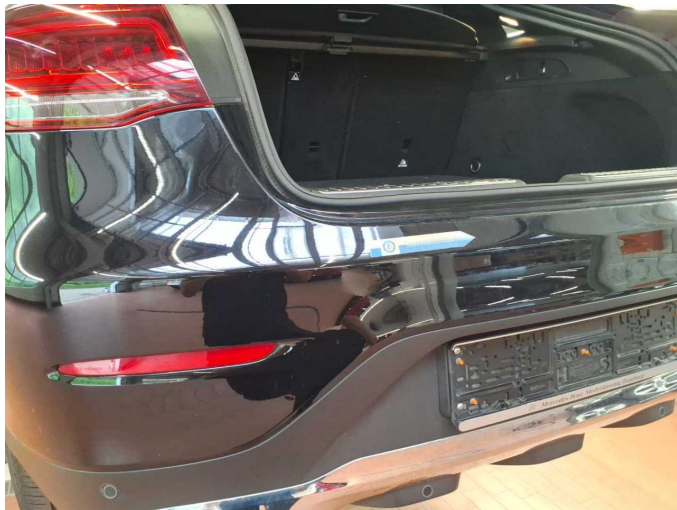
| No. | Component group | Description |
|---|---|---|
| 8 | Rear bumper | Rear bumper - Scratched - Paint |

**Damage 8:** Rear bumper: Rear bumper - Scratched - Paint

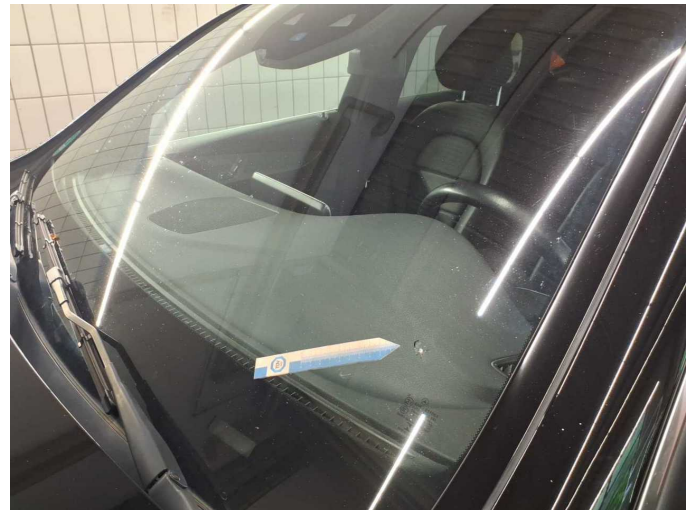
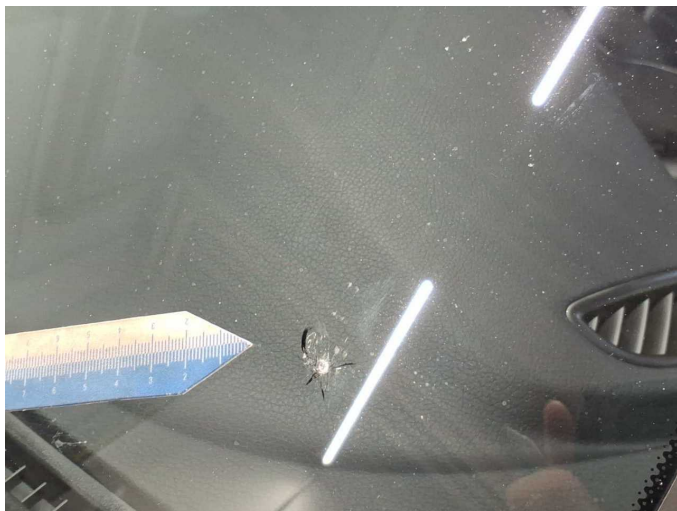
| No. | Component group | Description |
|---|---|---|
| 9 | Vehicle glazing | Windscreen - Stone chips - Replace |

**Damage 9:** Vehicle glazing: Windscreen - Stone chips - Replace

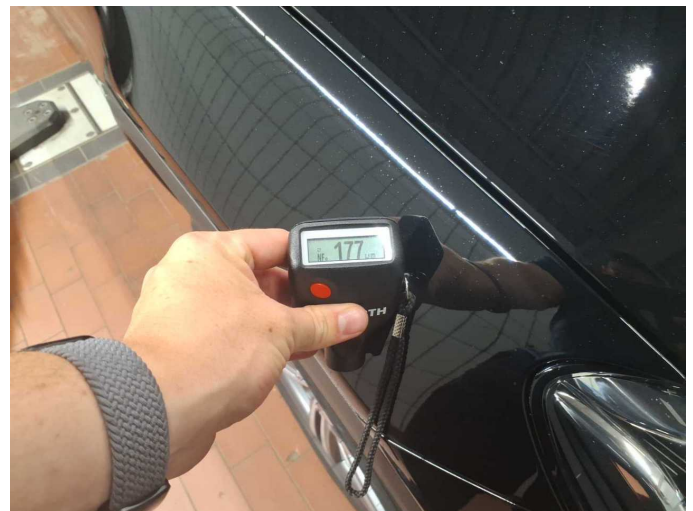
| No. | Repainting |
|---|---|
| 1 | Mudguard - right side, Professionally carried out, Invoice of repair done Non-existent |

| Mudguard - right side | 177 µm | Door - rear left side | 242 µm |

**Repainting 1:** Mudguard - right side

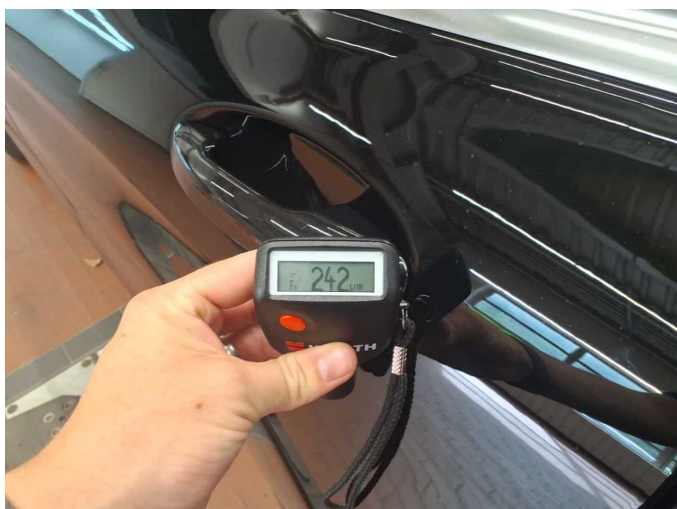
| No. | Repainting |
|---|---|
| 2 | Door - rear left side, Professionally carried out, Invoice of repair done Non-existent |

**Repainting 2:** Door - rear left side
