Expertise

Protocol number: 46523188  
Order No. / Reference: 26656734  
Inspection date: 15 Jul 2026

| Manufacturer: Opel | Model: Astra 1.5 D Start/Stop Sports Tourer Automatik Elegance |

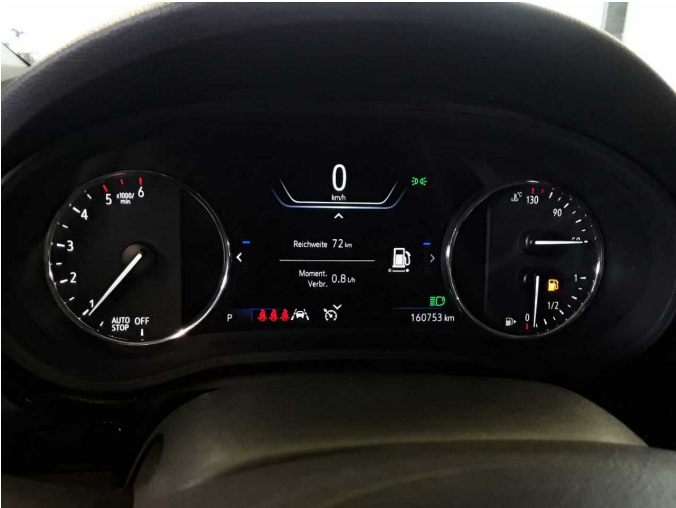
Figure 7: Instrument cluster

| Vehicle details | |
|---|---|
| Mileage (Read) | 160,753 km |

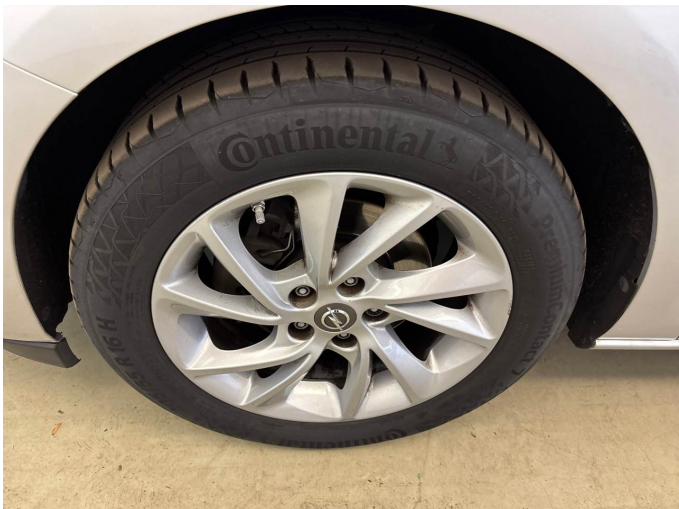
Figure 12: Mounted tyres

| Tyres | | | | |
|---|---|---|---|---|
| 1) | 205/55 R16 91V | Summer tyres on Light alloy | Continental | 4mm / 4mm |
| 2) | 205/55 R16 91V | Summer tyres on Light alloy | Continental | 4mm / 4mm |

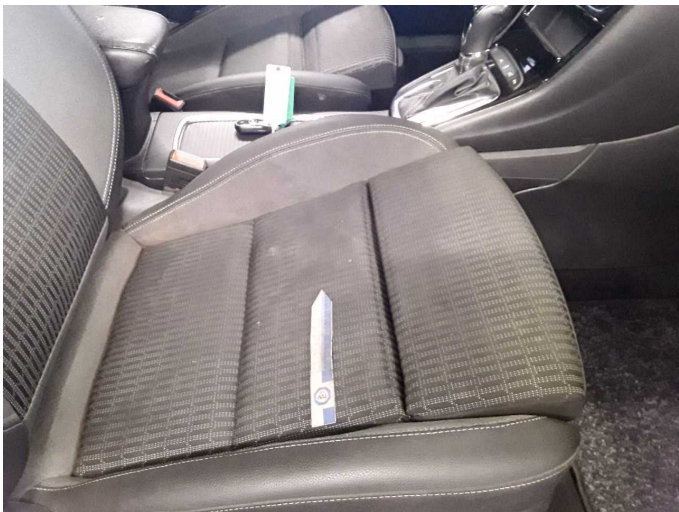
Damage 1: Seat - front: Seat cover - right side - Soiled - Clean

| No. | Component group | Description |
|---|---|---|
| 1 | Seat - front | Seat cover - right side - Soiled - Clean |

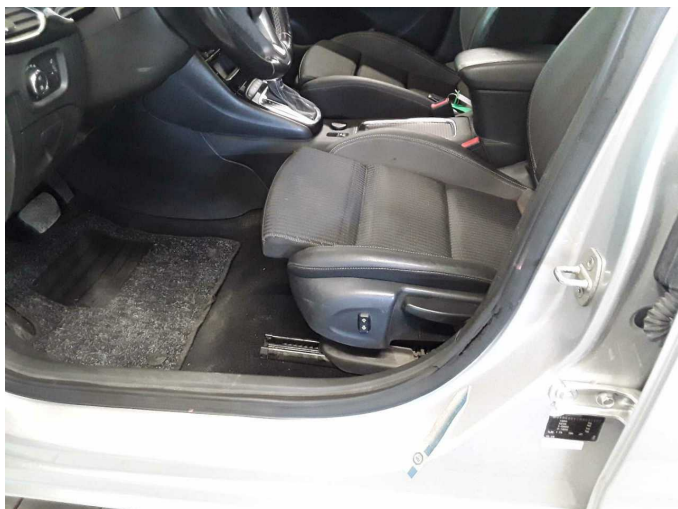
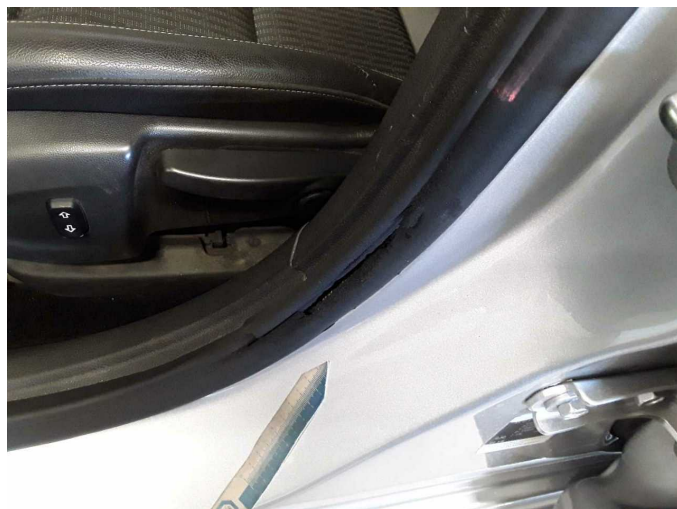
**Damage 2:** Cab: Door rubber seal - left side - Damaged - Replace

| No. | Component group | Description |
|---|---|---|
| 2 | Cab | Door rubber seal - left side - Damaged - Replace |

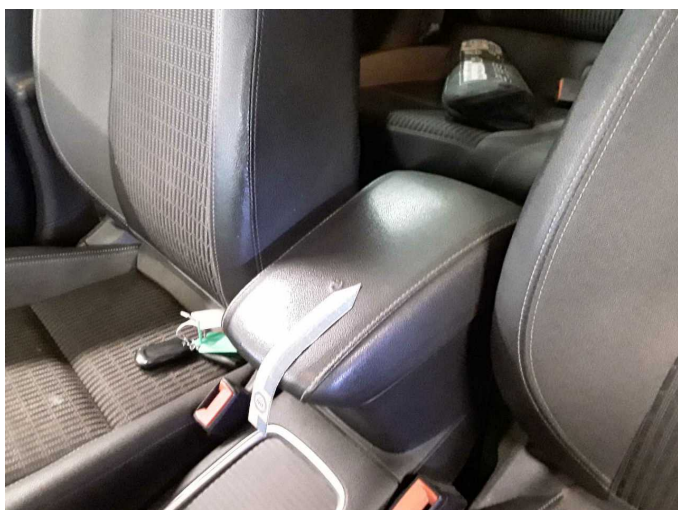
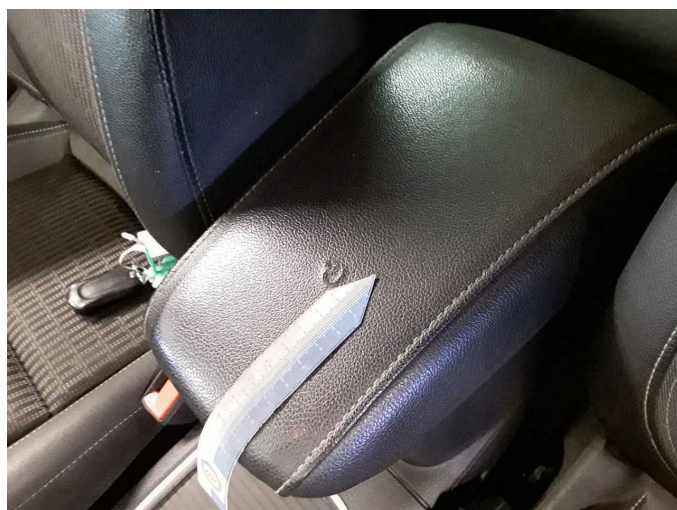
**Damage 3:** Seat - front: armrests - Damaged - Replace

| No. | Component group | Description |
|---|---|---|
| 3 | Seat - front | armrests - Damaged - Replace |

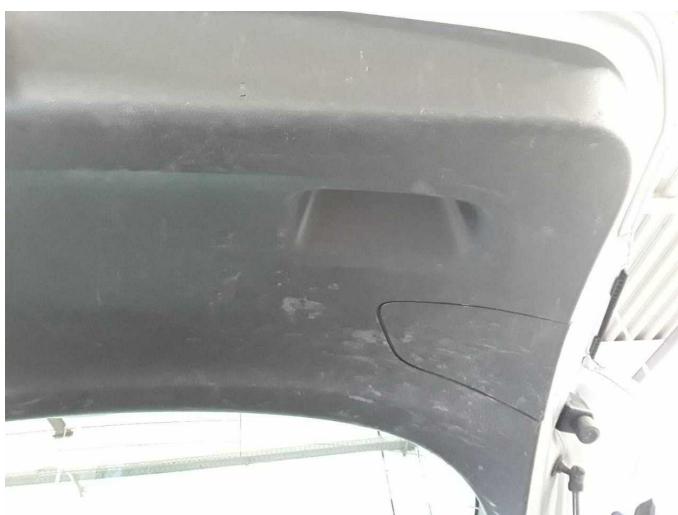
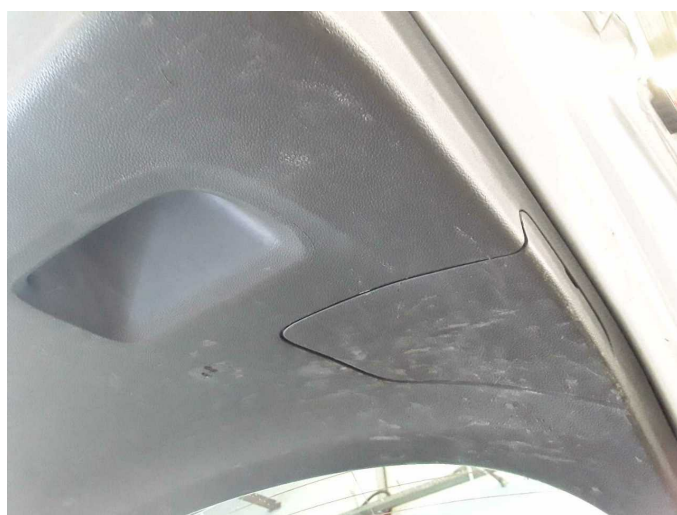
**Damage 4:** Trim / covers: Boot lid - interior trim - Scratched - Replace

| No. | Component group | Description |
|---|---|---|
| 4 | Trim / covers | Boot lid - interior trim - Scratched - Replace |

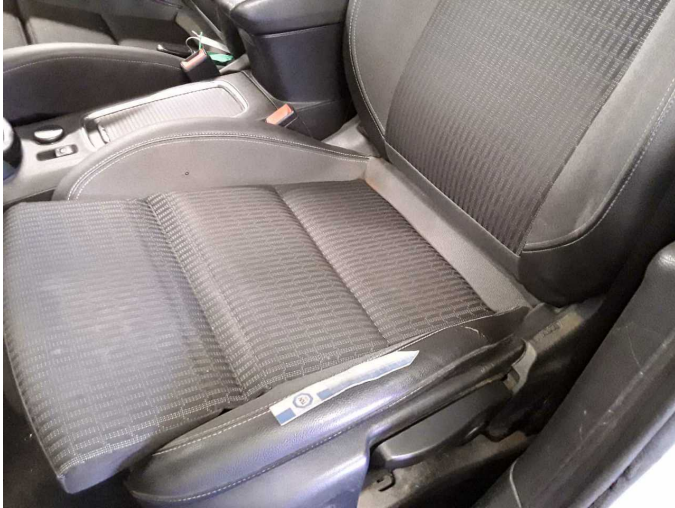
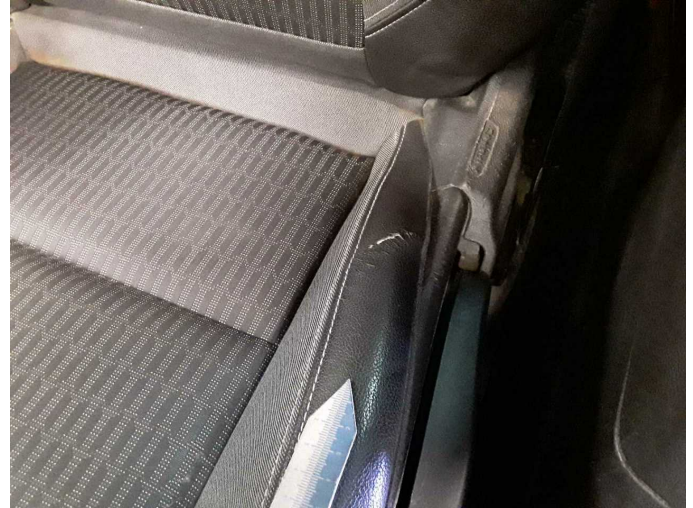
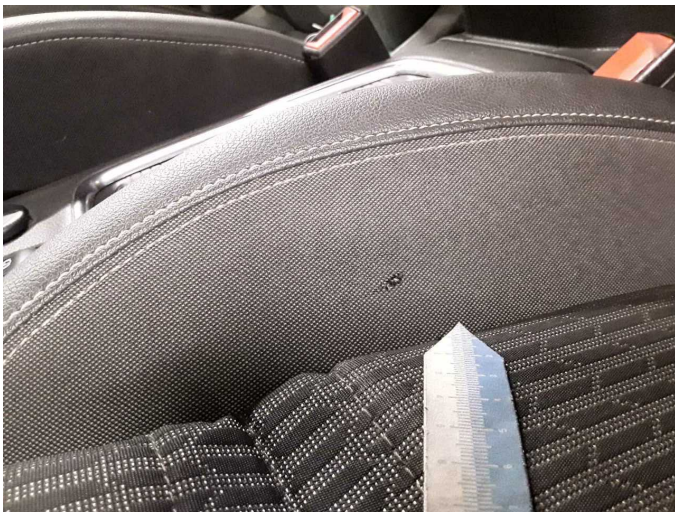
**Damage 5:** Seat - front: Seat cover - left side - Damaged - Replace

| No. | Component group | Description |
|---|---|---|
| 5 | Seat - front | Seat cover - left side - Damaged - Replace |

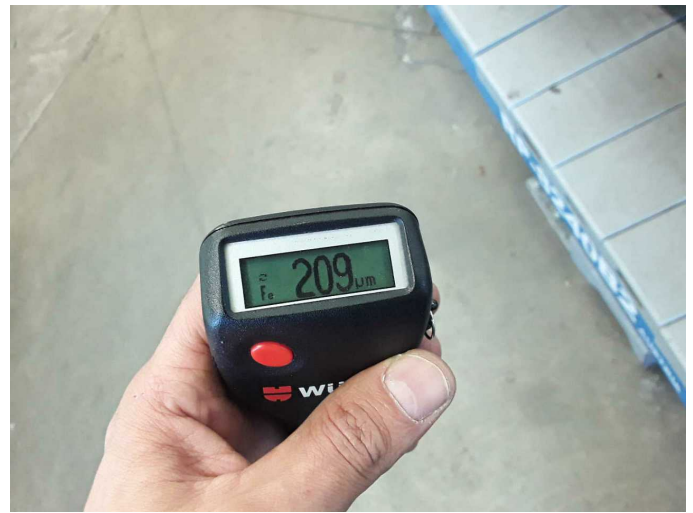
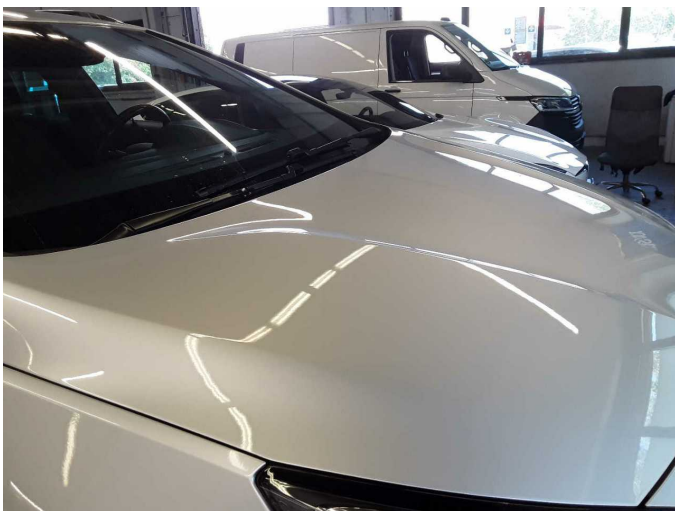
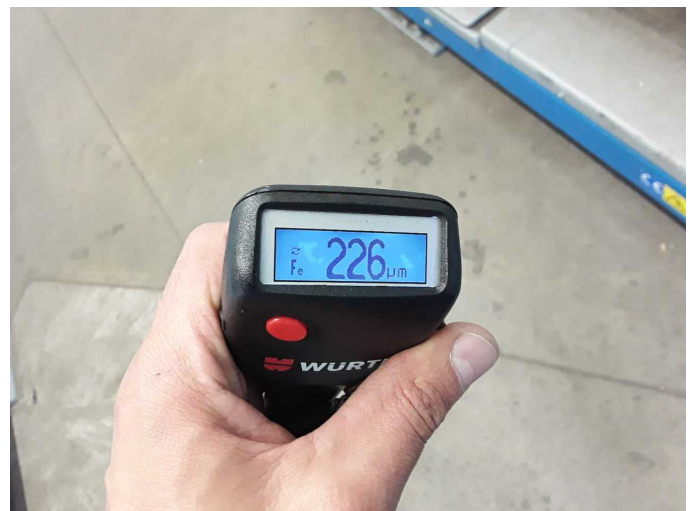
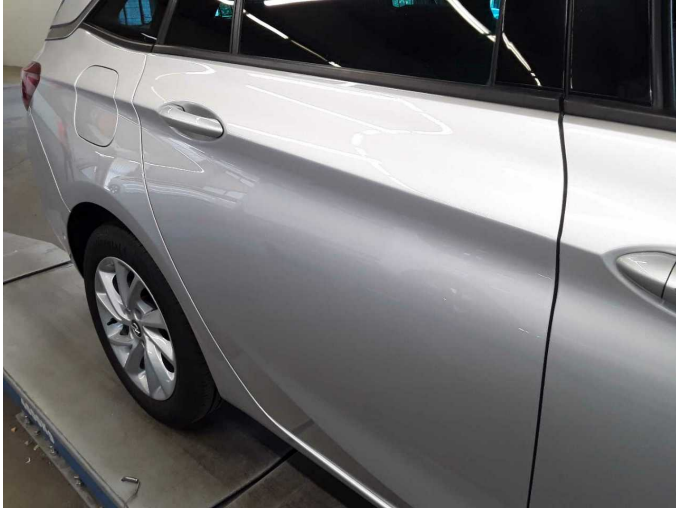
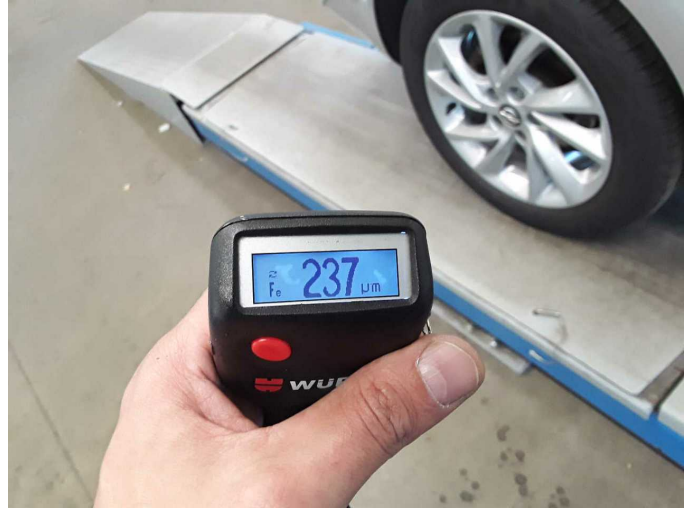
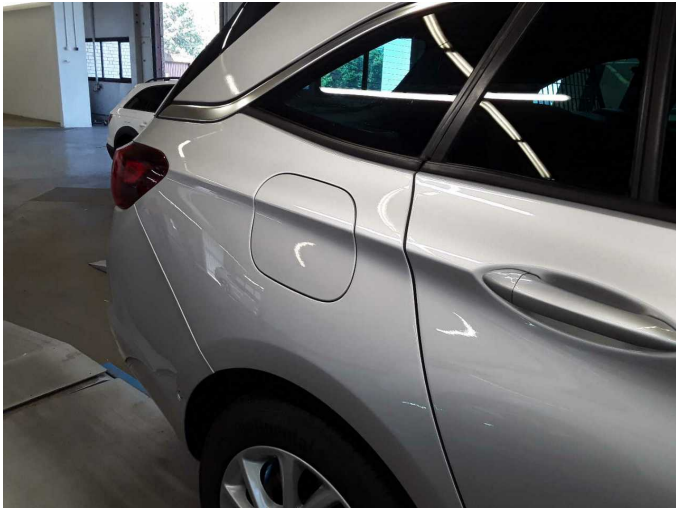
| No. | Repainting |
|---|---|
| 1 | Roof, Bonnet, Side panel - rear left side, Side panel - rear right side, Door - rear left side, Door - rear right side, Professionally carried out, Invoice of repair done Non-existent |

**Repainting 1:** Roof, Bonnet, Side panel - rear left side, Side panel - rear right side, Door - rear left side, Door - rear right side

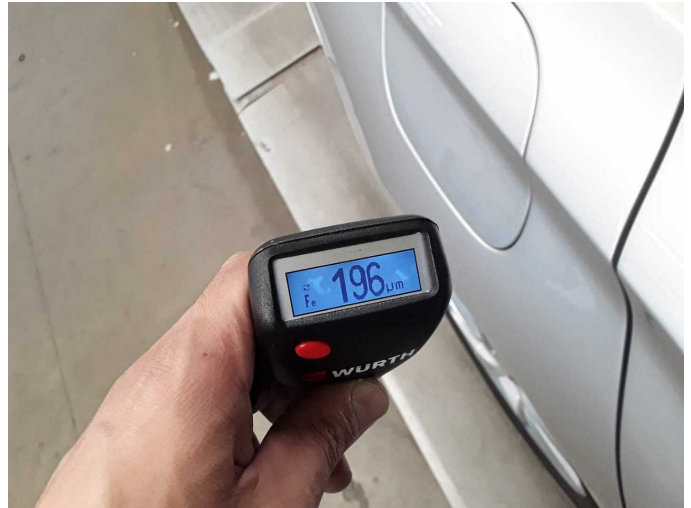
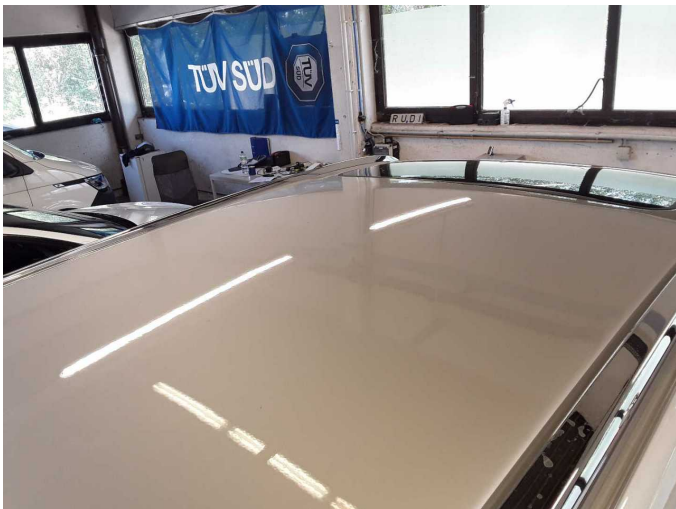
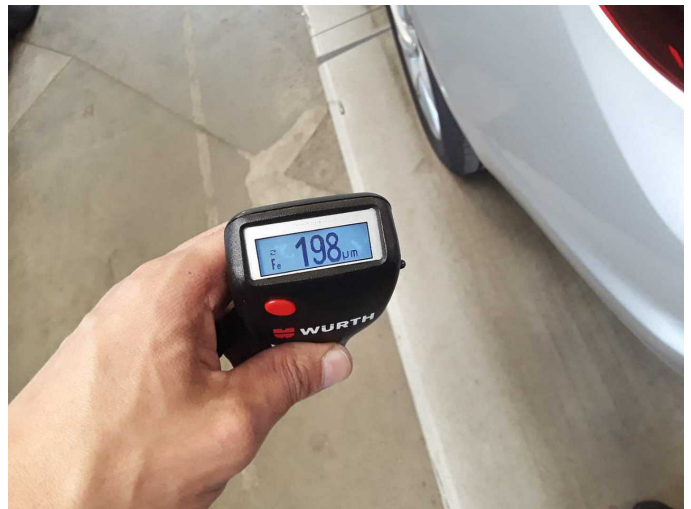
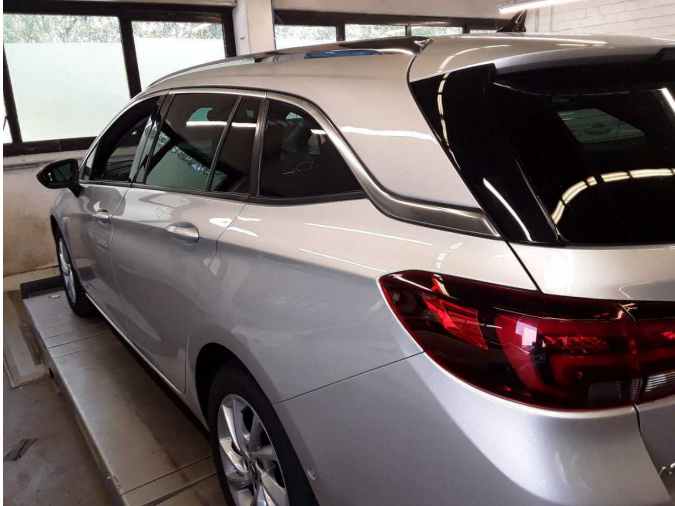
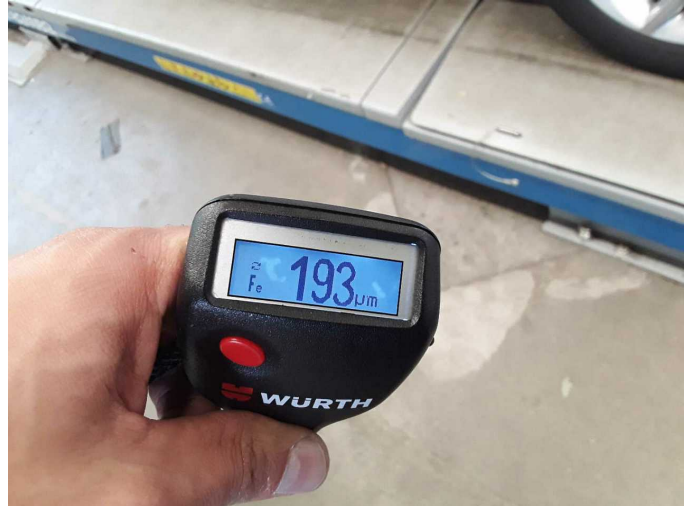
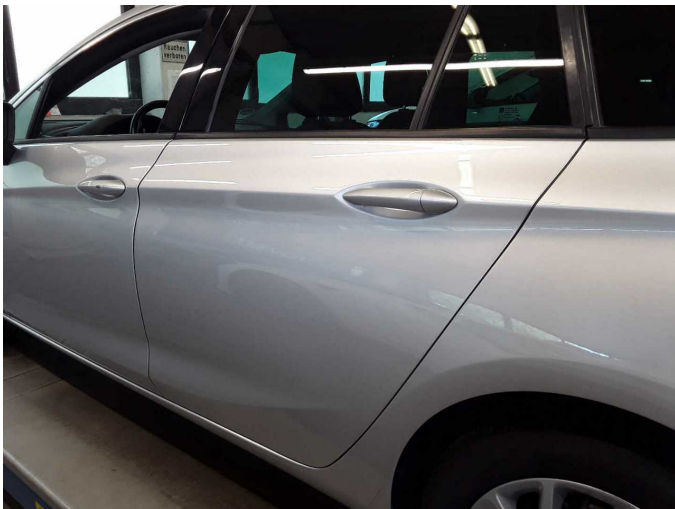
**Repainting 1:** Roof, Bonnet, Side panel - rear left side, Side panel - rear right side, Door - rear left side, Door - rear right side

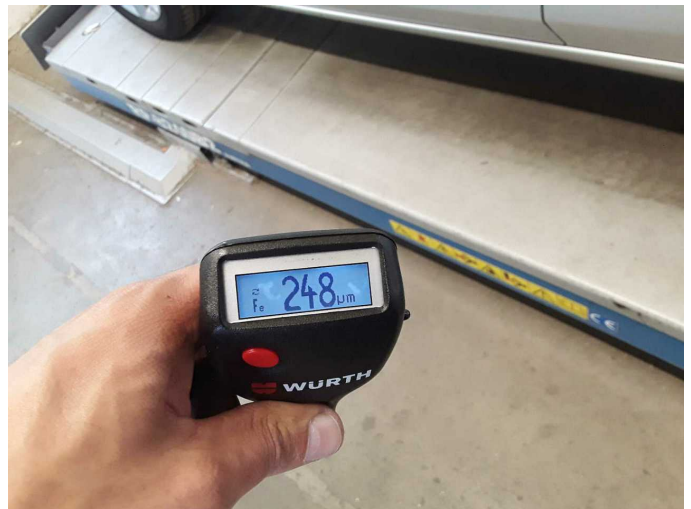
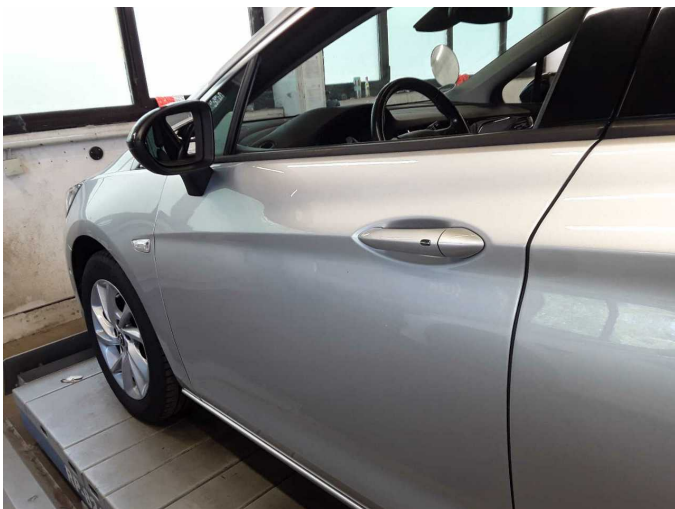
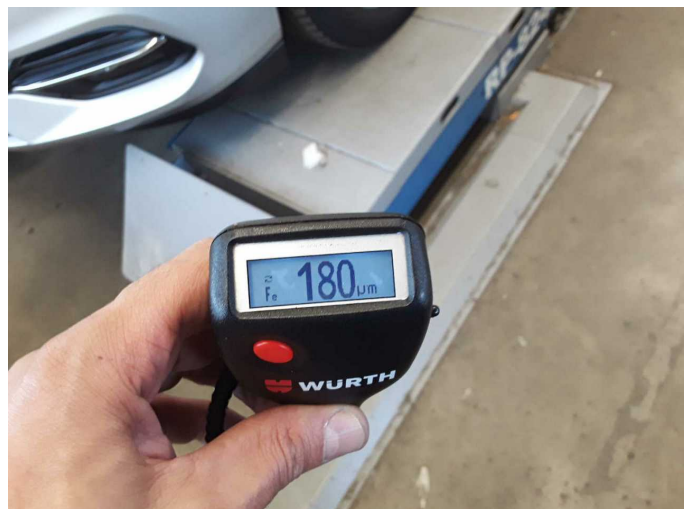
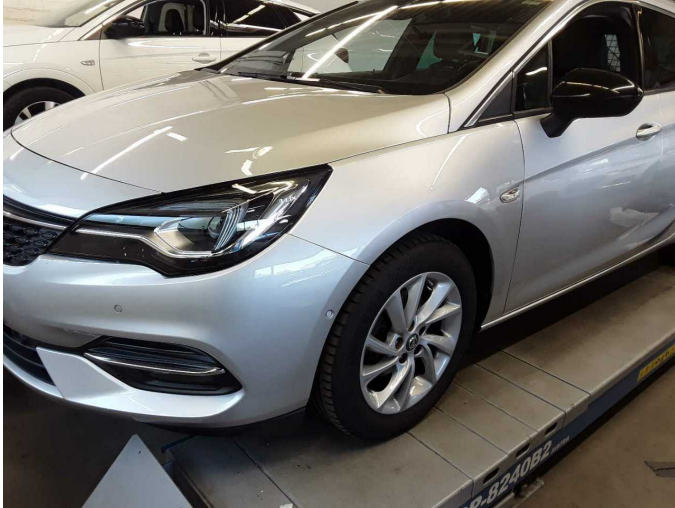
**Repainting 1:** Roof, Bonnet, Side panel - rear left side, Side panel - rear right side, Door - rear left side, Door - rear right side
