Protocol number: 46114308
Order No. / Reference: 26536732
Inspection date: 24 Jun 2026

Manufacturer: Skoda

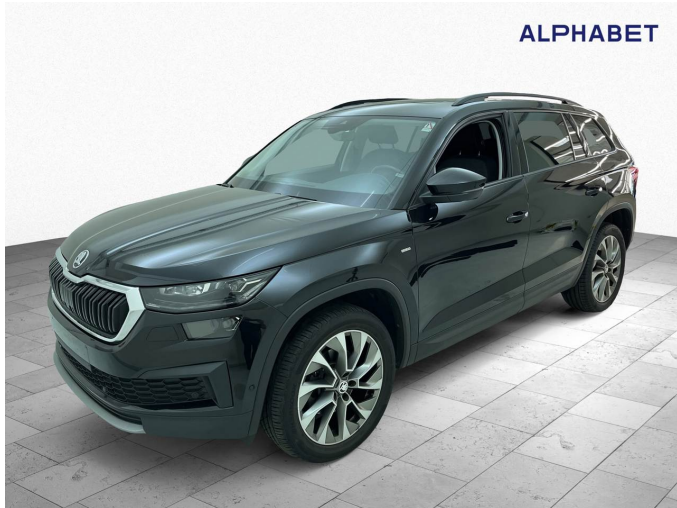
Figure 1: Diagonal front (left)

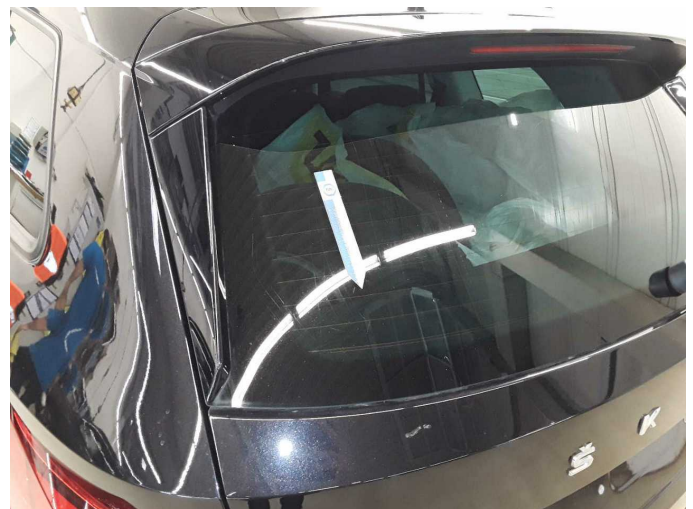
Damage 1: Vehicle glazing: Rear window - Scratch(es) - Loss in value

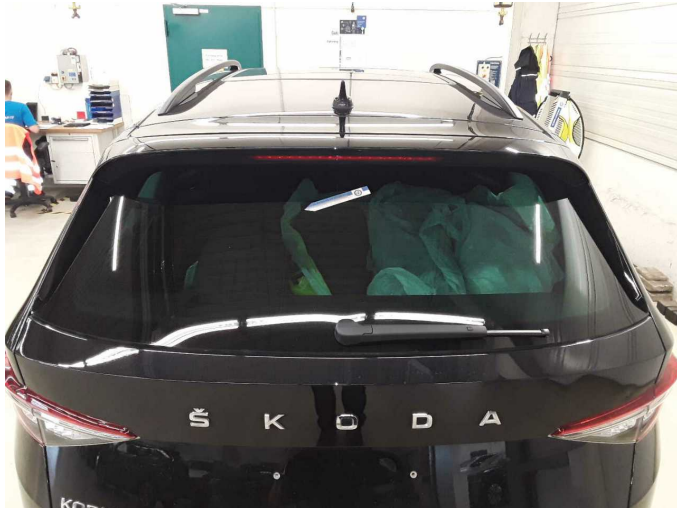
Damage 1: Vehicle glazing: Rear window - Scratch(es) - Loss in value

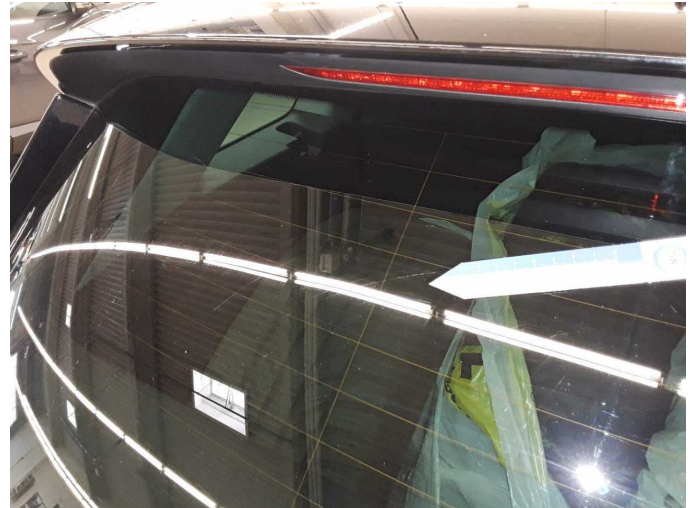
Damage 1: Vehicle glazing: Rear window - Scratch(es) - Loss in value

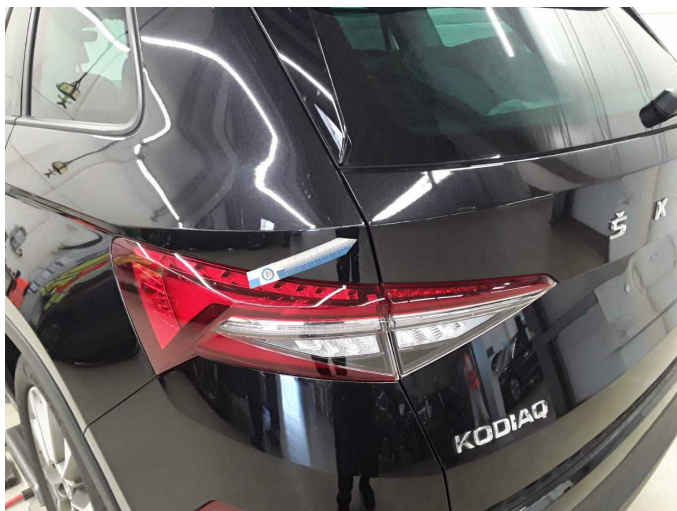
Damage 2: Side panel - rear left side: Side panel - Scratch(es) - Smart repair

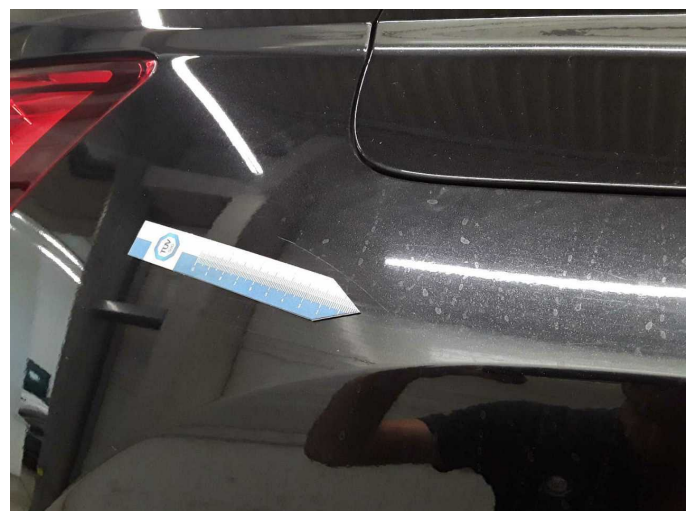
Damage 3: Side panel - rear right side: Side panel - Scratch(es) - Smart repair

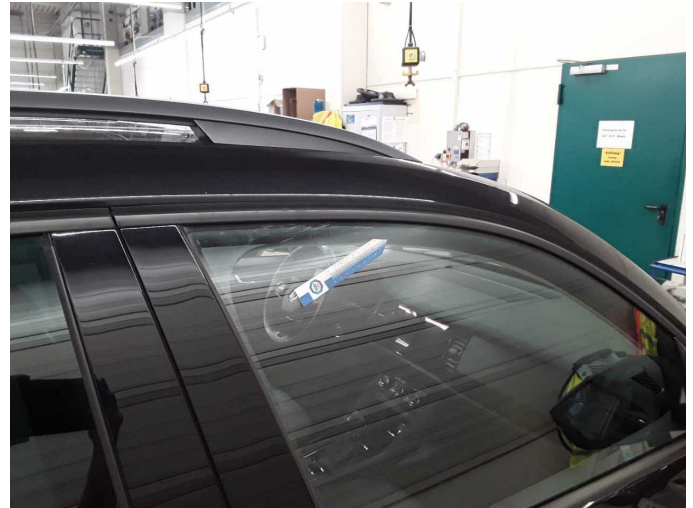
Damage 4: Vehicle glazing: Door glass - front right side - Scratch(es) - Replace

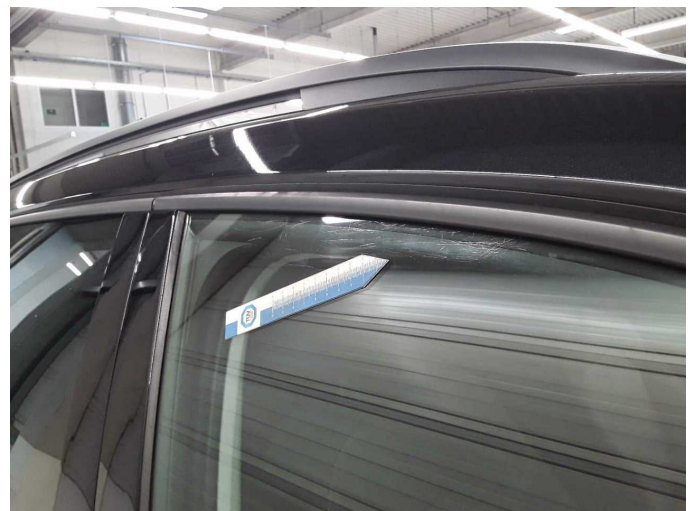
Damage 4: Vehicle glazing: Door glass - front right side - Scratch(es) - Replace

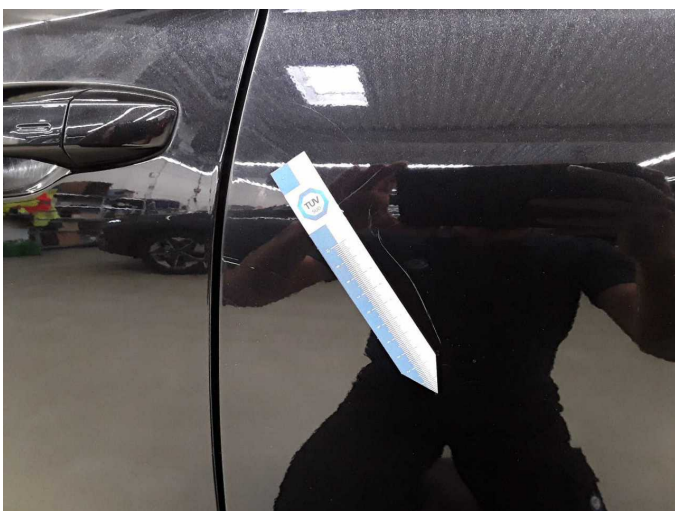
Damage 5: Door - rear left side: Door - Scratched - Repair and paint

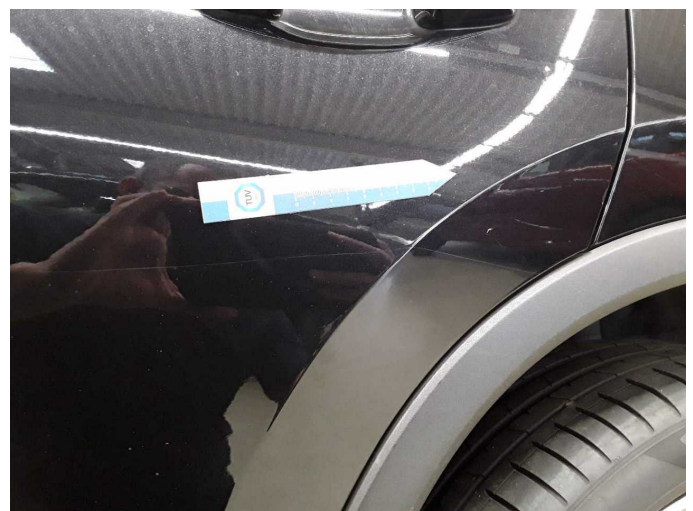
Damage 5: Door - rear left side: Door - Scratched - Repair and paint

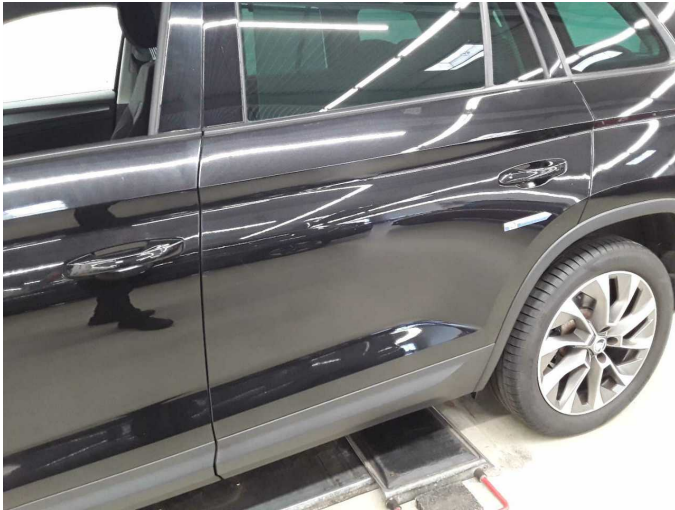
Damage 5: Door - rear left side: Door - Scratched - Repair and paint

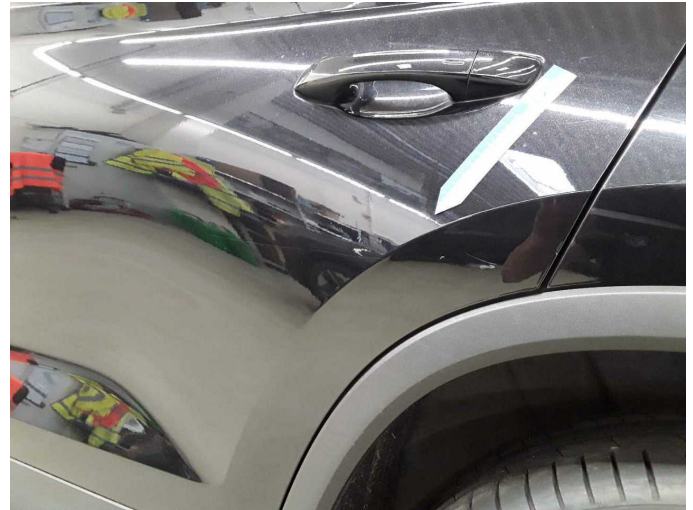
Damage 5: Door - rear left side: Door - Scratched - Repair and paint

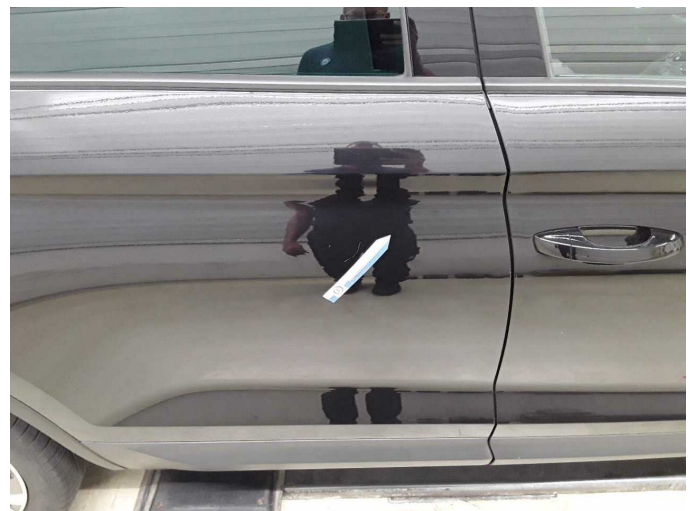
Damage 6: Door - rear right side: Door - Scratch(es) - Repair and paint

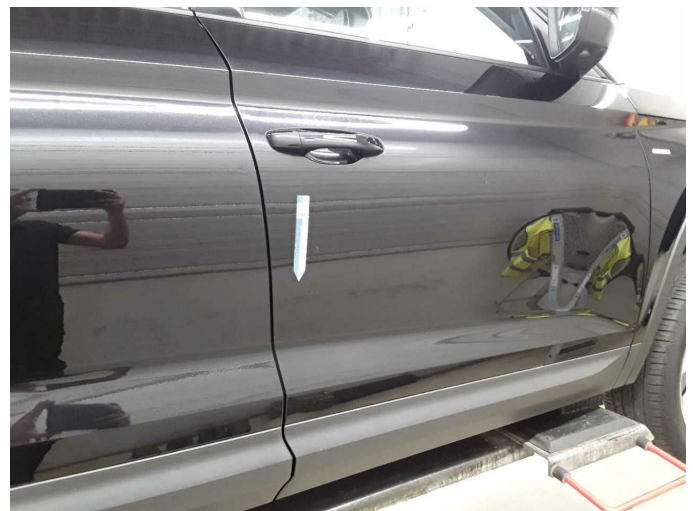
Damage 7: Door - front right side: Door - Scratch(es) - Repair and paint

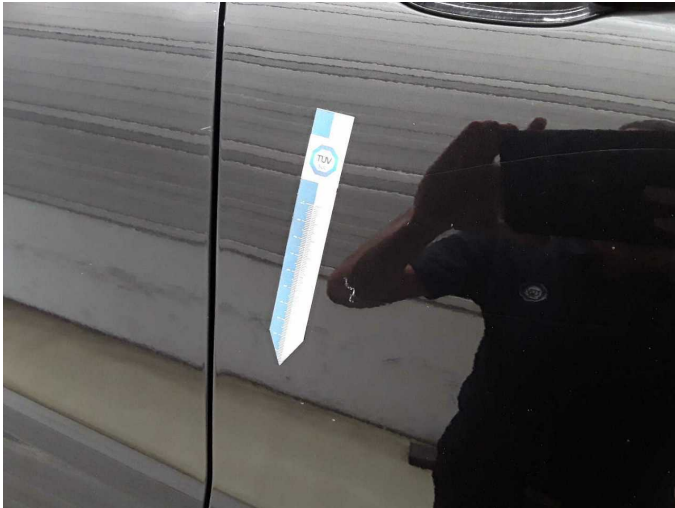
Damage 7: Door - front right side: Door - Scratch(es) - Repair and paint

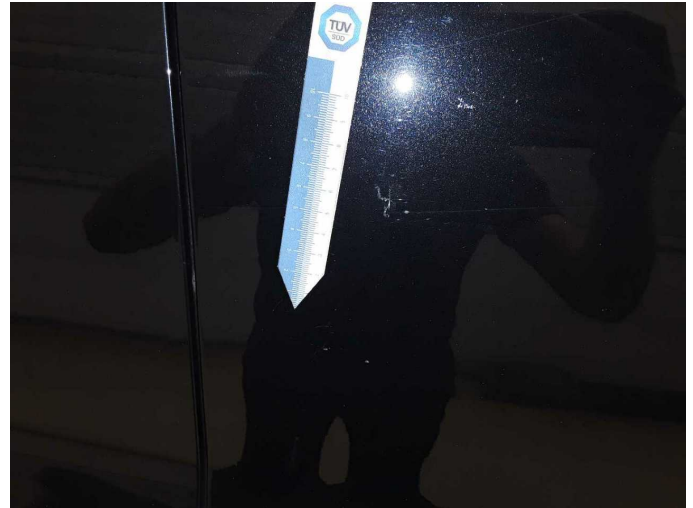
Damage 7: Door - front right side: Door - Scratch(es) - Repair and paint

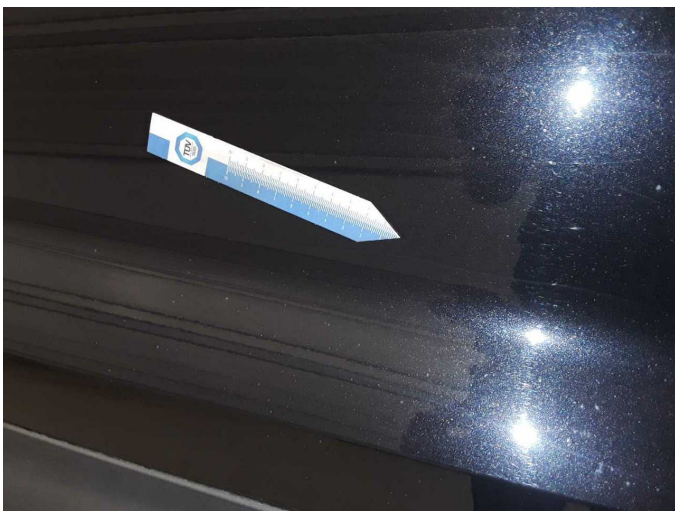
Damage 7: Door - front right side: Door - Scratch(es) - Repair and paint

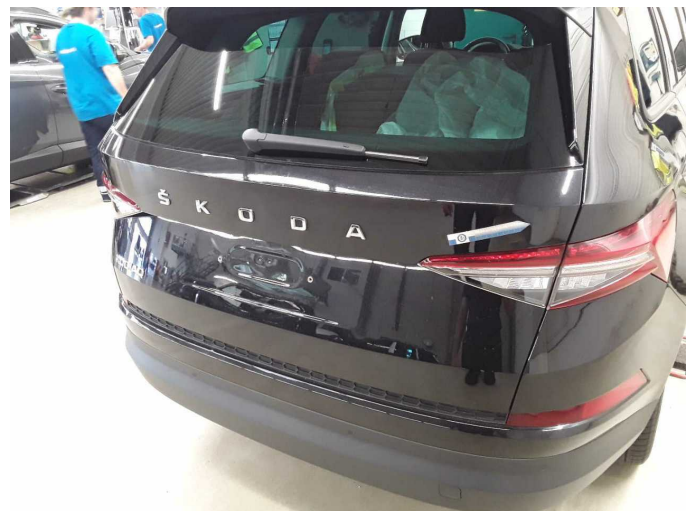
Damage 8: Boot lid / rear door: Boot lid - Dent / paintcoat damage - Repair and paint

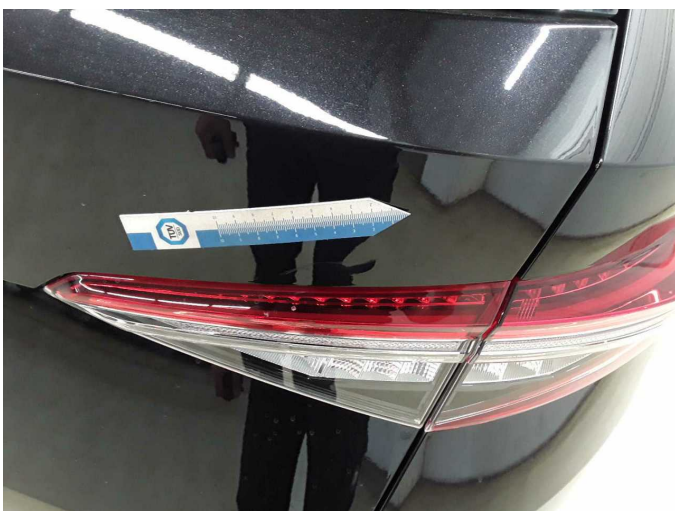
Damage 8: Boot lid / rear door: Boot lid - Dent / paintcoat damage - Repair and paint

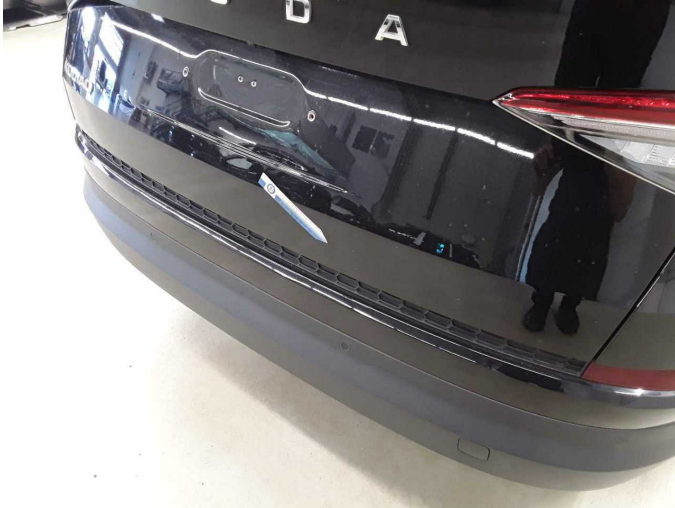
Damage 8: Boot lid / rear door: Boot lid - Dent / paintcoat damage - Repair and paint

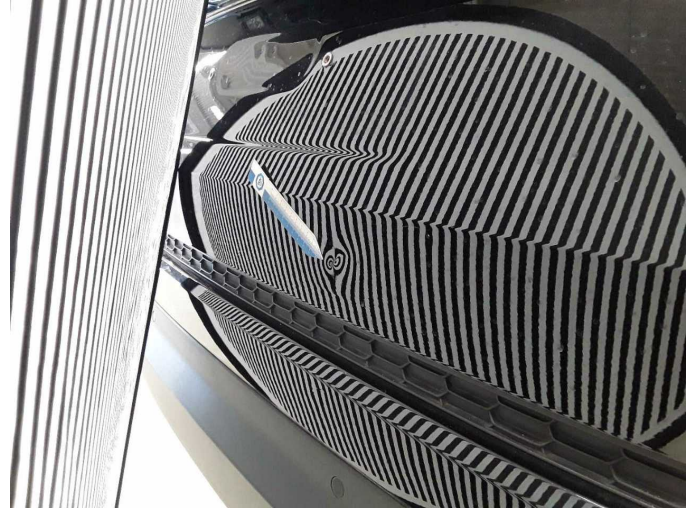
Damage 8: Boot lid / rear door: Boot lid - Dent / paintcoat damage - Repair and paint
