Expertise

Protocol number: 46240428
Order No. / Reference: 26621897
Inspection date: 29 Jun 2026

Manufacturer: Ford

Model: Puma 1.0 EcoBoost Aut. ST-LINE X

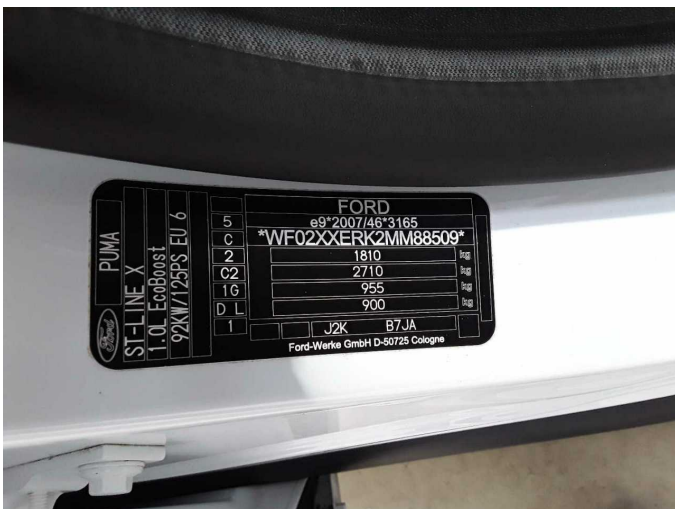
Figure 11: VIN

Documents submitted	At the time of the inspection, the vehicle registration certificate Part 2 (title) was available, but the vehicle registration certificate Part 1 (document) was not. (Copy)
VIN comparison	The vehicle identification number (VIN) was read from the vehicle and its conformity with the submitted documents was confirmed by the undersigned during the inspection.
Inspection	The inspection conditions were sufficient for the assessment of the vehicle. No lifting equipment or pit was available for inspecting the vehicle. Therefore, inspection of the vehicle's underside was only possible to a limited extent.
Test drive	No test drive/shunting maneuver was carried out during the inspection of the vehicle.
Engine function test	An engine test run was performed.
readiness to drive	The vehicle was roadworthy at the time of inspection.

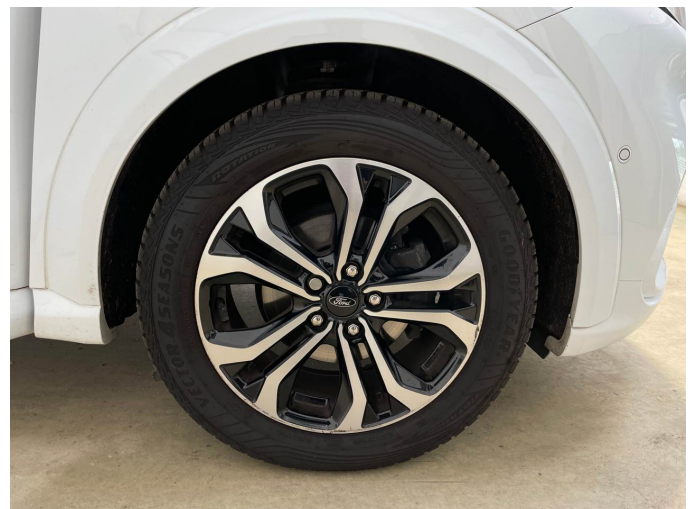
Figure 12: Mounted tyres

#	Tyre size	Type of tyre	Manufacturer	Tread depth
1)	215/55 R17 94V	All-season tyres on Light alloy	Goodyear	7mm / 7mm
2)	215/55 R17 94V	All-season tyres on Light alloy	Goodyear	7mm / 7mm

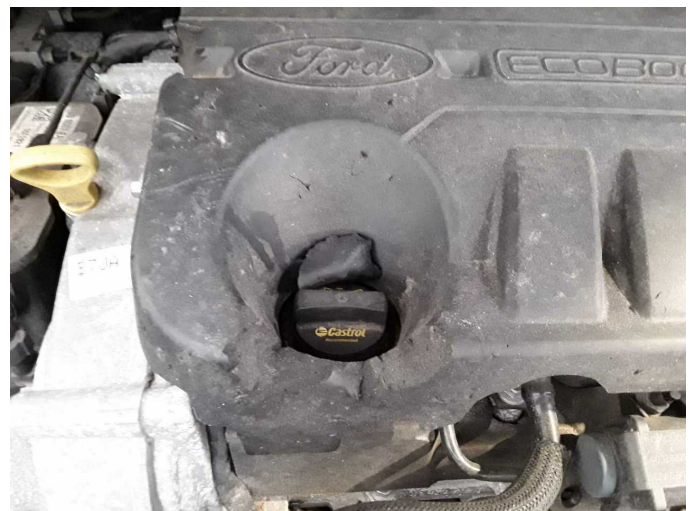
Damage 2: Engine: Engine cover - top / cover - Damage caused by marten / rodent - Replace

No.	Component group	Description
1	Misc.	Main inspection - No evidence - No deduction
2	Engine	Engine cover - top / cover - Damage caused by marten / rodent - Replace
3	Sill - left side	Sill - Scratch(es) - Smart repair
4	Roof	Roof (Lack platz ab) - Paint defect - Repair and paint

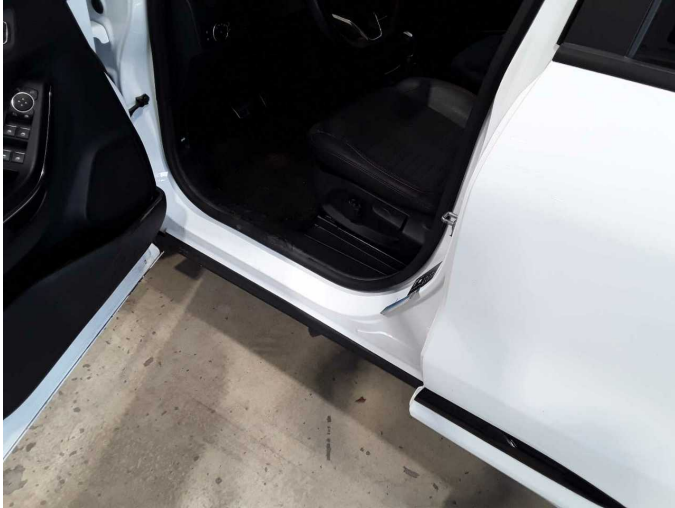
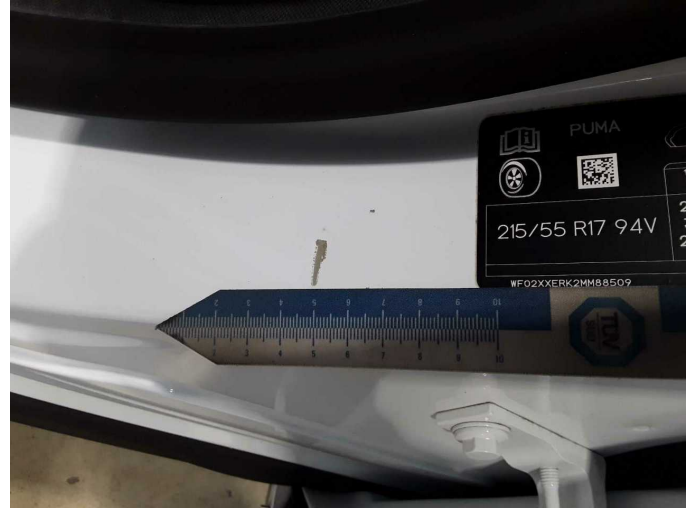
Damage 3: Sill - left side: Sill - Scratch(es) - Smart repair

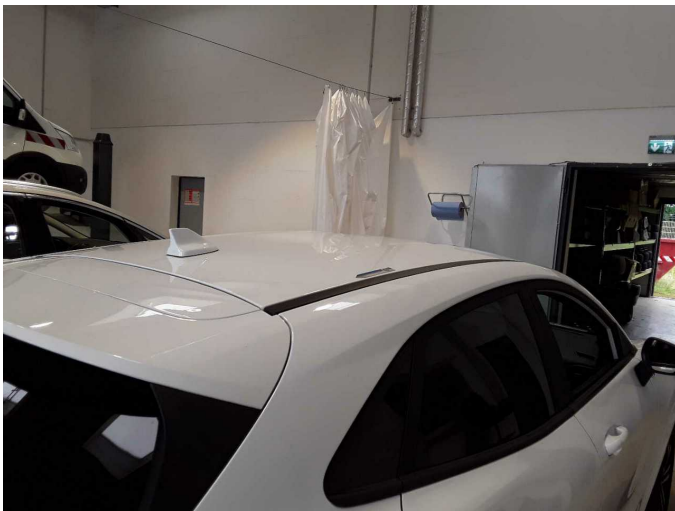
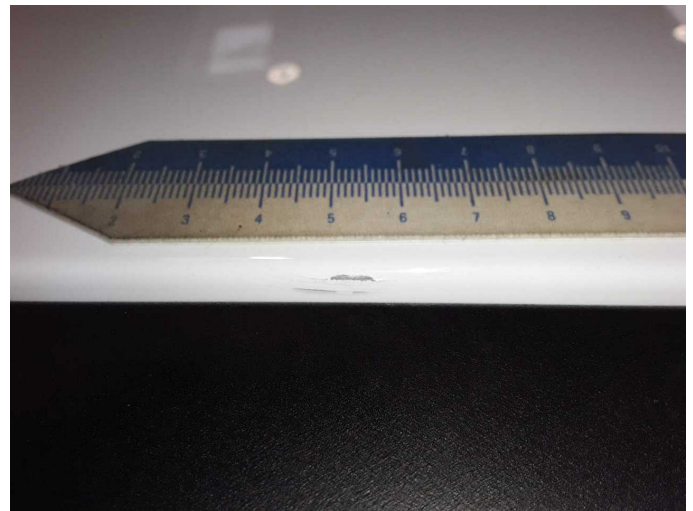
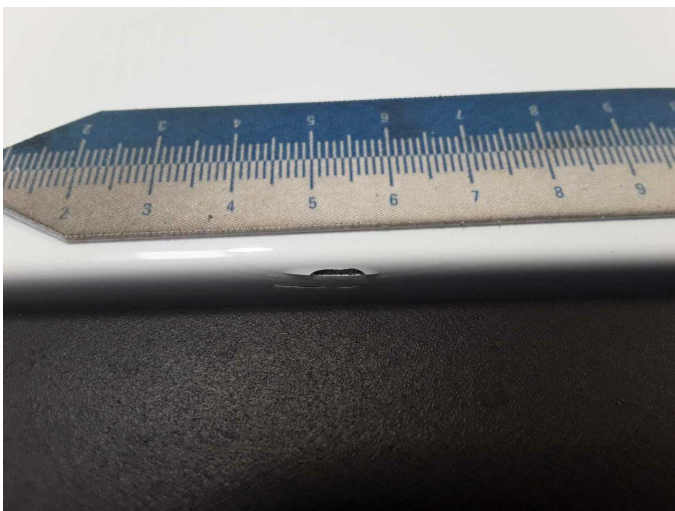
Damage 4: Roof: Roof (Lack platzt ab) - Paint defect - Repair and paint
