Expertise

Protocol number: 46383996  
Order No. / Reference: 26587863  
Inspection date: 8 Jul 2026

Manufacturer: Volvo

Model: XC90 T8 AWD Recharge Ultimate Dark

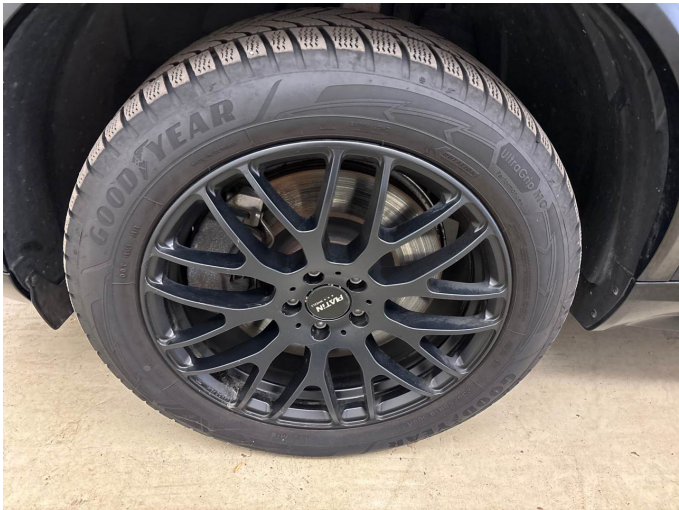
Figure 12: Mounted tyres

| # | Tyre size | Type of tyre | Manufacturer | Tread depth |
|---|---|---|---|---|
| 1) | 235/55 R19 105H | Winter tyres on Light alloy | Goodyear | 5mm / 5mm |
| 2) | 235/55 R19 105H | Winter tyres on Light alloy | Goodyear | 5mm / 5mm |

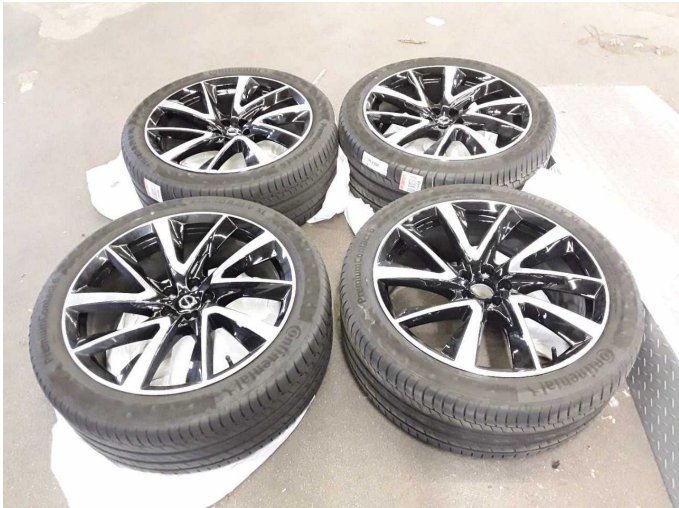
Figure 16: Additional tyres

| # | Tyre size | Type of tyre | Manufacturer | Tread depth |
|---|---|---|---|---|
| 1) | 275/40 R21 107V | Summer tyres on Light alloy | Continental | 3mm / 3mm |
| 2) | 275/40 R21 107V | Summer tyres on Light alloy | Continental | 3mm / 3mm |

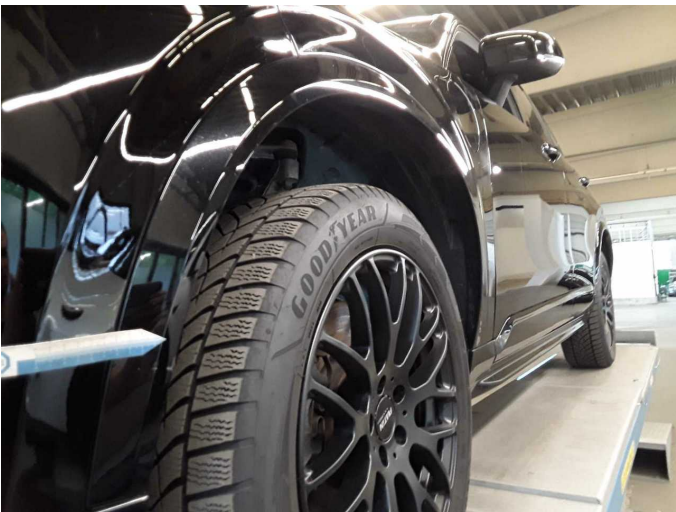
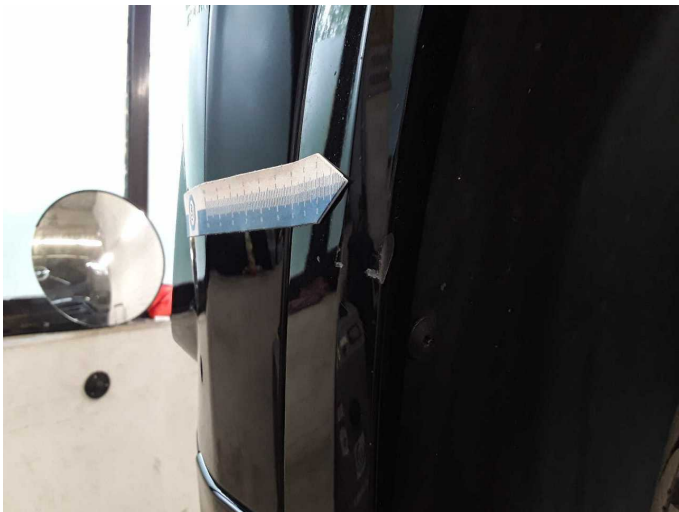
| No. | Component group | Description |
|---|---|---|
| 1 | Mudguard - left side | Wheel arch - Scratch(es) - Smart repair |

Damage 1: Mudguard - left side: Wheel arch - Scratch(es) - Smart repair

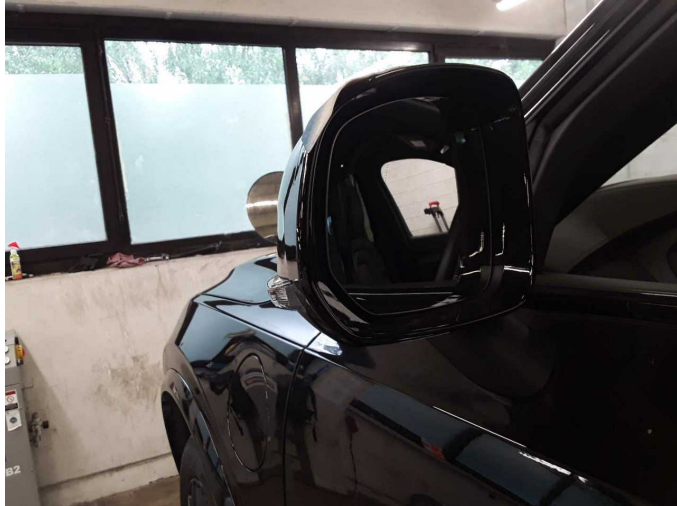
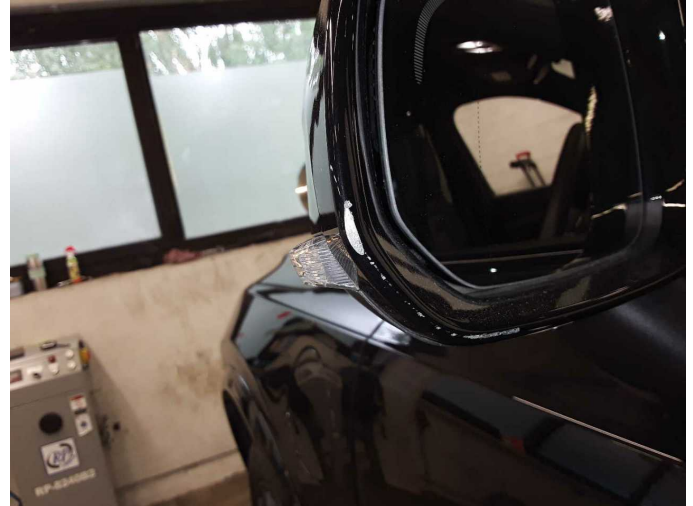
| No. | Component group | Description |
|---|---|---|
| 2 | Wing mirror - left side | Cap - Scratch(es) - Smart repair |

**Damage 2:** Wing mirror - left side: Cap - Scratch(es) - Smart repair

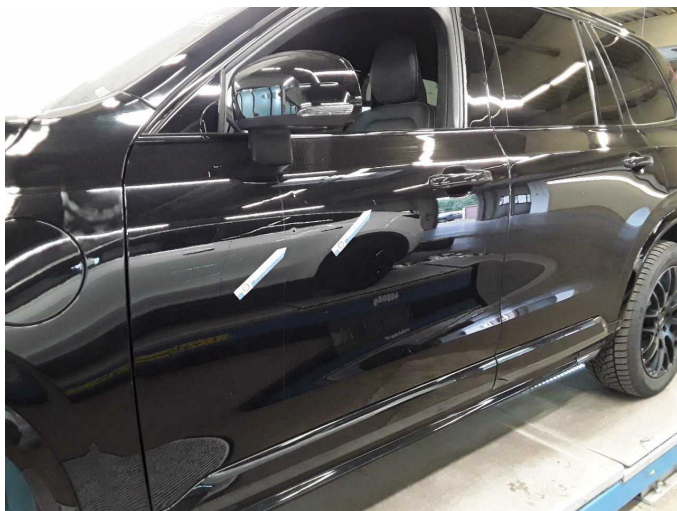
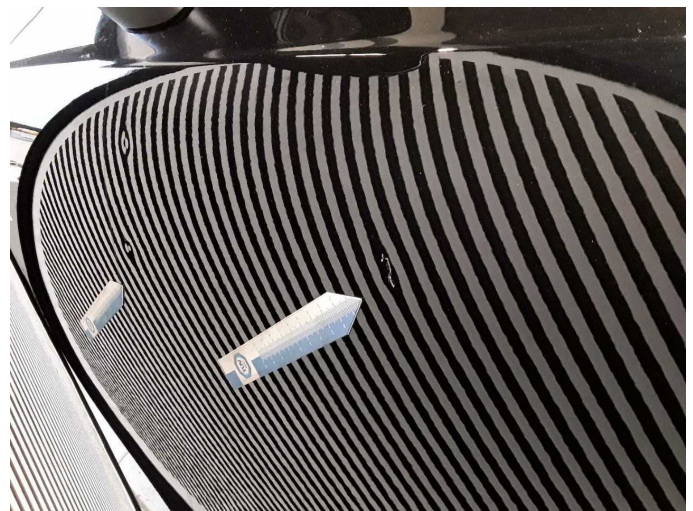
| No. | Component group | Description |
|---|---|---|
| 3 | Door - front left side | Door - Dent / paintcoat damage - Smart repair |

**Damage 3:** Door - front left side: Door - Dent / paintcoat damage - Smart repair

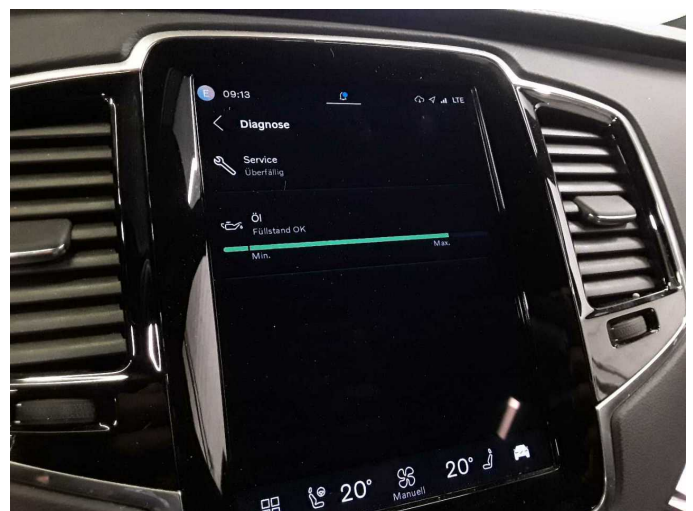
| No. | Component group | Description |
|---|---|---|
| 4 | Misc. | Inspection / maintenance - Due - Perform |

**Damage 4:** Misc.: Inspection / maintenance - Due - Perform
