Expertise

Protocol number: 46550211  
Order No. / Reference: 26631465  
Inspection date: 15 Jul 2026

Manufacturer: Volkswagen

Model: Tiguan 2.0 TDI SCR DSG Elegance

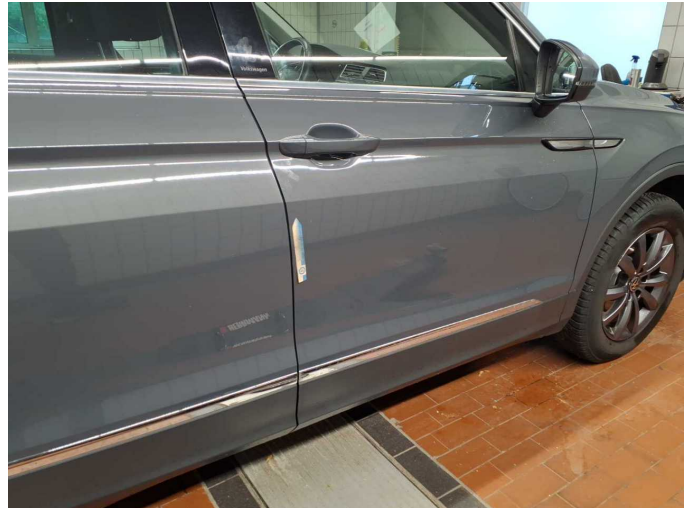
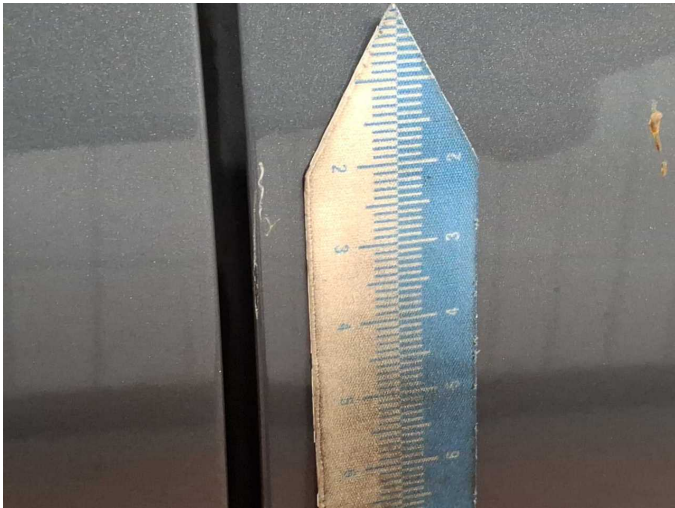
| No. | Component group | Description |
|---|---|---|
| 1 | Door - front right side | Door edge - Scratch(es) - Smart repair |

**Damage 1:** Door - front right side: Door edge - Scratch(es) - Smart repair

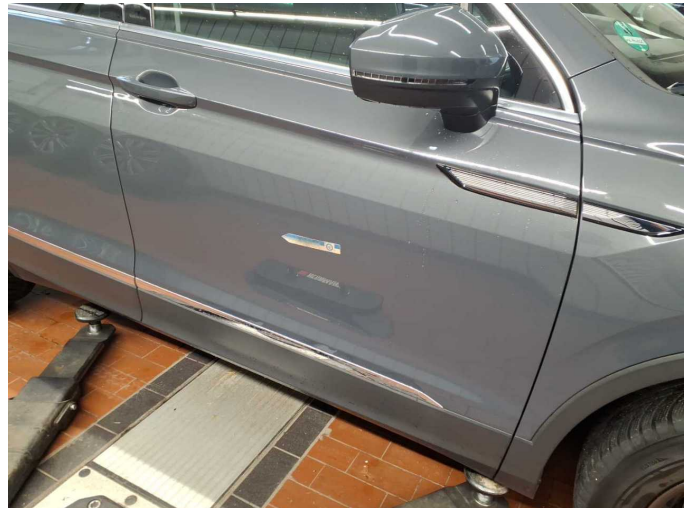
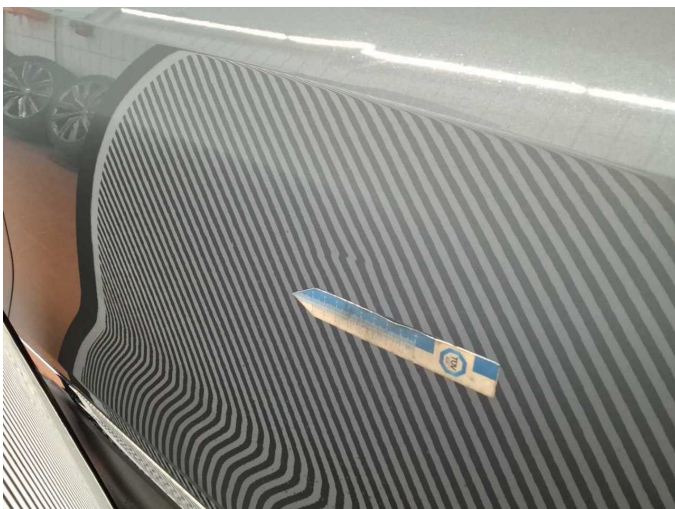
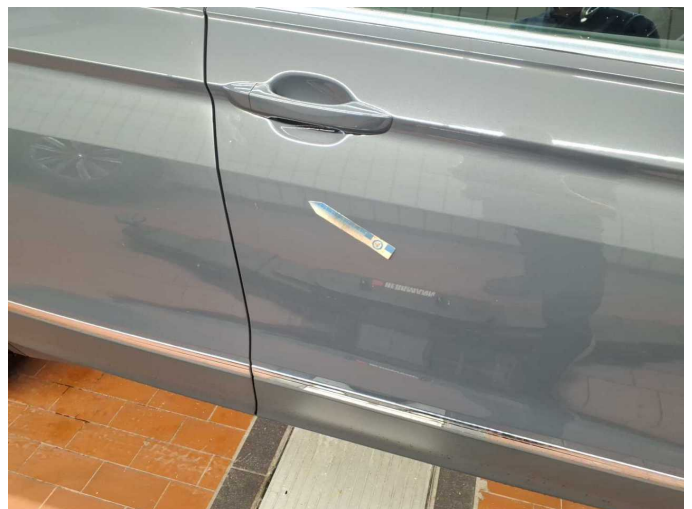
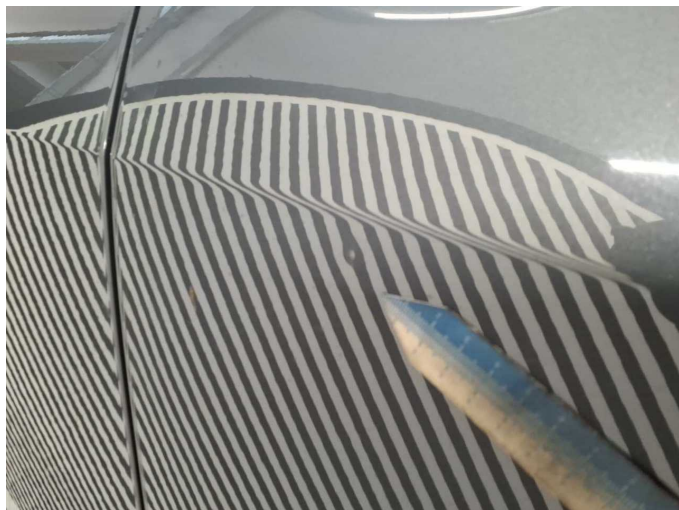
| No. | Component group | Description |
|---|---|---|
| 2 | Door - front right side | Door - dent(s) - Smooth repair work |

**Damage 2:** Door - front right side: Door - dent(s) - Smooth repair work

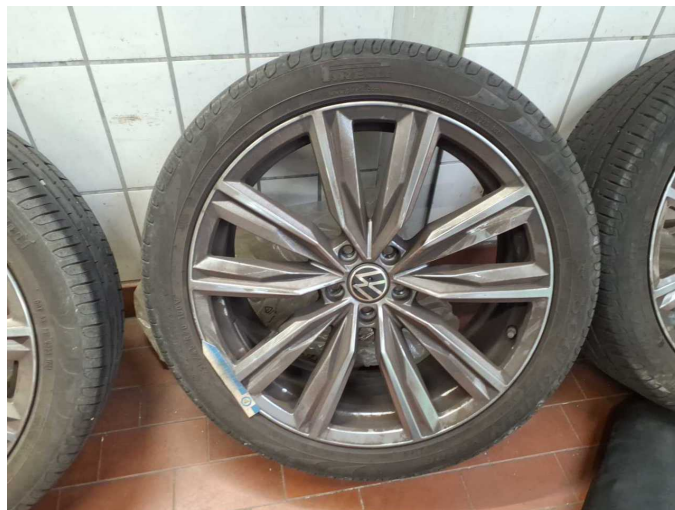
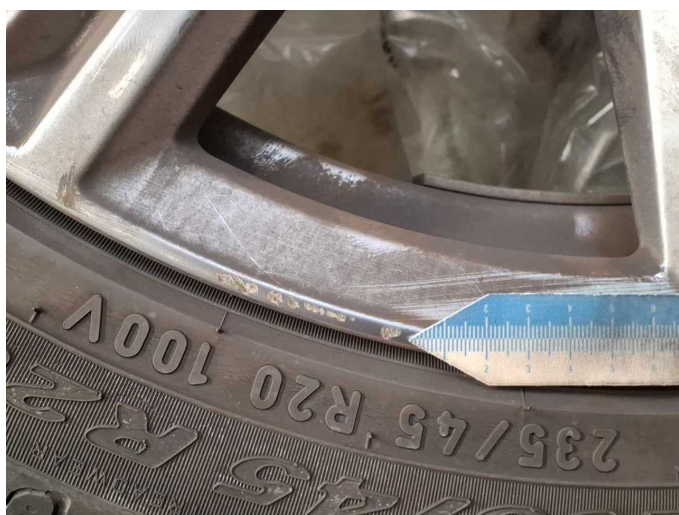
| No. | Component group | Description |
|---|---|---|
| 3 | 2nd wheel set | 1 alloy rim - Scratched - Loss in value |

**Damage 3:** 2nd wheel set: 1 alloy rim - Scratched - Loss in value

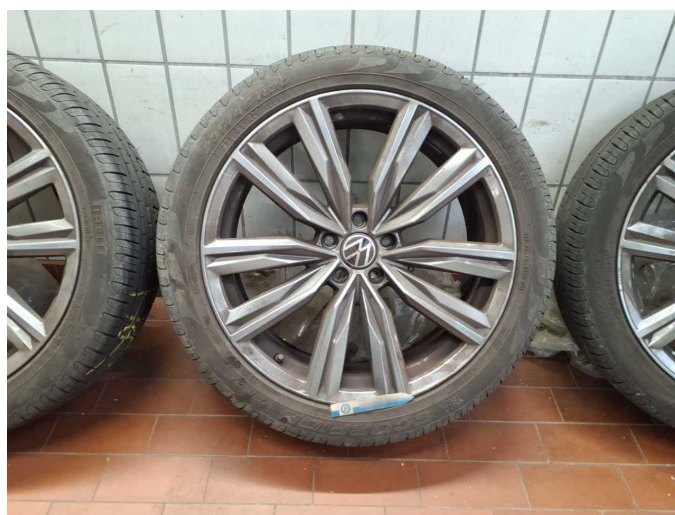
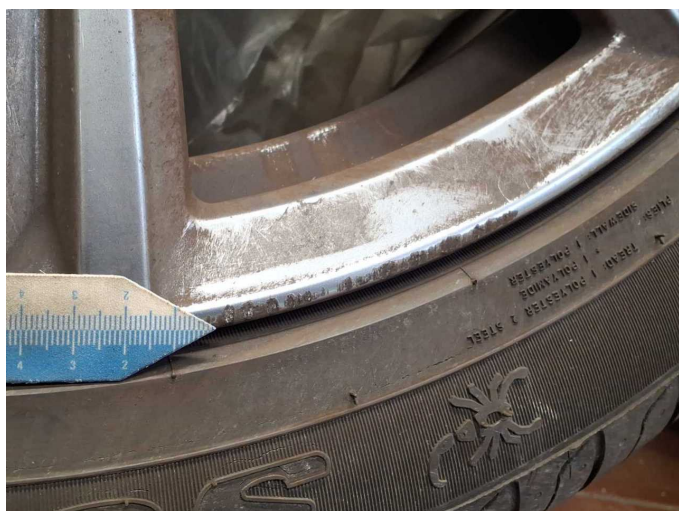
| No. | Component group | Description |
|---|---|---|
| 4 | 2nd wheel set | 1 alloy rim - Scratched - Loss in value |

**Damage 4:** 2nd wheel set: 1 alloy rim - Scratched - Loss in value

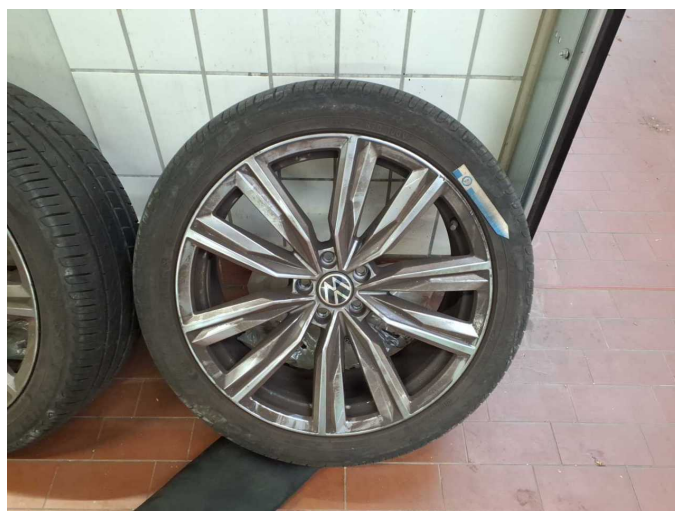
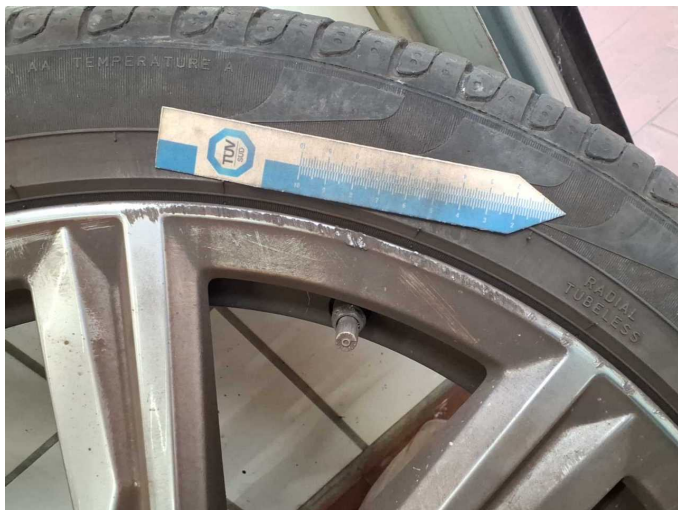
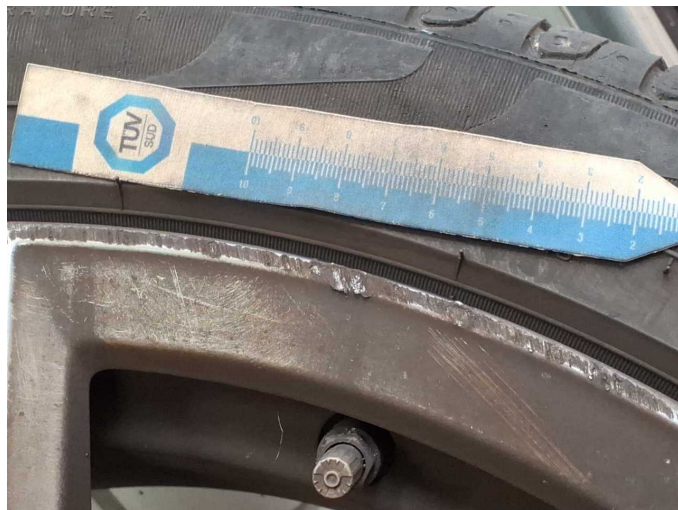
| No. | Component group | Description |
|---|---|---|
| 5 | 2nd wheel set | 1 alloy rim - Scratched - Replace |

**Damage 5:** 2nd wheel set: 1 alloy rim - Scratched - Replace
