Expertise

Protocol number: 47166291  
Order No. / Reference: 26759929  
Inspection date: 20 Aug 2026

Manufacturer: Polestar

Model: 2 Single Motor 82kWh

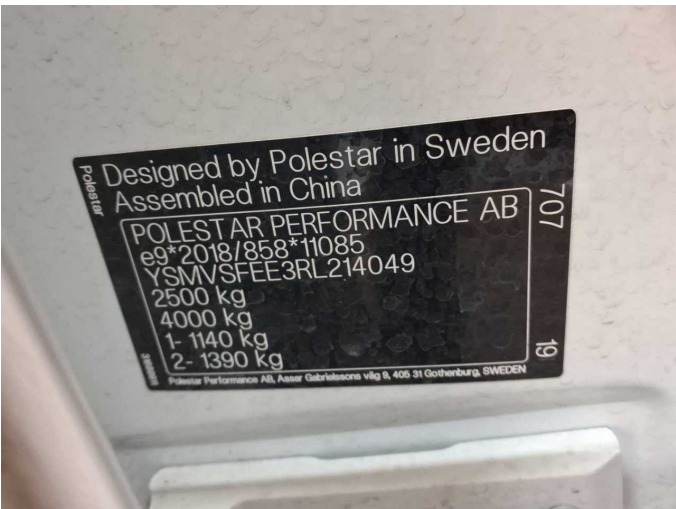
Figure 11: VIN

| VIN comparison | The vehicle identification number (VIN) was read from the vehicle and its conformity with the submitted documents was confirmed by the undersigned during the inspection. |

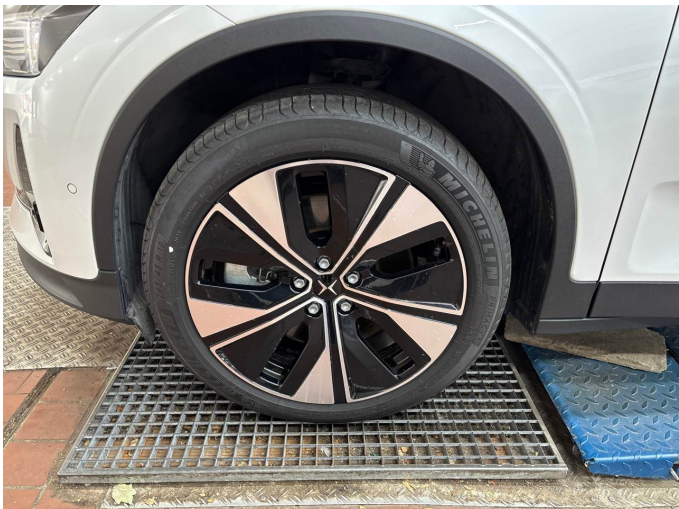
Figure 12: Mounted tyres

| # | Tyre size | Type of tyre | Manufacturer | Tread depth |
|---|---|---|---|---|
| 1) | 245/45 R19 102V | Summer tyres on Light alloy | Michelin | 7mm / 7mm |
| 2) | 245/45 R19 102V | Summer tyres on Light alloy | Michelin | 7mm / 7mm |

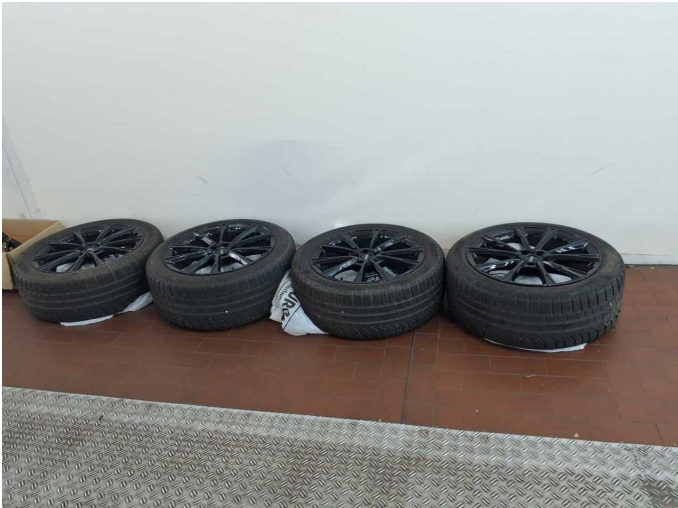
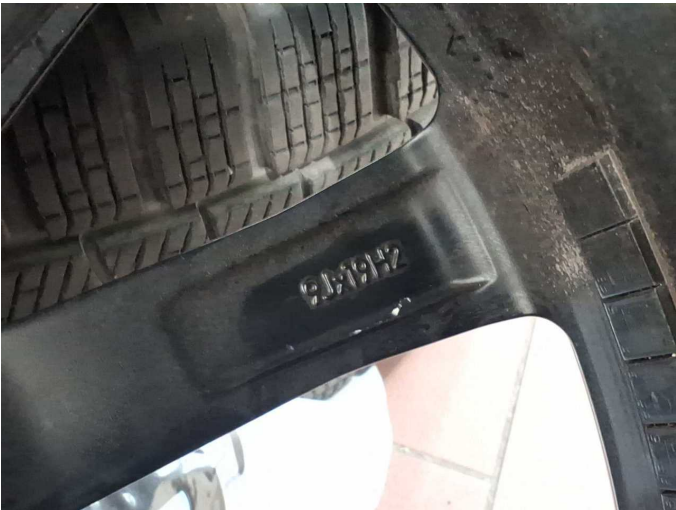
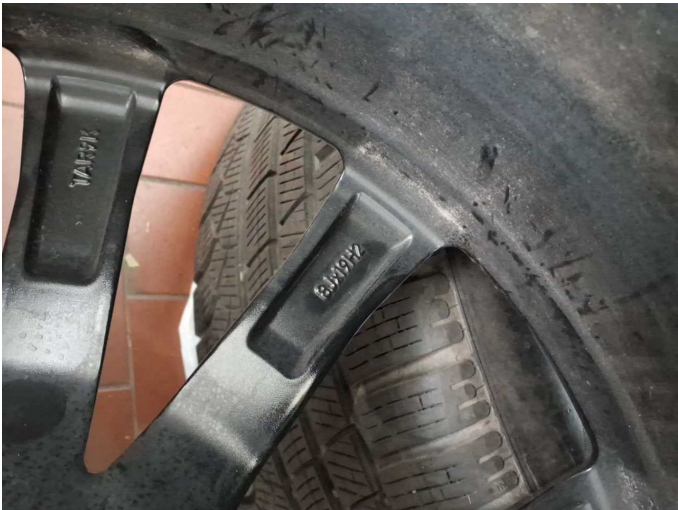
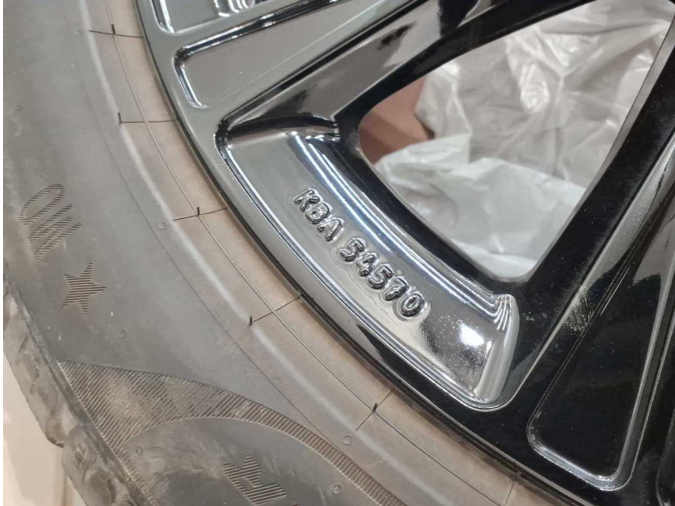
Figure 16: Additional tyres

| # | Tyre size | Type of tyre | Manufacturer | Tread depth |
|---|---|---|---|---|
| 1) | 245/45 R19 102H | Winter tyres on Light alloy | Pirelli | 7mm / 7mm |
| 2) | 245/45 R19 102H | Winter tyres on Light alloy | Pirelli | 7mm / 7mm |

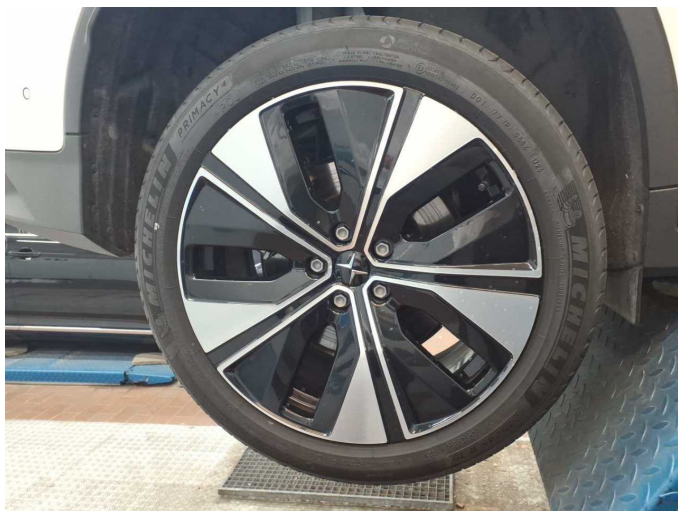
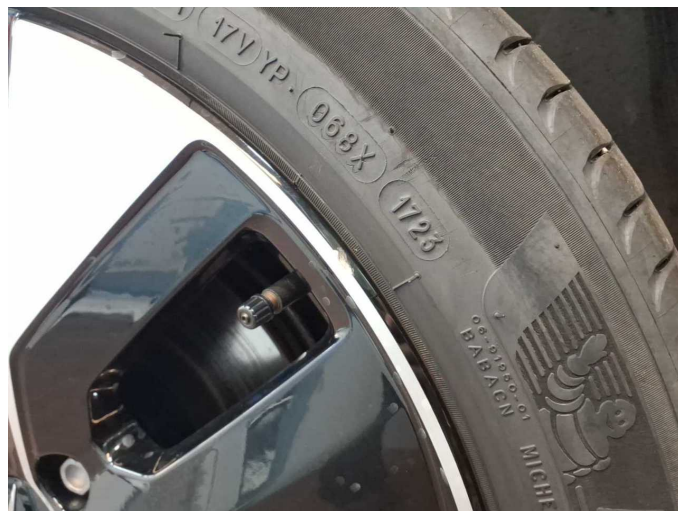
| No. | Component group | Description |
|---|---|---|
| 1 | Wheel / tyres | Alloy rim - rear right side - Scratch(es) - Loss in value |

**Damage 1:** Wheel / tyres: Alloy rim - rear right side - Scratch(es) - Loss in value

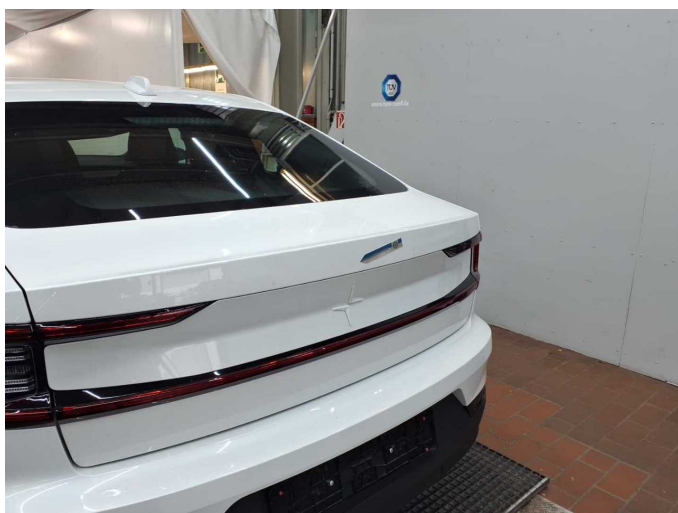
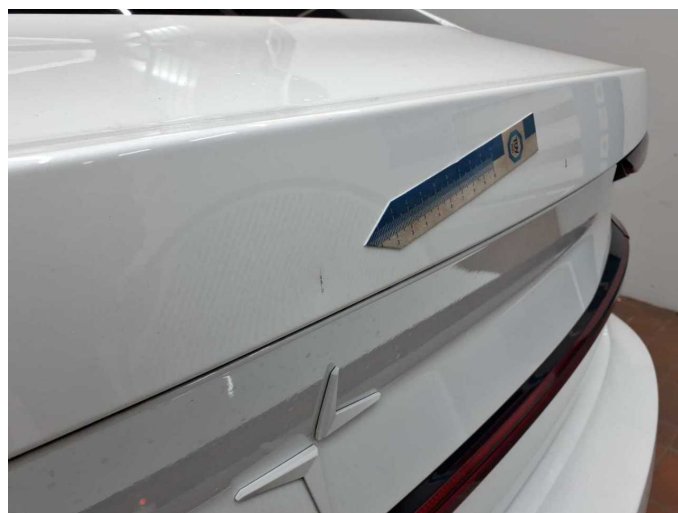
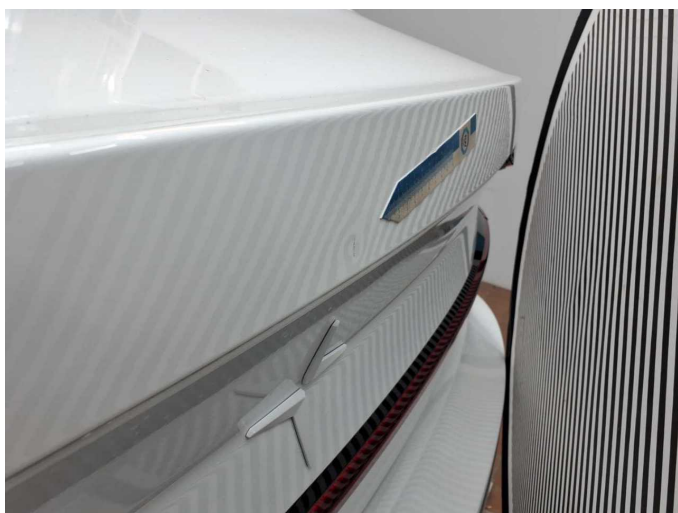
| No. | Component group | Description |
|---|---|---|
| 2 | Boot lid / rear door | Boot lid - Dent / paintcoat damage - Smart repair |

**Damage 2:** Boot lid / rear door: Boot lid - Dent / paintcoat damage - Smart repair
