Expertise

Protocol number: 46353321  
Order No. / Reference: 26397687-1  
Inspection date: 21 May 2026

Manufacturer: Opel

Model: Astra 1.5 D Business Edition

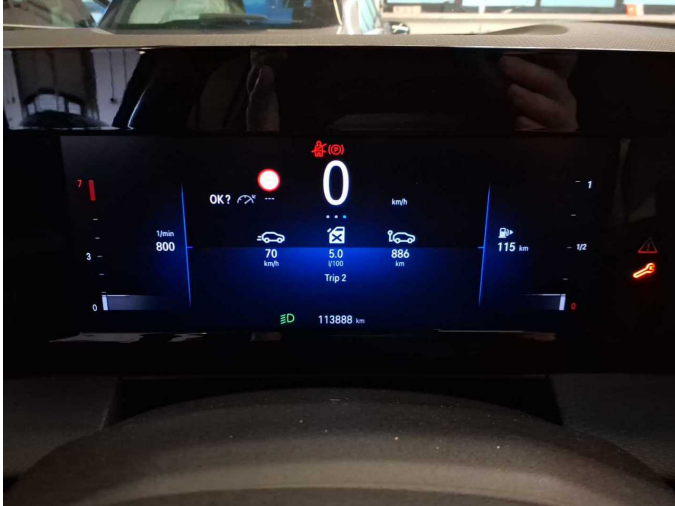
Figure 7: Instrument cluster

Mileage (Read) 113,888 km

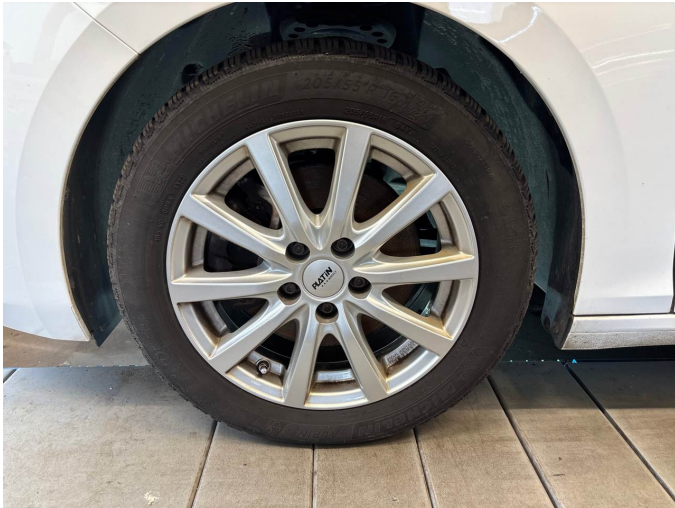
Figure 13: Mounted tyres

| # | Tyre size | Type of tyre | Manufacturer | Tread depth |
|---|---|---|---|---|
| 1) | 205/55 R16 94V | Winter tyres on Light alloy | Michelin | 5mm / 5mm |
| 2) | 205/55 R16 94V | Winter tyres on Light alloy | Michelin | 5mm / 5mm |

Der montierte Winterradsatz ist kein Bestandteil der Ausstattung.

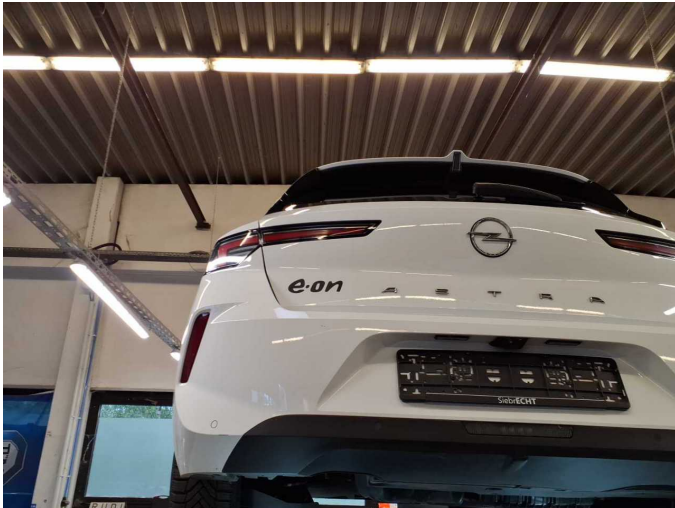
| No. | Component group | Description |
|---|---|---|
| 1 | Boot lid / rear door | Boot lid - Glued / labelled - De-glue / neutralise |

**Damage 1:** Boot lid / rear door: Boot lid - Glued / labelled - De-glue / neutralise

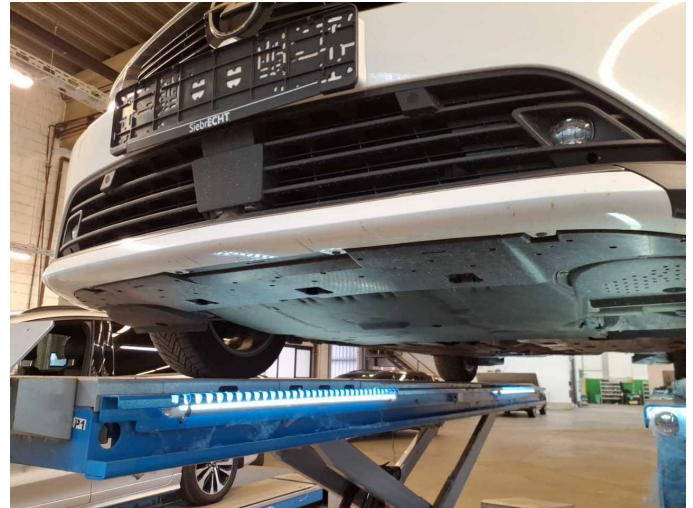
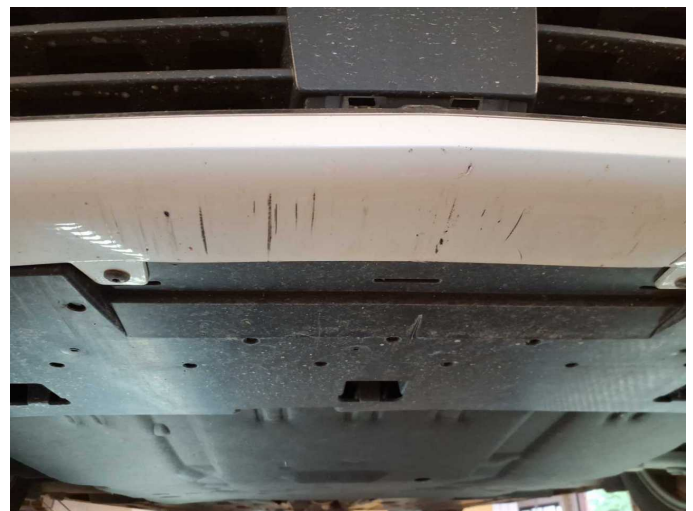
| No. | Component group | Description |
|---|---|---|
| 2 | Front bumper | Front bumper - Scratch(es) - Smart repair |

**Damage 2:** Front bumper: Front bumper - Scratch(es) - Smart repair

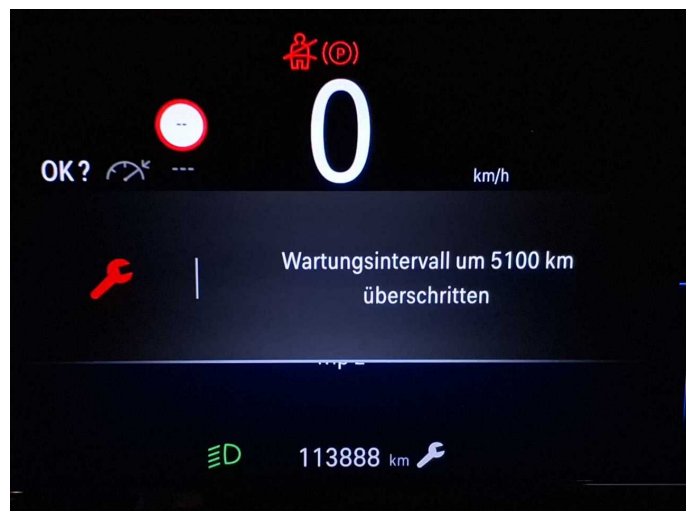
| No. | Component group | Description |
|---|---|---|
| 3 | Misc. | Inspection / maintenance - Due - Perform |

**Damage 3:** Misc.: Inspection / maintenance - Due - Perform

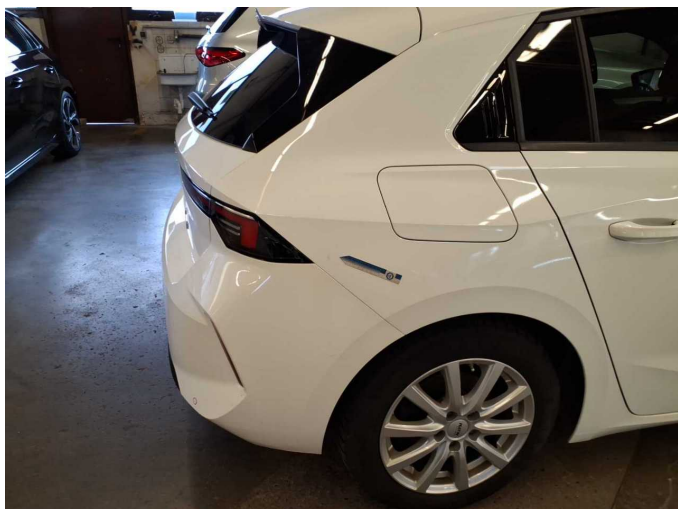
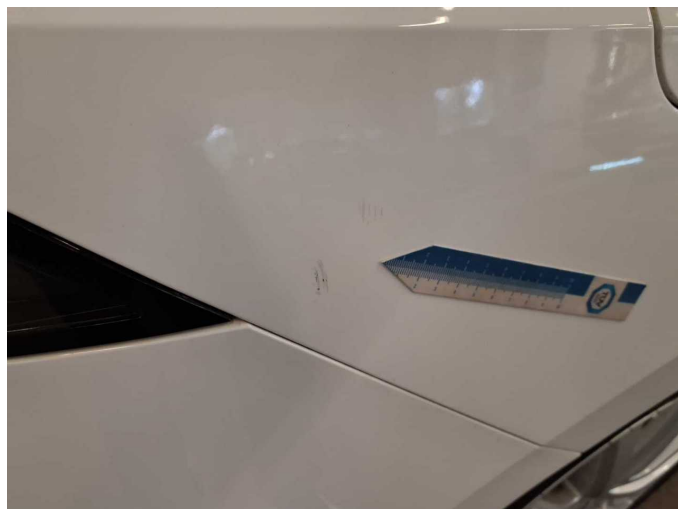
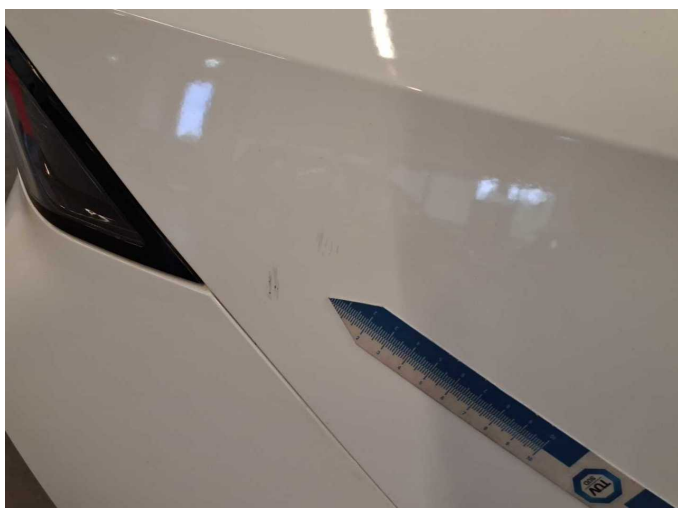
| No. | Component group | Description |
|---|---|---|
| 4 | Side panel - rear right side | Side panel - Scratch(es) - Paint |

**Damage 4:** Side panel - rear right side: Side panel - Scratch(es) - Paint

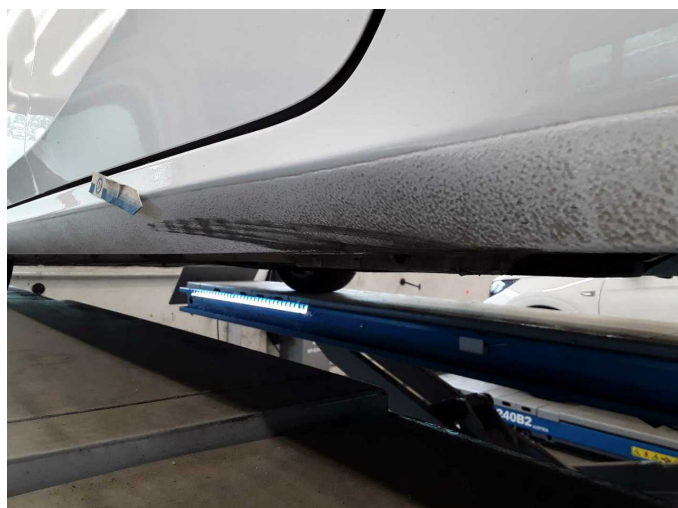
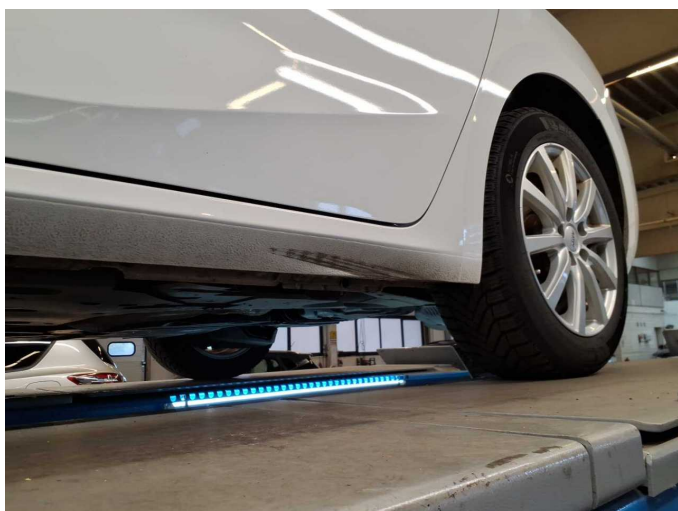
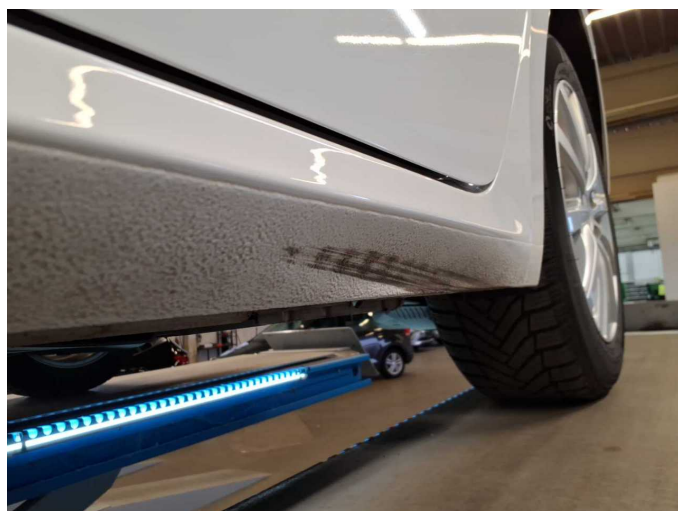
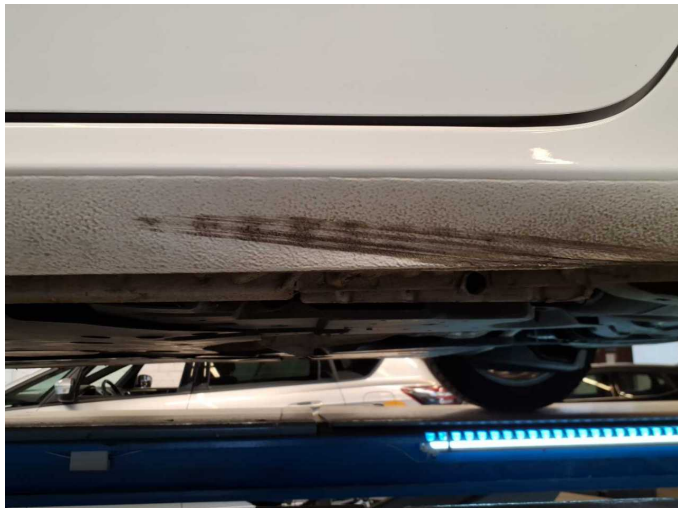
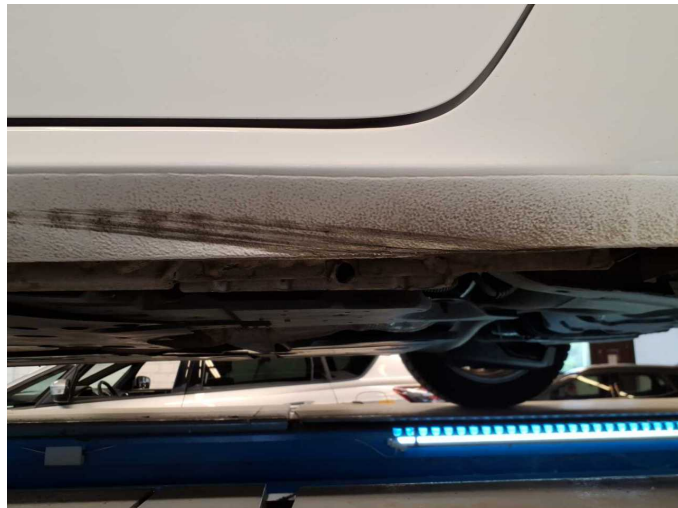
| No. | Component group | Description |
|---|---|---|
| 5 | Sill - left side | Sill - Damaged - Paint |

**Damage 5:** Sill - left side: Sill - Damaged - Paint

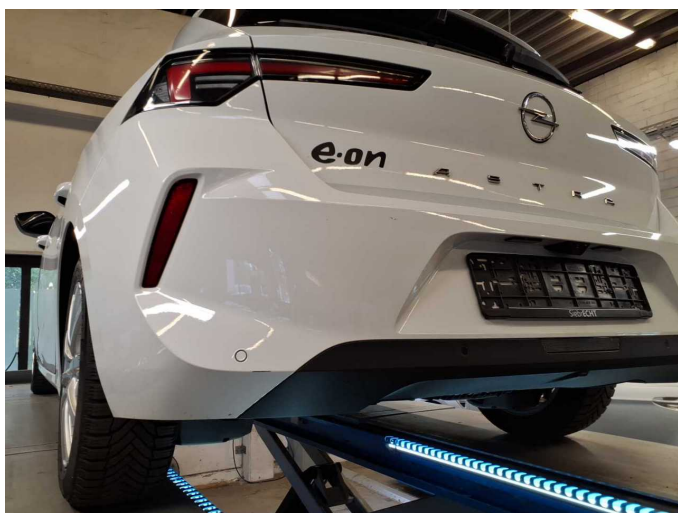
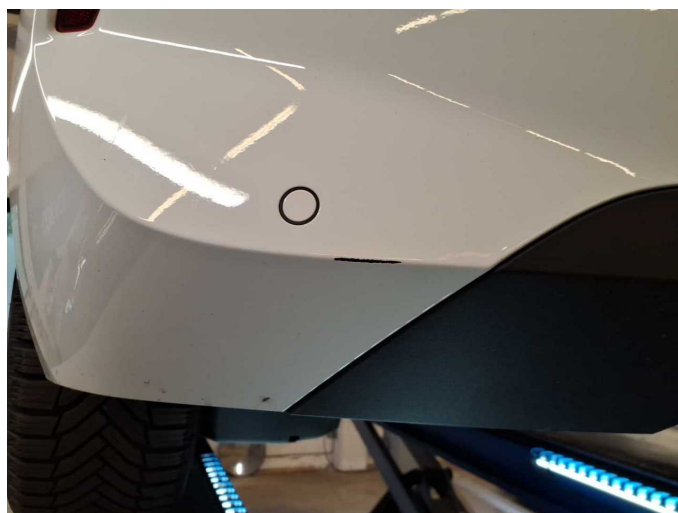
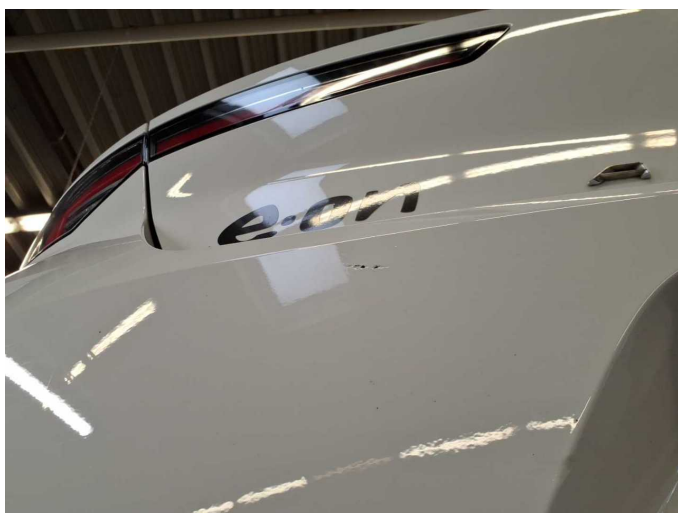
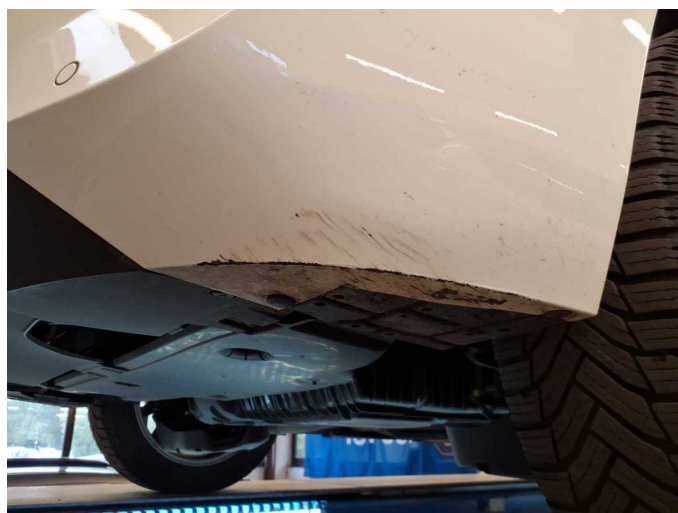
| No. | Component group | Description |
|---|---|---|
| 6 | Rear bumper | Rear bumper - Scratch(es) - Paint |

**Damage 6:** Rear bumper: Rear bumper - Scratch(es) - Paint
