Expertise

Protocol number: 46154228  
Order No. / Reference: 26554776  
Inspection date: 25 Jun 2026

Manufacturer: Volkswagen

Model: Touran 2.0 TDI SCR Comfortline

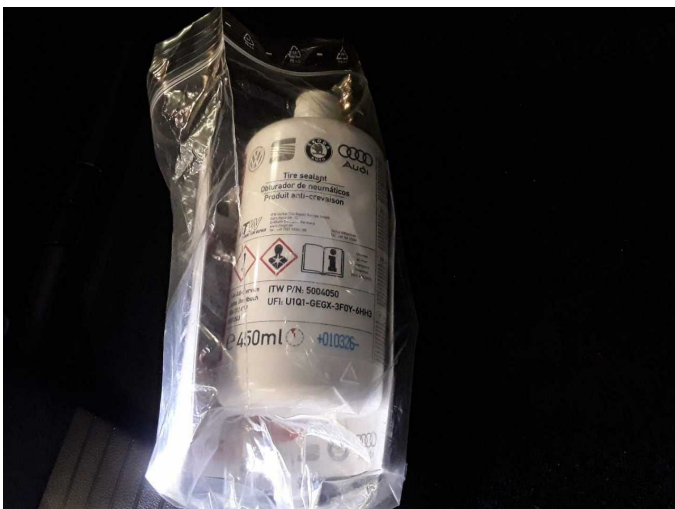
**Damage 1:** Equipment: Tirefit filler - Expired - Replace

| No. | Component group | Description |
|---|---|---|
| 1 | Equipment | Tirefit filler - Expired - Replace |

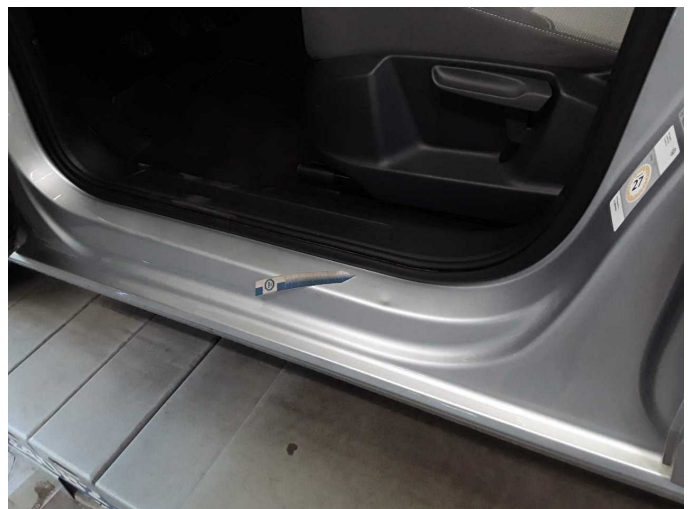
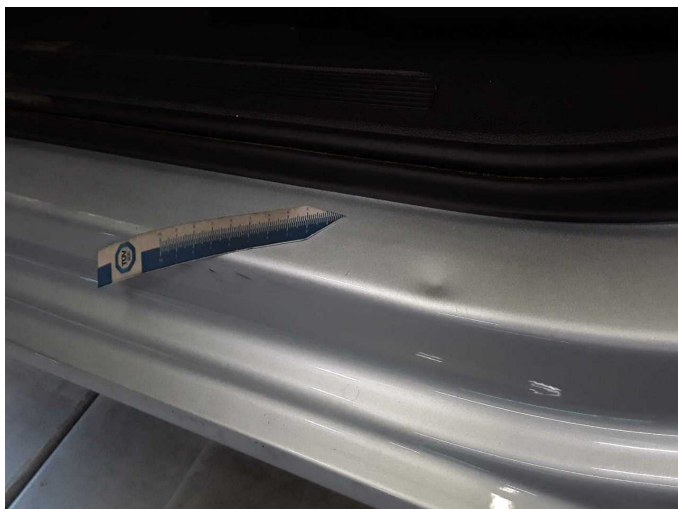
**Damage 2:** Sill - left side: Sill - dent(s) - Smart repair

| No. | Component group | Description |
|---|---|---|
| 2 | Sill - left side | Sill - dent(s) - Smart repair |

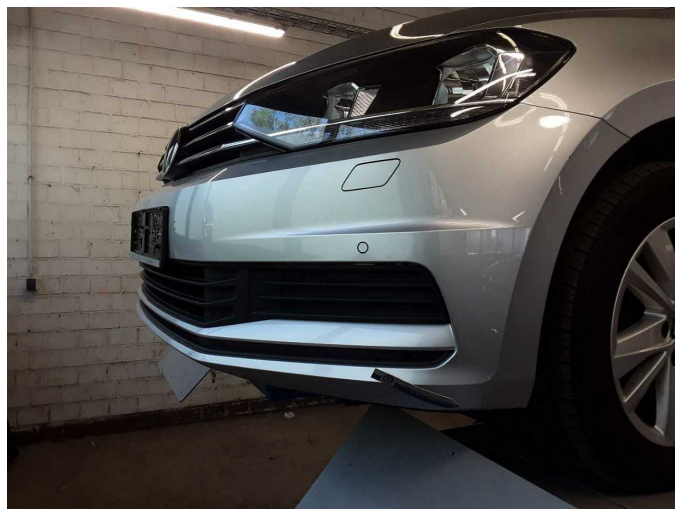
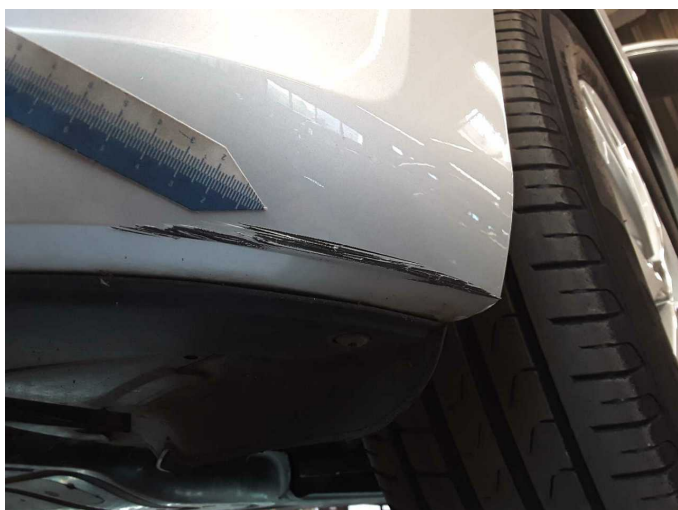
**Damage 3:** Front bumper: Front bumper - Scratch(es) - Smart repair

| No. | Component group | Description |
|---|---|---|
| 3 | Front bumper | Front bumper - Scratch(es) - Smart repair |

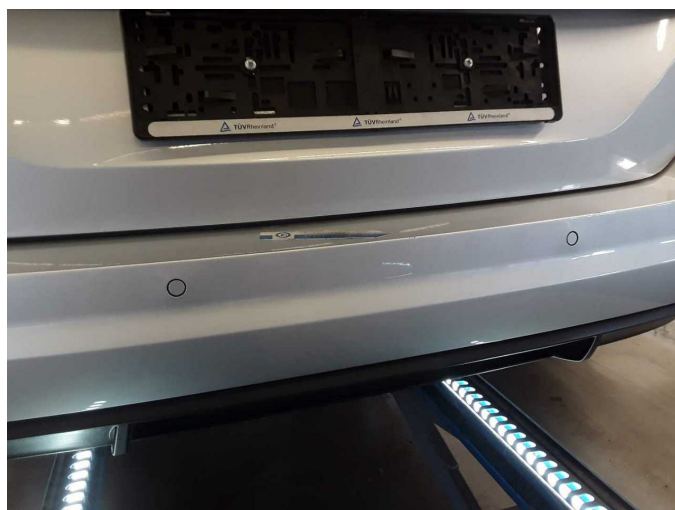
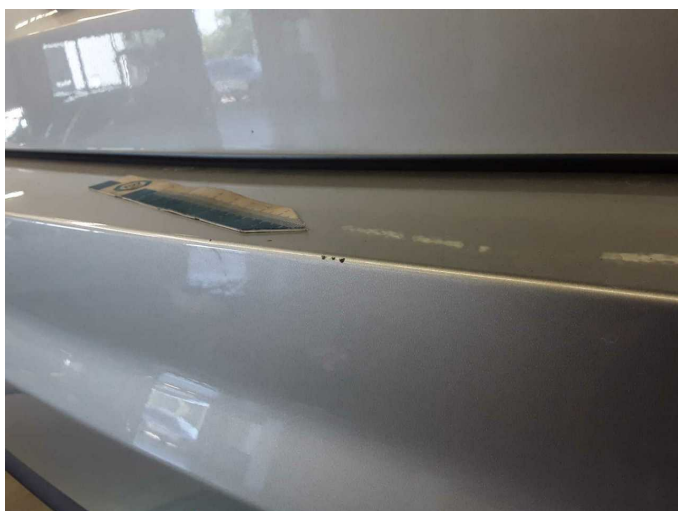
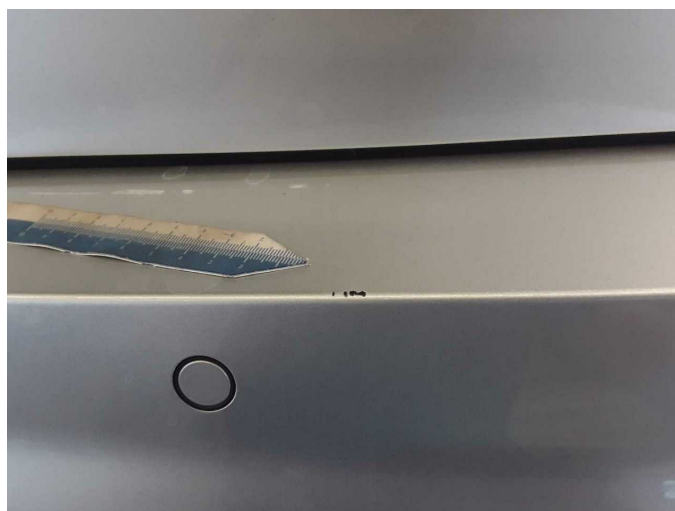
**Damage 4:** Rear bumper: Rear bumper - Scratch(es) - Smart repair

| No. | Component group | Description |
|---|---|---|
| 4 | Rear bumper | Rear bumper - Scratch(es) - Smart repair |

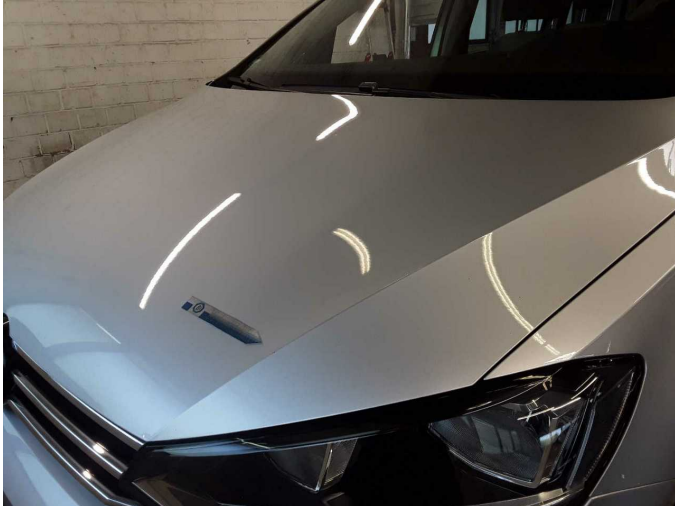
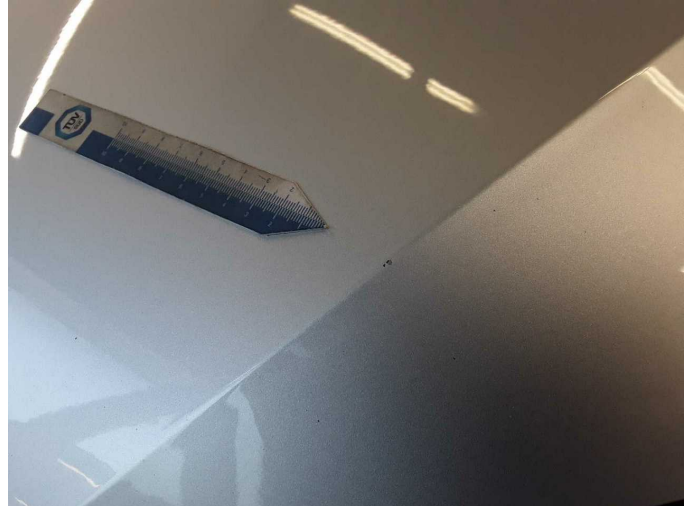
| No. | Component group | Description |
|---|---|---|
| 1 | Bonnet | Bonnet - Stone chips - No deduction |

**Wear and tear 1:** Bonnet: Bonnet - Stone chips - No deduction

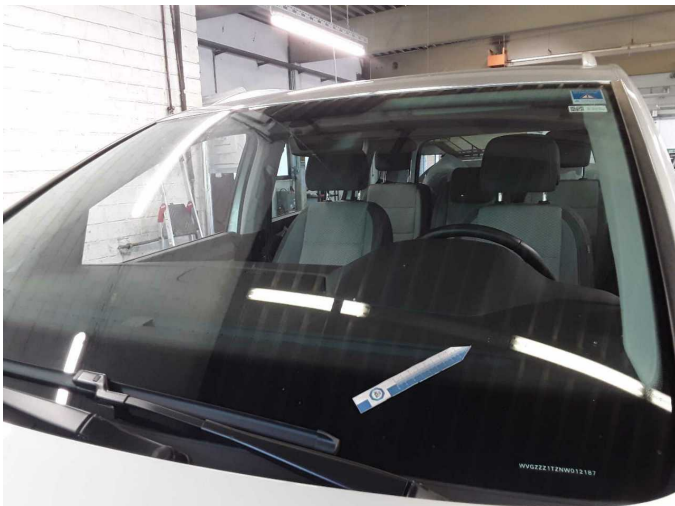
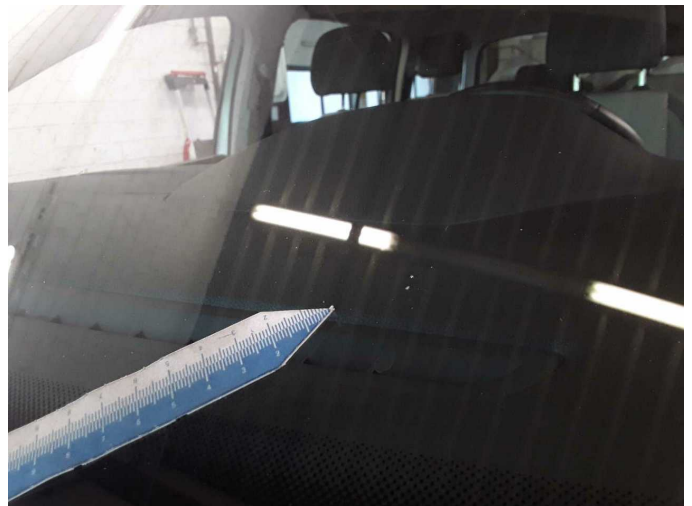
| No. | Component group | Description |
|---|---|---|
| 2 | Vehicle glazing | Windscreen - Stone chips - No deduction |

**Wear and tear 2:** Vehicle glazing: Windscreen - Stone chips - No deduction

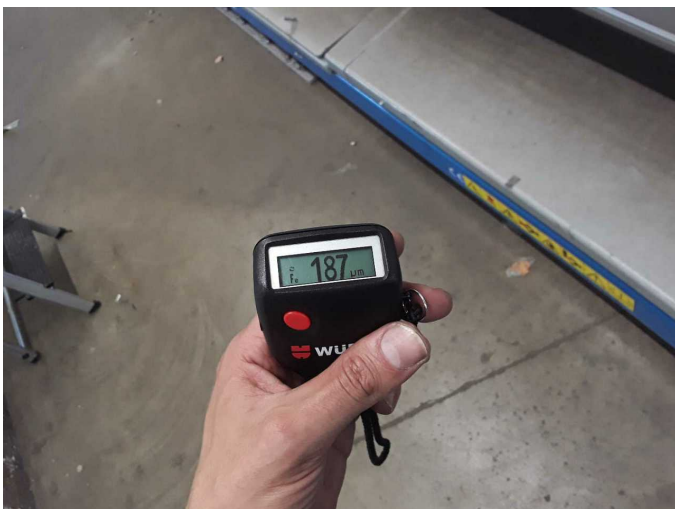
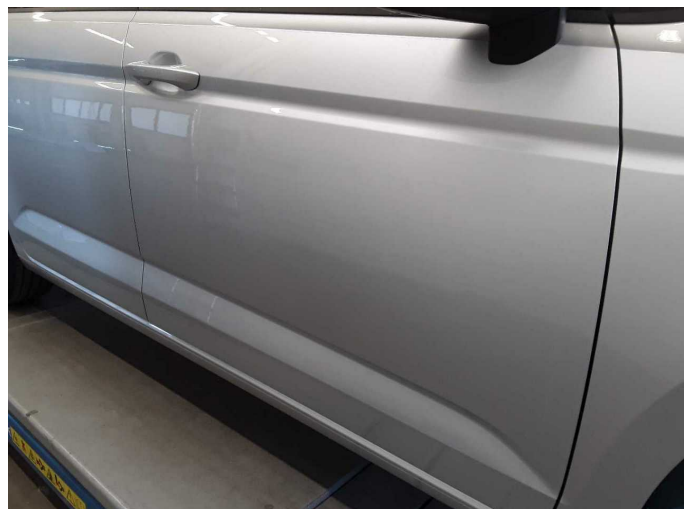
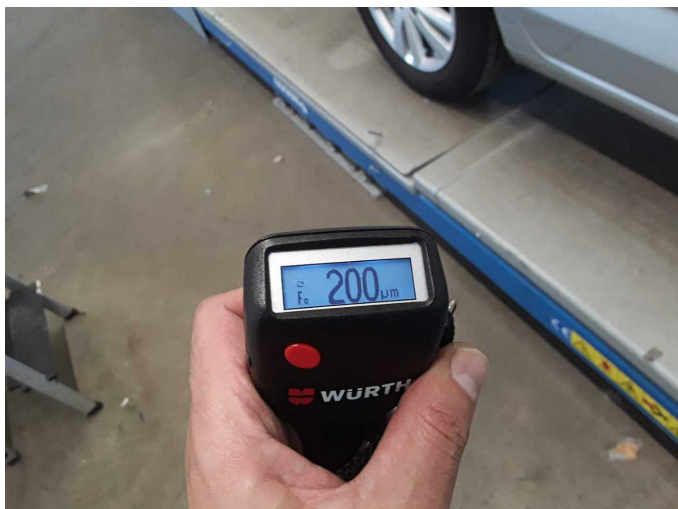
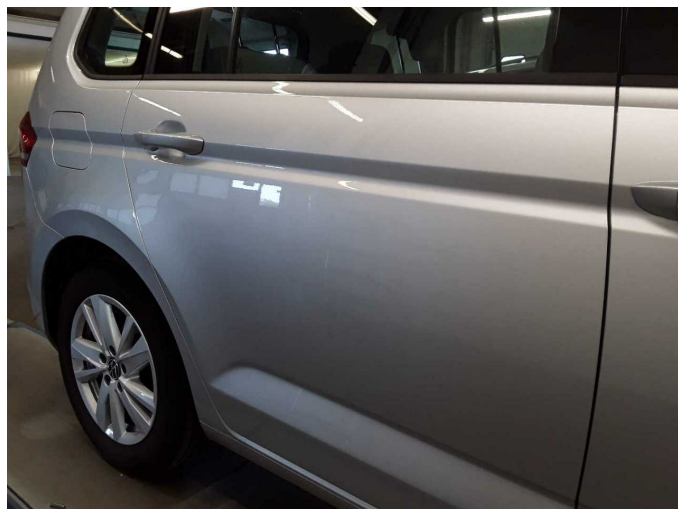
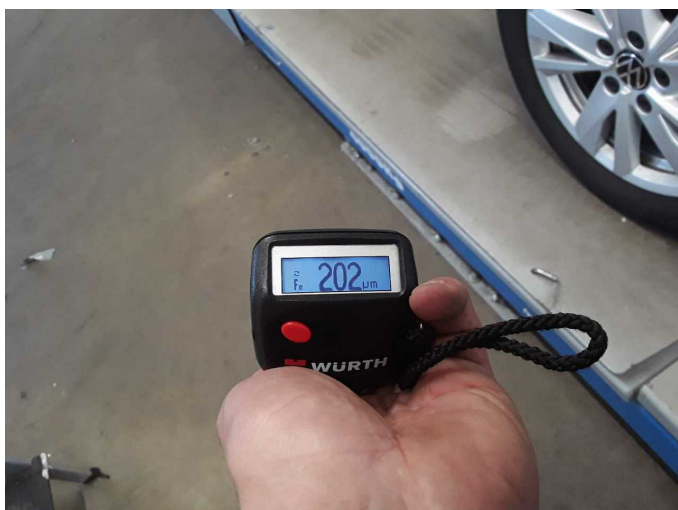
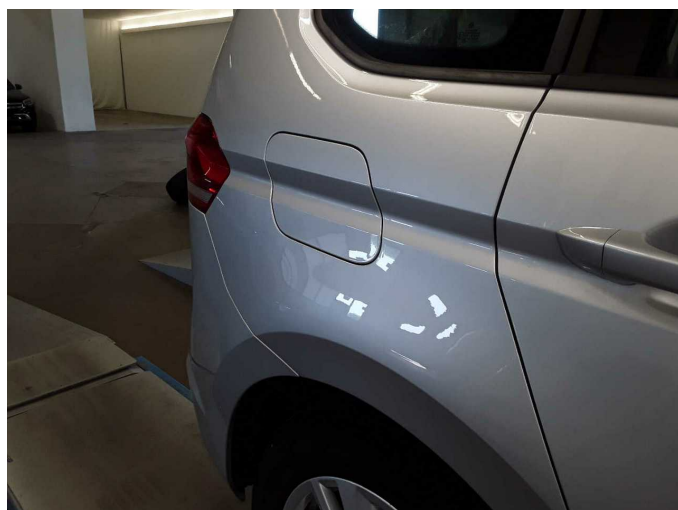
| No. | Repainting |
|---|---|
| 1 | Side panel - rear right side, Door - rear right side, Door - front right side, Professionally carried out, Invoice of repair done |

| Side panel - rear right side | 202 µm | Door - rear right side | 200 µm |
| Door - front right side | 187 µm | | |

**Repainting 1:** Side panel - rear right side, Door - rear right side, Door - front right side
