Expertise

Protocol number: 46657010  
Order No. / Reference: 26649800  
Inspection date: 22 Jul 2026

Manufacturer: Mercedes-Benz

Model: C 220 d 4Matic T 9G-TRONIC AMG Line

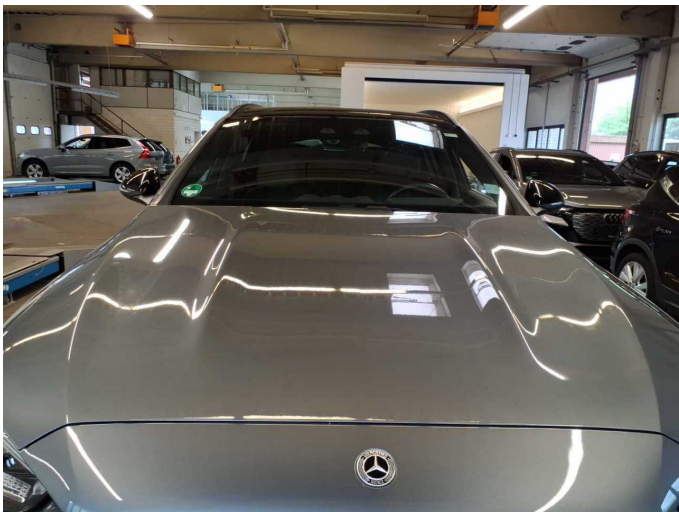
| No. | Component group | Description |
|---|---|---|
| 1 | Bonnet | Bonnet - dent(s) - Smooth repair work |

Damage 1: Bonnet: Bonnet - dent(s) - Smooth repair work

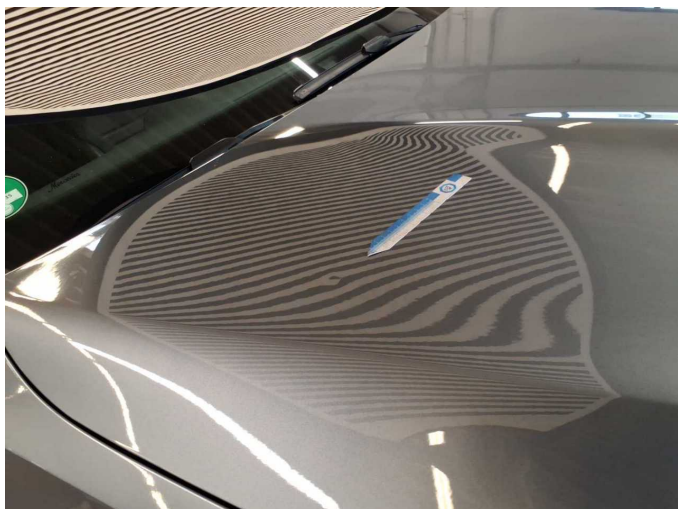
**Damage 1:** Bonnet: Bonnet - dent(s) - Smooth repair work

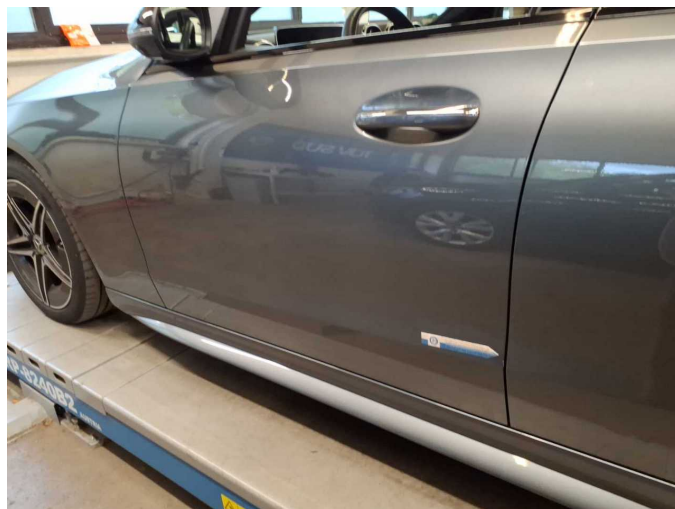
| No. | Component group | Description |
|---|---|---|
| 2 | Door - front left side | Door edge - Scratched - Smart repair |

**Damage 2:** Door - front left side: Door edge - Scratched - Smart repair

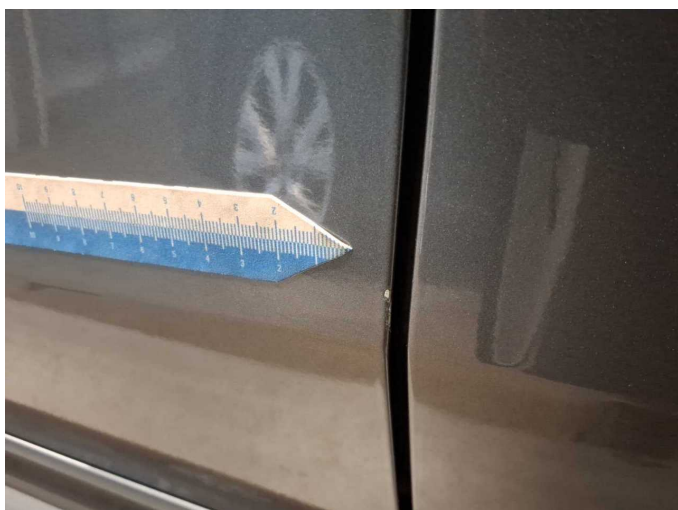
**Damage 2:** Door - front left side: Door edge - Scratched - Smart repair

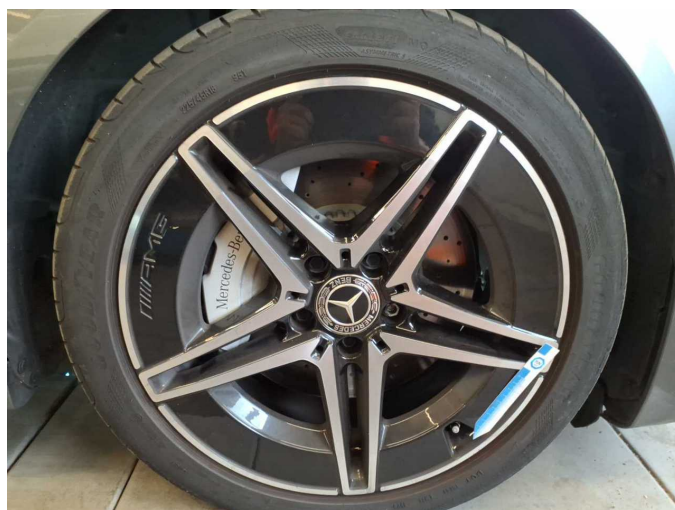
| No. | Component group | Description |
|---|---|---|
| 3 | Wheel / tyres | Tyre - front right side (nicht fahrbereit) - Damaged - Replace |

**Damage 3:** Wheel / tyres: Tyre - front right side (nicht fahrbereit) - Damaged - Replace

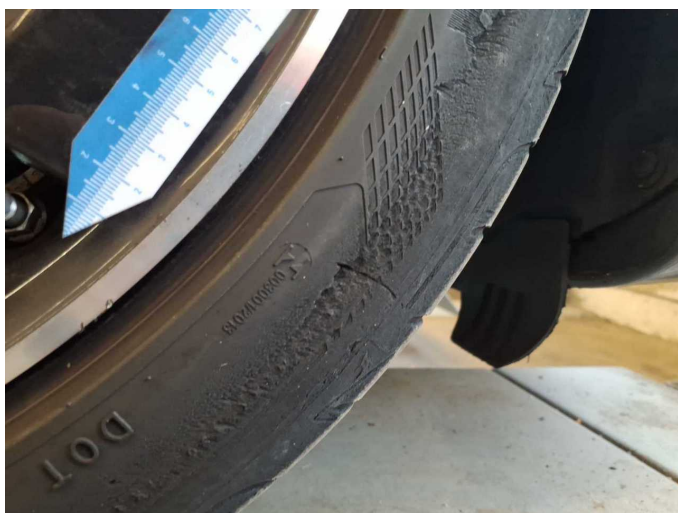
**Damage 3:** Wheel / tyres: Tyre - front right side (nicht fahrbereit) - Damaged - Replace

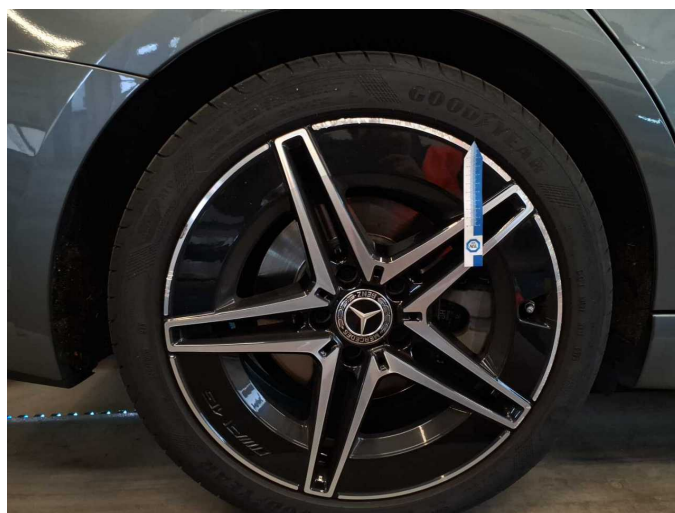
| No. | Component group | Description |
|---|---|---|
| 4 | Wheel / tyres | Tyre - rear right side - Damaged - Replace |

**Damage 4:** Wheel / tyres: Tyre - rear right side - Damaged - Replace

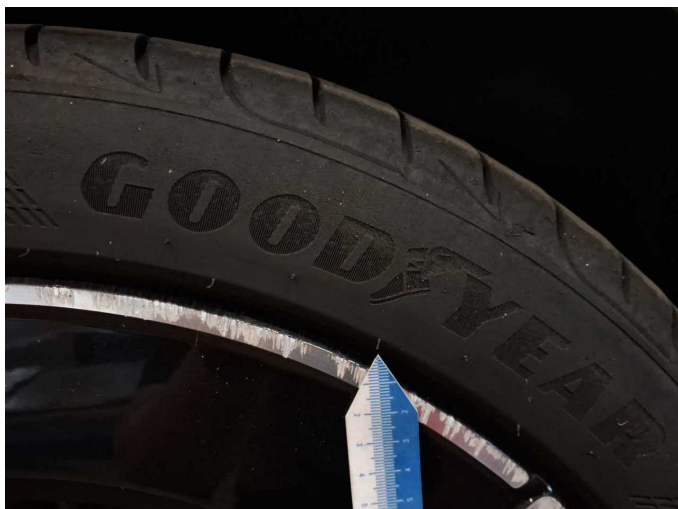
**Damage 4:** Wheel / tyres: Tyre - rear right side - Damaged - Replace

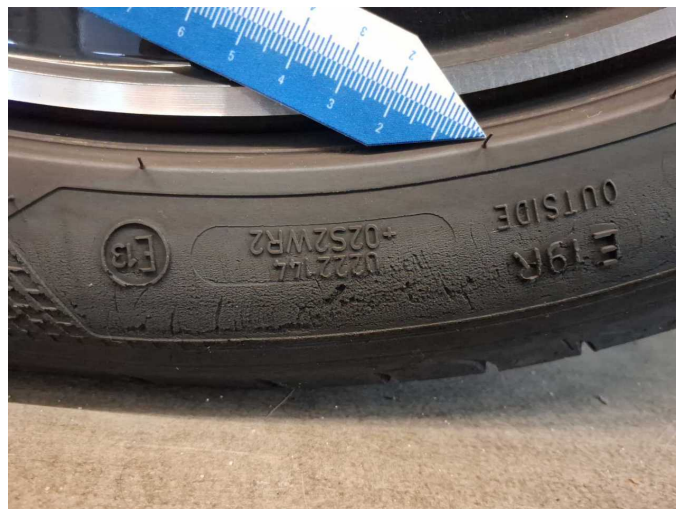
**Damage 4:** Wheel / tyres: Tyre - rear right side - Damaged - Replace

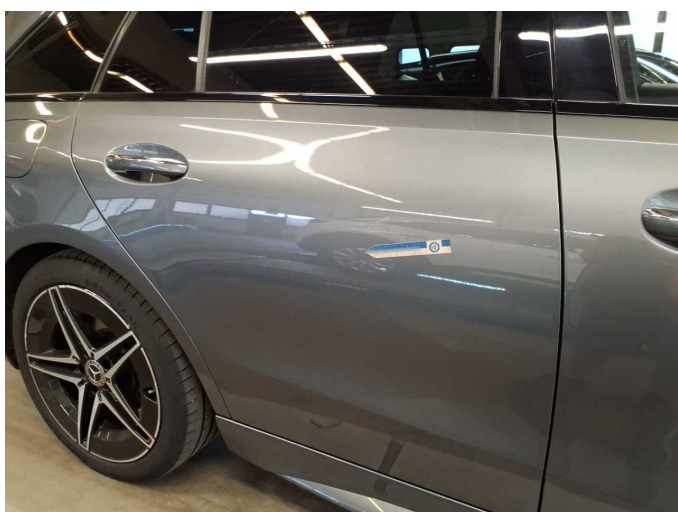
| No. | Component group | Description |
|---|---|---|
| 5 | Door - rear right side | Door - Scratched - Smart repair |

**Damage 5:** Door - rear right side: Door - Scratched - Smart repair

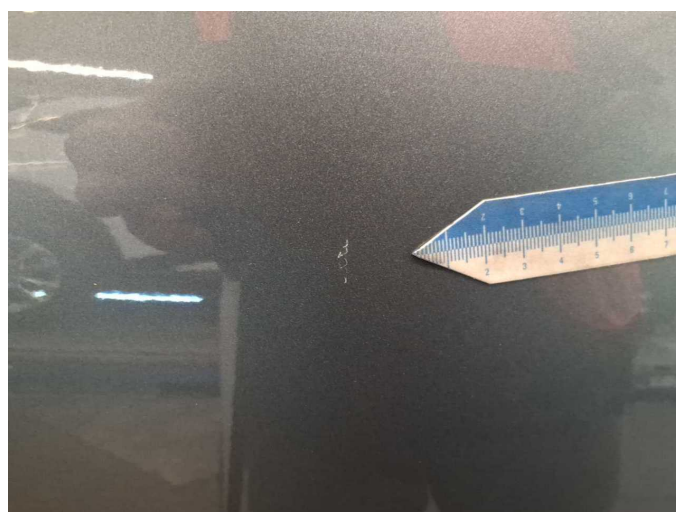
**Damage 5:** Door - rear right side: Door - Scratched - Smart repair

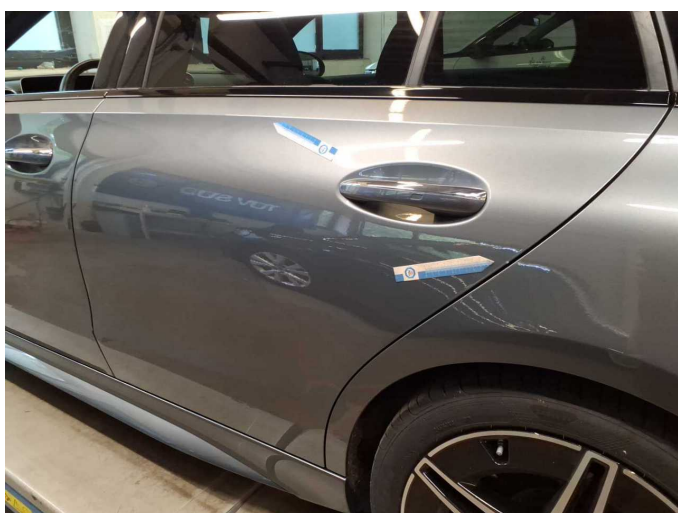
| No. | Component group | Description |
|---|---|---|
| 7 | Door - rear left side | Door - Scratched - Paint |

**Damage 7:** Door - rear left side: Door - Scratched - Paint

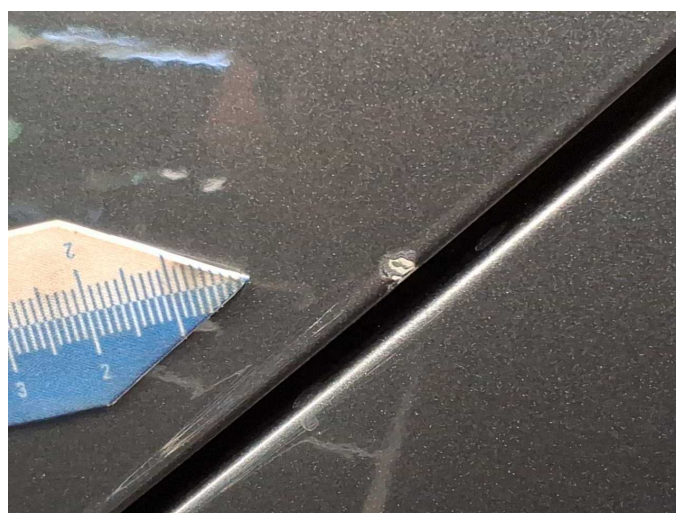
**Damage 7:** Door - rear left side: Door - Scratched - Paint

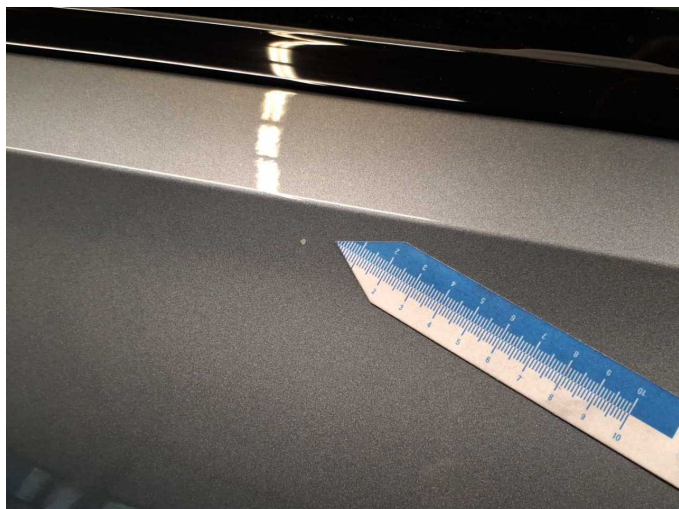
**Damage 7:** Door - rear left side: Door - Scratched - Paint

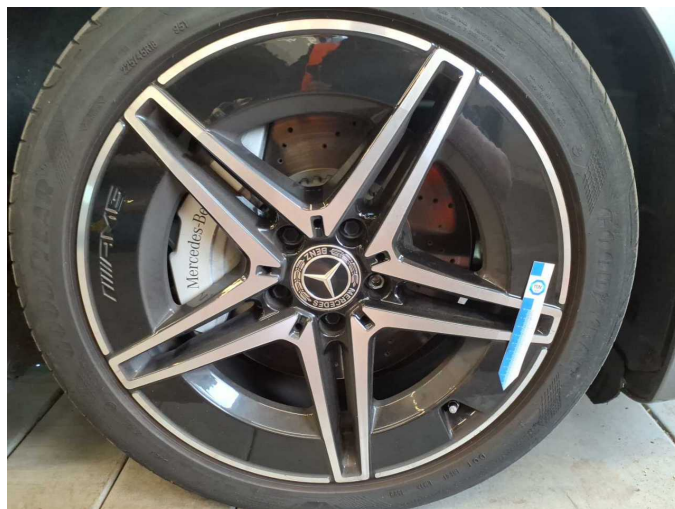
| No. | Component group | Description |
|---|---|---|
| 8 | Wheel / tyres | Alloy rim - front right side - Scratched - Loss in value |

**Damage 8:** Wheel / tyres: Alloy rim - front right side - Scratched - Loss in value

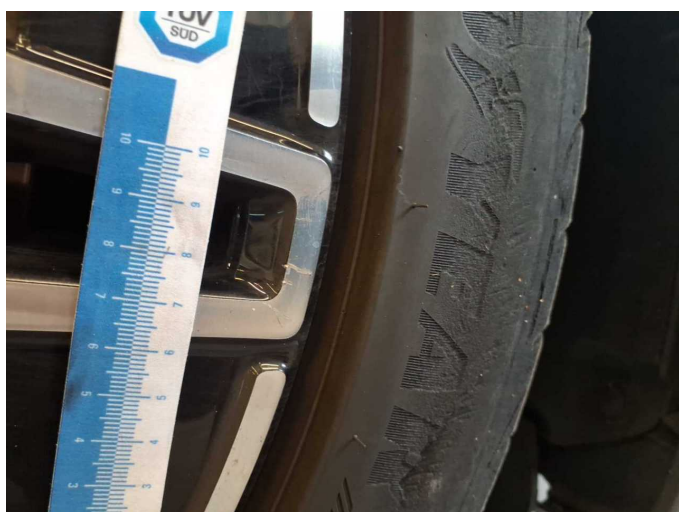
**Damage 8:** Wheel / tyres: Alloy rim - front right side - Scratched - Loss in value

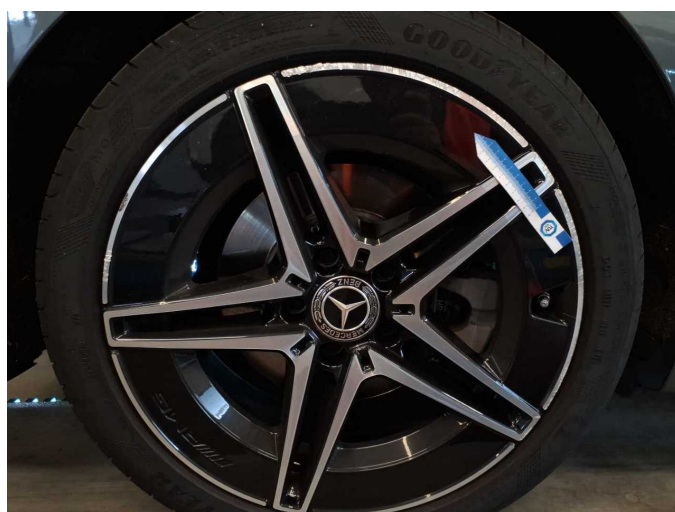
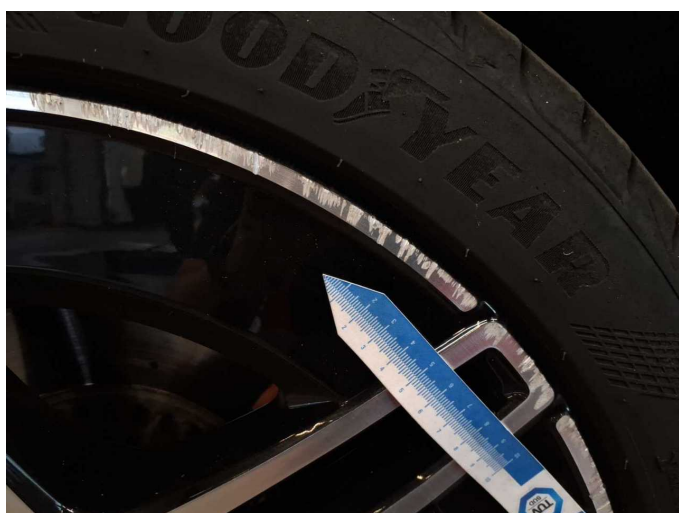
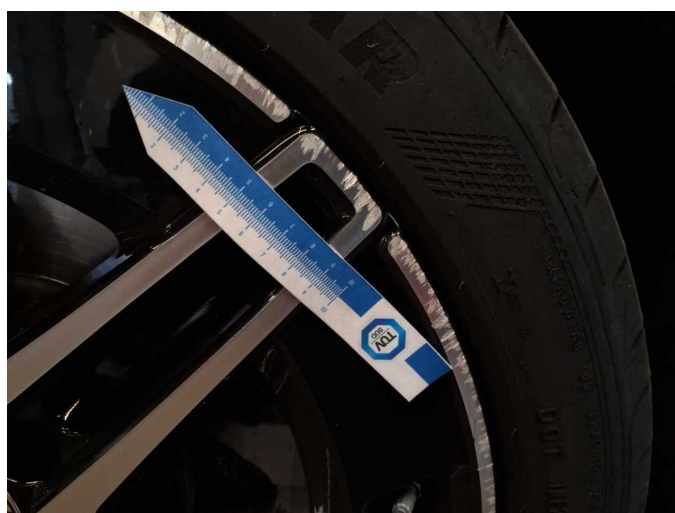
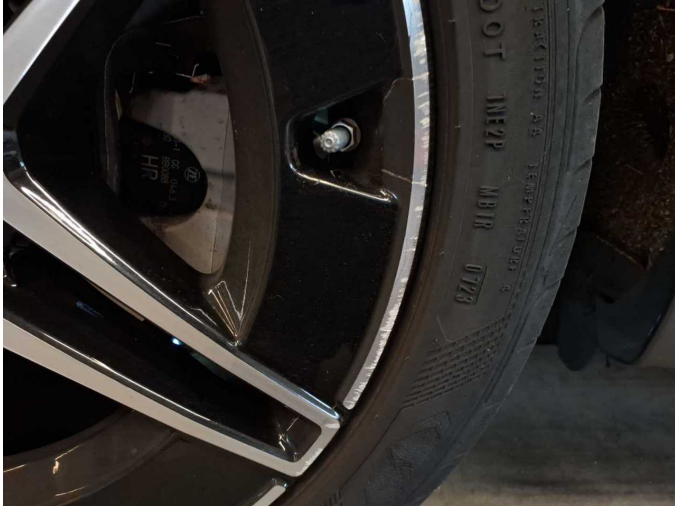
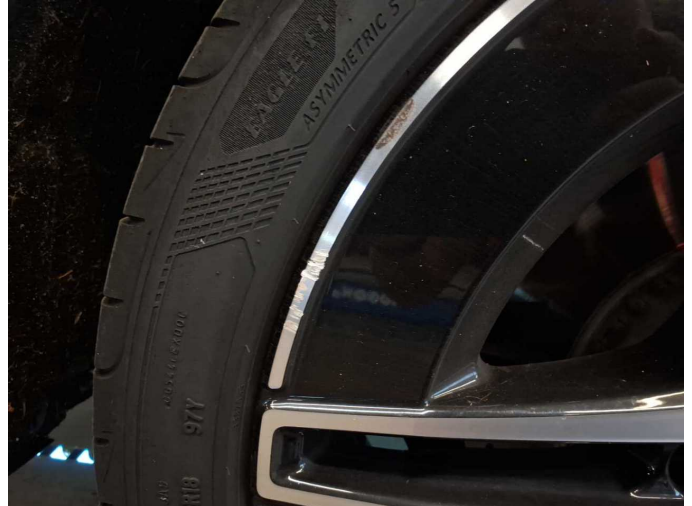
| No. | Component group | Description |
|---|---|---|
| 9 | Wheel / tyres | Alloy rim - rear right side (Materialabtrag) - Scratched - Replace |

**Damage 9:** Wheel / tyres: Alloy rim - rear right side (Materialabtrag) - Scratched - Replace

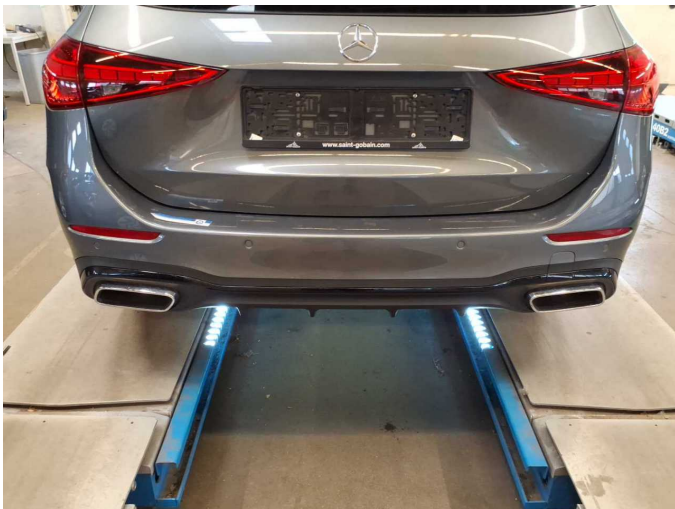
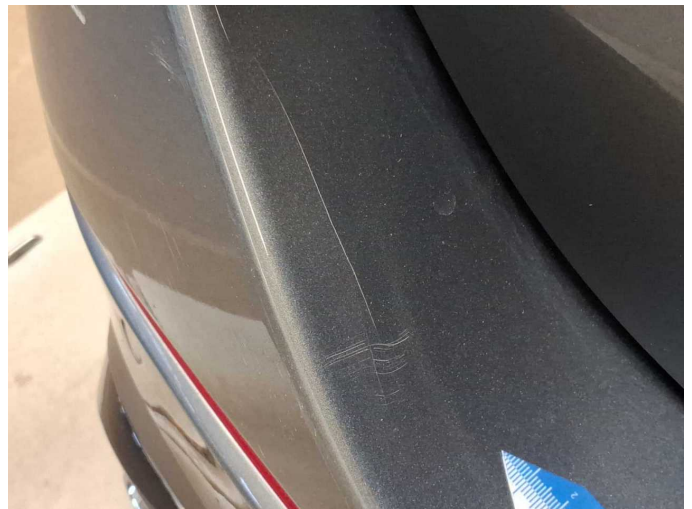
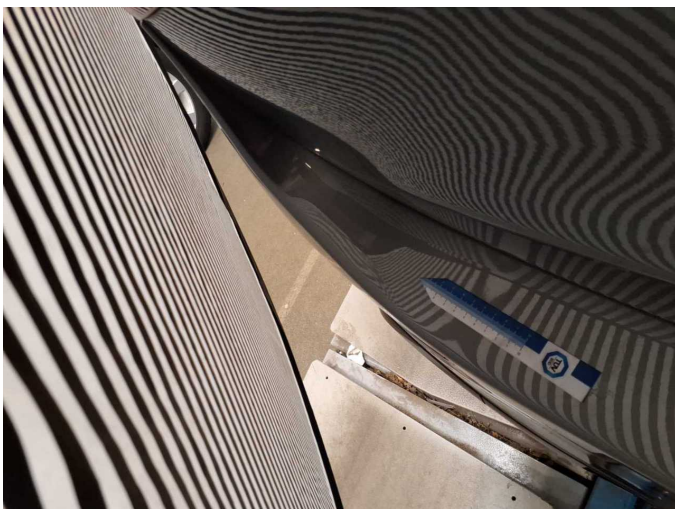
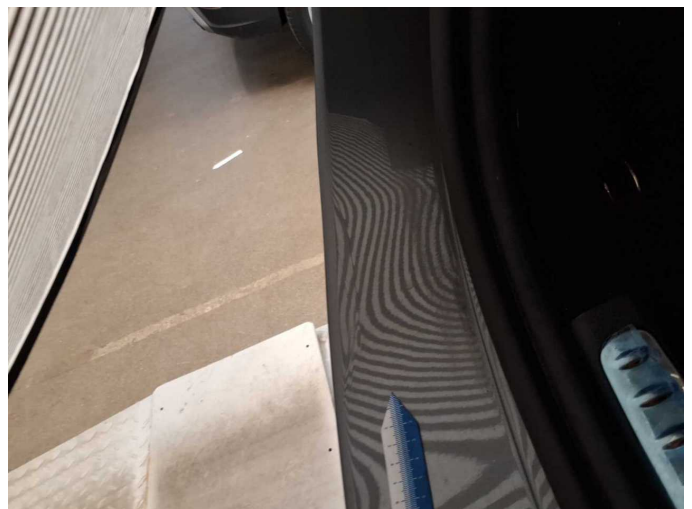
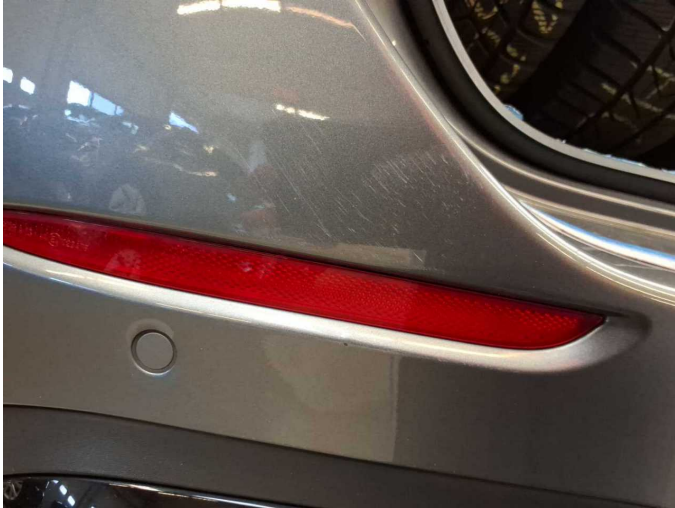
| No. | Component group | Description |
|---|---|---|
| 10 | Rear bumper | Rear bumper - Broken / torn - repair according to calculation |

**Damage 10:** Rear bumper: Rear bumper - Broken / torn - repair according to calculation

Die beigefügte Reparaturkostenkalkulation wurde nach bestem Wissen und Gewissen unter eingeschränkten Besichtigungsbedingung im demontagefreien Zustand erstellt. Es können aufgrund verdeckter Beschädigung, Mehrkosten und somit Abweichung der für die Stoßstange ausgewiesenen Reparaturkosten nicht ausgeschlossen werden.

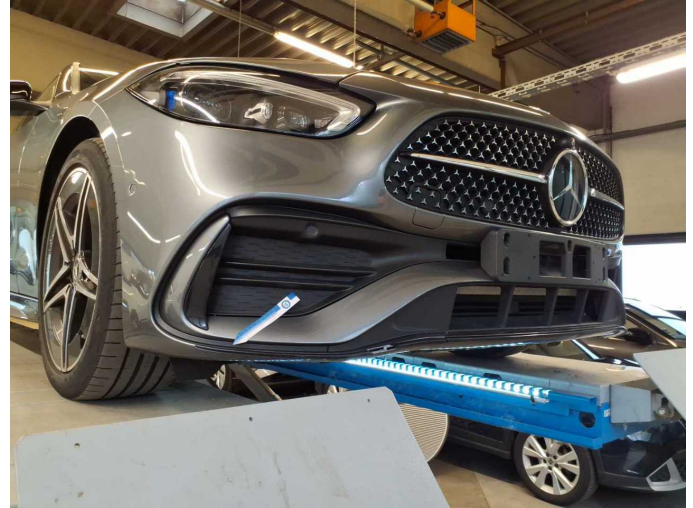
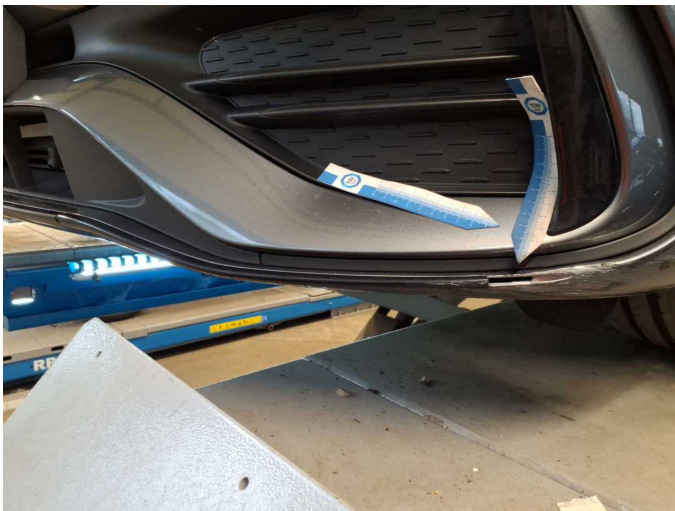
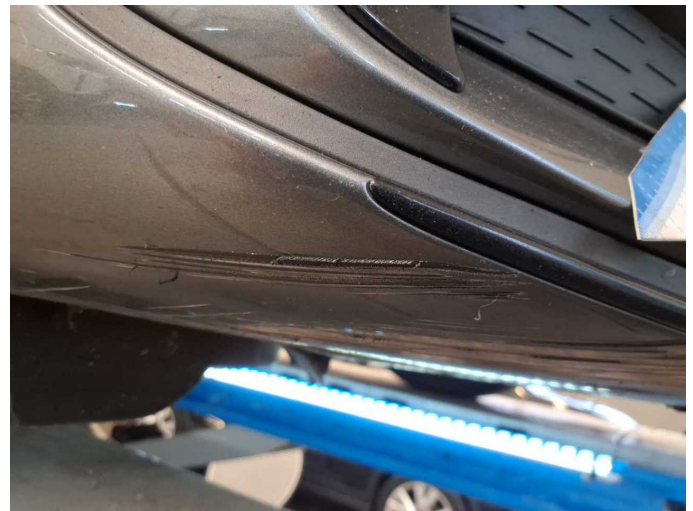
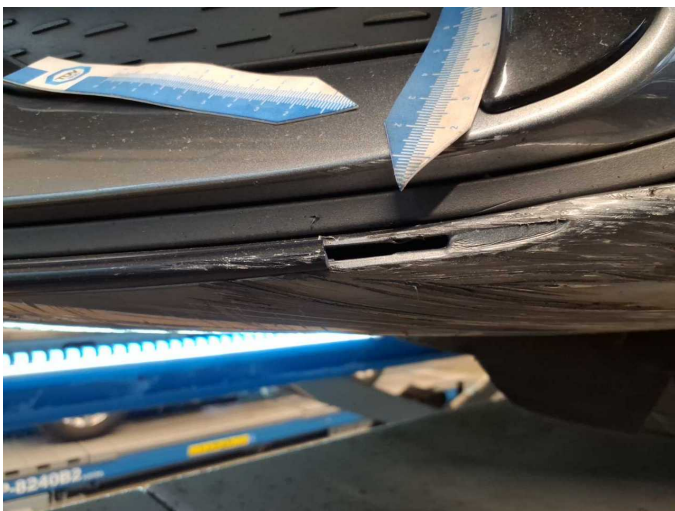
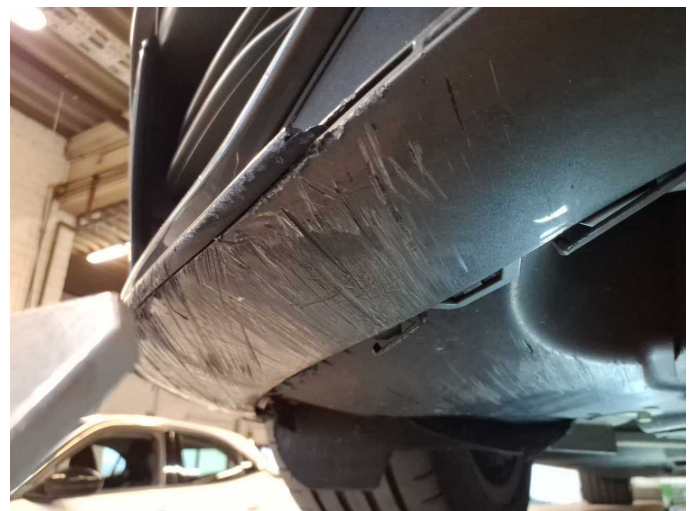
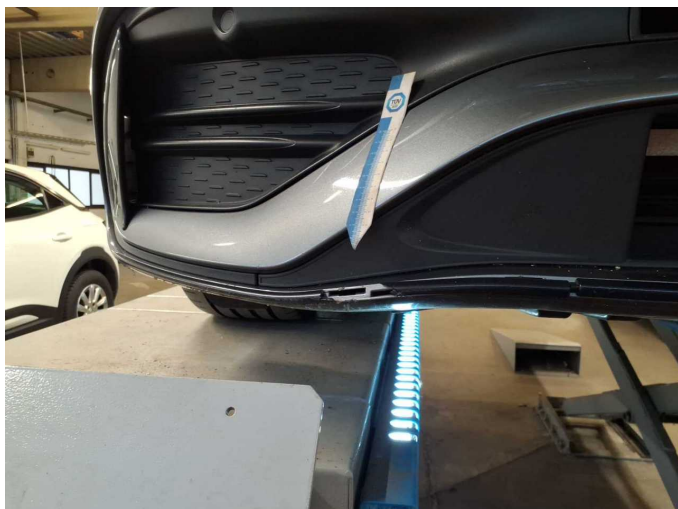
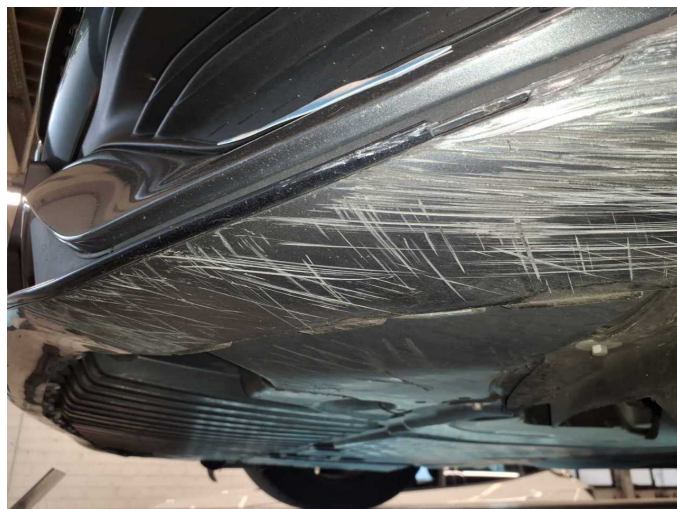
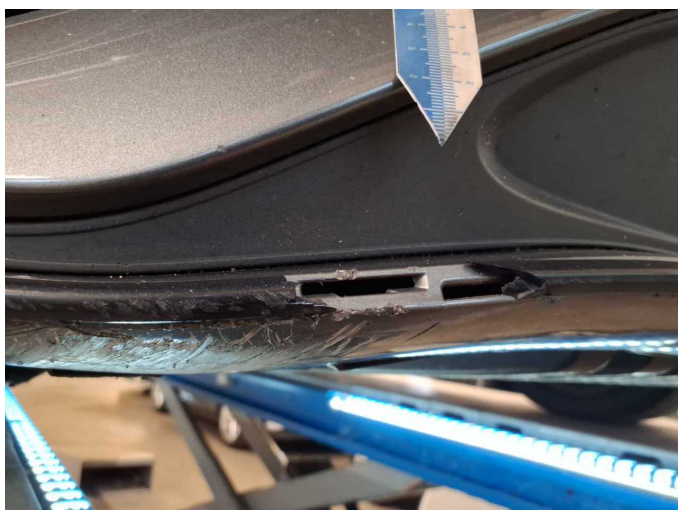
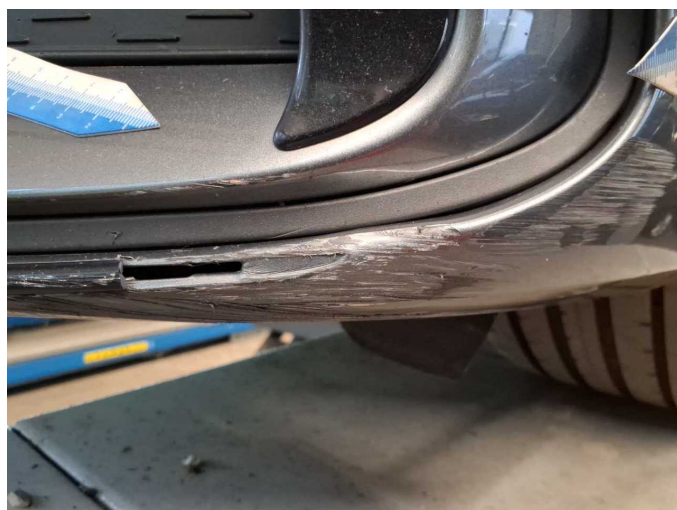
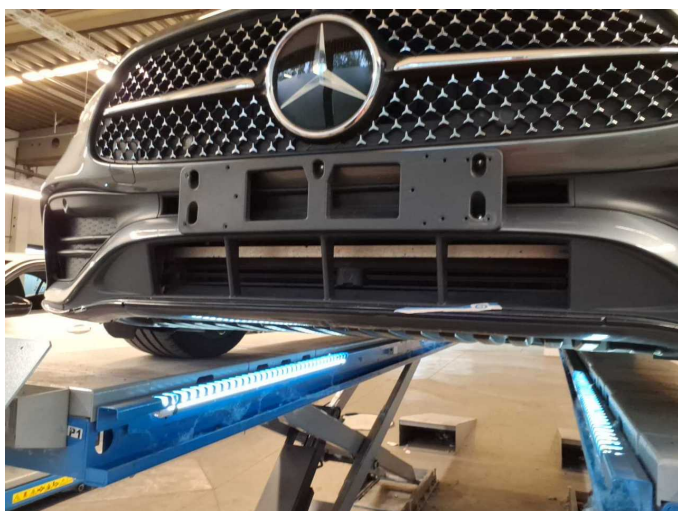
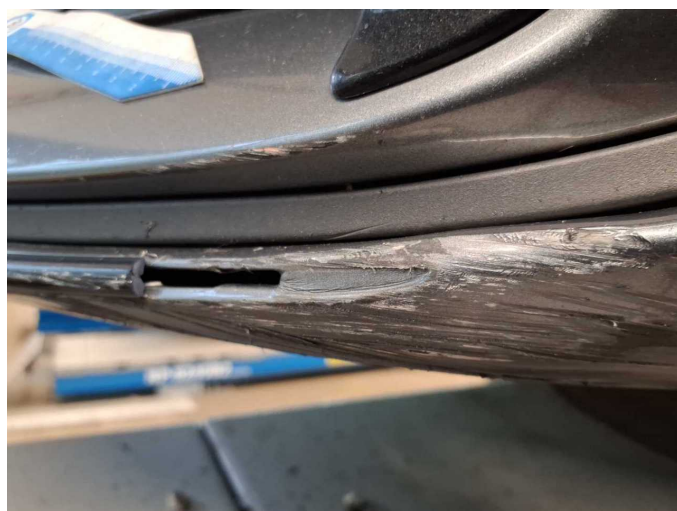
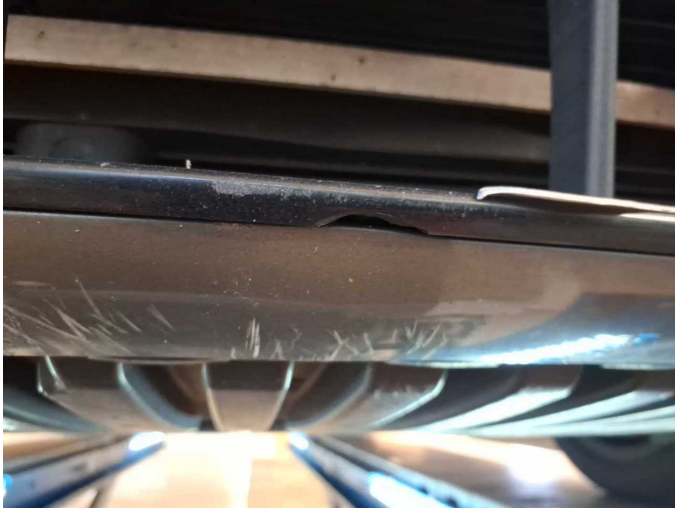
| No. | Component group | Description |
|---|---|---|
| 11 | Front bumper | Front bumper (Materialabtrag) - Scratched - repair according to calculation |

**Damage 11:** Front bumper: Front bumper (Materialabtrag) - Scratched - repair according to calculation

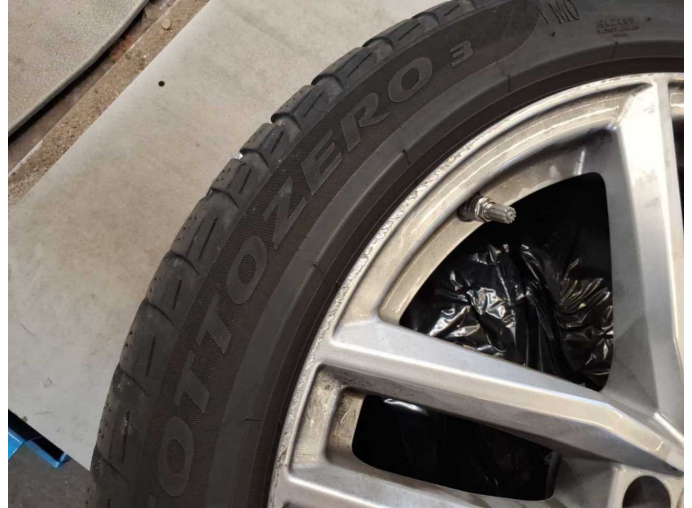
| No. | Component group | Description |
|---|---|---|
| 1 | 2nd wheel set | 1 alloy rim - Scratched - No deduction |

**Wear and tear 1:** 2nd wheel set: 1 alloy rim - Scratched - No deduction
