Expertise

Protocol number: 46851103  
Order No. / Reference: 26576812  
Inspection date: 30 Jul 2026

Manufacturer: Mercedes-Benz  
VIN: W1N4M1EB7PW335228

Model: GLB 220 d 8G-DCT AMG Line

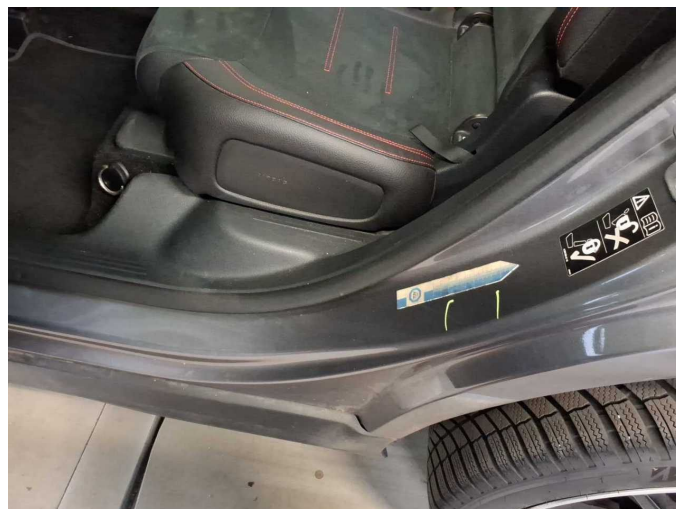
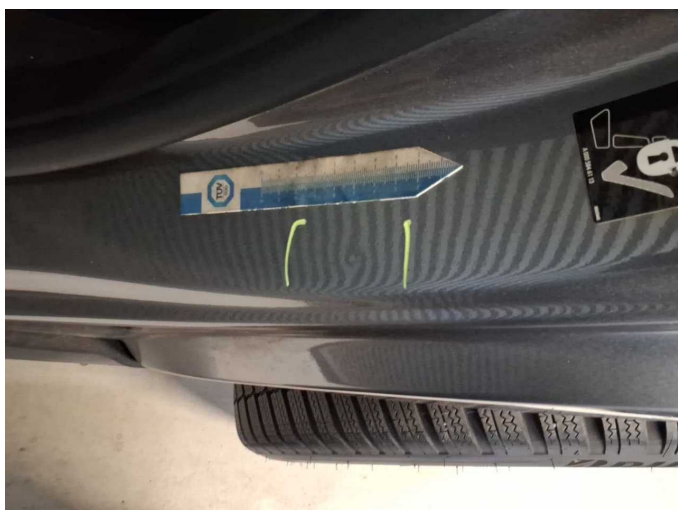
| No. | Component group | Description |
|---|---|---|
| 1 | Side panel - rear left side | Sill - dent(s) - Smooth repair work |

**Damage 1:** Side panel - rear left side: Sill - dent(s) - Smooth repair work

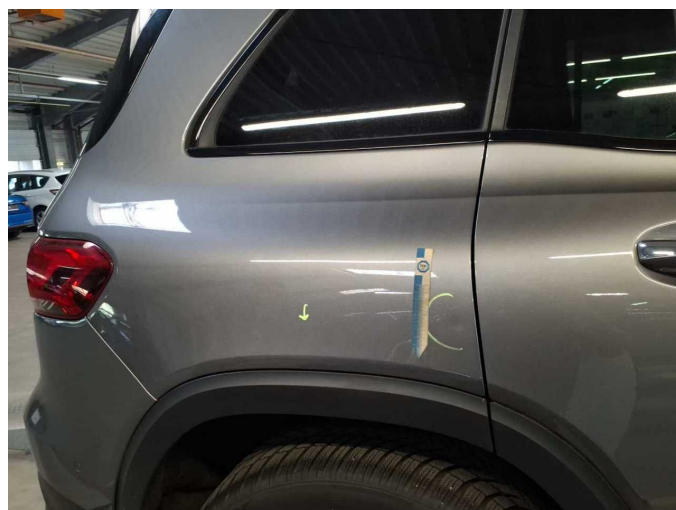
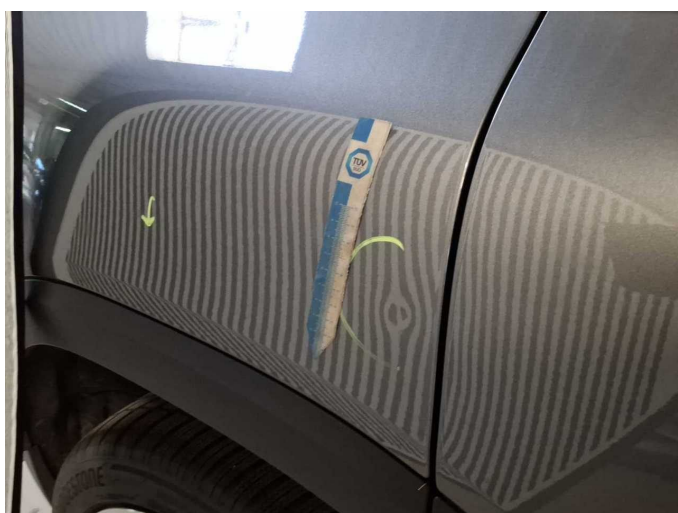
| No. | Component group | Description |
|---|---|---|
| 2 | Side panel - rear right side | Side panel - dent(s) - Smooth repair work |

**Damage 2:** Side panel - rear right side: Side panel - dent(s) - Smooth repair work

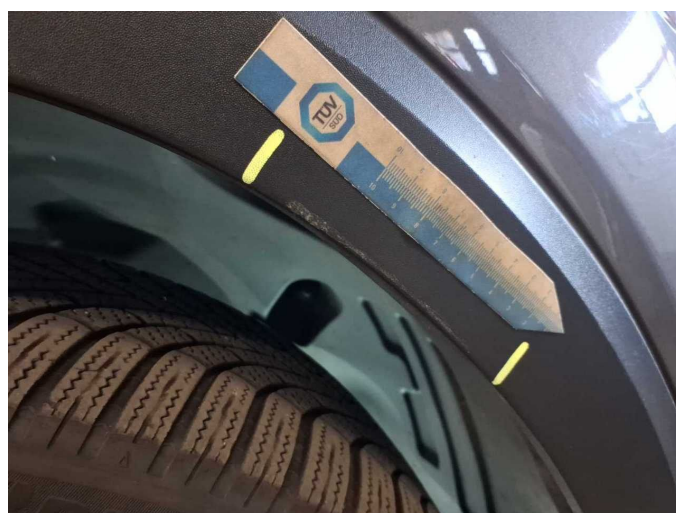
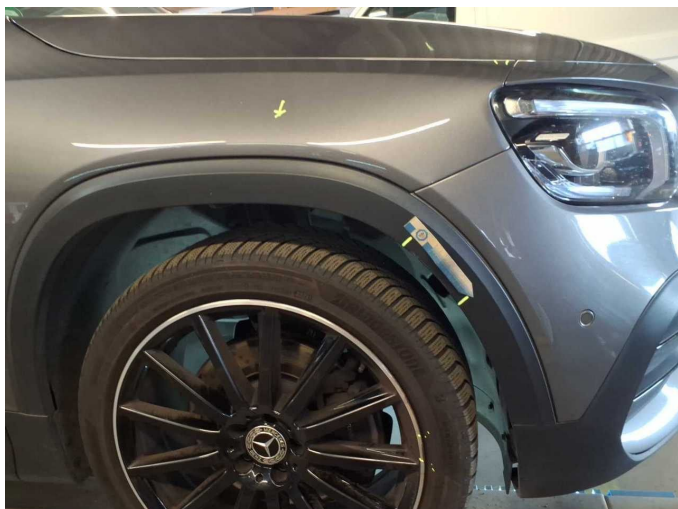
| No. | Component group | Description |
|---|---|---|
| 3 | Mudguard - right side | Wheel well extension - Scratch(es) - Smart repair |

**Damage 3:** Mudguard - right side: Wheel well extension - Scratch(es) - Smart repair

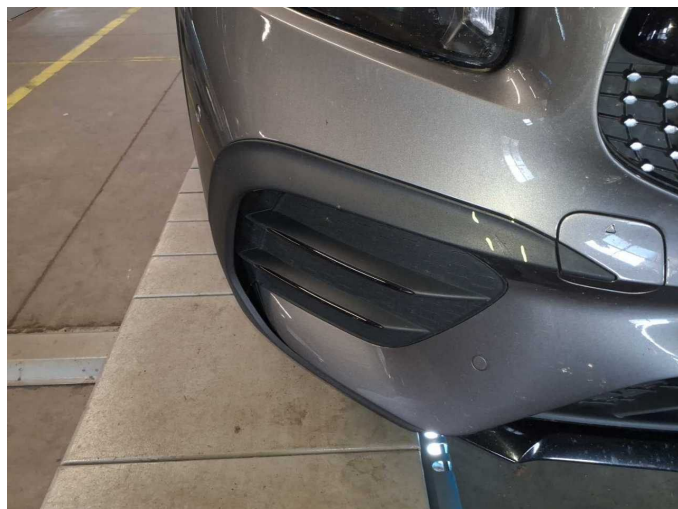
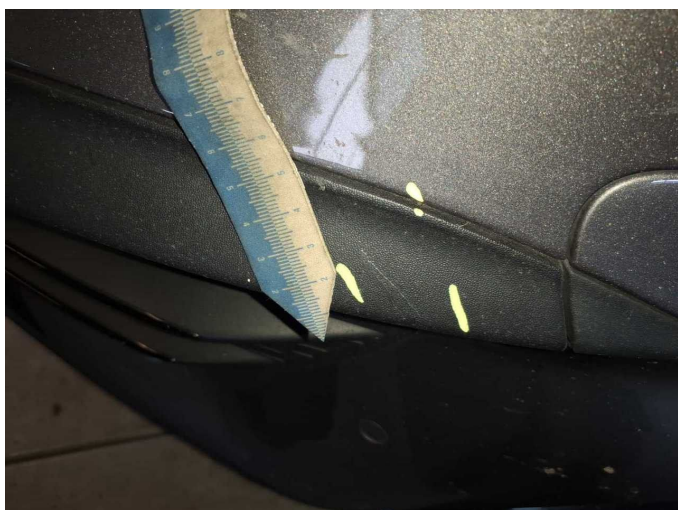
| No. | Component group | Description |
|---|---|---|
| 4 | Front bumper | Cover bumper - front - Scratched - Smart repair |

**Damage 4:** Front bumper: Cover bumper - front - Scratched - Smart repair

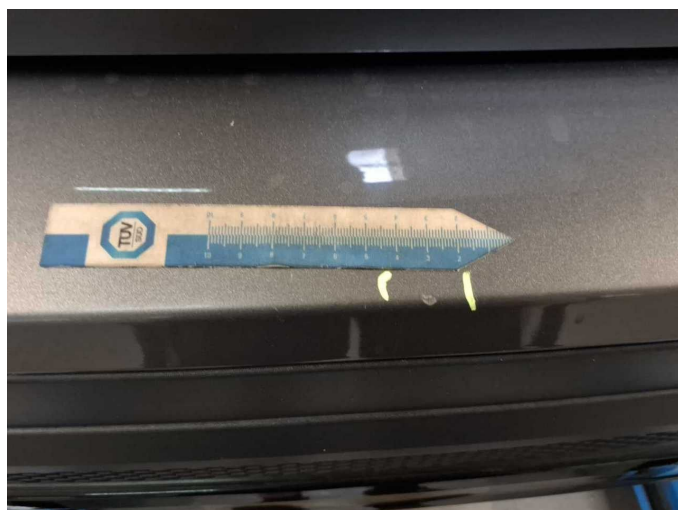
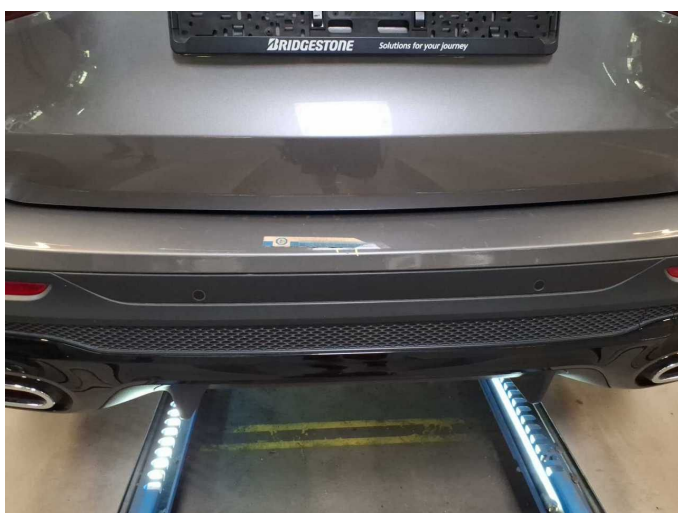
| No. | Component group | Description |
|---|---|---|
| 5 | Rear bumper | Rear bumper - Scratched - Smart repair |

**Damage 5:** Rear bumper: Rear bumper - Scratched - Smart repair

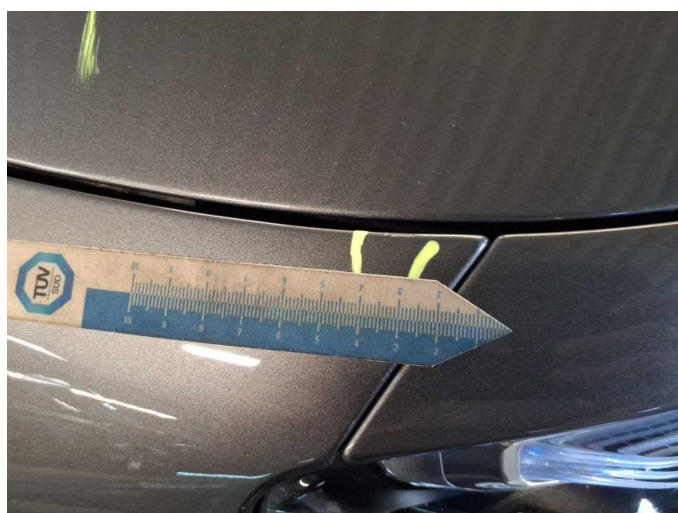
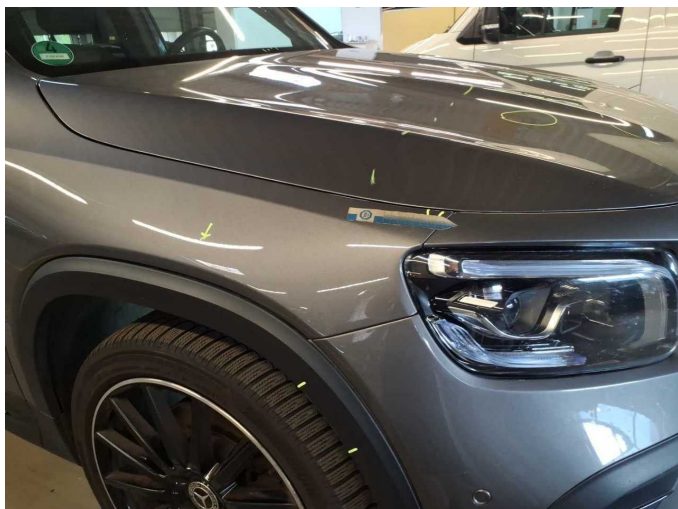
| No. | Component group | Description |
|---|---|---|
| 6 | Mudguard - right side | Mudguard - right side - Scratched - Smart repair |

**Damage 6:** Mudguard - right side: Mudguard - right side - Scratched - Smart repair

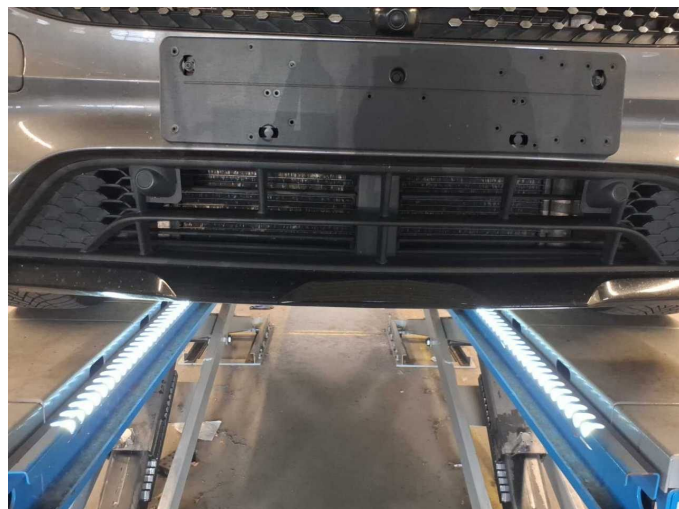
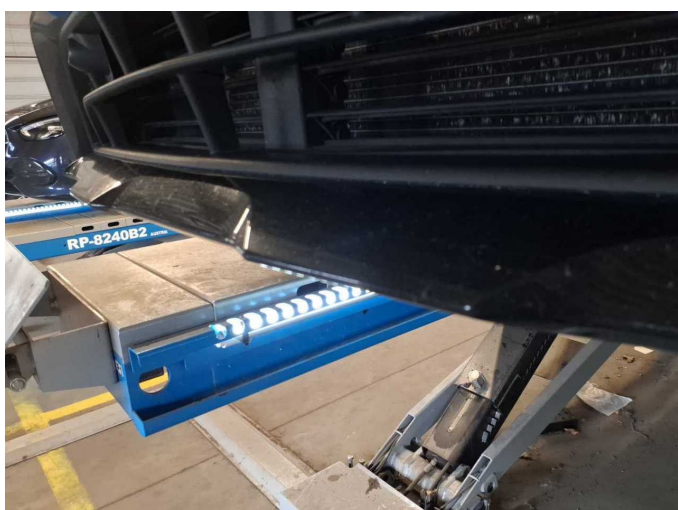
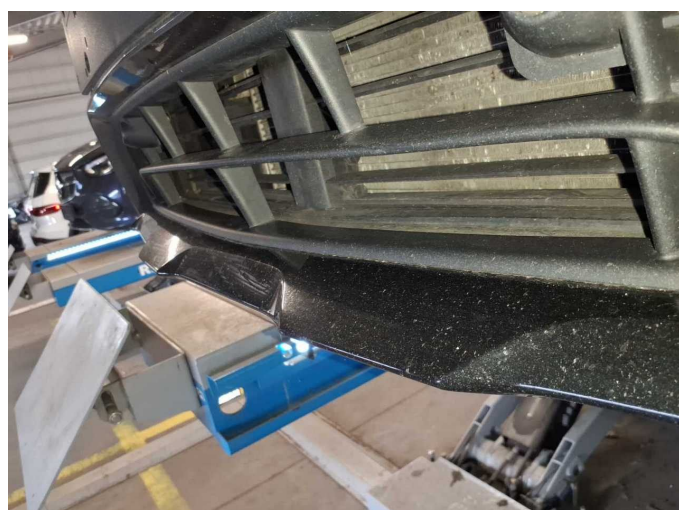
| No. | Component group | Description |
|---|---|---|
| 7 | Front bumper | Spoiler (Sandstrahleffekt) - Stone chips - Paint |

**Damage 7:** Front bumper: Spoiler (Sandstrahleffekt) - Stone chips - Paint

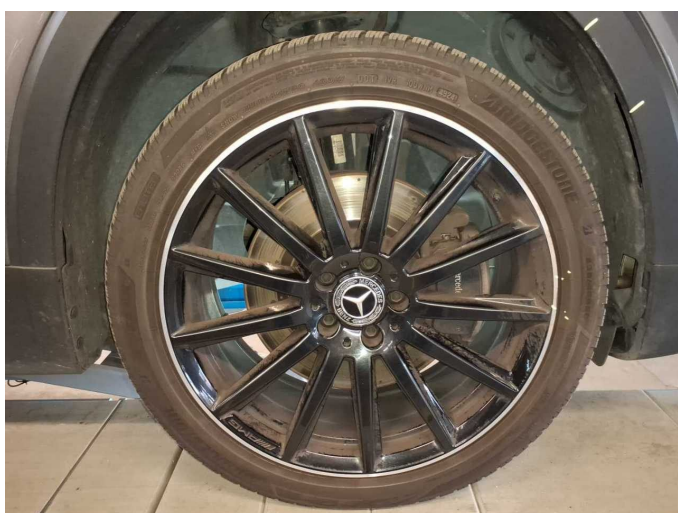
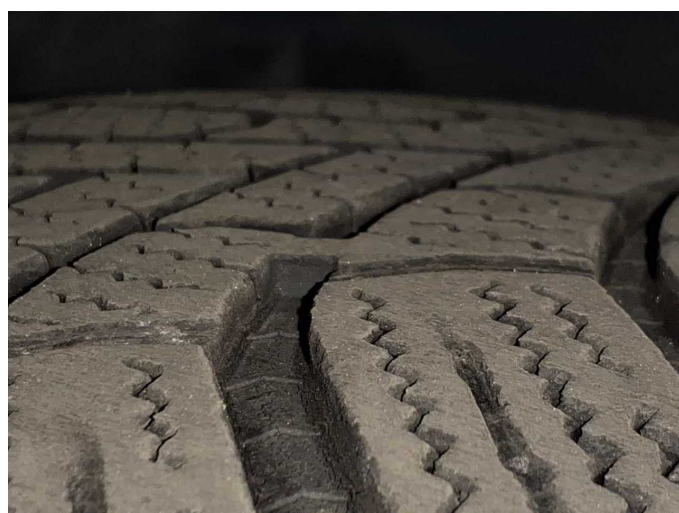
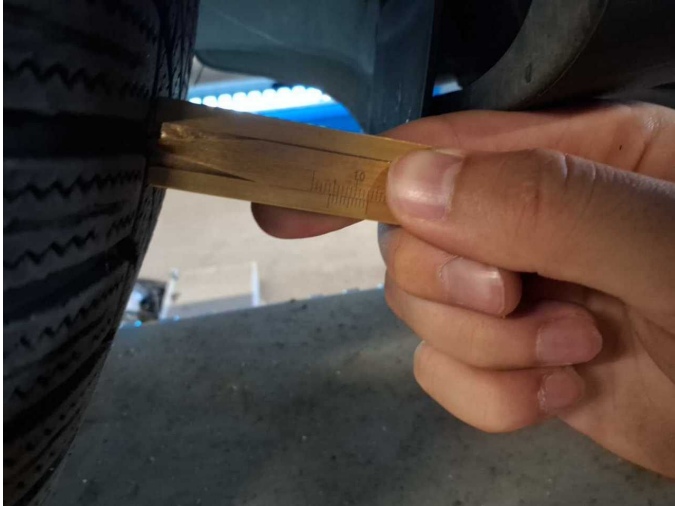
| No. | Component group | Description |
|---|---|---|
| 8 | Wheel / tyres | Tyre - front - Does not meet the leasing specifications - Replace |

**Damage 8:** Wheel / tyres: Tyre - front - Does not meet the leasing specifications - Replace

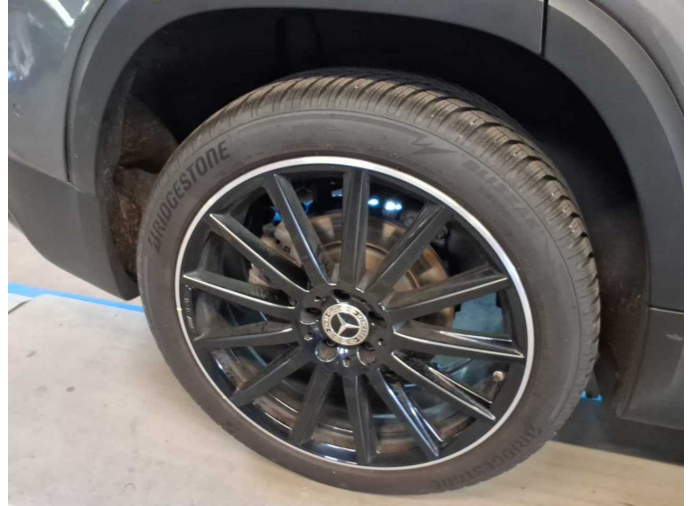
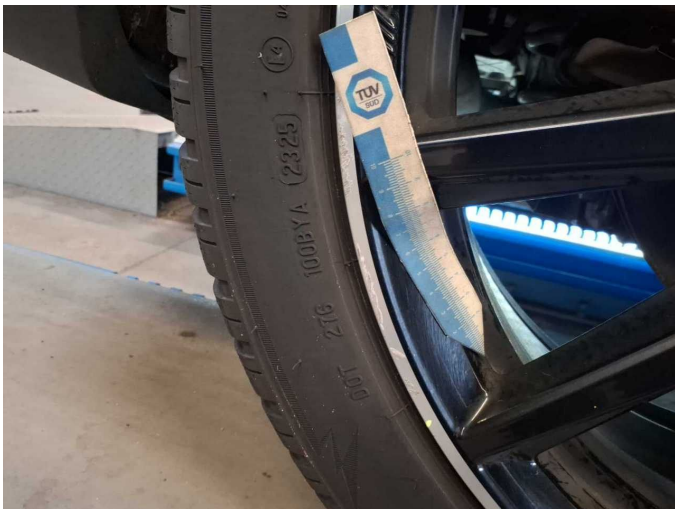
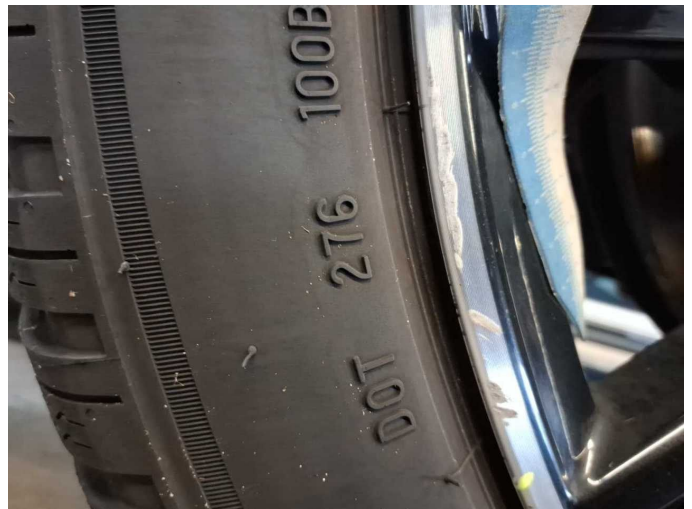
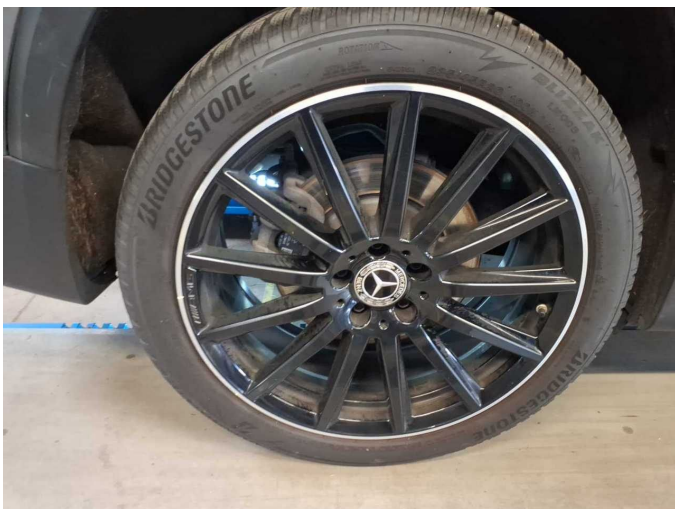
| No. | Component group | Description |
|---|---|---|
| 9 | Wheel / tyres | Wheel rim - rear right side - Scratched - Loss in value |

**Damage 9:** Wheel / tyres: Wheel rim - rear right side - Scratched - Loss in value

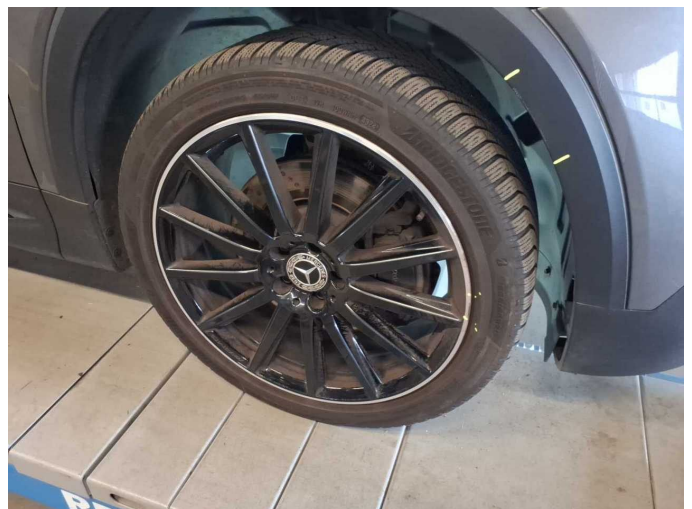
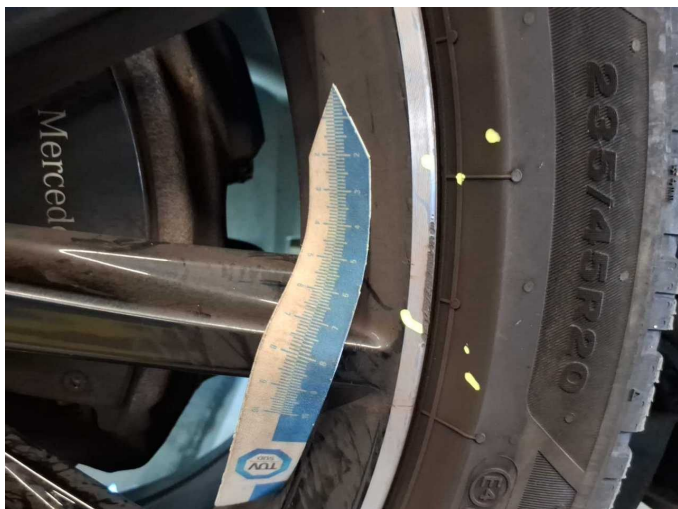
| No. | Component group | Description |
|---|---|---|
| 10 | Wheel / tyres | Alloy rim - front right side - Scratched - Loss in value |

**Damage 10:** Wheel / tyres: Alloy rim - front right side - Scratched - Loss in value

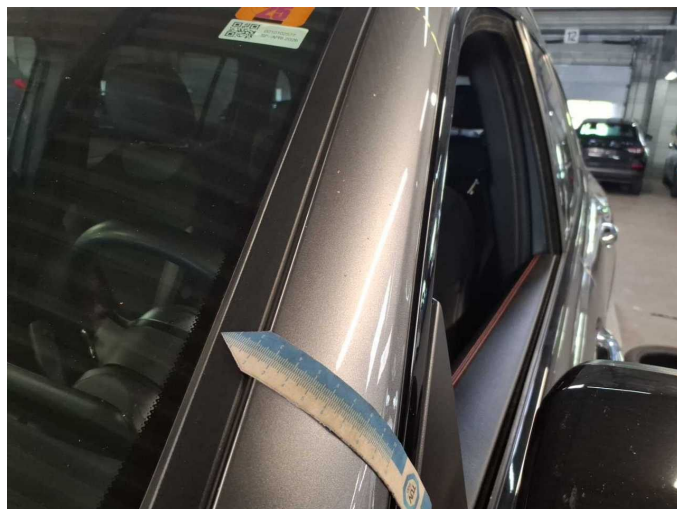
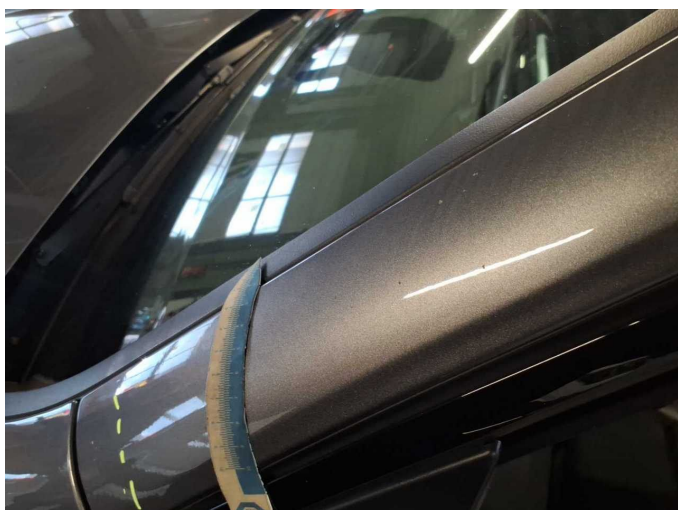
| No. | Component group | Description |
|---|---|---|
| 11 | Body | A-pillar - left side (Sandstrahleffekt) - Stone chips - Paint |

**Damage 11:** Body: A-pillar - left side (Sandstrahleffekt) - Stone chips - Paint

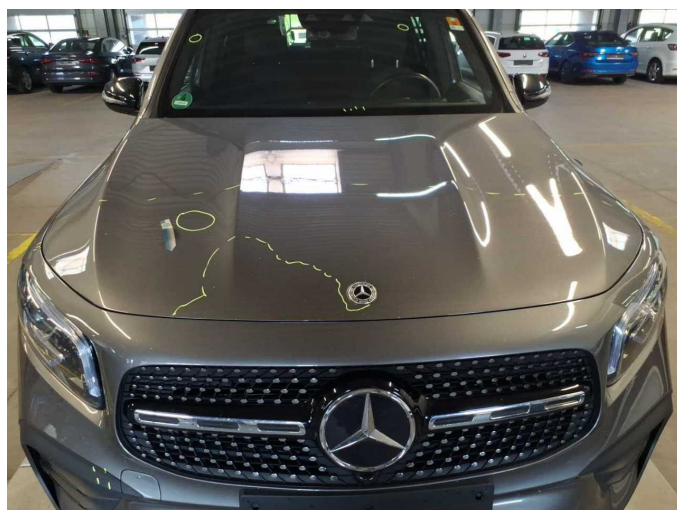
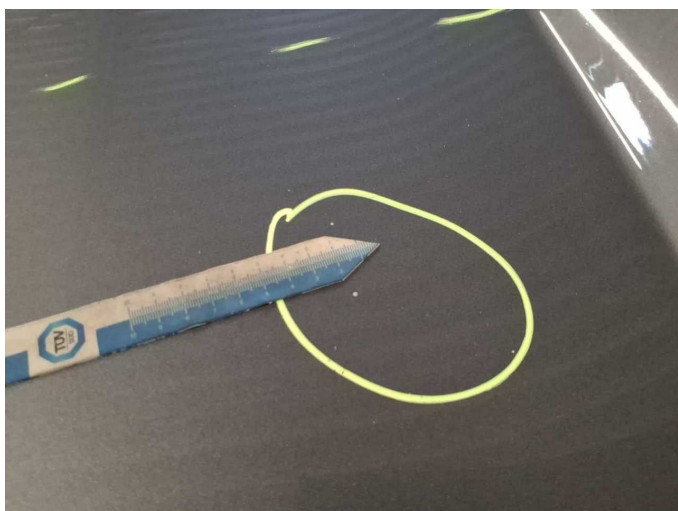
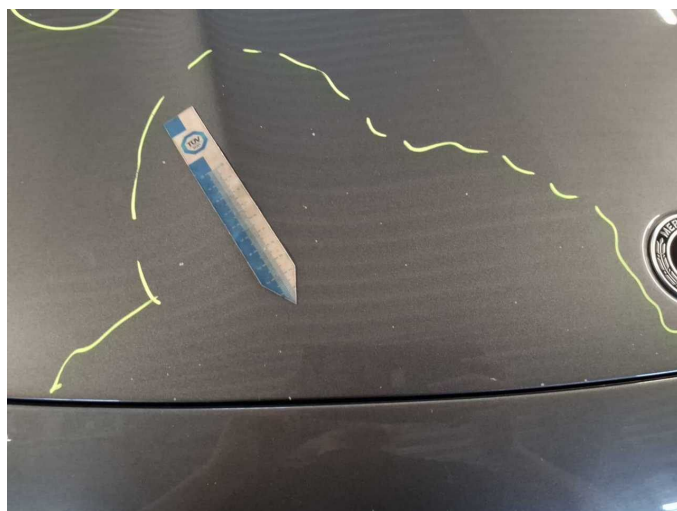
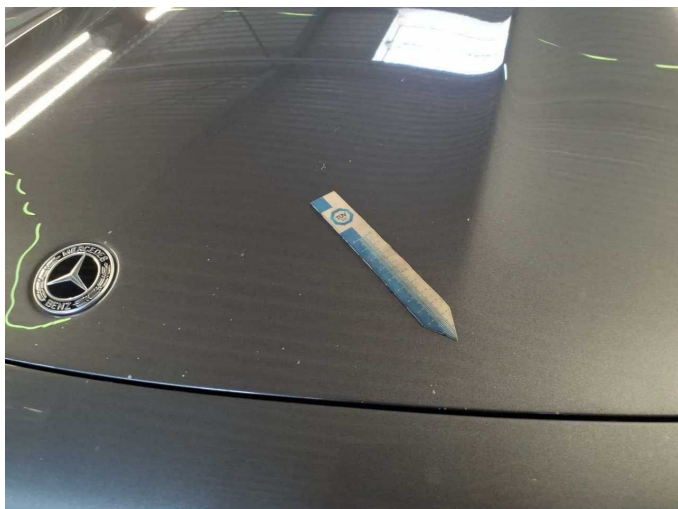
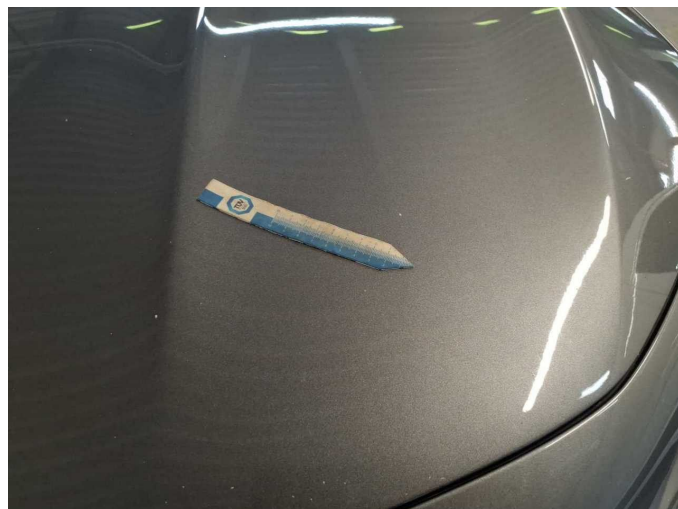
| No. | Component group | Description |
|---|---|---|
| 12 | Bonnet | Bonnet (Sandstrahleffekt) - Stone chips - Paint |

**Damage 12:** Bonnet: Bonnet (Sandstrahleffekt) - Stone chips - Paint

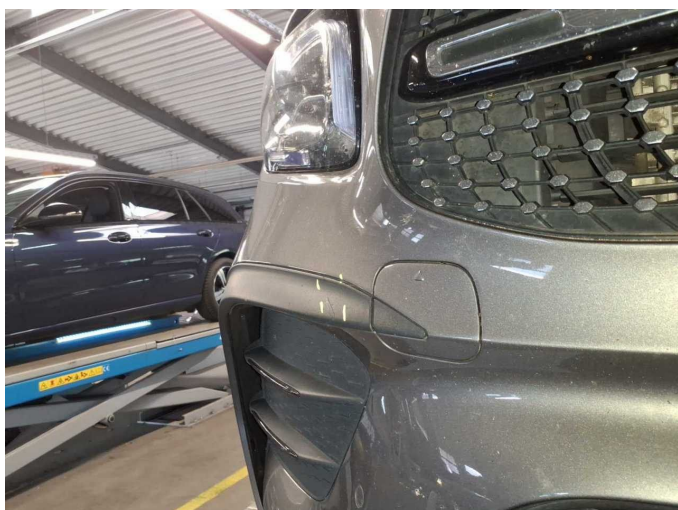
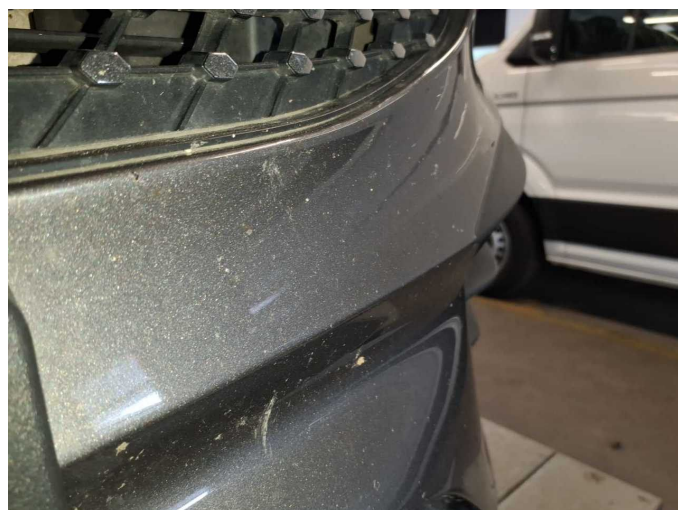
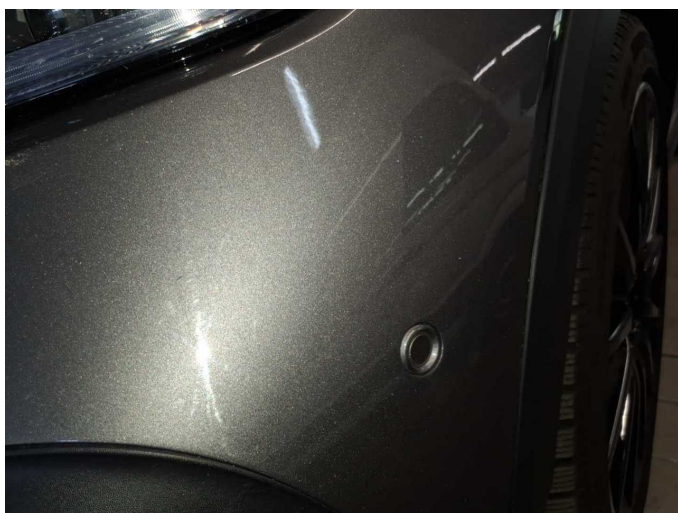
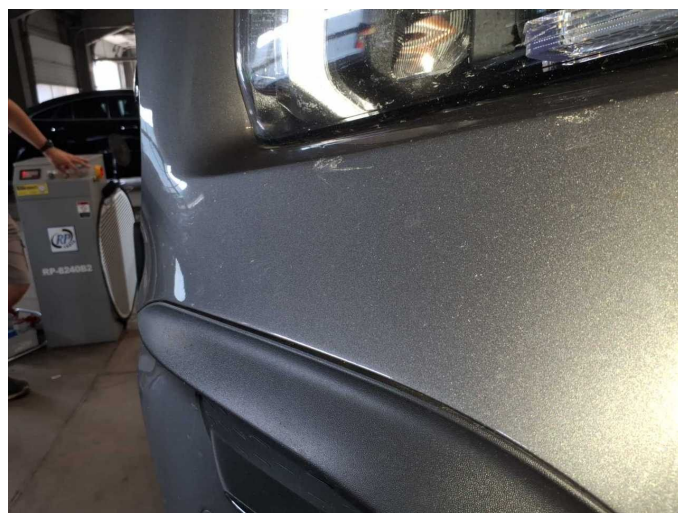
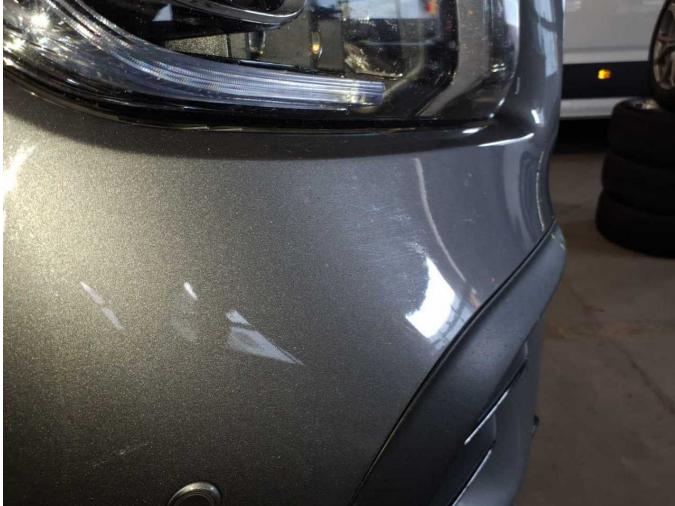
| No. | Component group | Description |
|---|---|---|
| 13 | Front bumper | Front bumper (Sandstrahleffekt) - Stone chips - Paint |

**Damage 13:** Front bumper: Front bumper (Sandstrahleffekt) - Stone chips - Paint

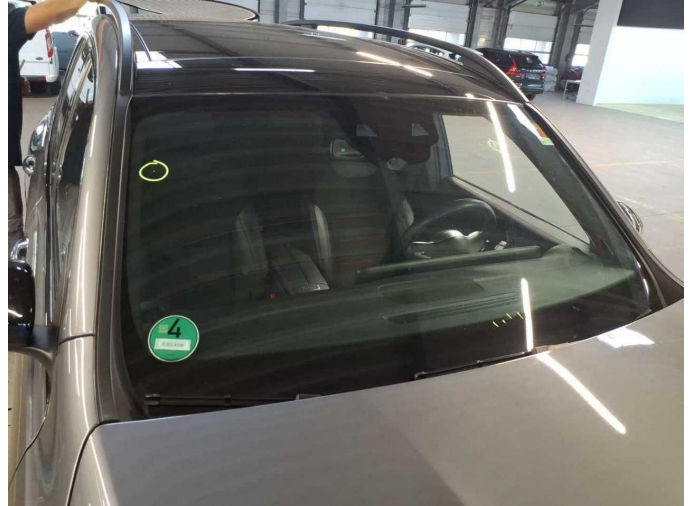
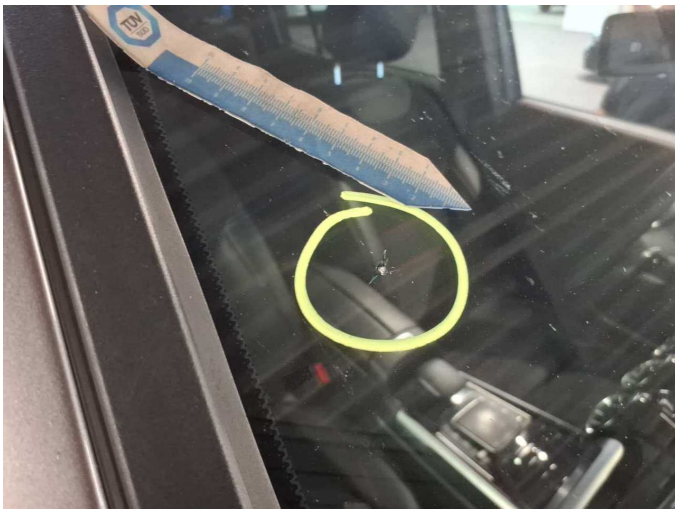
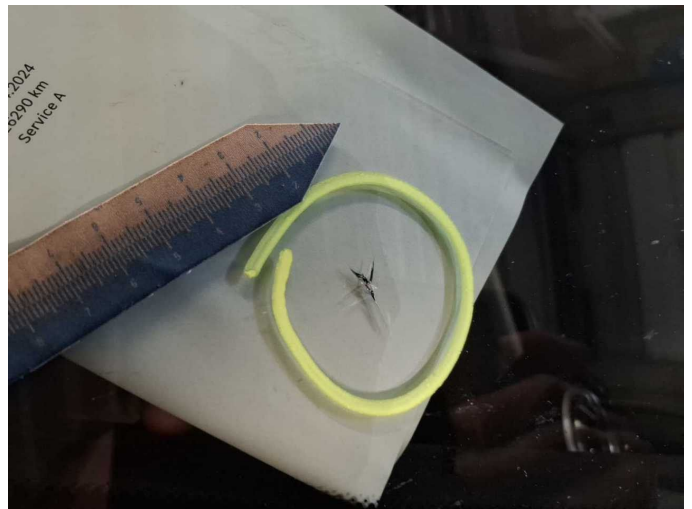
| No. | Component group | Description |
|---|---|---|
| 14 | Vehicle glazing | Windscreen - Stone chips - repair according to calculation |

**Damage 14:** Vehicle glazing: Windscreen - Stone chips - repair according to calculation

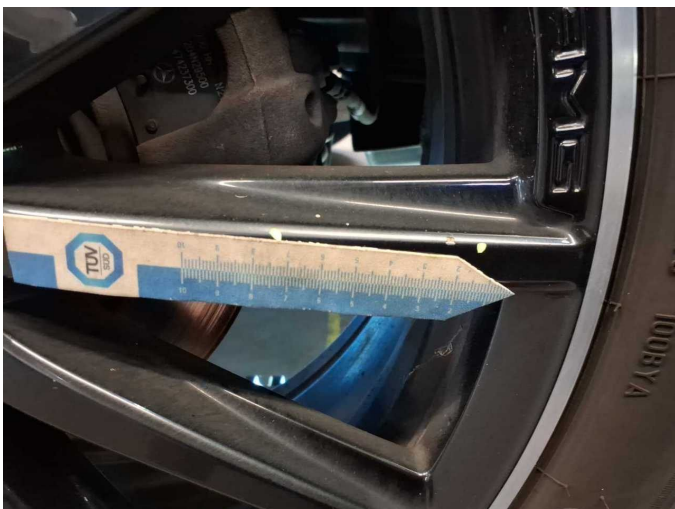
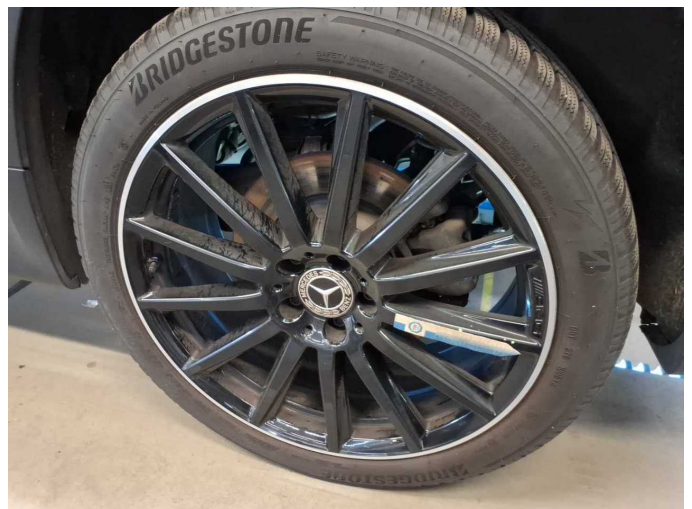
| No. | Component group | Description |
|---|---|---|
| 1 | Wheel / tyres | Alloy rim - rear left side - Scratch(es) - No deduction |

**Wear and tear 1:** Wheel / tyres: Alloy rim - rear left side - Scratch(es) - No deduction

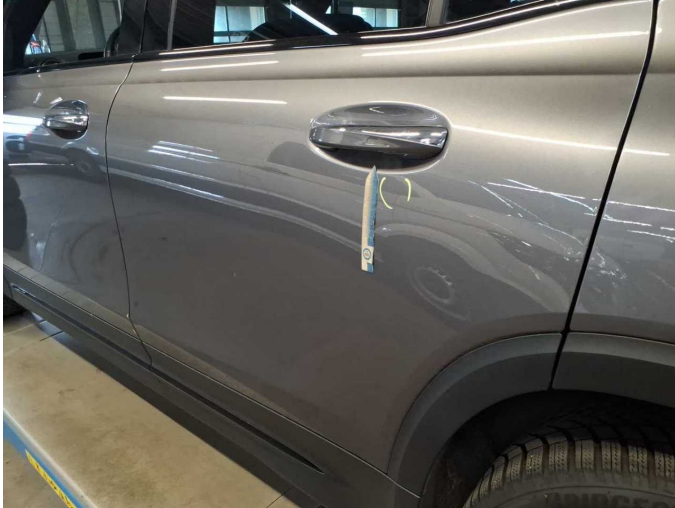
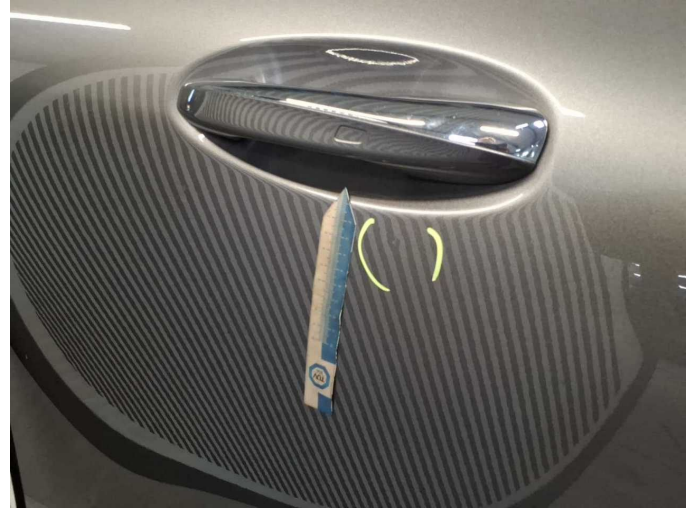
| No. | Component group | Description |
|---|---|---|
| 2 | Door - rear left side | Door - dent(s) - Smooth repair work |

**Wear and tear 2:** Door - rear left side: Door - dent(s) - Smooth repair work
