Expertise

Protocol number: 46542933  
Order No. / Reference: 26664571  
Inspection date: 15 Jul 2026

Manufacturer: Volkswagen

Model: Passat Variant 1.4 TSI Plug-In-Hybrid DSG GTE

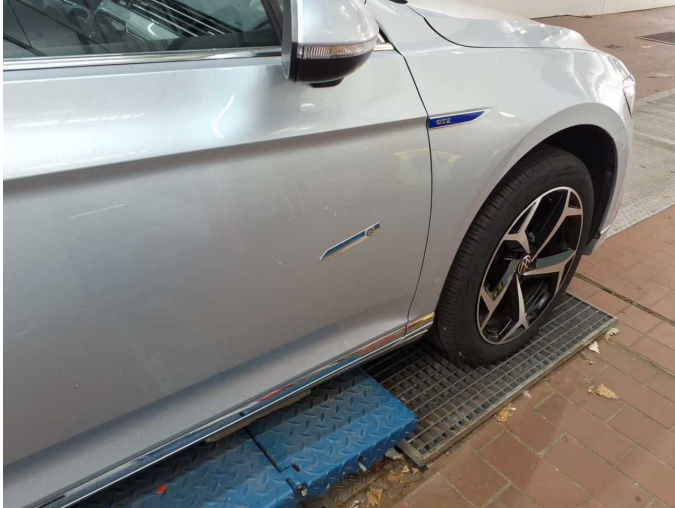
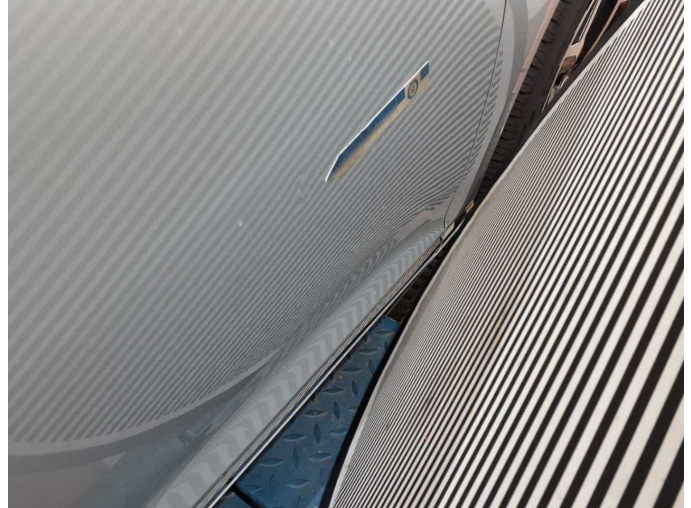
| No. | Component group | Description |
|---|---|---|
| 1 | Door - front right side | Door - dent(s) - Smart repair |

**Damage 1:** Door - front right side: Door - dent(s) - Smart repair

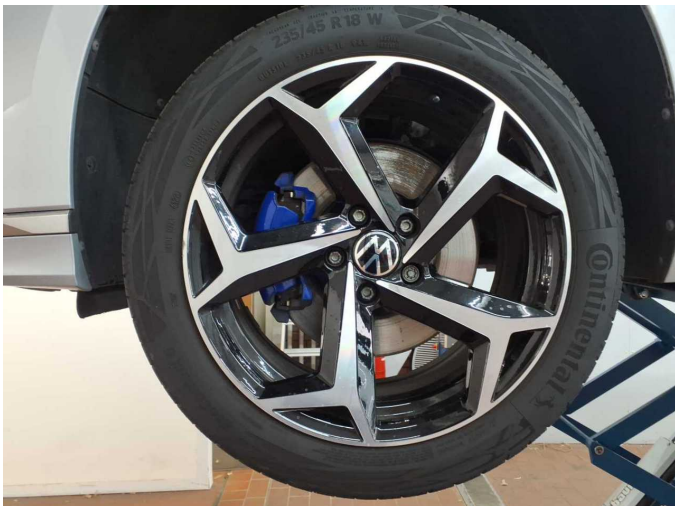
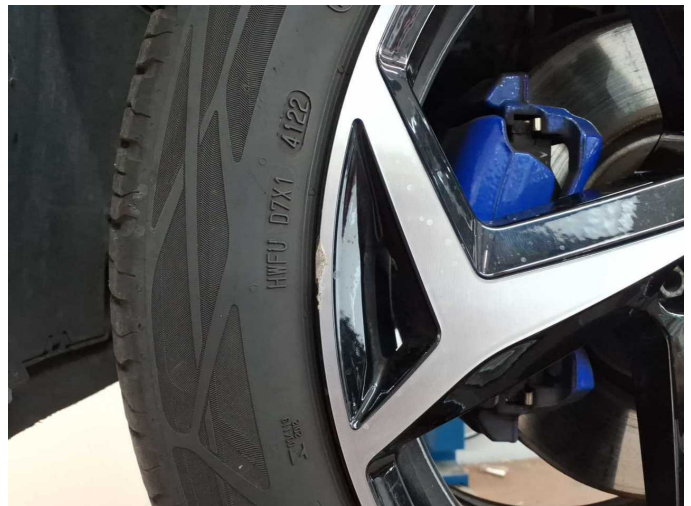
| No. | Component group | Description |
|---|---|---|
| 2 | Wheel / tyres | Alloy rim - front left side - Scratch(es) - Loss in value |

**Damage 2:** Wheel / tyres: Alloy rim - front left side - Scratch(es) - Loss in value

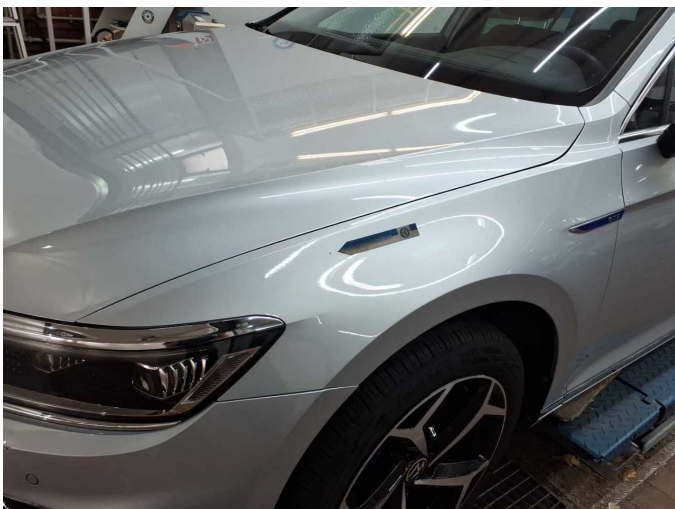
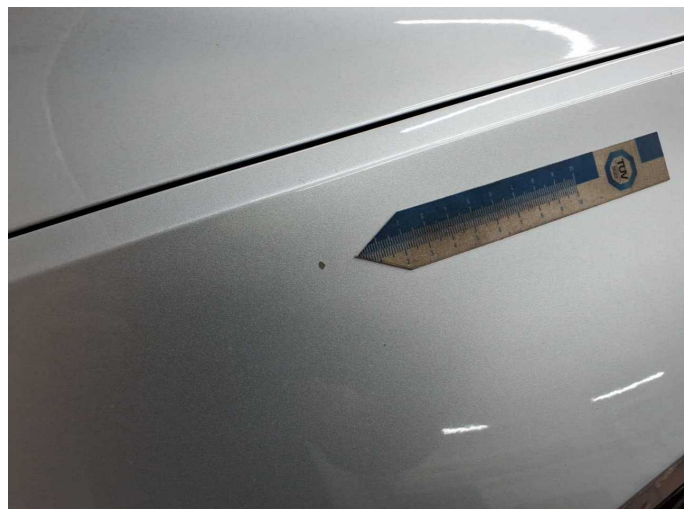
| No. | Component group | Description |
|---|---|---|
| 3 | Mudguard - left side | Mudguard - left side - Scratch(es) - Smart repair |

**Damage 3:** Mudguard - left side: Mudguard - left side - Scratch(es) - Smart repair

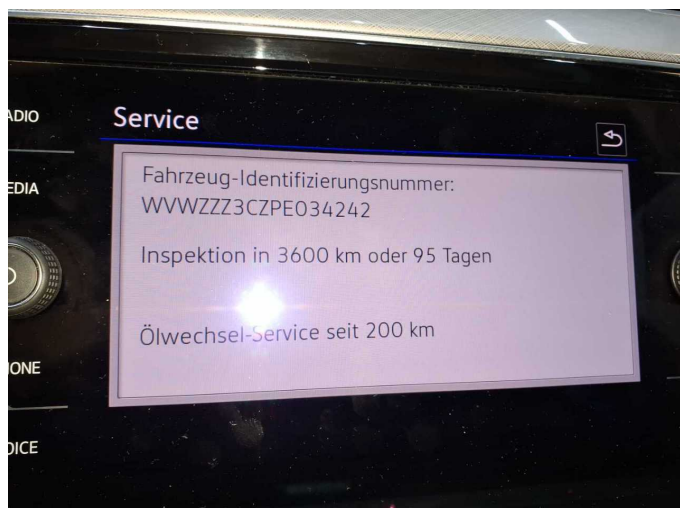
| No. | Component group | Description |
|---|---|---|
| 4 | Misc. | Inspection / maintenance (Kein Nachweis) - Due - Perform |

**Damage 4:** Misc.: Inspection / maintenance (Kein Nachweis) - Due - Perform

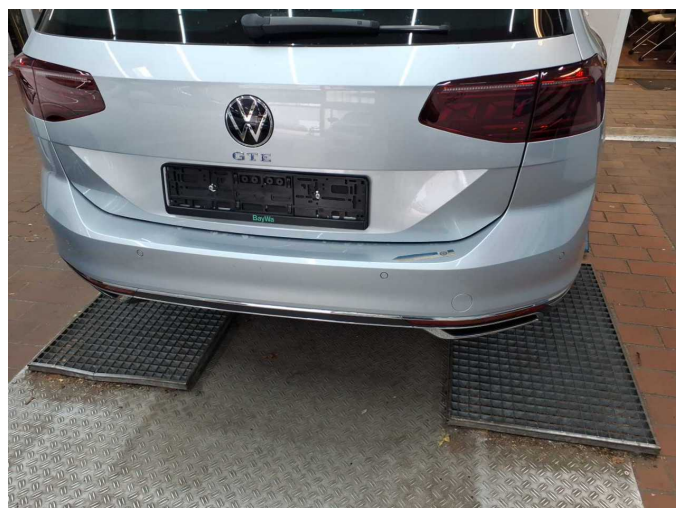
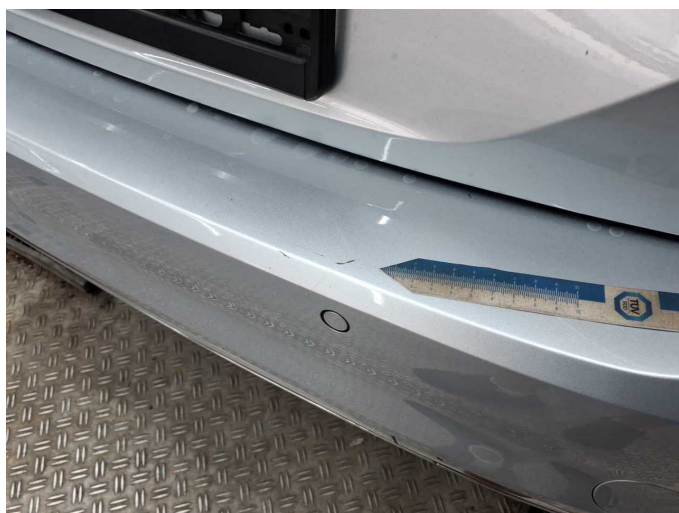
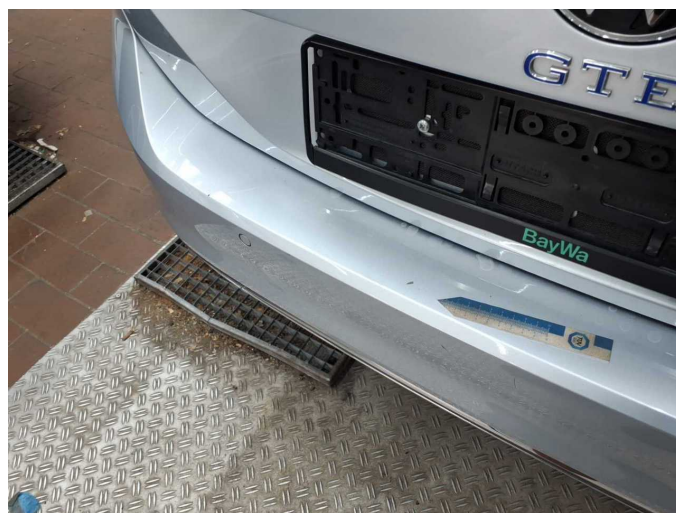
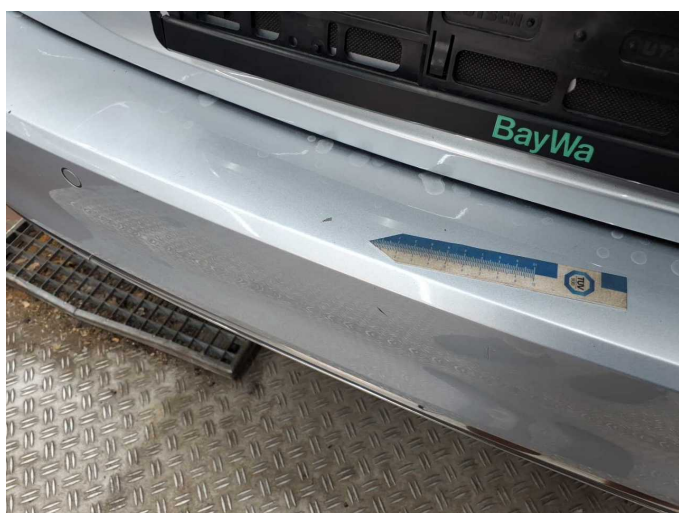
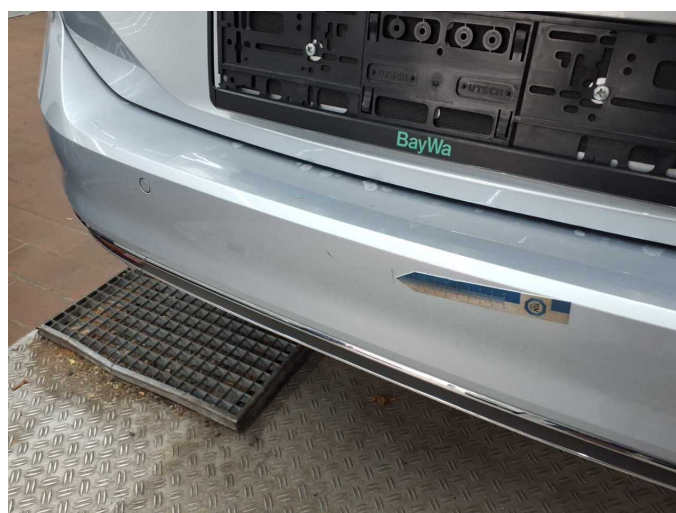
| No. | Component group | Description |
|---|---|---|
| 5 | Rear bumper | Rear bumper - Scratch(es) - Paint |

**Damage 5:** Rear bumper: Rear bumper - Scratch(es) - Paint

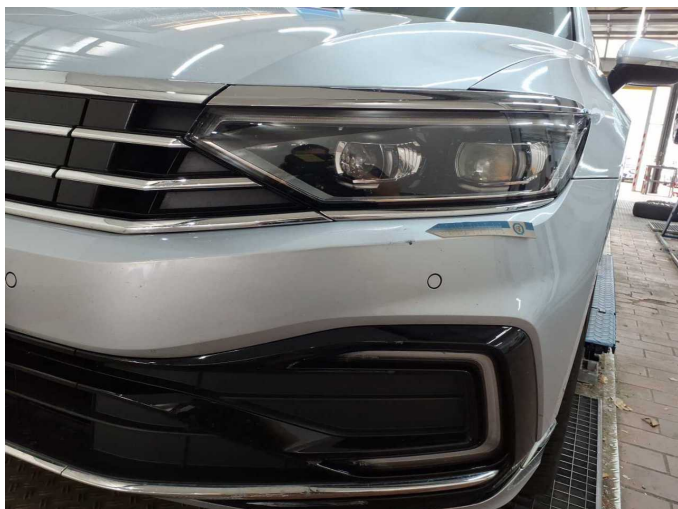
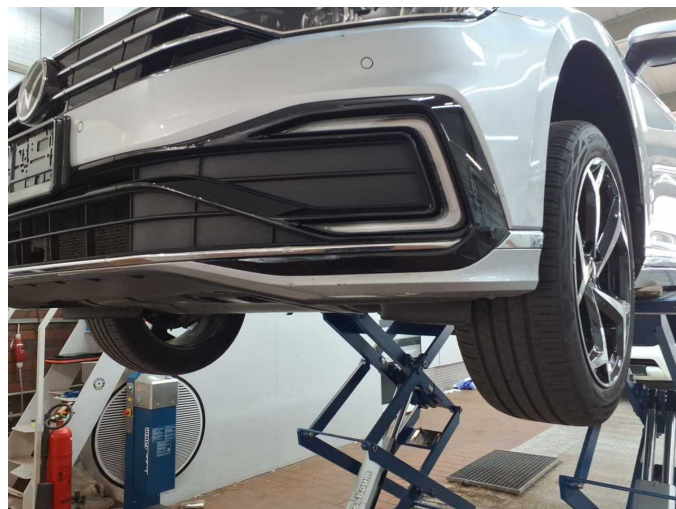
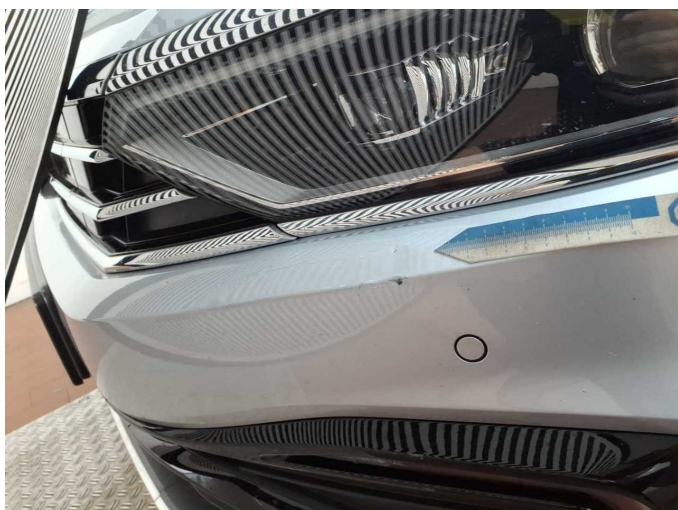
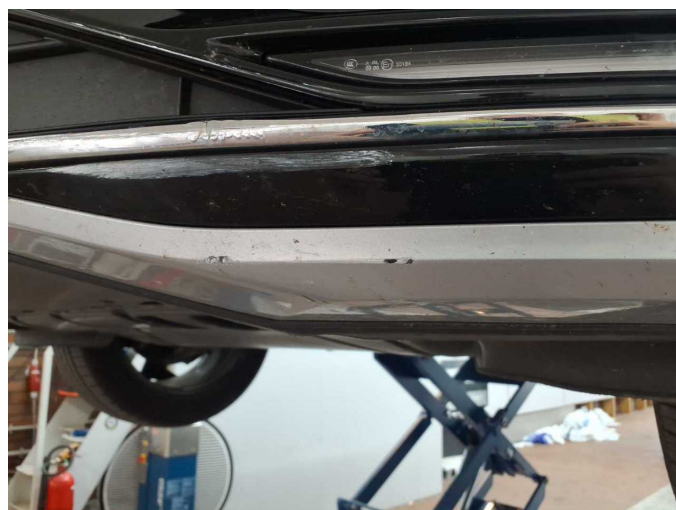
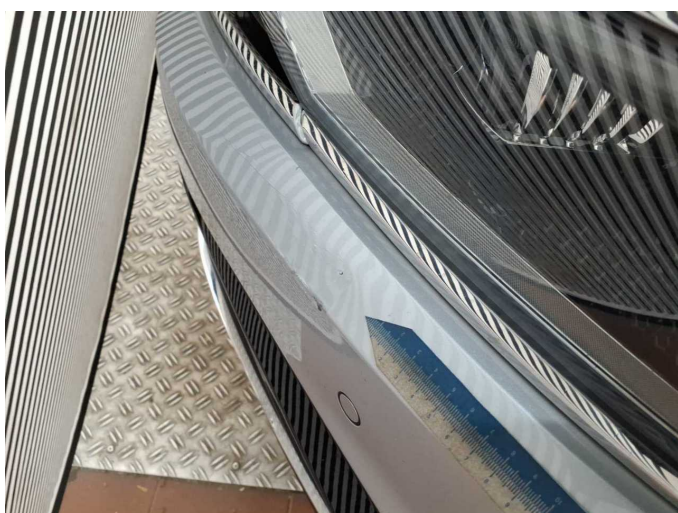
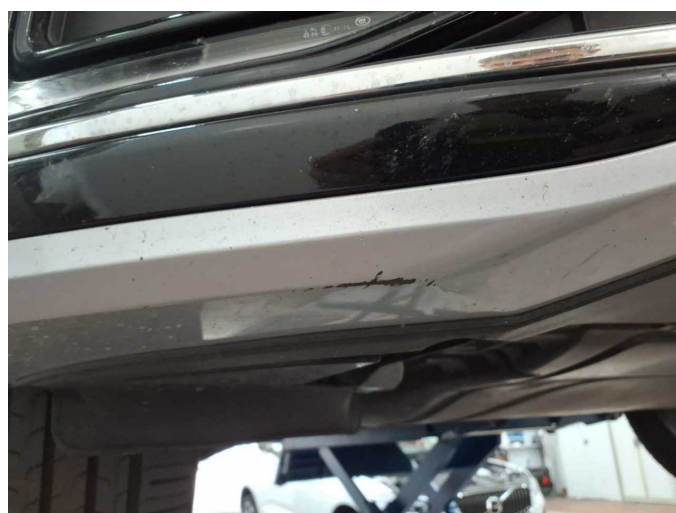
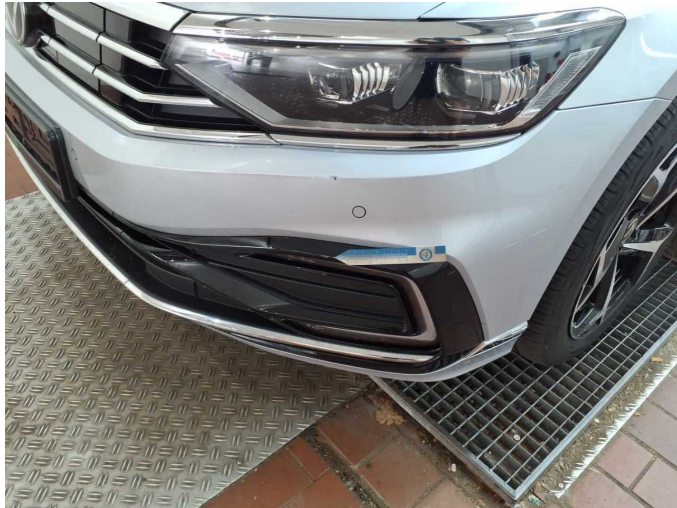
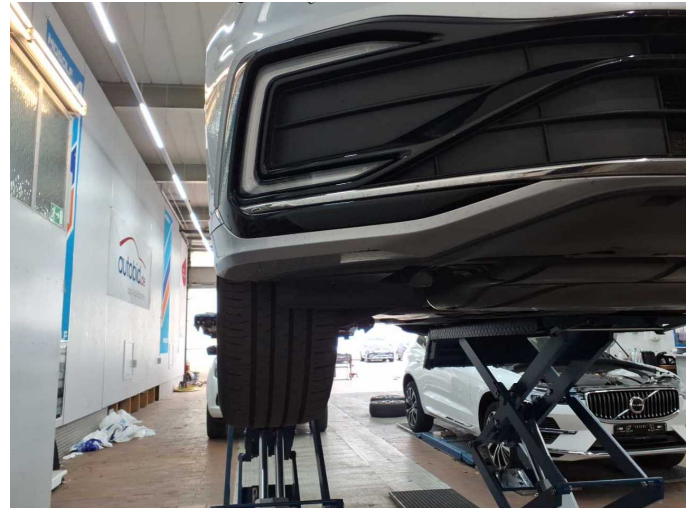
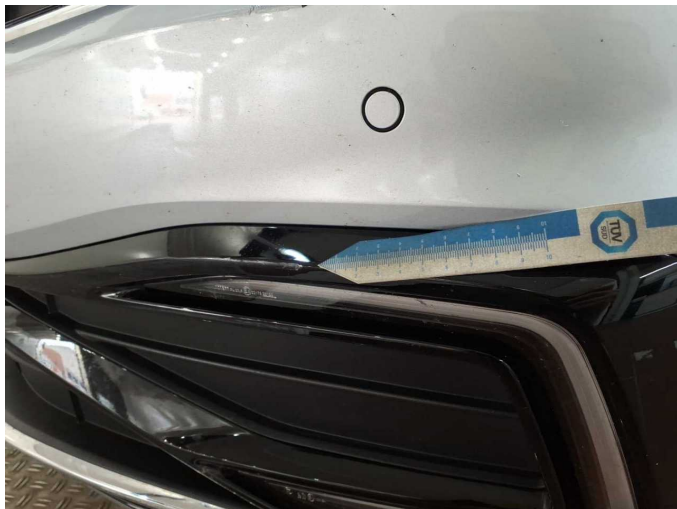
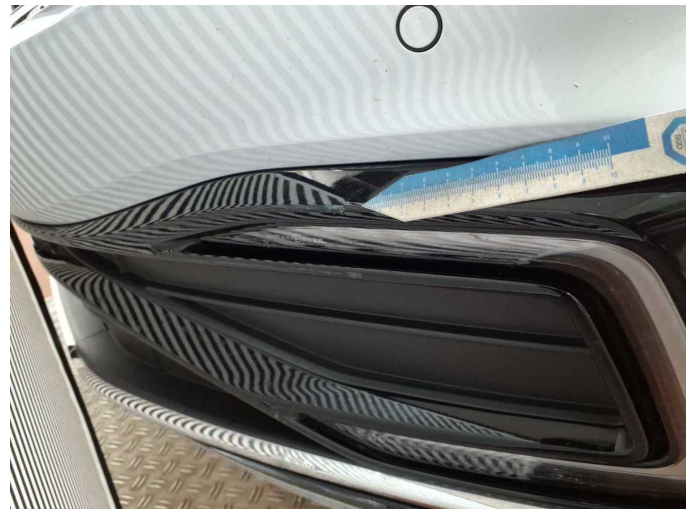
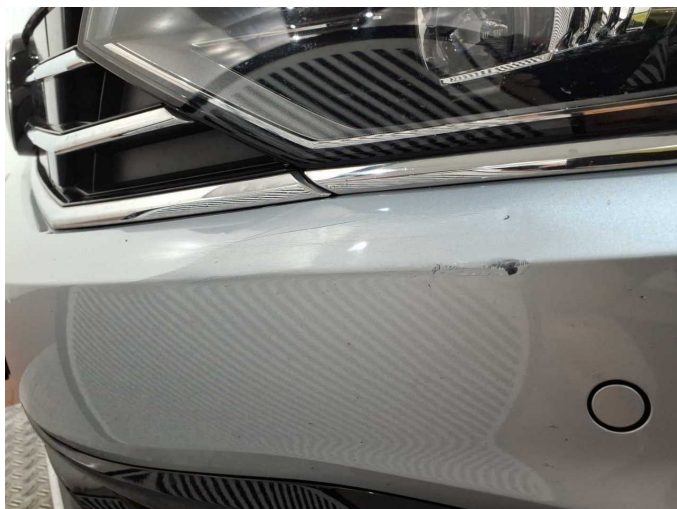
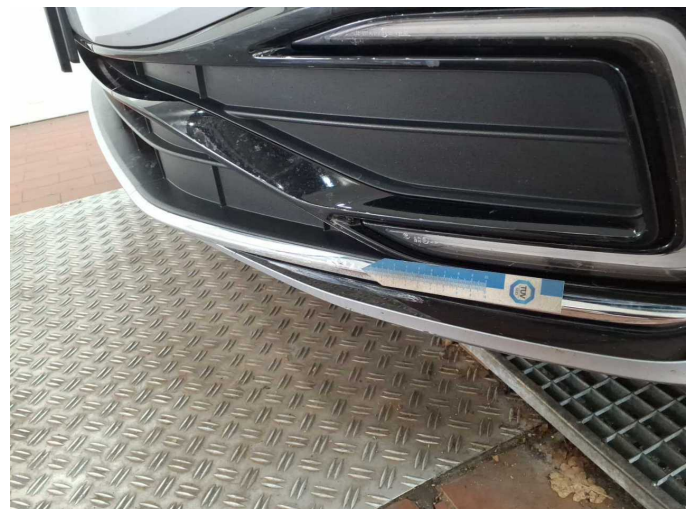
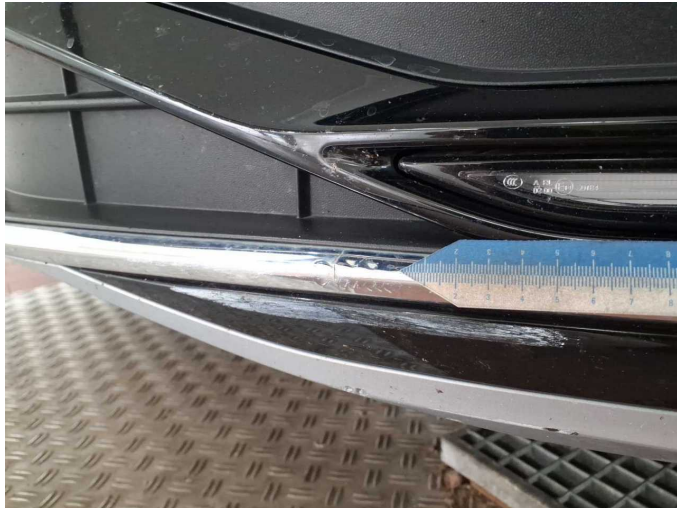
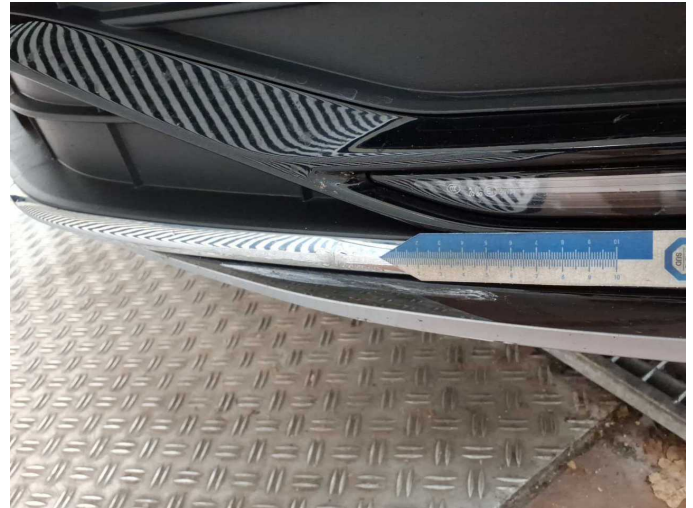
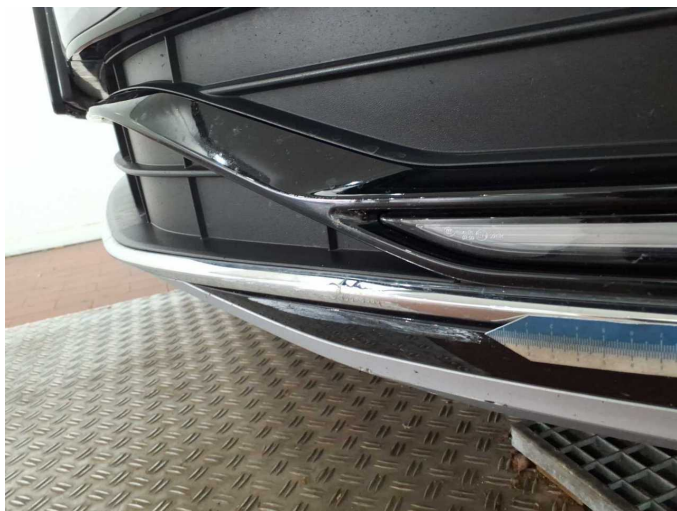
| No. | Component group | Description |
|---|---|---|
| 6 | Front bumper | Front bumper (Mit Blenden L und Zierleiste L+ Spoiler) - Deformed - repair according to calculation |

**Damage 6:** Front bumper: Front bumper (Mit Blenden L und Zierleiste L+ Spoiler) - Deformed - repair according to calculation

Die beigefügte Reparaturkostenkalkulation wurde nach bestem Wissen und Gewissen unter eingeschränkten Besichtigungsbedingung im demontagefreien Zustand erstellt. Es können aufgrund verdeckter Beschädigung, Mehrkosten und somit Abweichung der für die Stoßstange ausgewiesenen Reparaturkosten nicht ausgeschlossen werden.
