Expertise

Protocol number: 46375850  
Order No. / Reference: 26663212  
Inspection date: 6 Jul 2026

Manufacturer: Opel

Model: Insignia Sports Tourer 2.0 Diesel Business

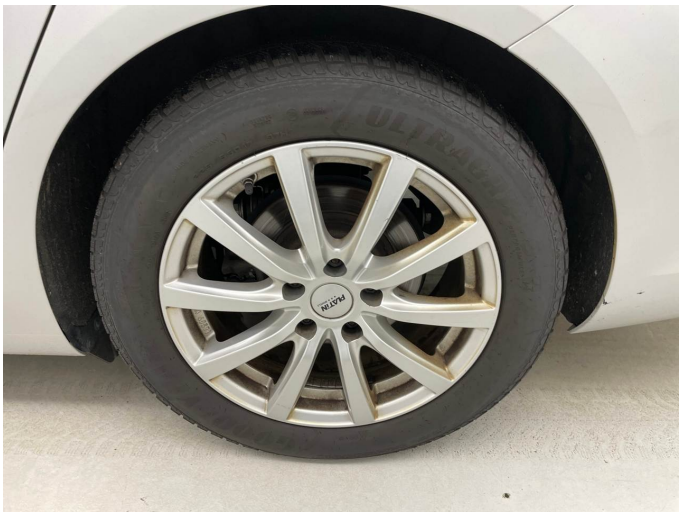
Figure 12: Mounted tyres

| # | Tyre size | Type of tyre | Manufacturer | Tread depth |
|---|---|---|---|---|
| 1) | 225/55 R17 101V | Winter tyres on Light alloy | Pirelli | 5mm / 5mm |
| 2) | 225/55 R17 101V | Winter tyres on Light alloy | Goodyear | 5mm / 5mm |

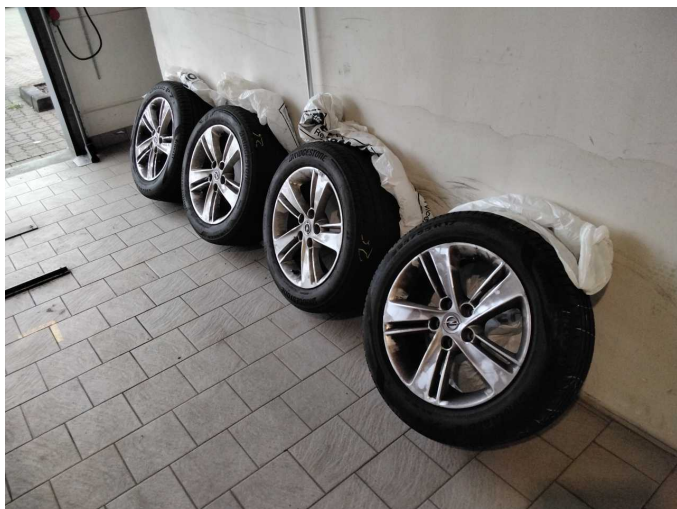
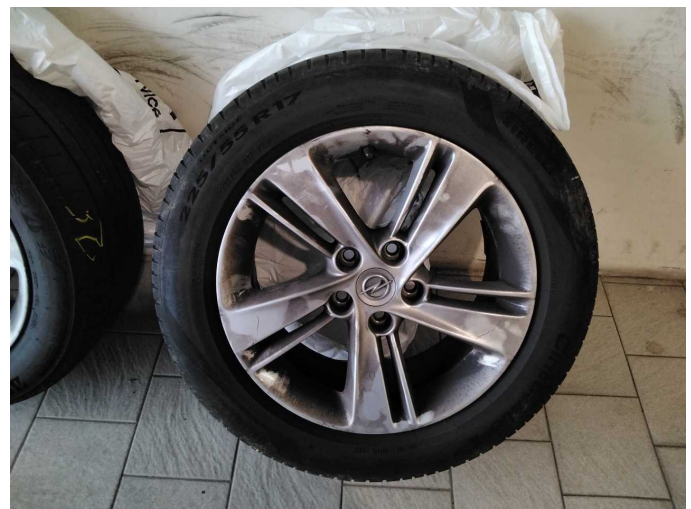
Figure 17: Additional tyres

| # | Tyre size | Type of tyre | Manufacturer | Tread depth |
|---|---|---|---|---|
| 1) | 225/55 R17 97W | Summer tyres on Light alloy | Pirelli | 4mm / 4mm |
| 2) | 225/55 R17 97W | Summer tyres on Light alloy | Pirelli | 4mm / 4mm |

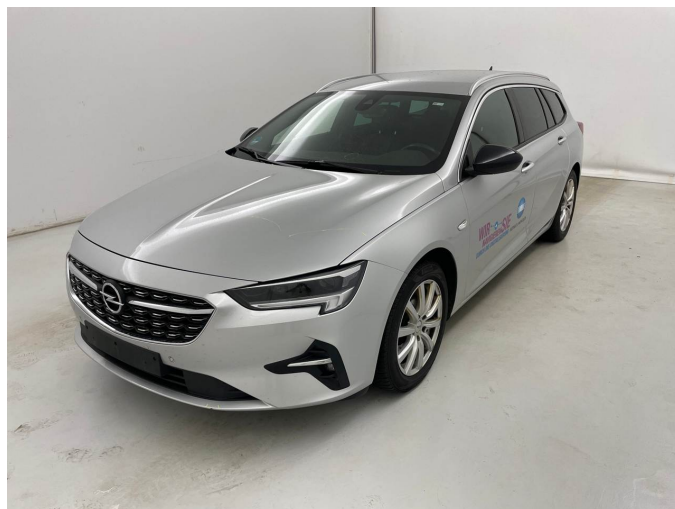
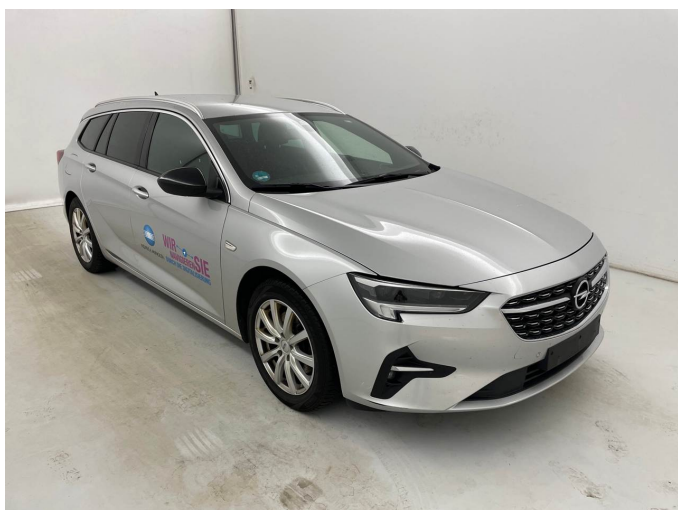
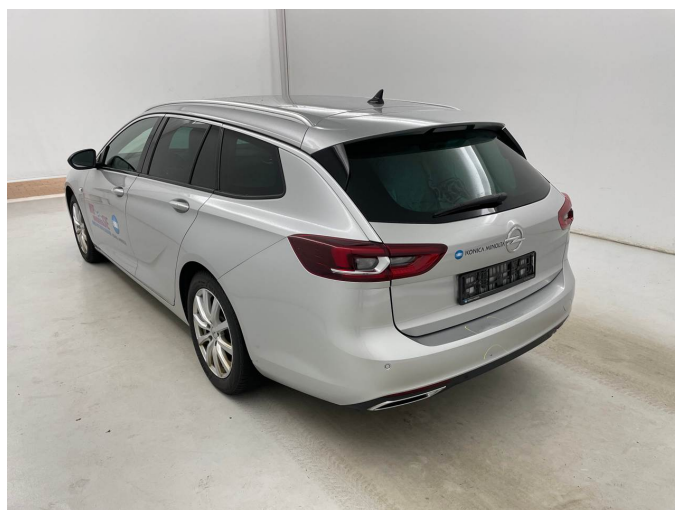
| No. | Component group | Description |
|---|---|---|
| 2 | Body | Body - Glued / labelled - De-glue / neutralise |

**Damage 2:** Body: Body - Glued / labelled - De-glue / neutralise

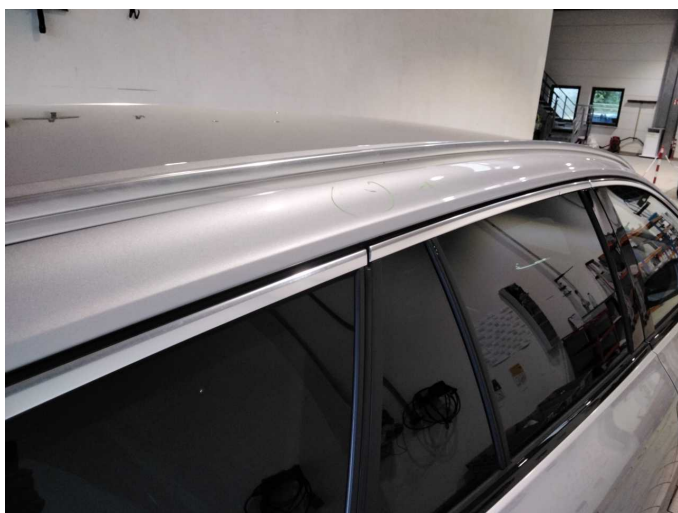
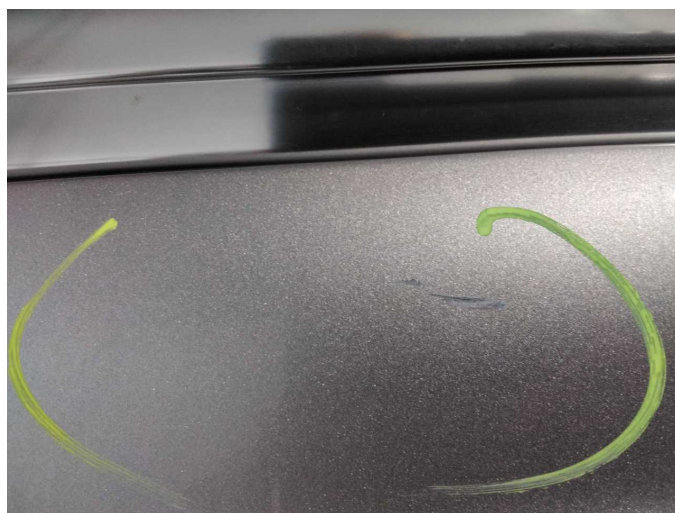
| No. | Component group | Description |
|---|---|---|
| 3 | Roof | Roof rail - right side - Scratch(es) - Smart repair |

**Damage 3:** Roof: Roof rail - right side - Scratch(es) - Smart repair

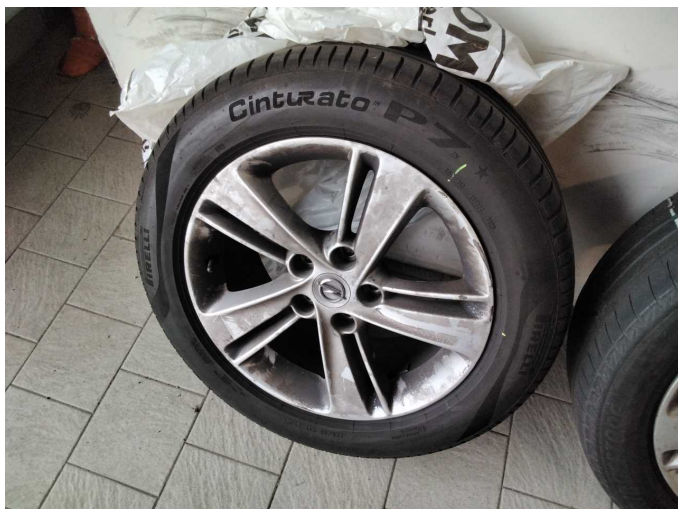
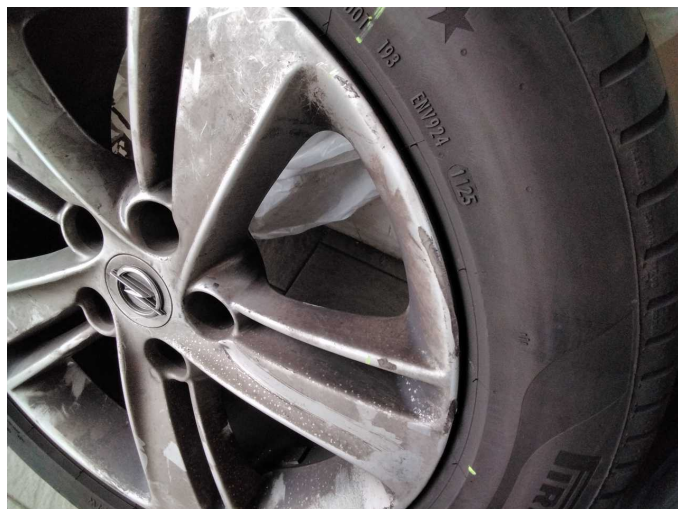
| No. | Component group | Description |
|---|---|---|
| 4 | 2nd wheel set | 1 alloy rim - Scratch(es) - Loss in value |

**Damage 4:** 2nd wheel set: 1 alloy rim - Scratch(es) - Loss in value

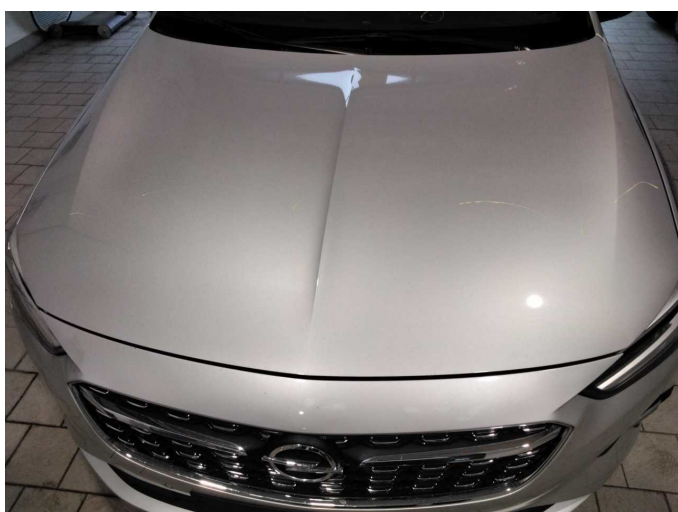
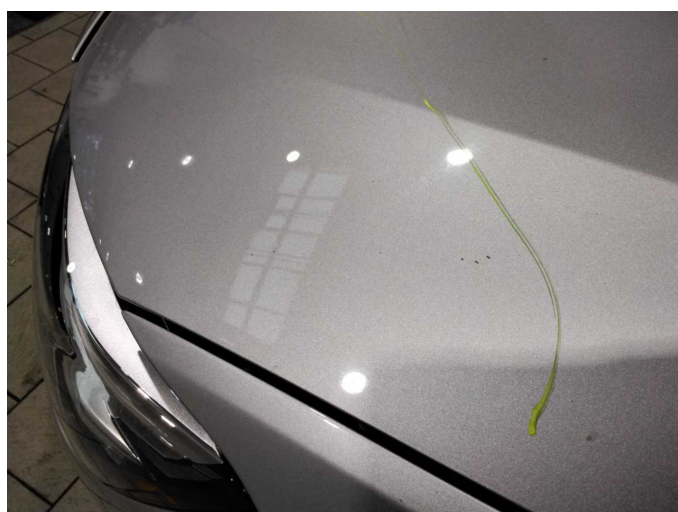
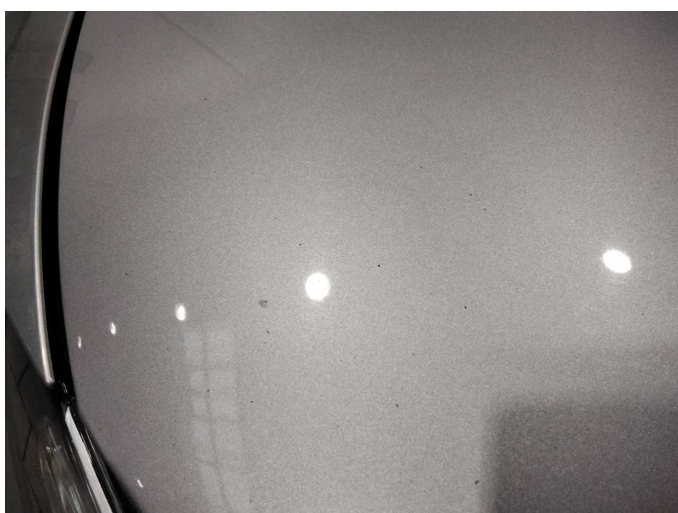
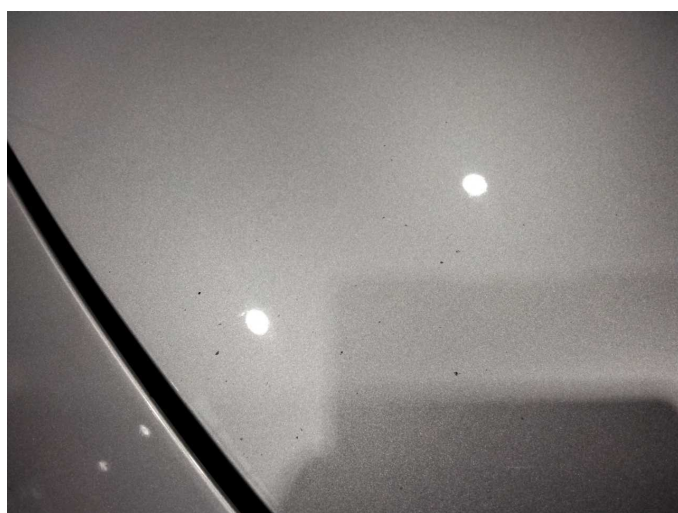
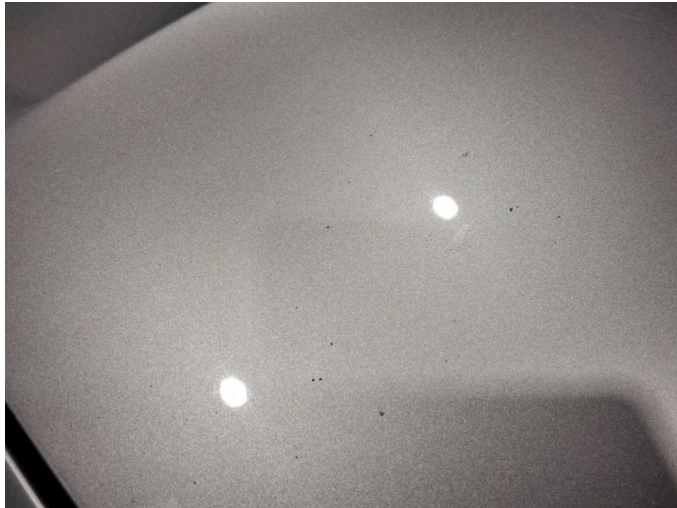
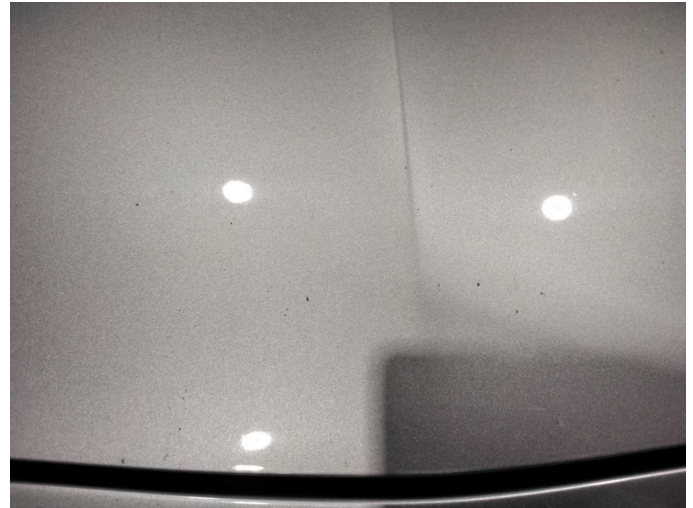
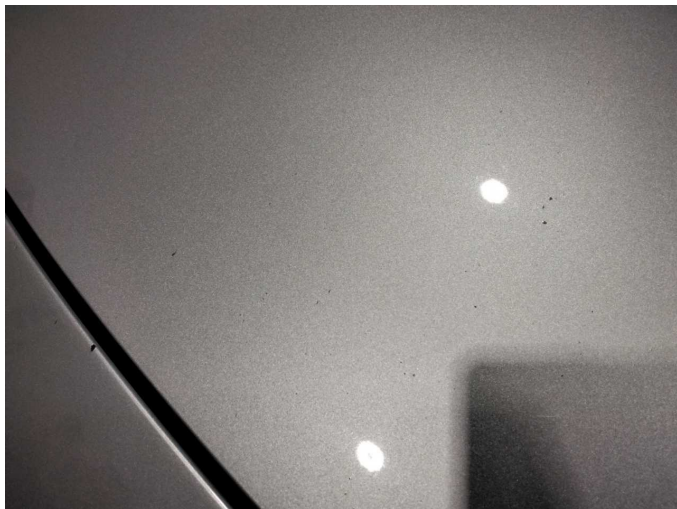
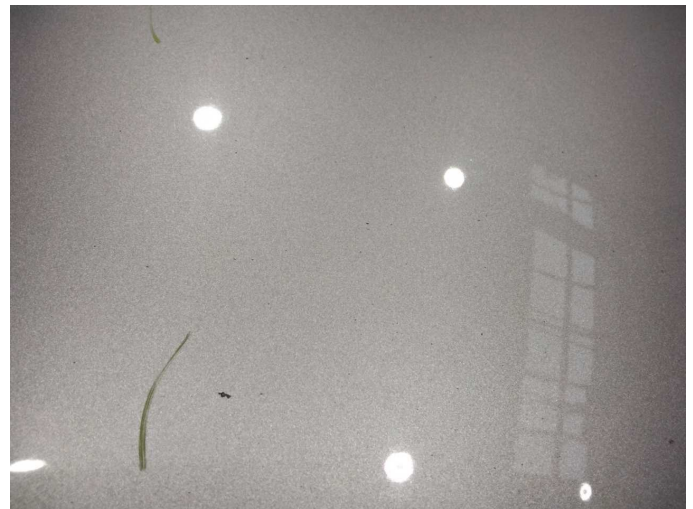
| No. | Component group | Description |
|---|---|---|
| 5 | Bonnet | Bonnet - Stone chips - Paint |

**Damage 5:** Bonnet: Bonnet - Stone chips - Paint

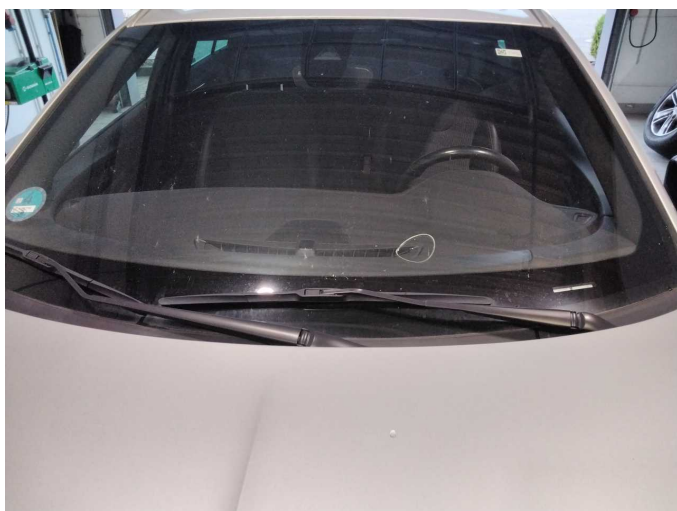
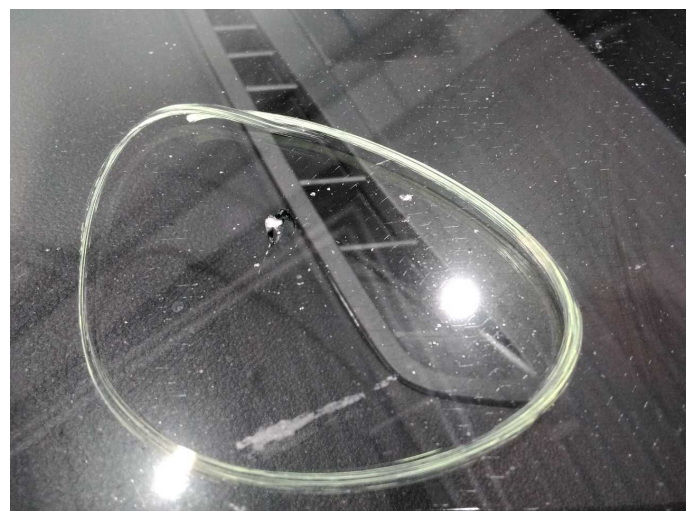
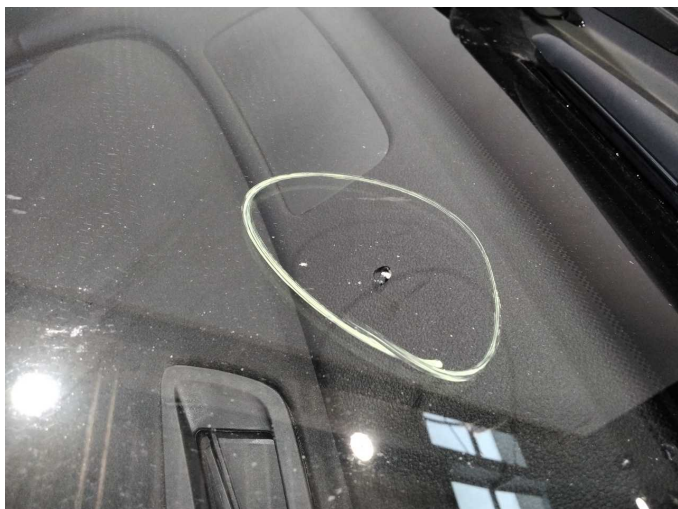
| No. | Component group | Description |
|---|---|---|
| 6 | Vehicle glazing | Windscreen - Stone chips - Replace |

**Damage 6:** Vehicle glazing: Windscreen - Stone chips - Replace

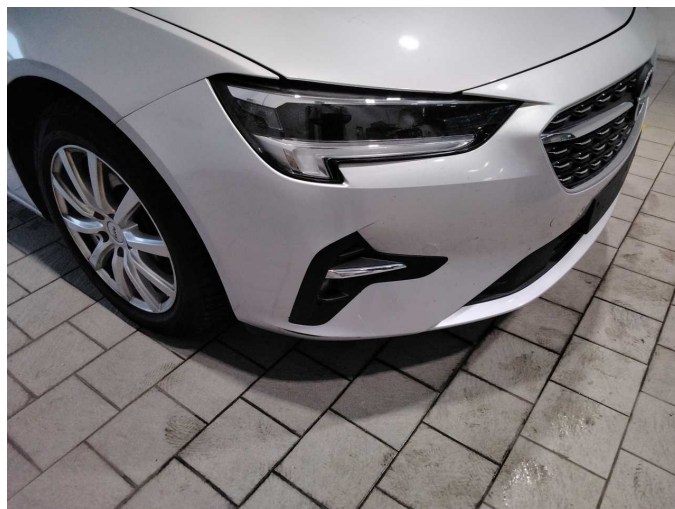
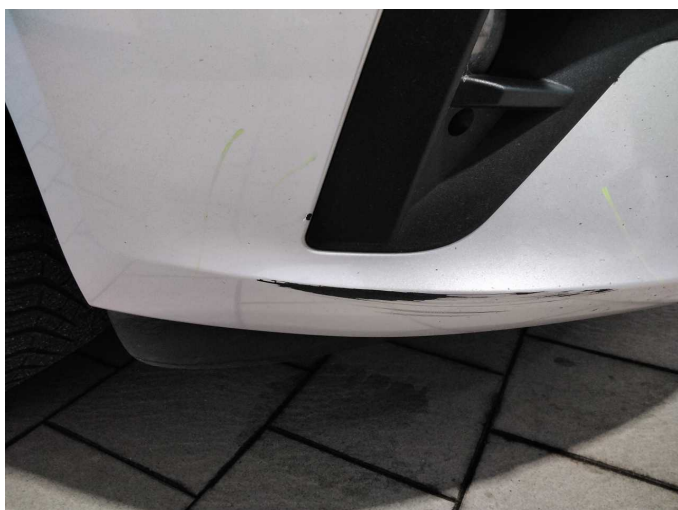
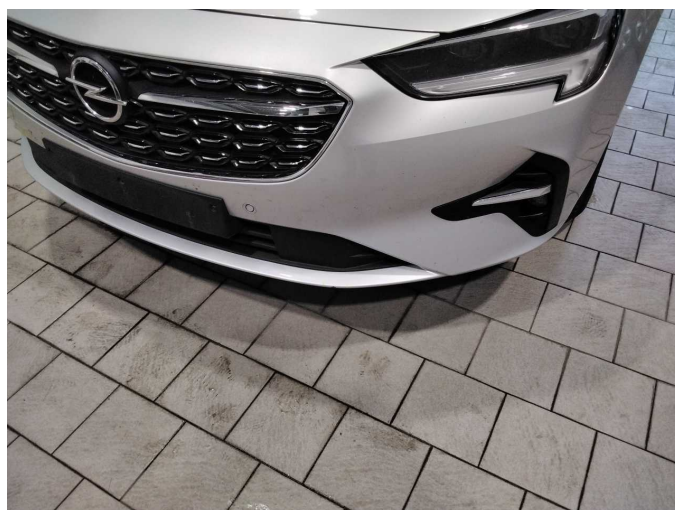
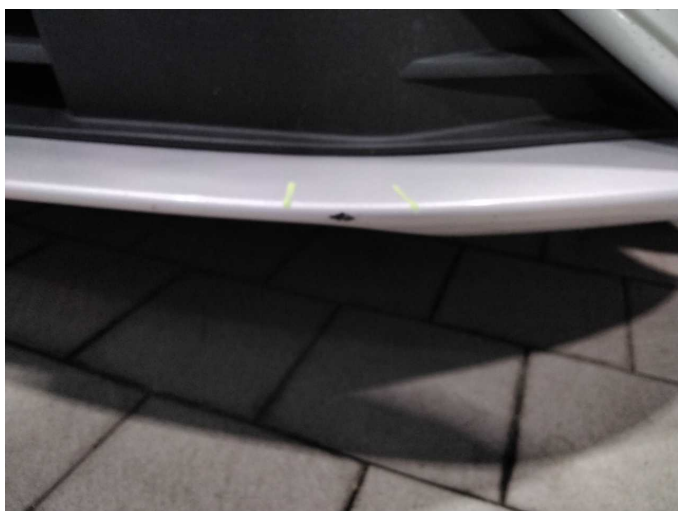
| No. | Component group | Description |
|---|---|---|
| 7 | Front bumper | Front bumper - Scratch(es) - Paint |

**Damage 7:** Front bumper: Front bumper - Scratch(es) - Paint

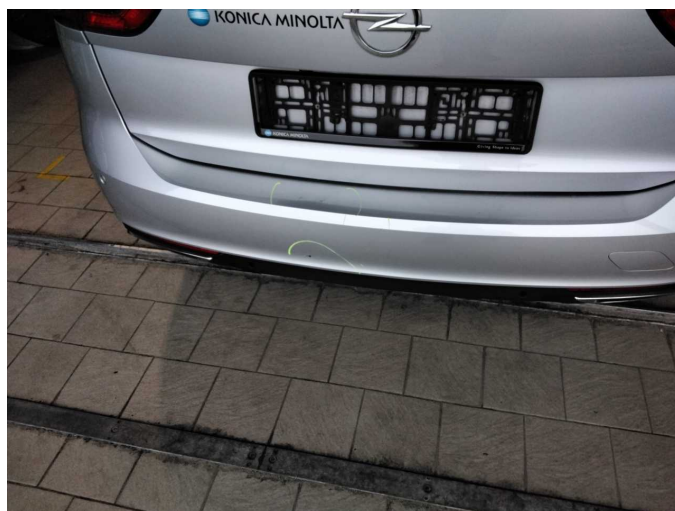
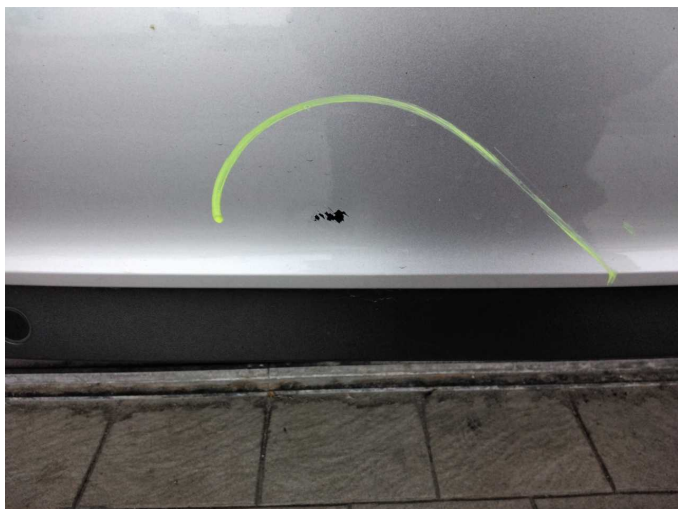
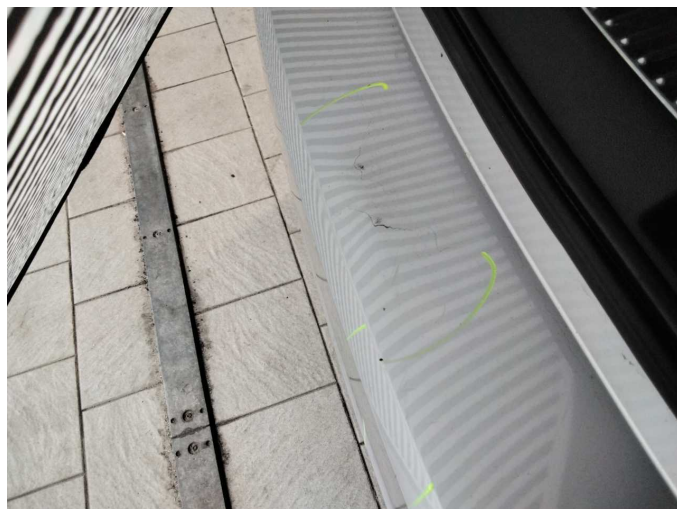
| No. | Component group | Description |
|---|---|---|
| 8 | Rear bumper | Rear bumper - Dent / paintcoat damage - Repair and paint |

**Damage 8:** Rear bumper: Rear bumper - Dent / paintcoat damage - Repair and paint

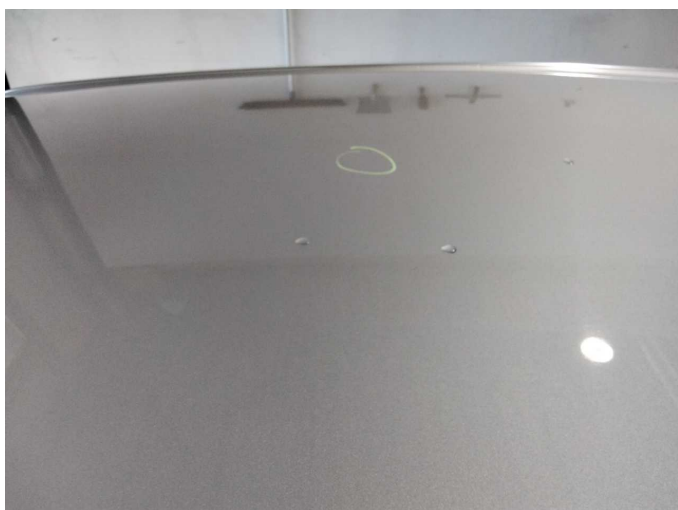
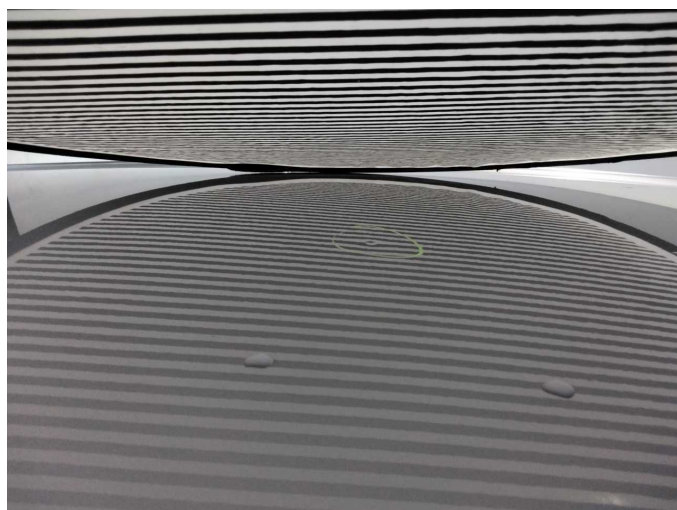
| No. | Component group | Description |
|---|---|---|
| 1 | Roof | Roof - dent(s) - No deduction |

**Wear and tear 1:** Roof: Roof - dent(s) - No deduction

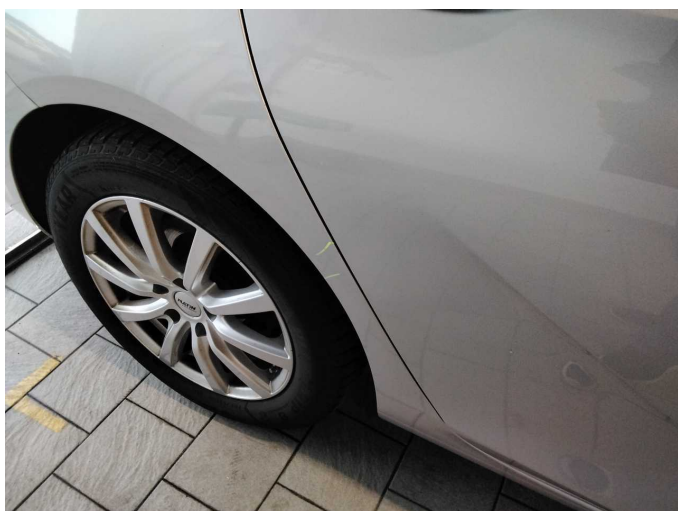
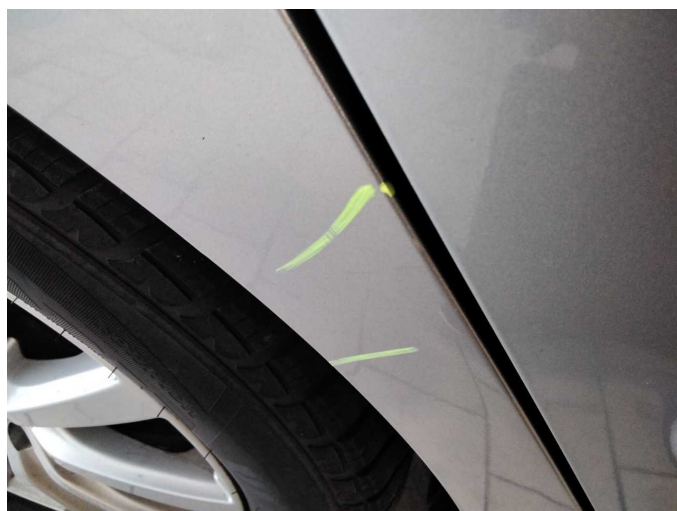
| No. | Component group | Description |
|---|---|---|
| 2 | Side panel - rear right side | Side panel - Scratch(es) - No deduction |

**Wear and tear 2:** Side panel - rear right side: Side panel - Scratch(es) - No deduction
