Expertise

Protocol number: 46605222  
Order No. / Reference: 26727202  
Inspection date: 14 Jul 2026

Manufacturer: Volkswagen

Model: Golf Variant 2.0 TDI SCR DSG Life

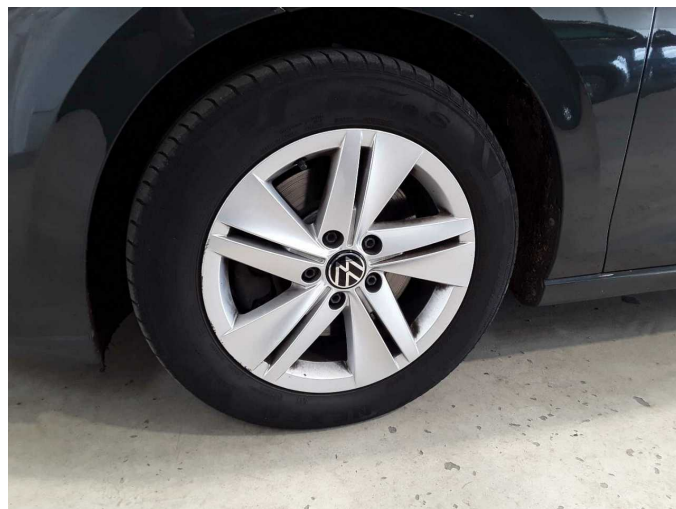
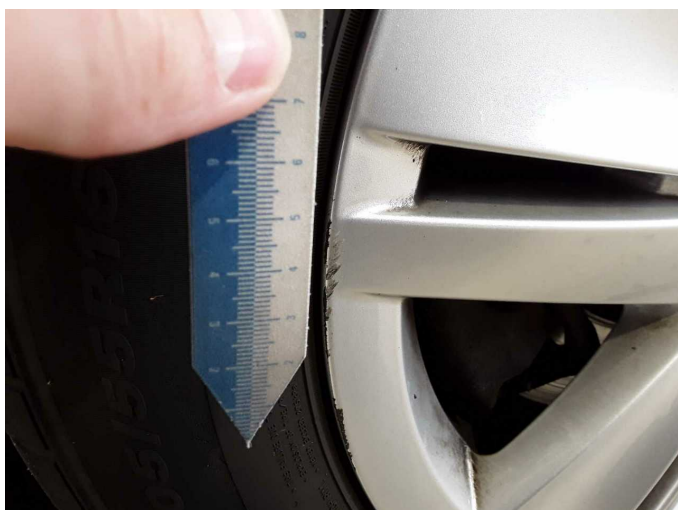
**Damage 1:** Wheel / tyres: Alloy rim - front left side - Scratch(es) - Loss in value

| No. | Component group | Description |
|---|---|---|
| 1 | Wheel / tyres | Alloy rim - front left side - Scratch(es) - Loss in value |

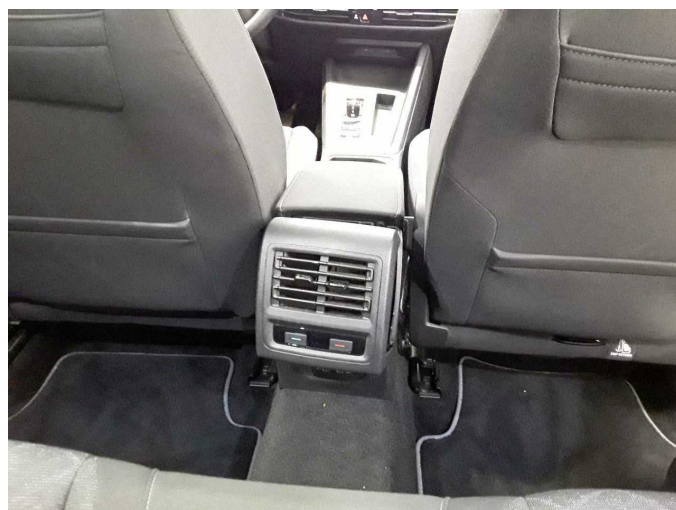
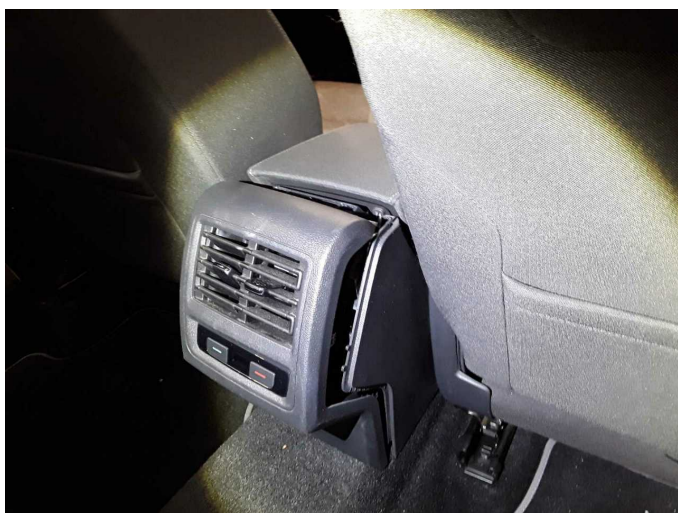
**Damage 2:** Instrument panel: Air nozzle - centre - Malposition - Un- / install

| No. | Component group | Description |
|---|---|---|
| 2 | Instrument panel | Air nozzle - centre - Malposition - Un- / install |

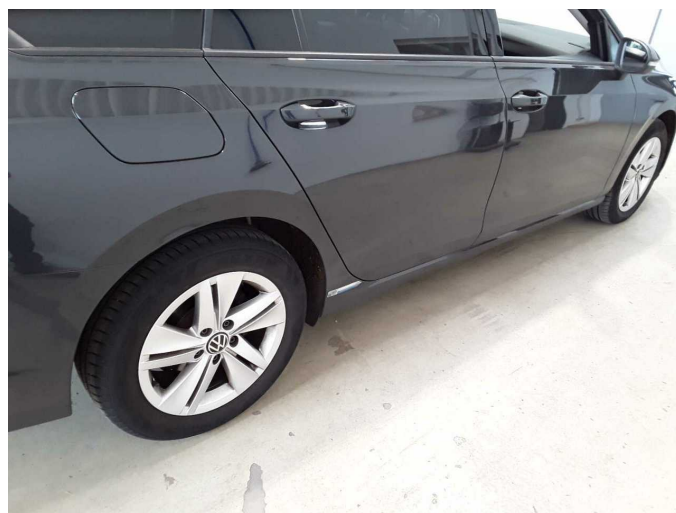
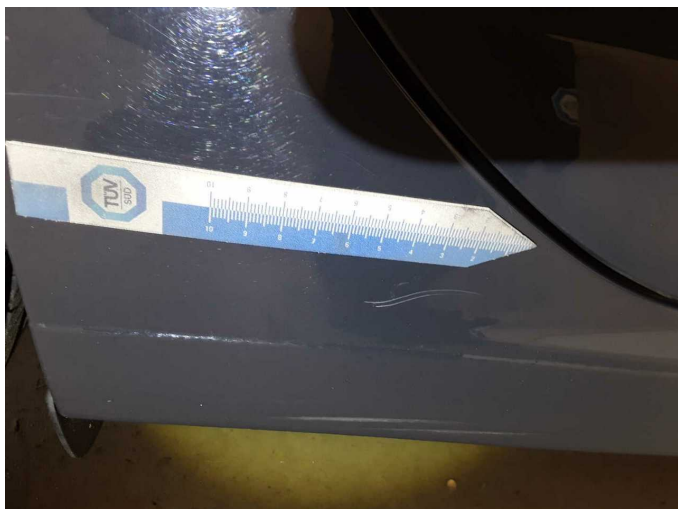
**Damage 3:** Sill - right side: Sill - Scratch(es) - Smart repair

| No. | Component group | Description |
|---|---|---|
| 3 | Sill - right side | Sill - Scratch(es) - Smart repair |

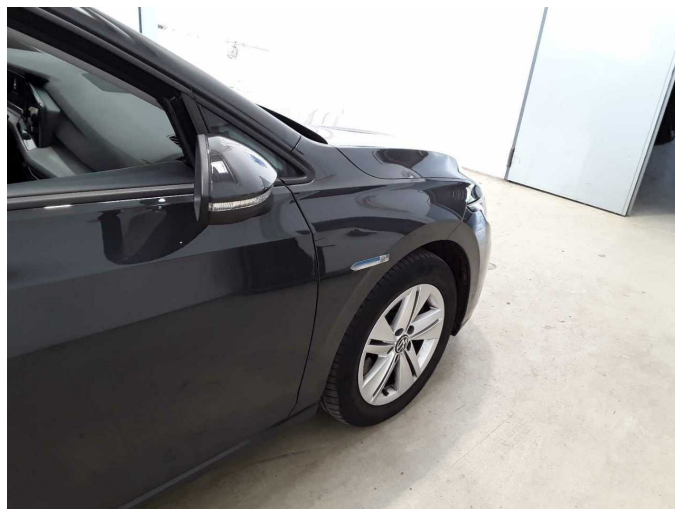
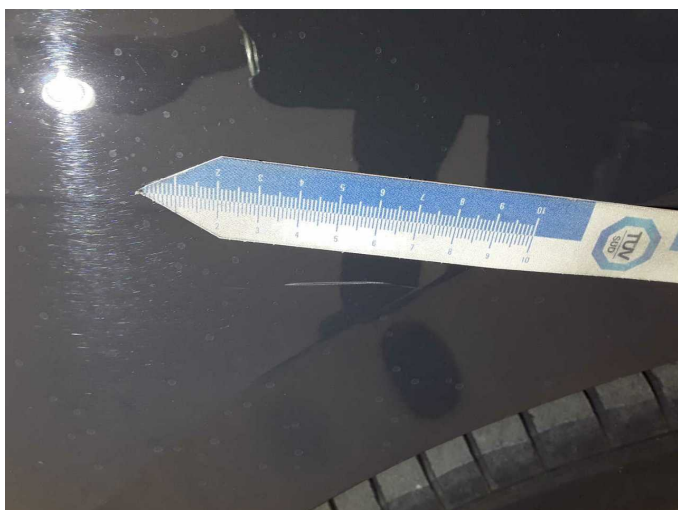
**Damage 4:** Mudguard - right side: Mudguard - right side - Scratch(es) - Paint

| No. | Component group | Description |
|---|---|---|
| 4 | Mudguard - right side | Mudguard - right side - Scratch(es) - Paint |

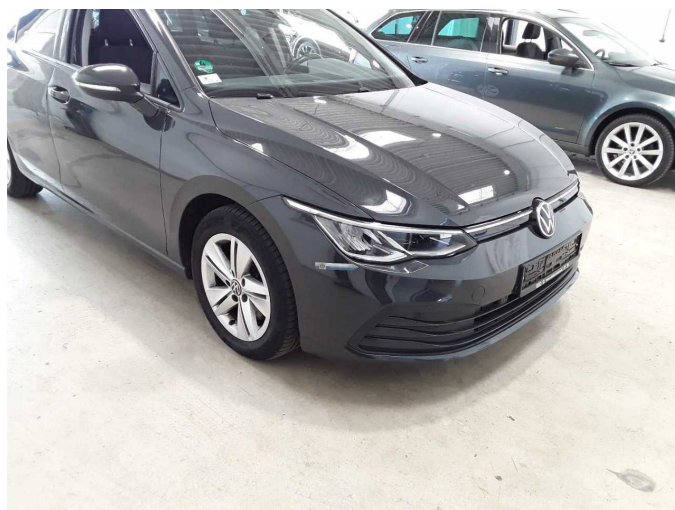
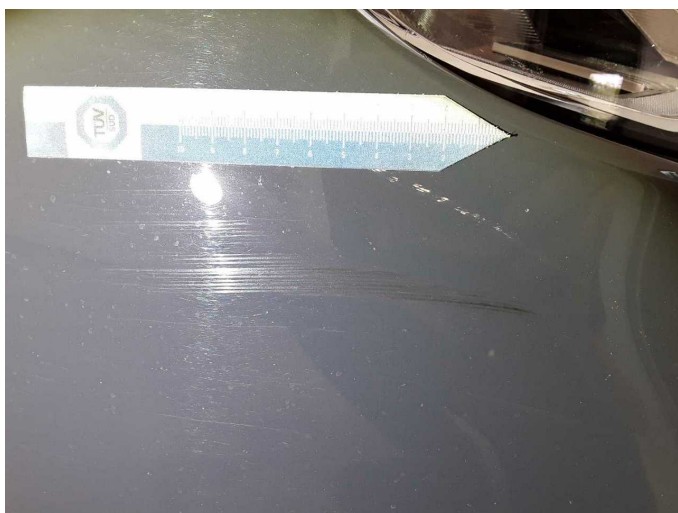
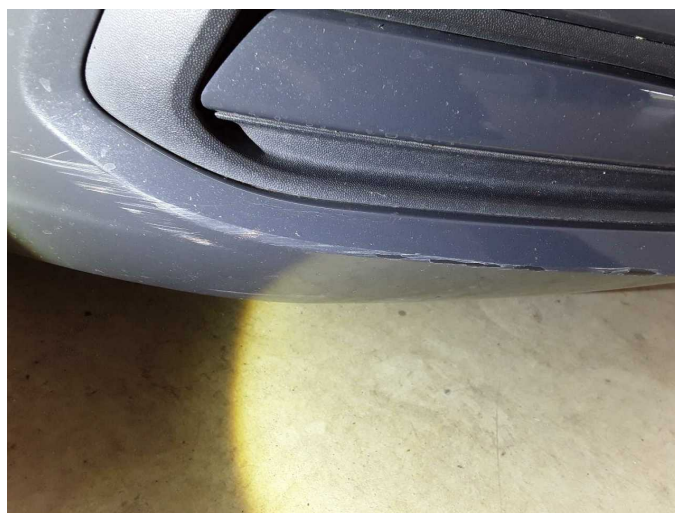
**Damage 5:** Front bumper: Front bumper - Scratch(es) - Paint

| No. | Component group | Description |
|---|---|---|
| 5 | Front bumper | Front bumper - Scratch(es) - Paint |

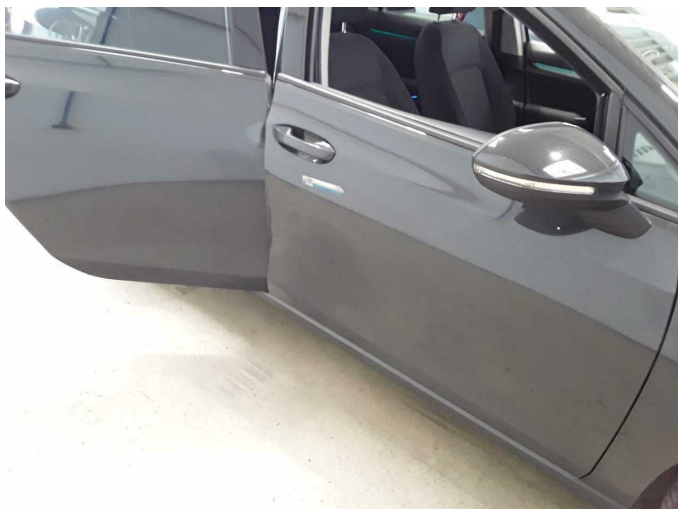
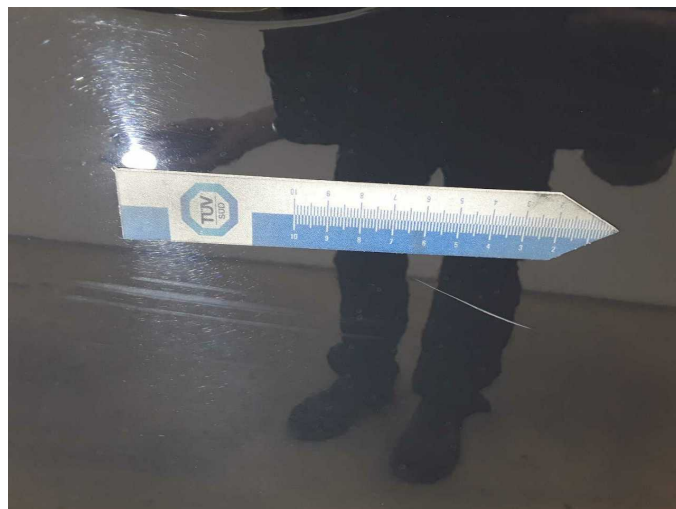
**Damage 6:** Door - front right side: Door - Scratch(es) - Paint

| No. | Component group | Description |
|---|---|---|
| 6 | Door - front right side | Door - Scratch(es) - Paint |

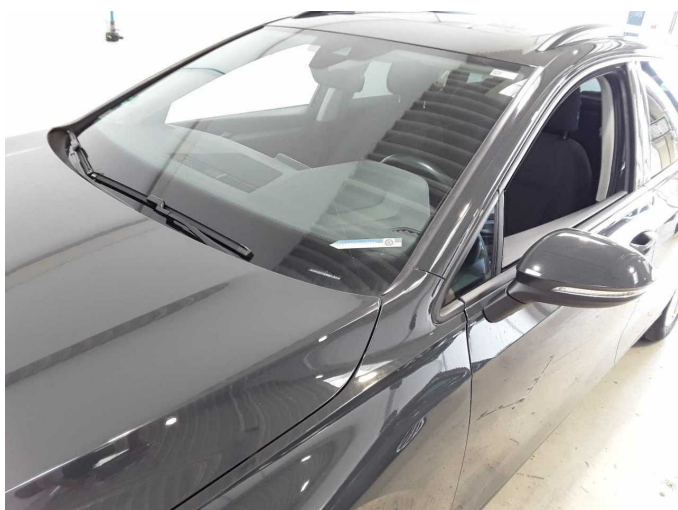
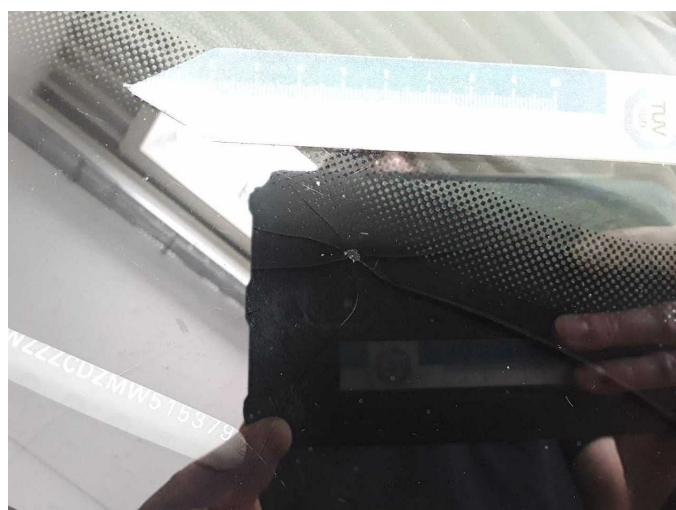
**Damage 7:** Vehicle glazing: Windscreen - Broken / torn - Replace

| No. | Component group | Description |
|---|---|---|
| 7 | Vehicle glazing | Windscreen - Broken / torn - Replace |

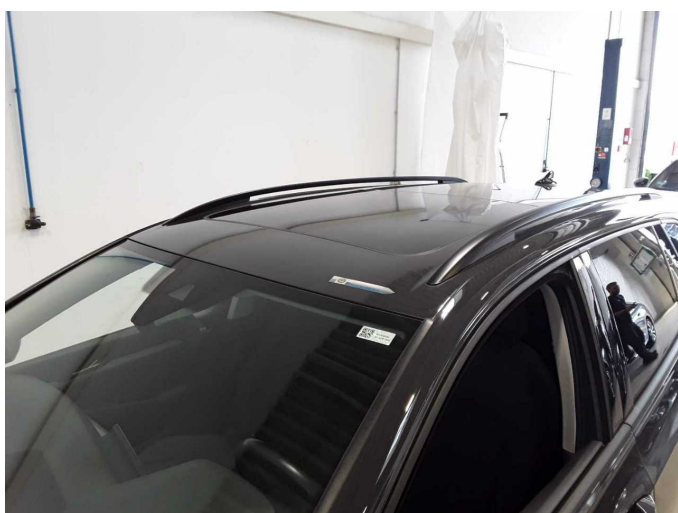
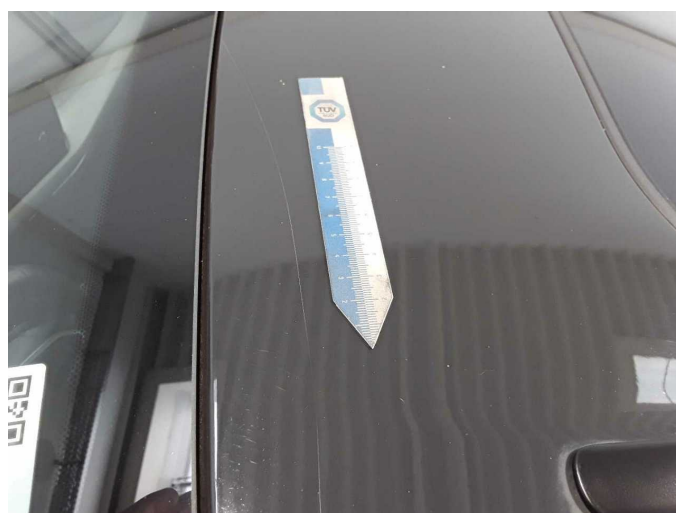
**Damage 8:** Roof: Roof - Scratch(es) - Paint

| No. | Component group | Description |
|---|---|---|
| 8 | Roof | Roof - Scratch(es) - Paint |
