Expertise

Protocol number: 46706265  
Order No. / Reference: 26495895-1  
Inspection date: 23 Jul 2026

Manufacturer: Mercedes-Benz  
VIN: W1NKM0KB0TF536081

Model: GLC 300 de 4Matic 9G-TRONIC AMG Line Advanced

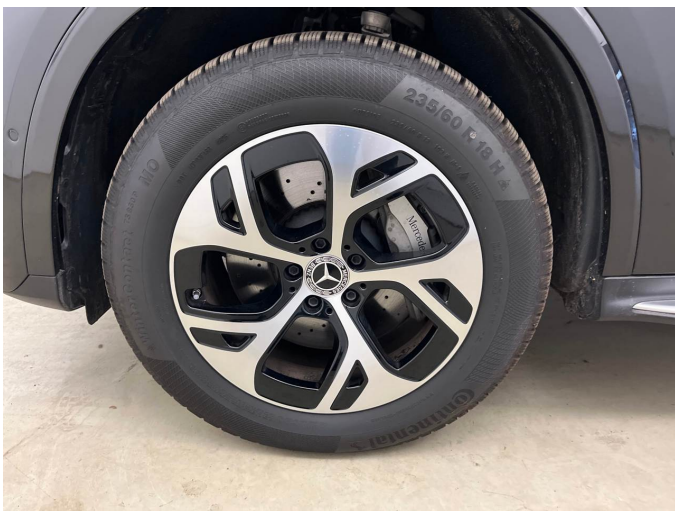
Figure 11: Mounted tyres

| # | Tyre size | Type of tyre | Manufacturer | Tread depth |
|---|---|---|---|---|
| 1) | 235/60 R18 103H | Winter tyres on Light alloy | Continental | 7mm / 7mm |
| 2) | 255/55 R18 109H | Winter tyres on Light alloy | Continental | 7mm / 7mm |

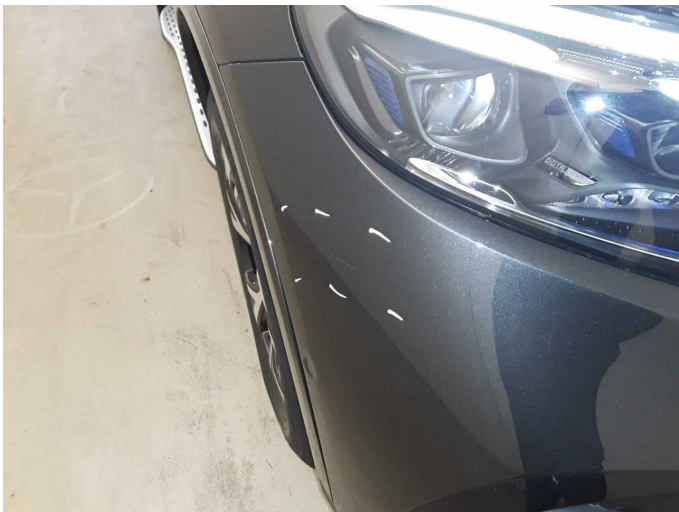
Damage 1: Front bumper: Front bumper - Scratch(es) - Smart repair

| No. | Component group | Description |
|---|---|---|
| 1 | Front bumper | Front bumper - Scratch(es) - Smart repair |

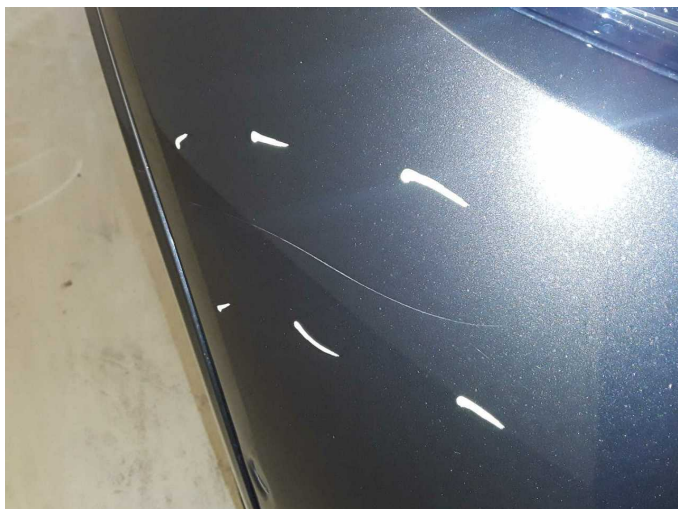
**Damage 1:** Front bumper: Front bumper - Scratch(es) - Smart repair

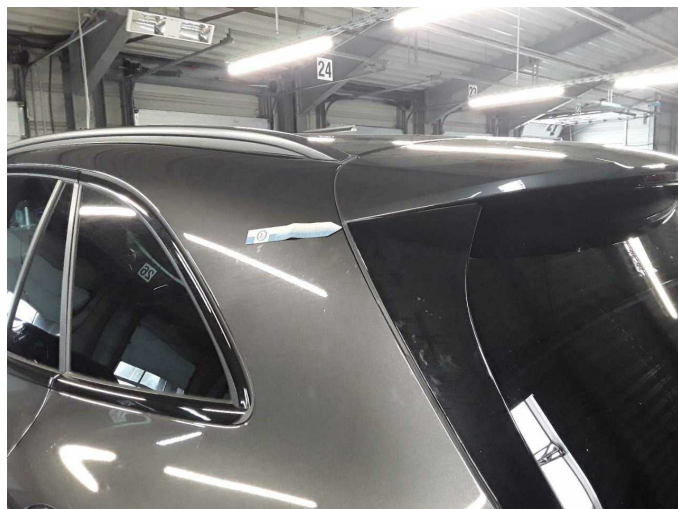
**Damage 2:** Boot lid / rear door: Boot lid (Verkleidung links Leiste befestigung beschädigt) - Damaged - Replace

| No. | Component group | Description |
|---|---|---|
| 2 | Boot lid / rear door | Boot lid (Verkleidung links Leiste befestigung beschädigt) - Damaged - Replace |

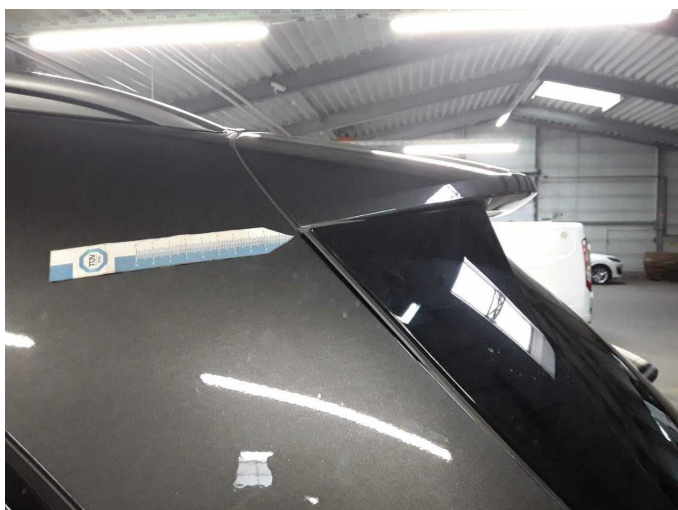
**Damage 2:** Boot lid / rear door: Boot lid (Verkleidung links Leiste befestigung beschädigt) - Damaged - Replace

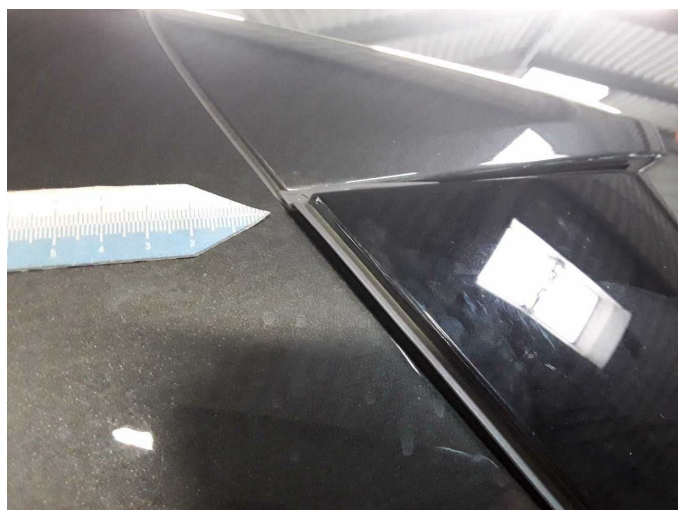
**Damage 2:** Boot lid / rear door: Boot lid (Verkleidung links Leiste befestigung beschädigt) - Damaged - Replace
