Expertise

Protocol number: 46507132  
Order No. / Reference: 26576653  
Inspection date: 9 Jul 2026

Model: Leon Sportstourer 2.0 TDI Style

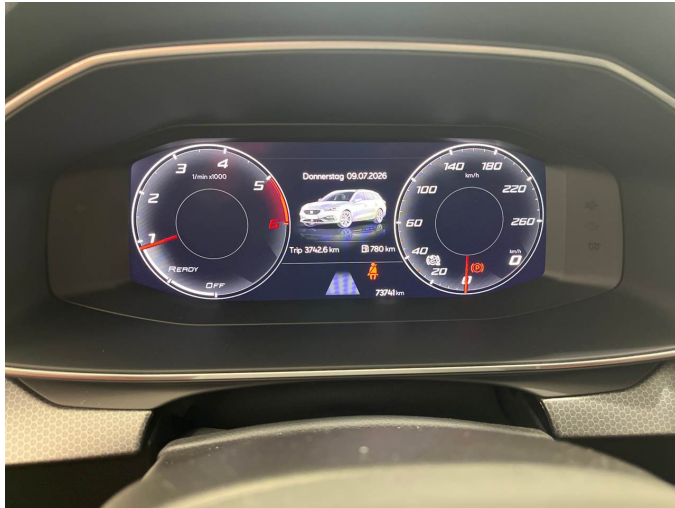
Figure 7: Instrument cluster

Mileage (Read) 73,741 km

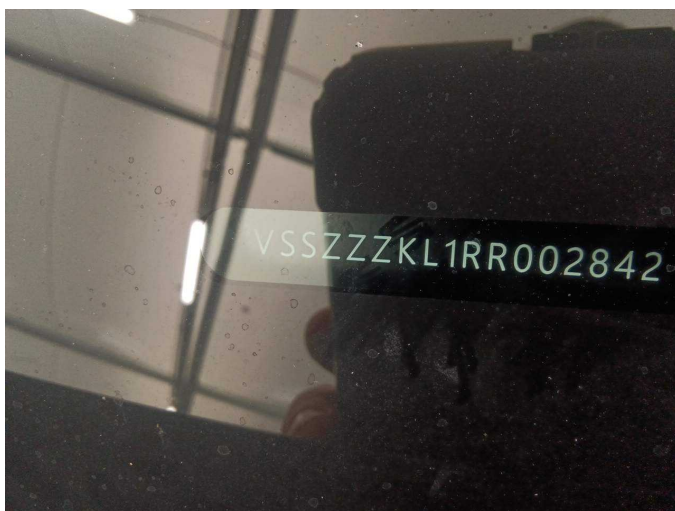
Figure 11: VIN

| VIN comparison | The vehicle identification number (VIN) was read from the vehicle and its conformity with the submitted documents was confirmed by the undersigned during the inspection. |

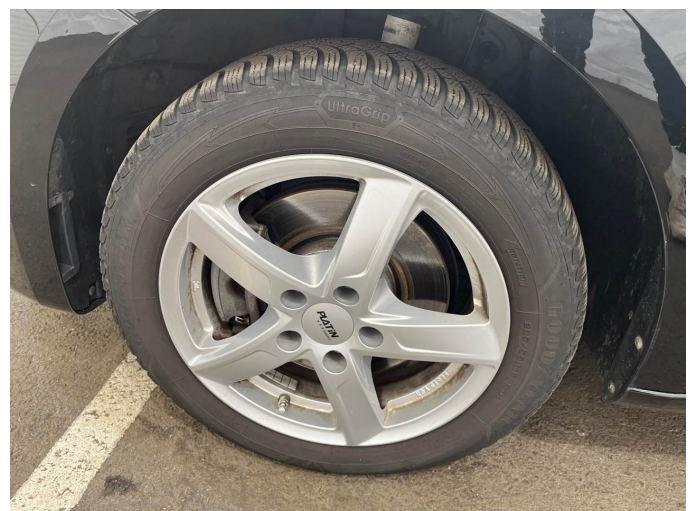
Figure 12: Mounted tyres

| Tyres | | | | |
|---|---|---|---|---|
| 1) | 205/55 R16 91H | Winter tyres on Light alloy | Goodyear | 5mm / 5mm |
| 2) | 205/55 R16 91H | Winter tyres on Light alloy | Goodyear | 6mm / 6mm |

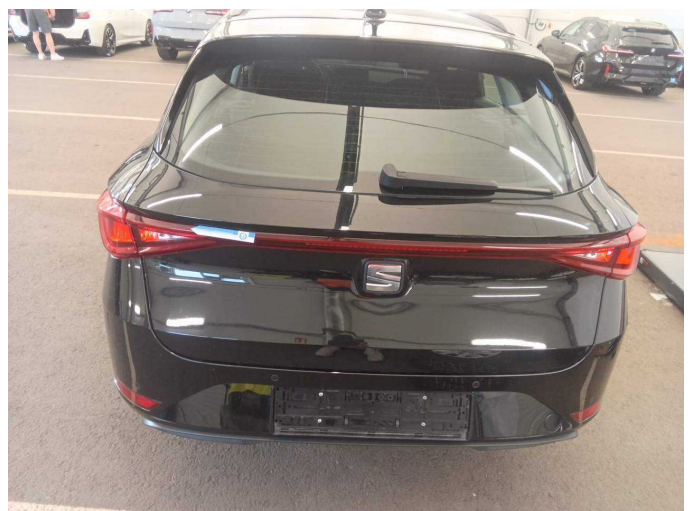
**Damage 2:** Tail light: Auxiliary brake light (Bremsleuchte/Lichtband Heckklappe) - Broken / torn - Replace

| No. | Component group | Description |
|---|---|---|
| 2 | Tail light | Auxiliary brake light (Bremsleuchte/Lichtband Heckklappe) - Broken / torn - Replace |

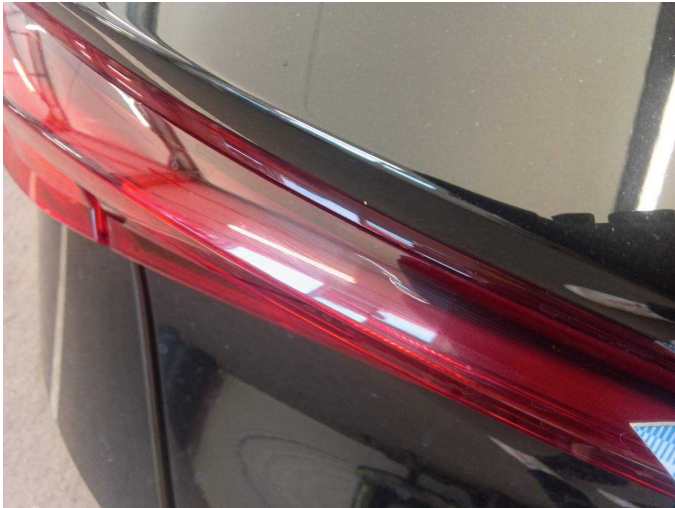
**Damage 2:** Tail light: Auxiliary brake light (Bremsleuchte/Lichtband Heckklappe) - Broken / torn - Replace

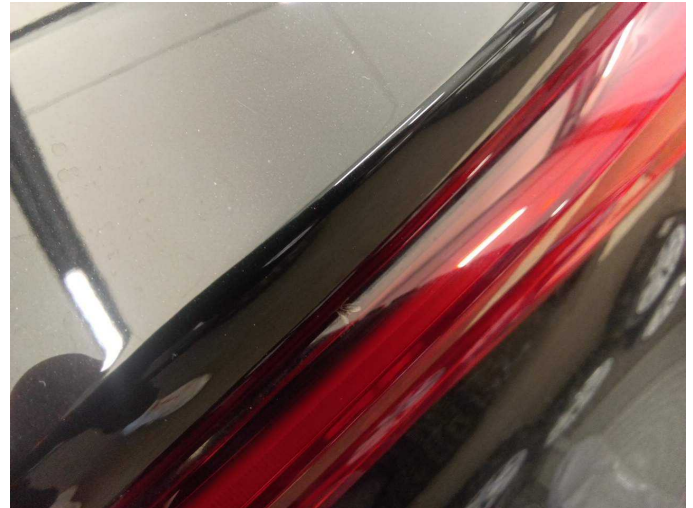
**Damage 2:** Tail light: Auxiliary brake light (Bremsleuchte/Lichtband Heckklappe) - Broken / torn - Replace

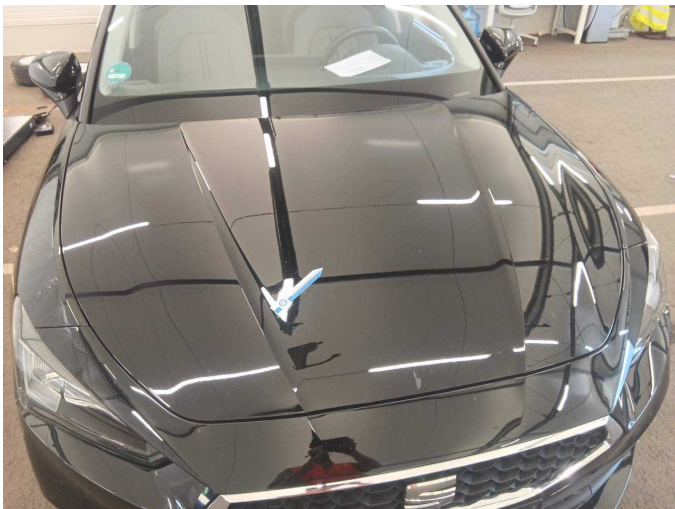
**Wear and tear 1:** Bonnet: Bonnet - Stone chips - No deduction

| No. | Component group | Description |
|---|---|---|
| 1 | Bonnet | Bonnet - Stone chips - No deduction |

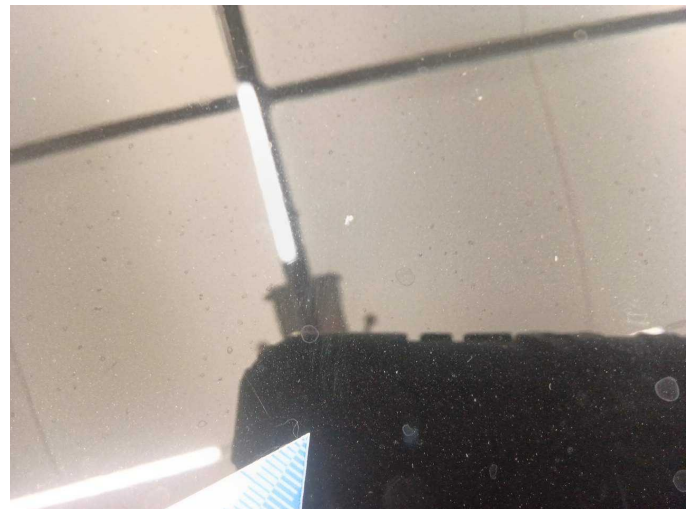
**Wear and tear 1:** Bonnet: Bonnet - Stone chips - No deduction
