Expertise

Protocol number: 47188278  
Order No. / Reference: 26831294  
Inspection date: 20 Aug 2026

Manufacturer: Ford

Model: Grand Tourneo Connect 2.0 EcoBlue Aut. TITANIUM

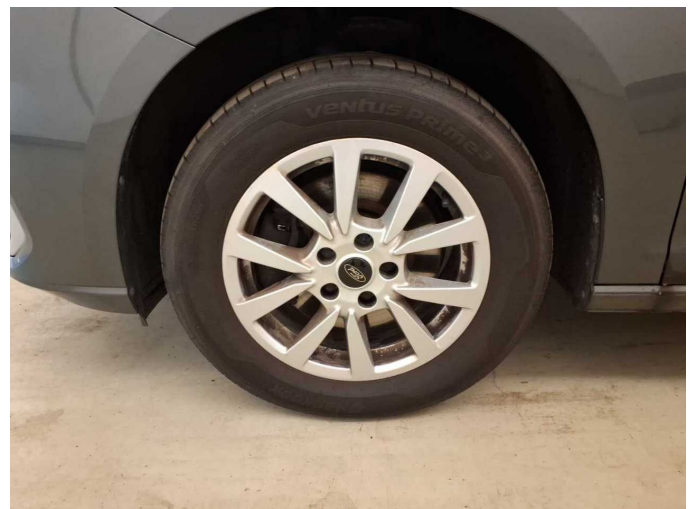
Figure 12: Mounted tyres

| # | Tyre size | Type of tyre | Manufacturer | Tread depth |
|---|---|---|---|---|
| 1) | 205/60 R16 96H | Summer tyres on Light alloy | Hankook | 5mm / 5mm |
| 2) | 205/60 R16 96H | Summer tyres on Light alloy | Hankook | 5mm / 5mm |

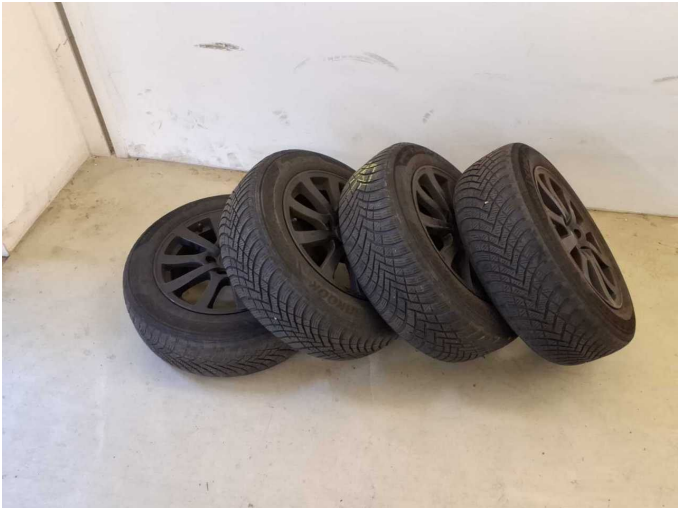
Figure 16: Additional tyres

| # | Tyre size | Type of tyre | Manufacturer | Tread depth |
|---|---|---|---|---|
| 1) | 205/60 R16 96H | Winter tyres on Light alloy | Hankook | 3mm / 3mm |
| 2) | 205/60 R16 96H | Winter tyres on Light alloy | Hankook | 3mm / 3mm |

- Der angegebene Winterradsatz ist kein Bestandteil des Auslieferungsumfangs.
- Ein Nachweis über die Zulässigkeit des beiliegenden Radsatzes wurde nicht erbracht.

| No. | Component group | Description |
|---|---|---|
| 1 | 2nd wheel set | Tyres - complete set (Nicht Bestandteil der Ausstattung) - Does not meet the leasing specifications - No deduction |

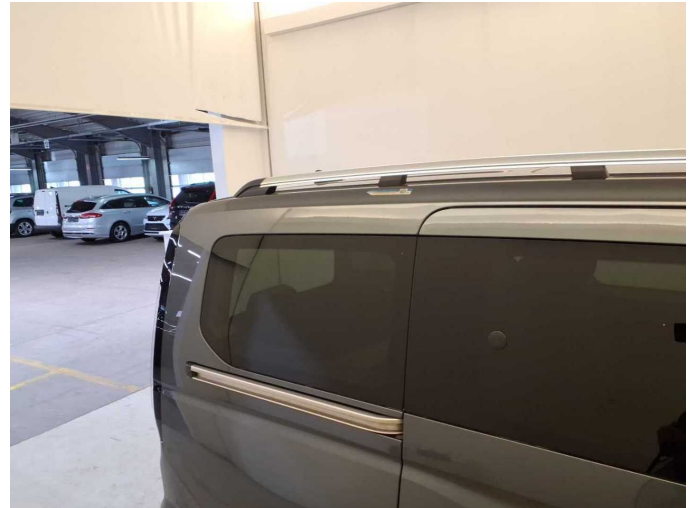
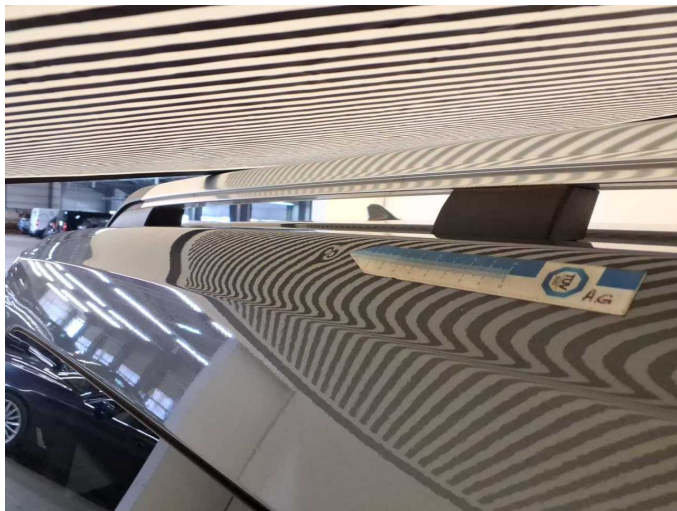
**Damage 2:** Roof: Roof rail - right side - dent(s) - Smooth repair work

| No. | Component group | Description |
|---|---|---|
| 2 | Roof | Roof rail - right side - dent(s) - Smooth repair work |

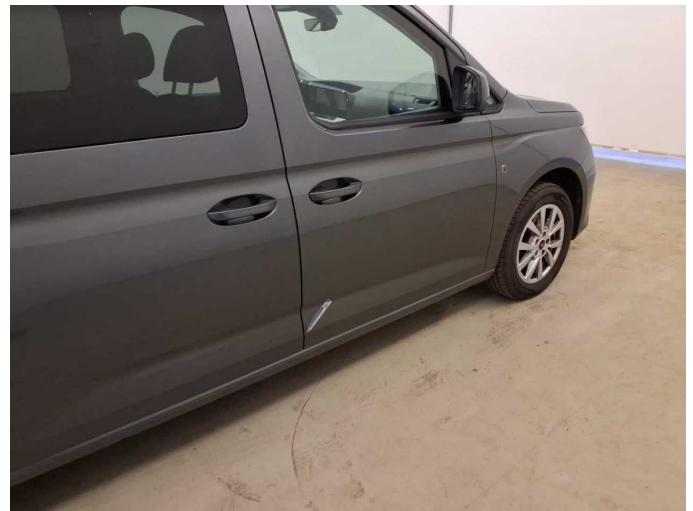
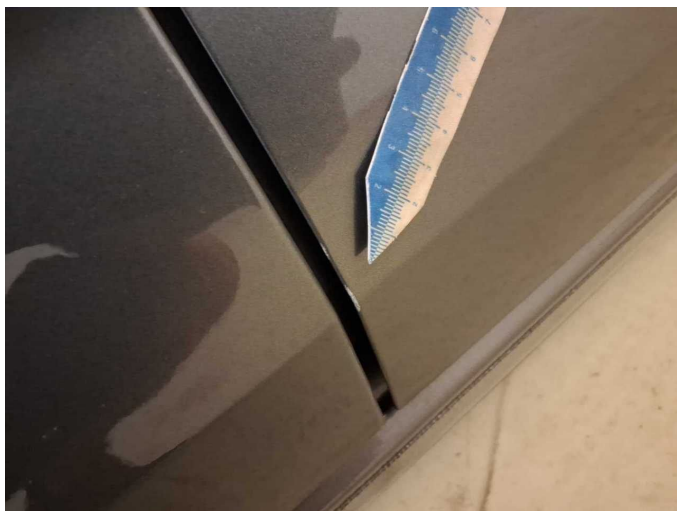
**Damage 3:** Door - front right side: Door edge - Scratch(es) - Smart repair

| No. | Component group | Description |
|---|---|---|
| 3 | Door - front right side | Door edge - Scratch(es) - Smart repair |

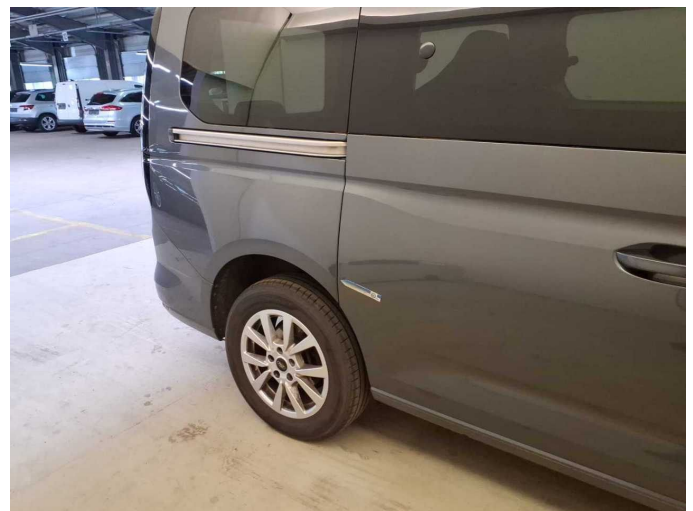
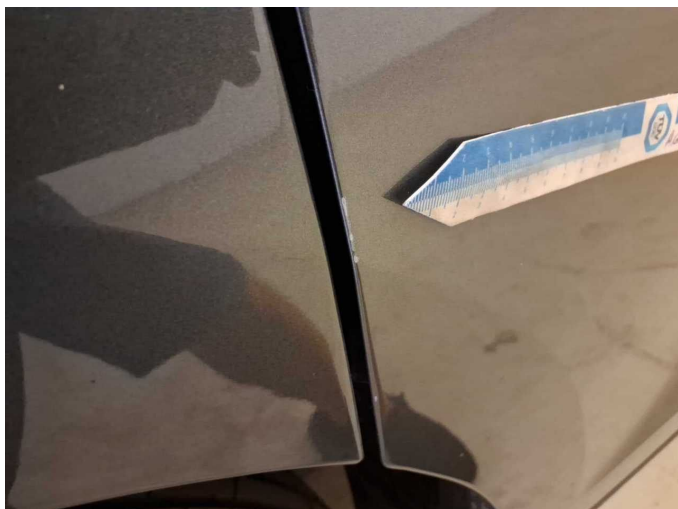
**Damage 4:** Sliding door, right: Sliding door with glass panel (Türkante) - Scratch(es) - Smart repair

| No. | Component group | Description |
|---|---|---|
| 4 | Sliding door, right | Sliding door with glass panel (Türkante) - Scratch(es) - Smart repair |

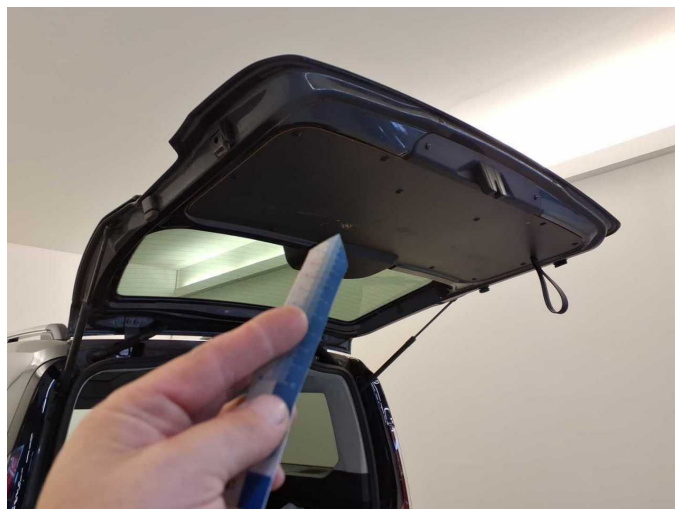
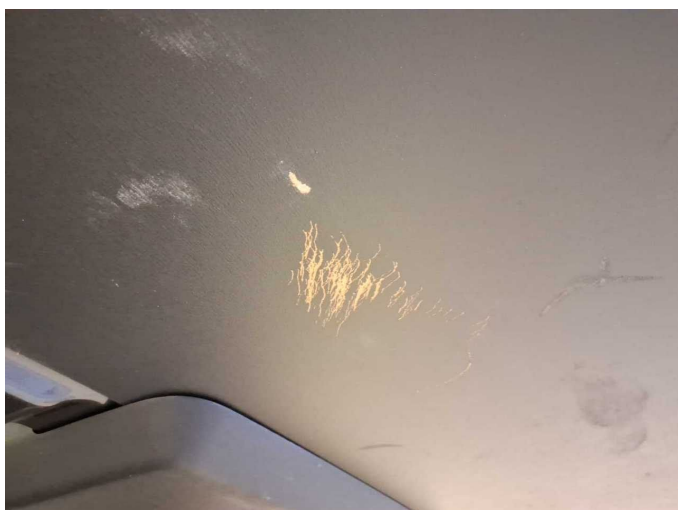
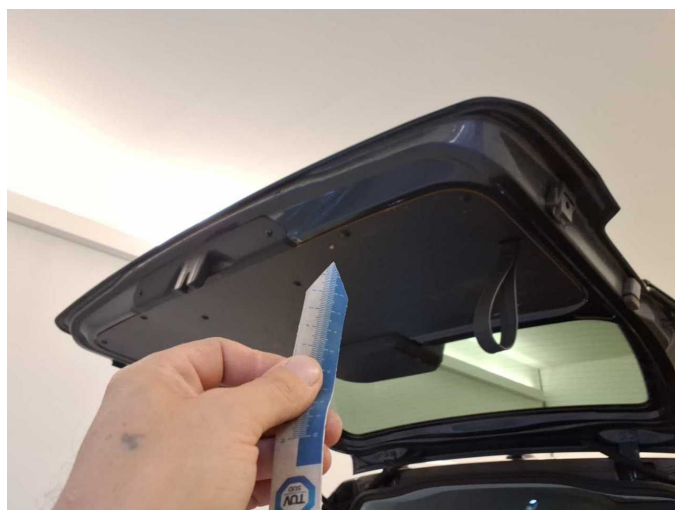
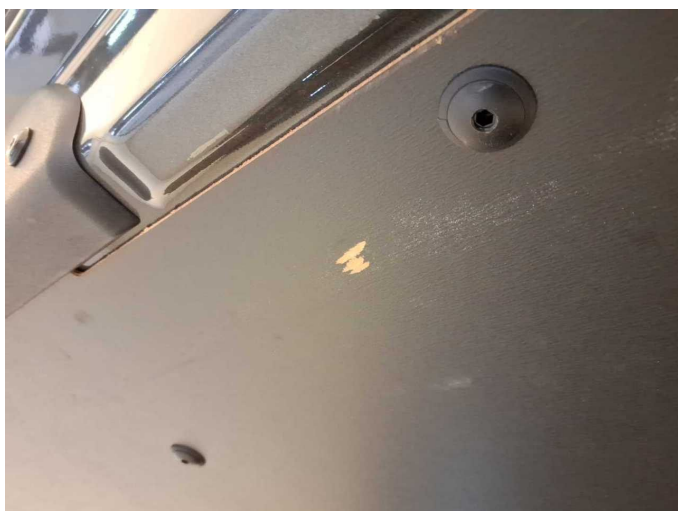
**Damage 5:** Trim / covers: Boot lid - interior trim - Scratched - Replace

| No. | Component group | Description |
|---|---|---|
| 5 | Trim / covers | Boot lid - interior trim - Scratched - Replace |

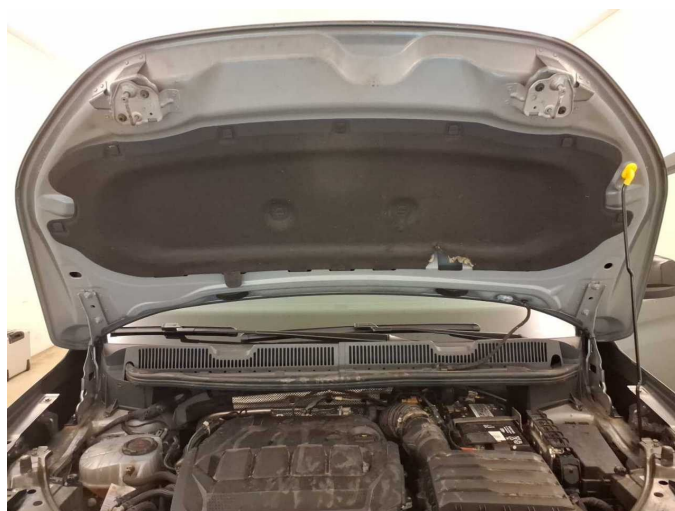
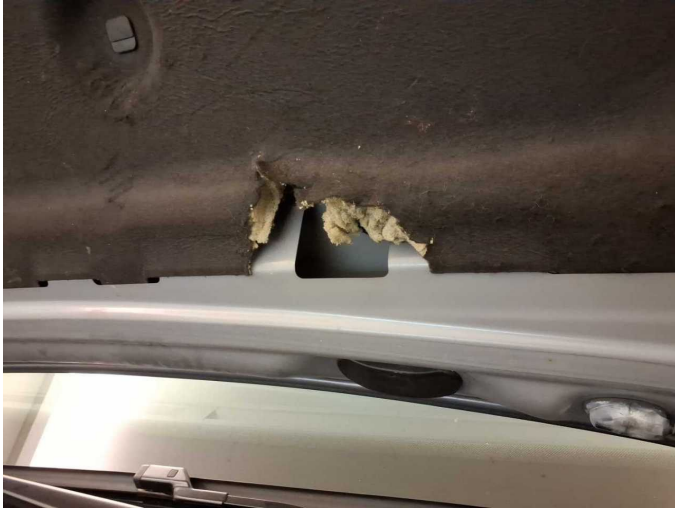
**Damage 6:** Bonnet: Insulation lining - Damage caused by marten / rodent - Replace

| No. | Component group | Description |
|---|---|---|
| 6 | Bonnet | Insulation lining - Damage caused by marten / rodent - Replace |

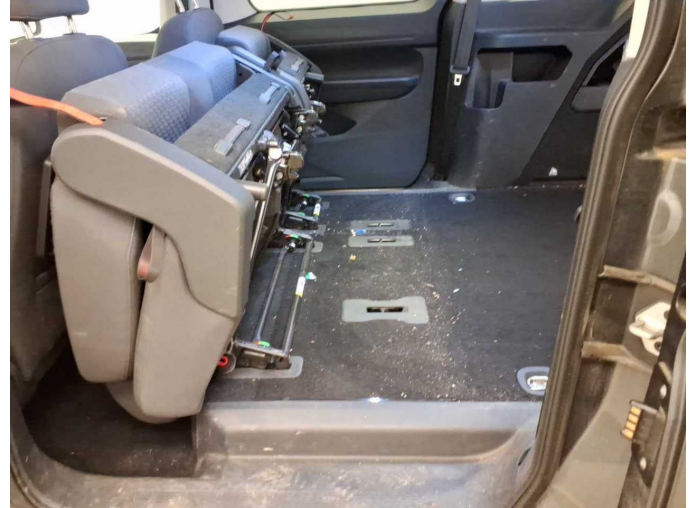
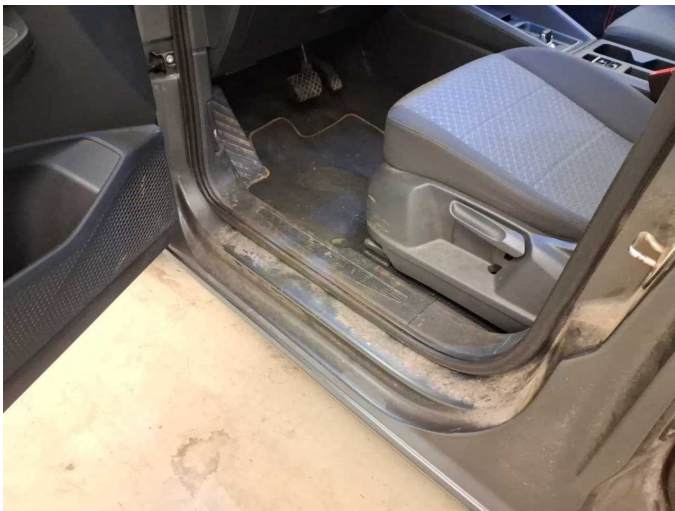
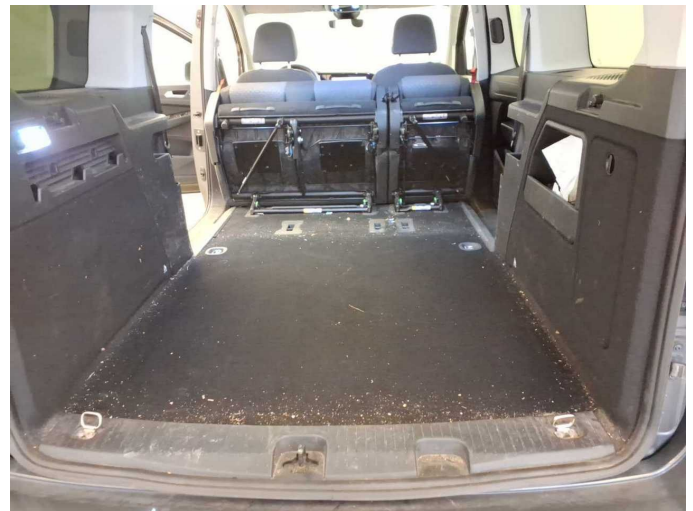
**Damage 7:** Interior: Interior - Soiled - Clean

| No. | Component group | Description |
|---|---|---|
| 7 | Interior | Interior - Soiled - Clean |

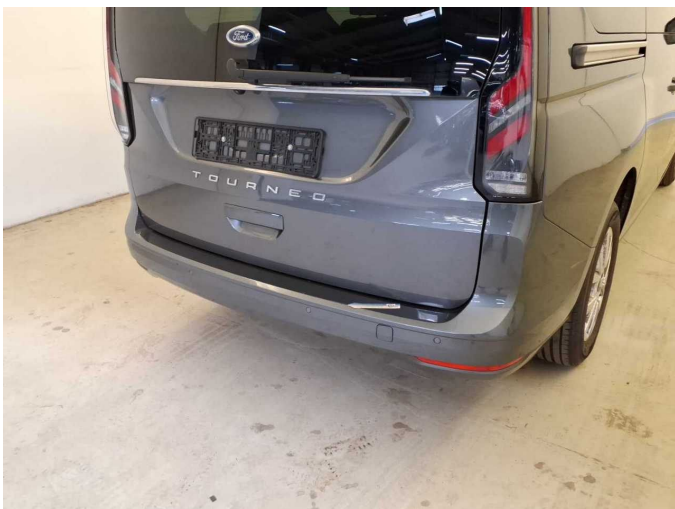
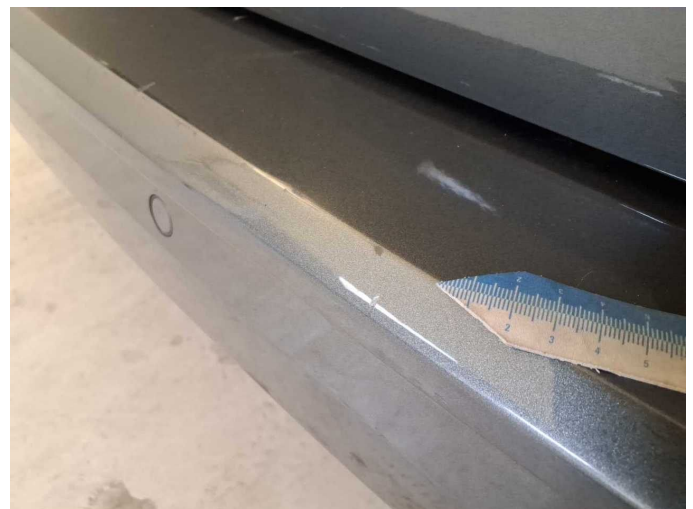
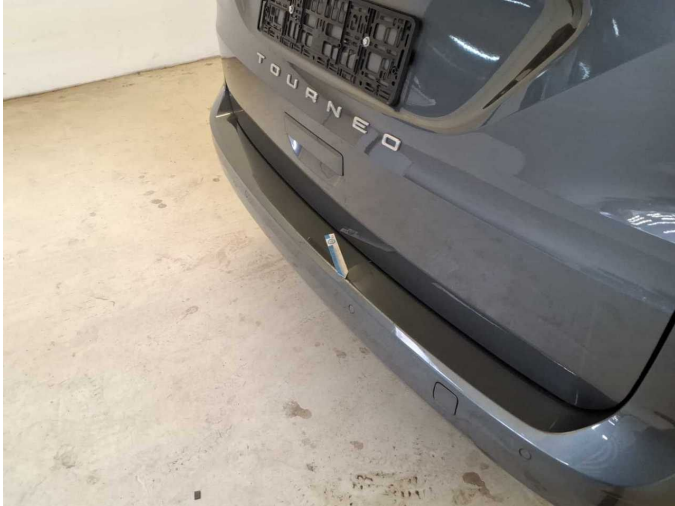
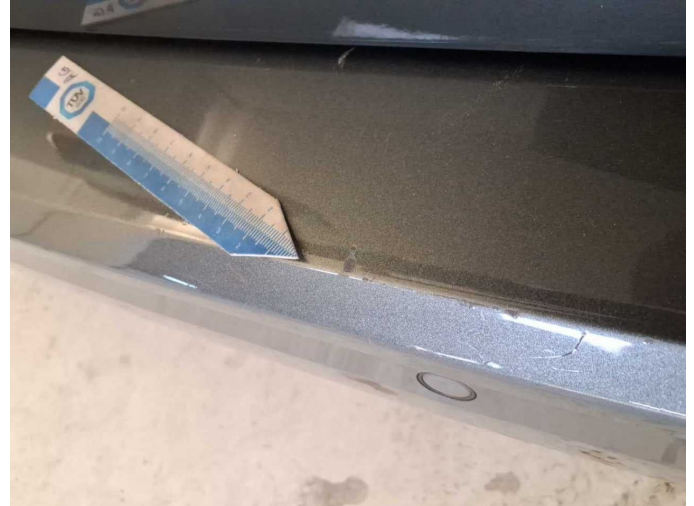
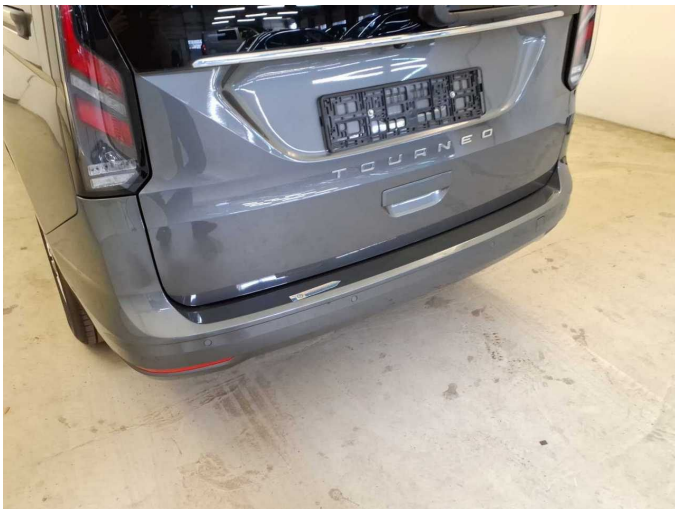
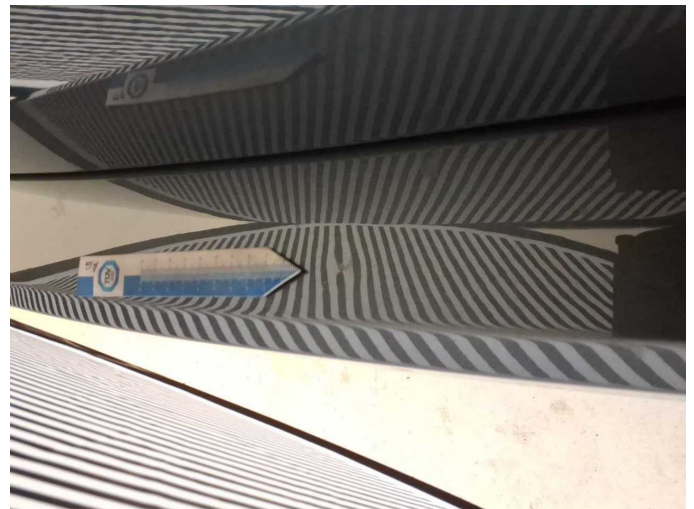
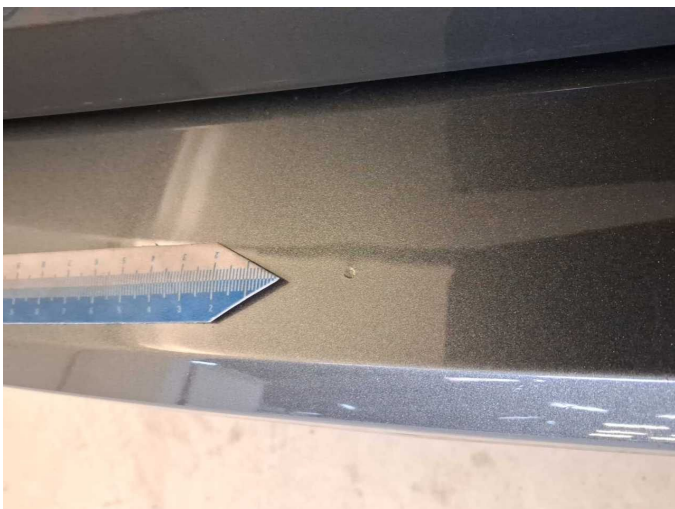
**Damage 8:** Rear bumper: Rear bumper - Scratched - Paint

| No. | Component group | Description |
|---|---|---|
| 8 | Rear bumper | Rear bumper - Scratched - Paint |

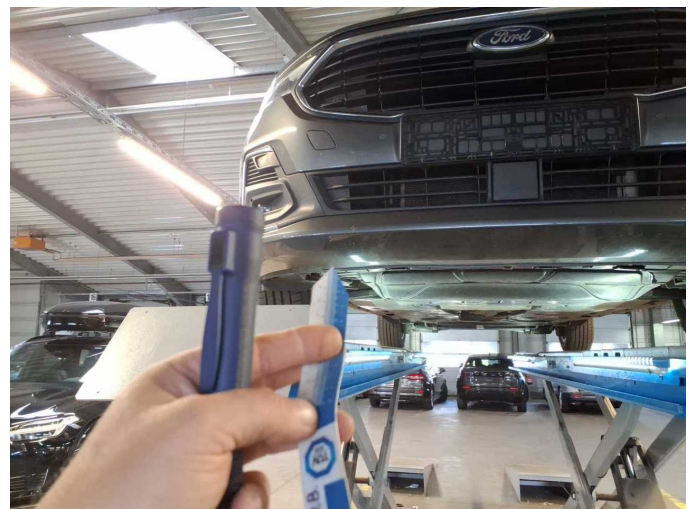
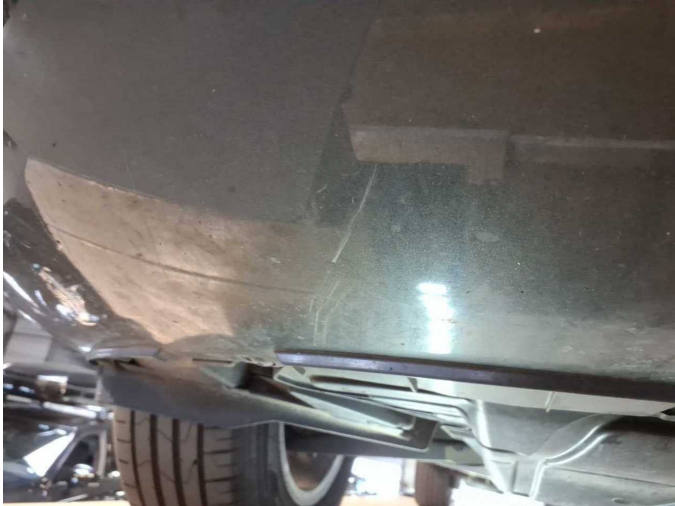
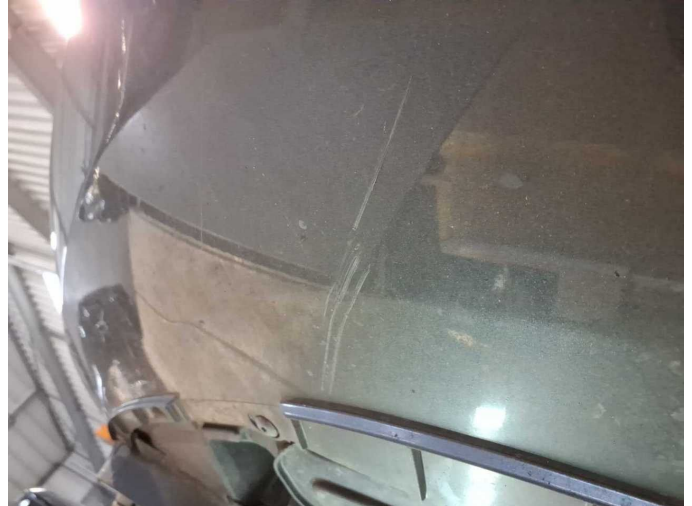
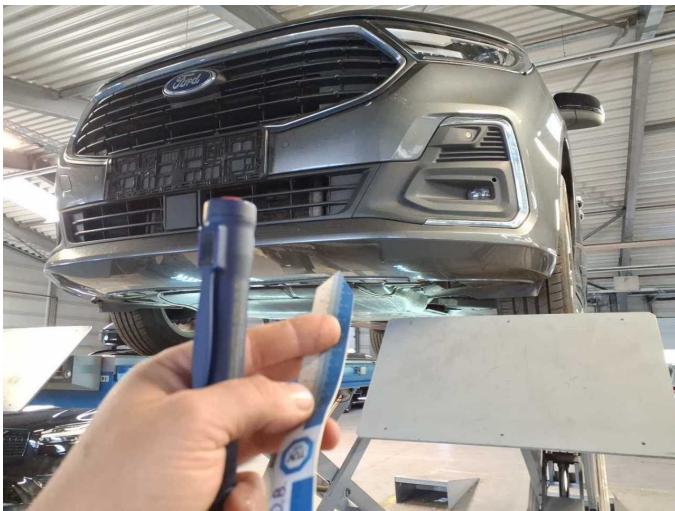
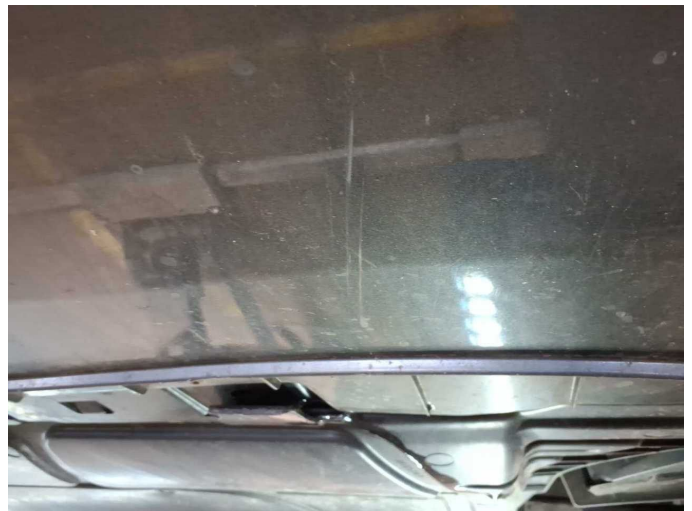
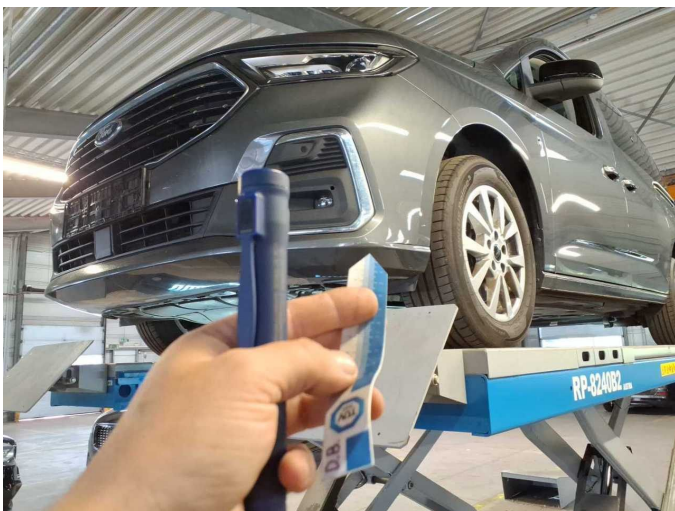
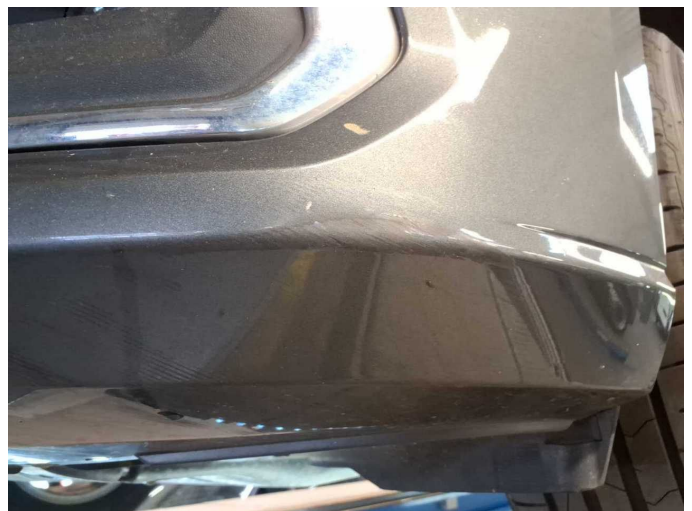
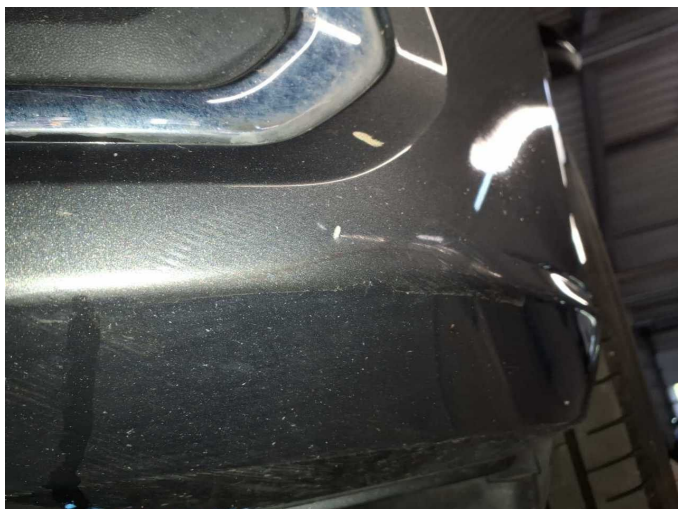
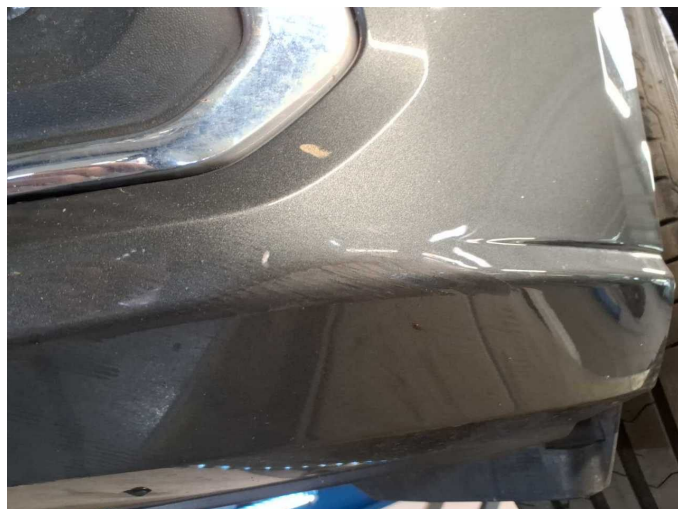
**Damage 9:** Front bumper: Front bumper - Scratched - Paint

| No. | Component group | Description |
|---|---|---|
| 9 | Front bumper | Front bumper - Scratched - Paint |

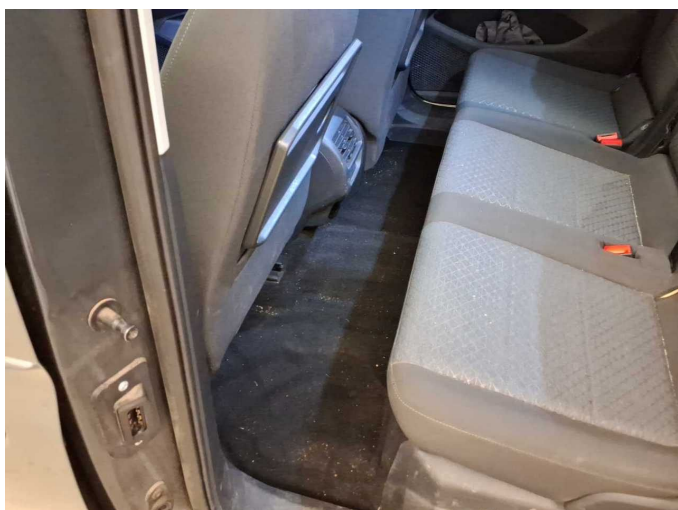
**Missing part 1:** Trim / covers: Floor mats (Hinten beide) - Missing - Replace

Trim / covers - Floor mats (Hinten beide)
