Expertise

Protocol number: 46412004  
Order No. / Reference: 26520550  
Inspection date: 8 Jul 2026

Model: Tiguan 2.0 TDI SCR DSG Elegance

VIN: WVGZZZ5NXPW525382

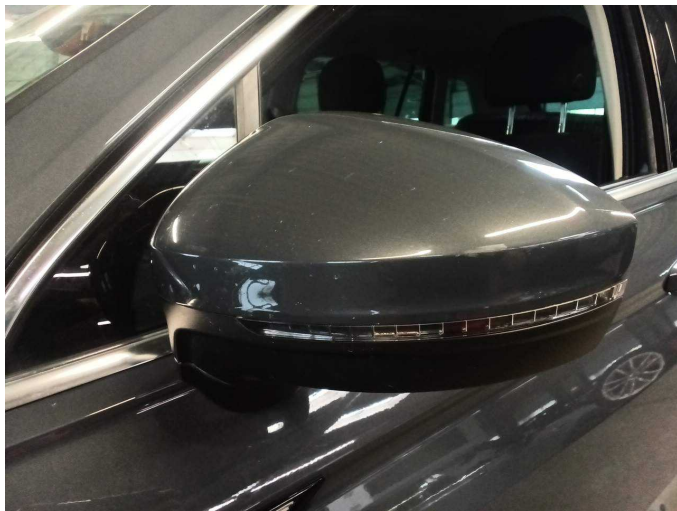
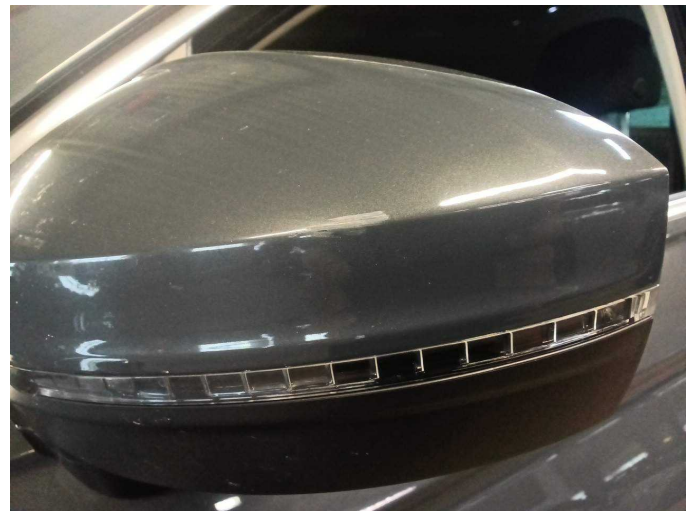
| No. | Component group | Description |
|---|---|---|
| 1 | Wing mirror - left side | Cap - Scratch(es) - Smart repair |

**Damage 1:** Wing mirror - left side: Cap - Scratch(es) - Smart repair

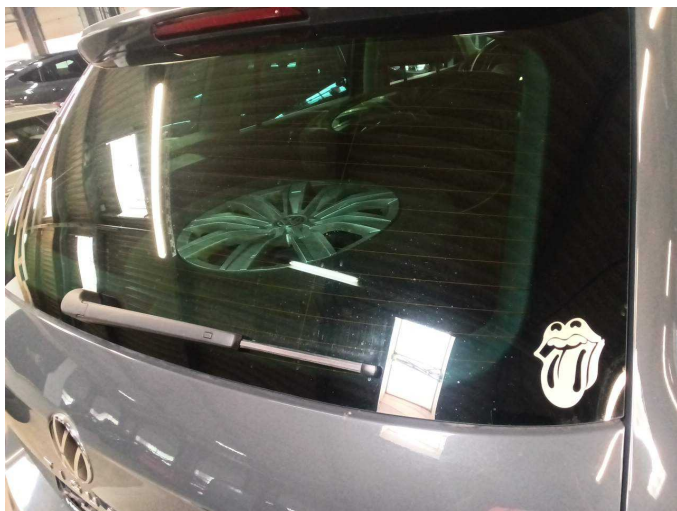
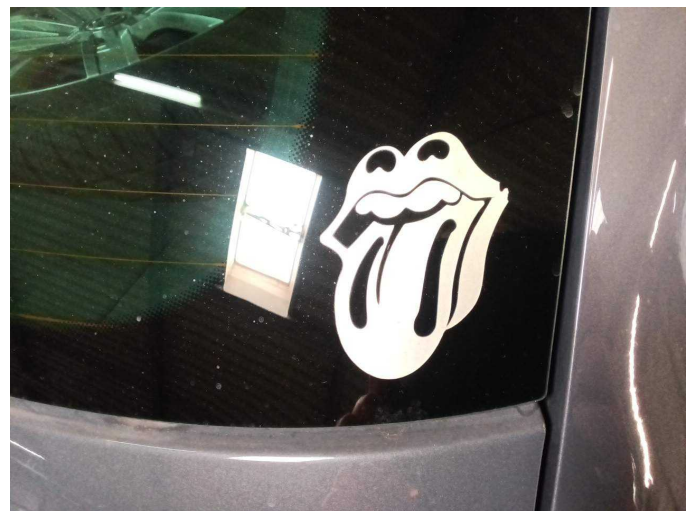
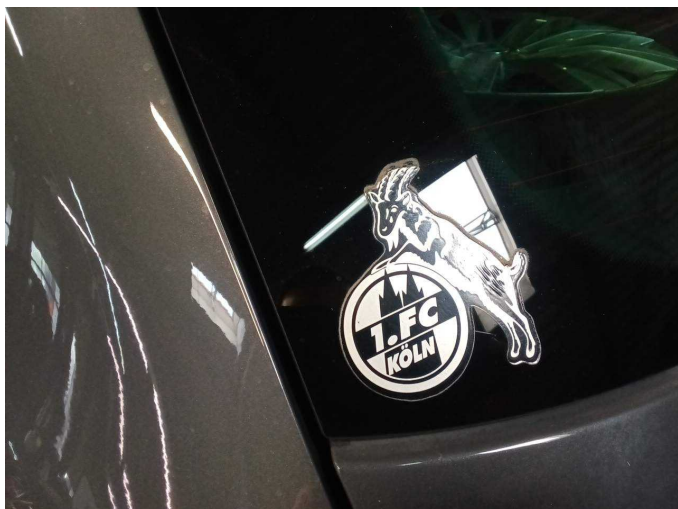
| No. | Component group | Description |
|---|---|---|
| 2 | Vehicle glazing | Rear window - Glued / labelled - Remove |

**Damage 2:** Vehicle glazing: Rear window - Glued / labelled - Remove

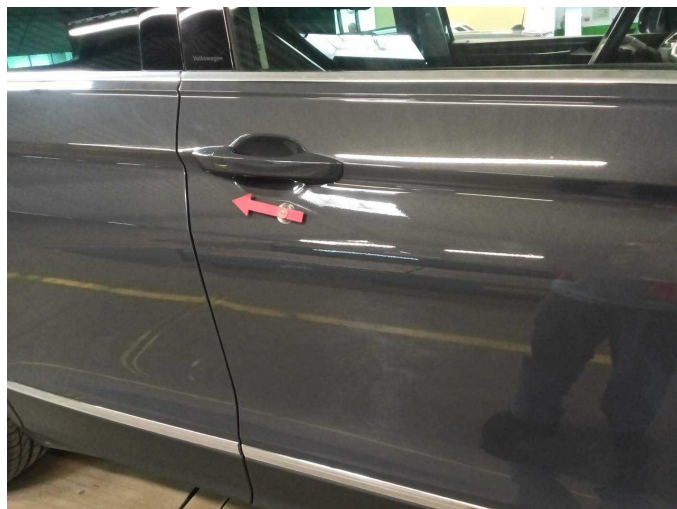
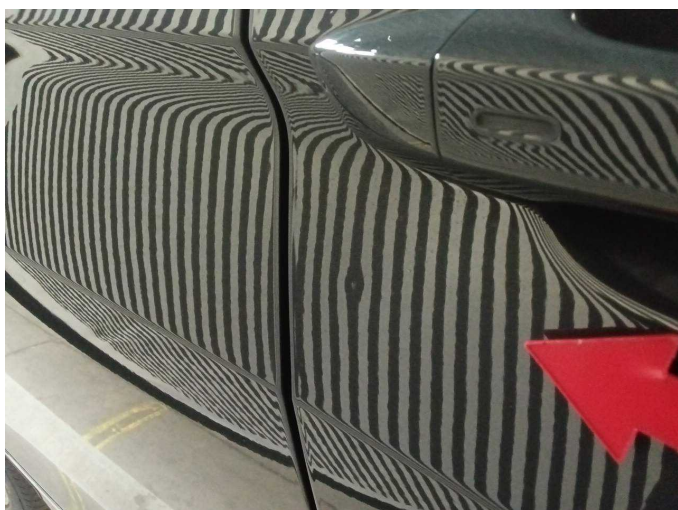
| No. | Component group | Description |
|---|---|---|
| 3 | Door - front right side | Door - dent(s) - Smooth repair work |

**Damage 3:** Door - front right side: Door - dent(s) - Smooth repair work

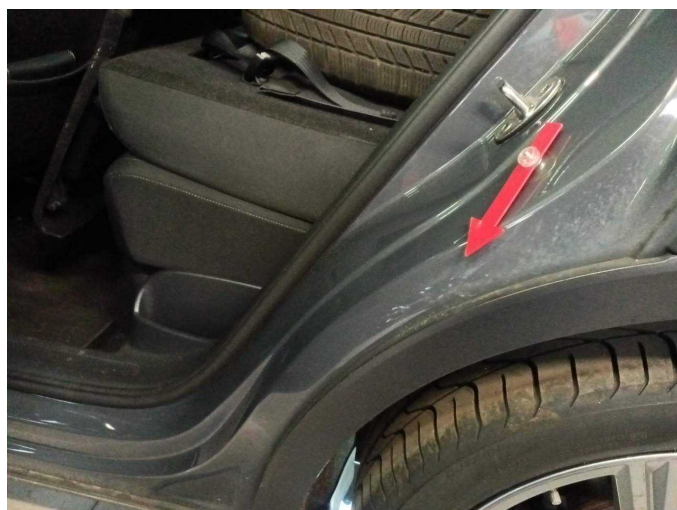
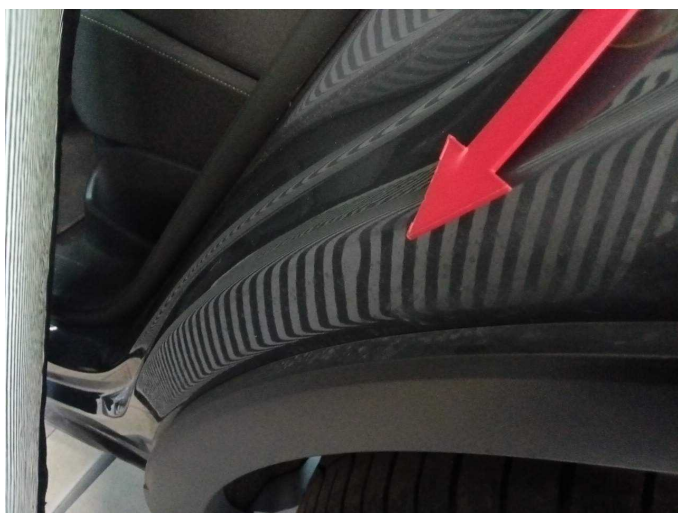
| No. | Component group | Description |
|---|---|---|
| 4 | Side panel - rear left side | Sill - dent(s) - Smooth repair work |

**Damage 4:** Side panel - rear left side: Sill - dent(s) - Smooth repair work

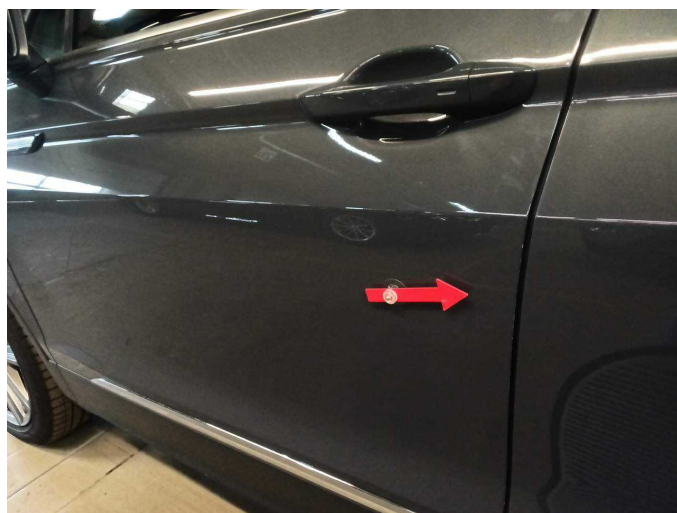
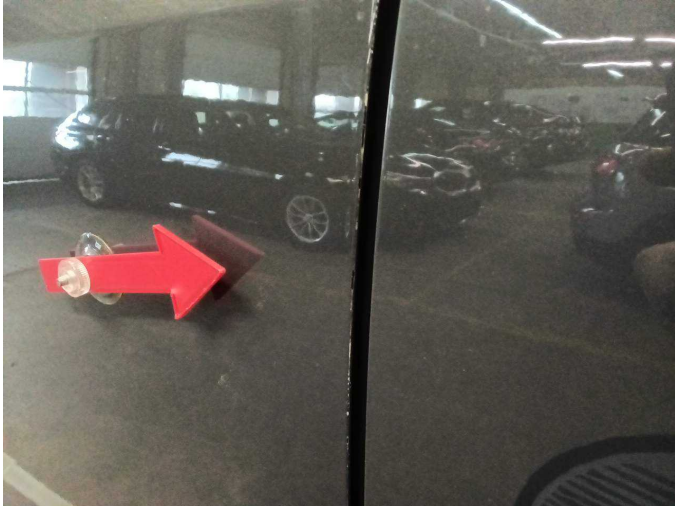
| No. | Component group | Description |
|---|---|---|
| 5 | Door - front left side | Door edge - Scratch(es) - Smart repair |

**Damage 5:** Door - front left side: Door edge - Scratch(es) - Smart repair

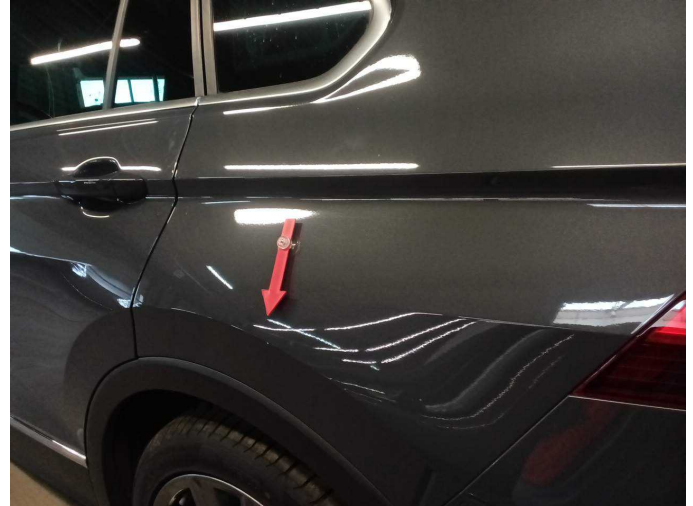
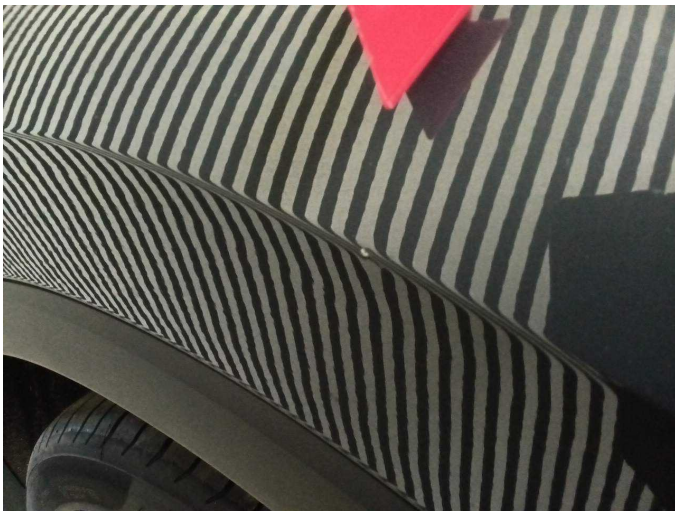
| No. | Component group | Description |
|---|---|---|
| 6 | Side panel - rear left side | Side panel - Dent / paintcoat damage - Smart repair |

**Damage 6:** Side panel - rear left side: Side panel - Dent / paintcoat damage - Smart repair

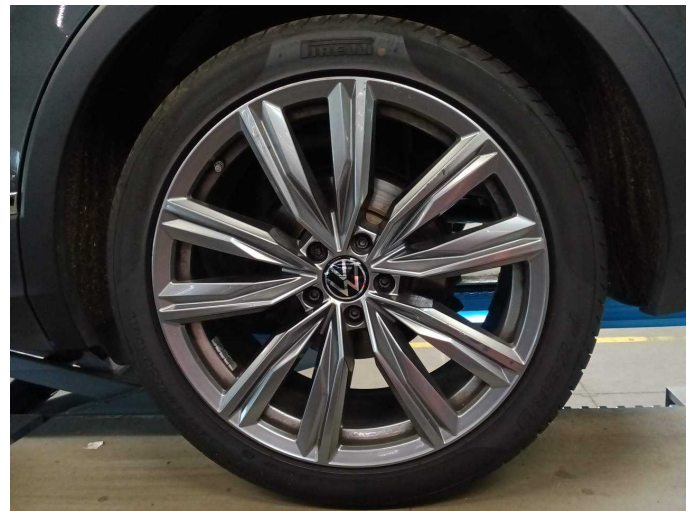
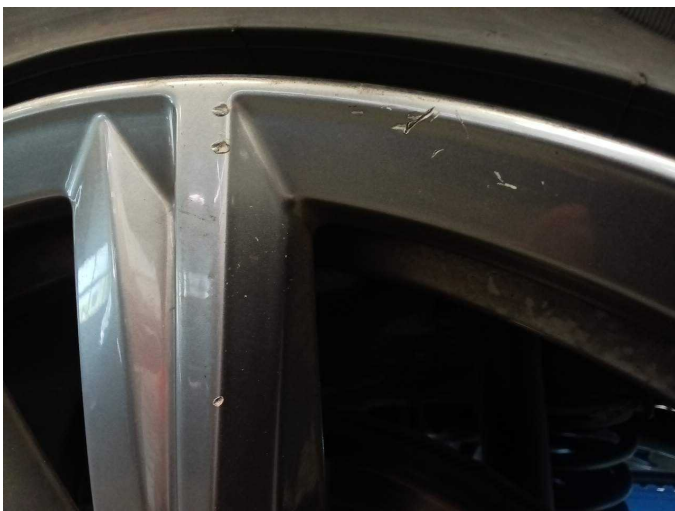
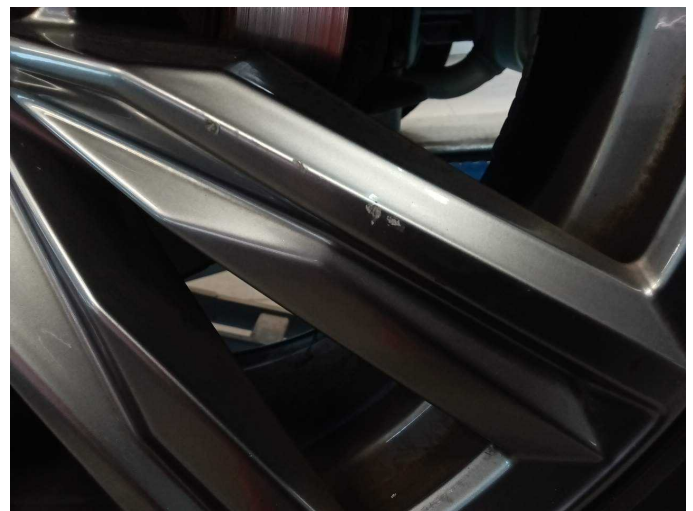
| No. | Component group | Description |
|---|---|---|
| 7 | Wheel / tyres | Alloy rim - rear left side - Scratched - Loss in value |

**Damage 7:** Wheel / tyres: Alloy rim - rear left side - Scratched - Loss in value

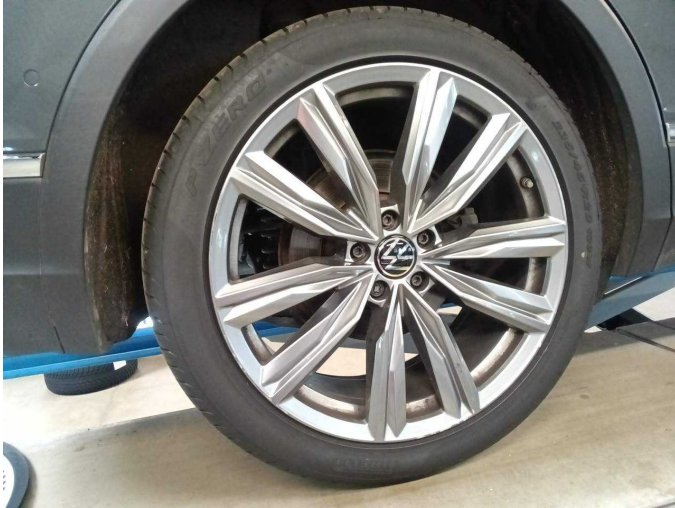
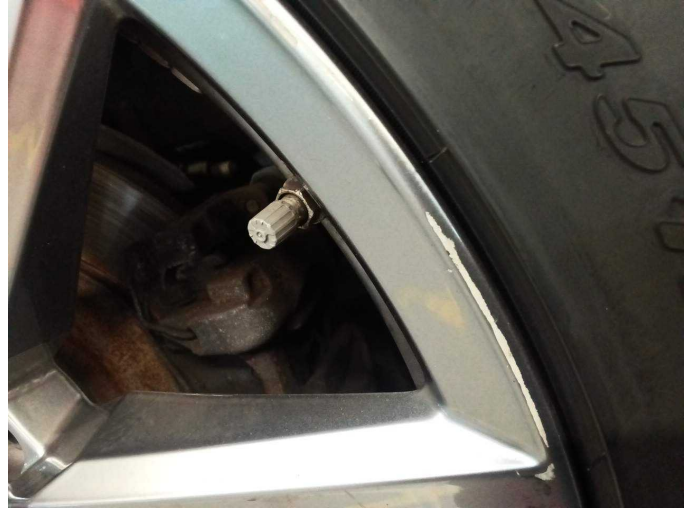
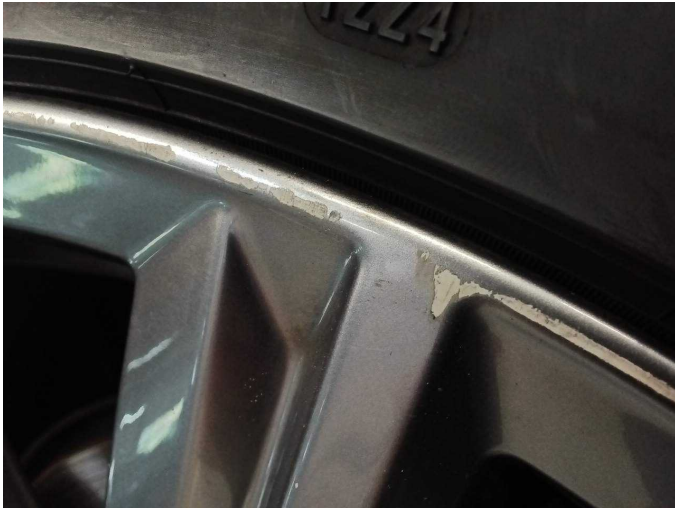
| No. | Component group | Description |
|---|---|---|
| 8 | Wheel / tyres | Alloy rim - rear right side - Scratched - Loss in value |

**Damage 8:** Wheel / tyres: Alloy rim - rear right side - Scratched - Loss in value

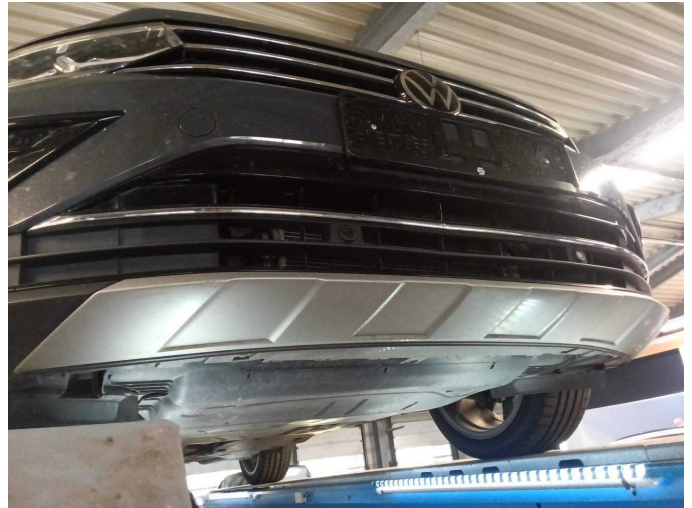
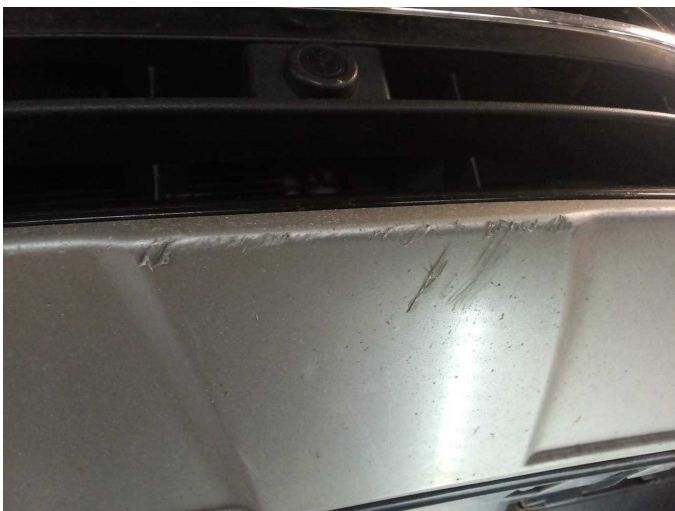
| No. | Component group | Description |
|---|---|---|
| 9 | Front bumper | Spoiler - Scratched - Loss in value |

**Damage 9:** Front bumper: Spoiler - Scratched - Loss in value

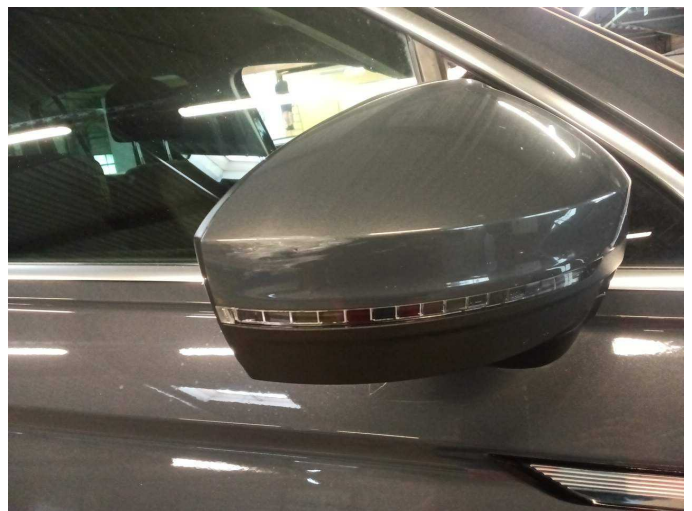
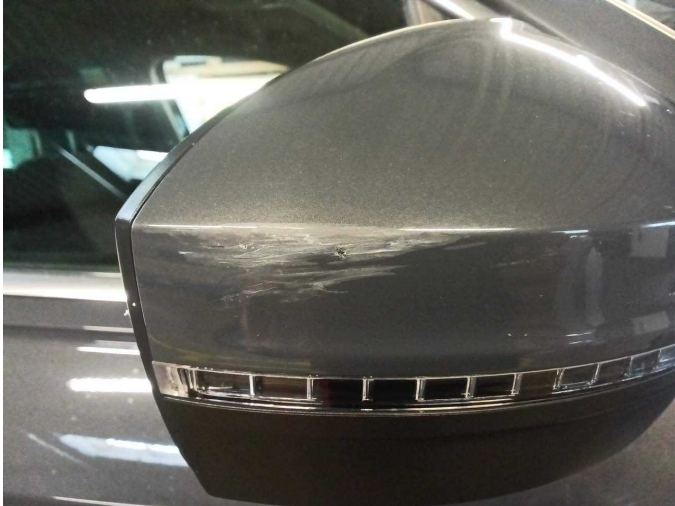
| No. | Component group | Description |
|---|---|---|
| 10 | Wing mirror - right side | Mirror housing - Scratch(es) - Paint |

**Damage 10:** Wing mirror - right side: Mirror housing - Scratch(es) - Paint

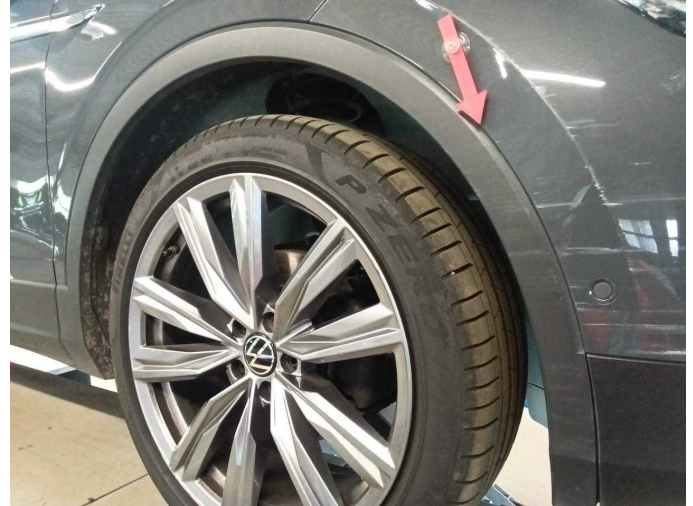
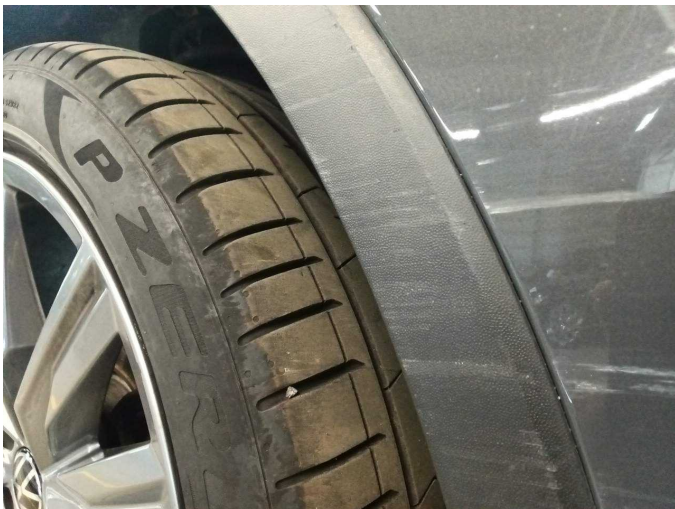
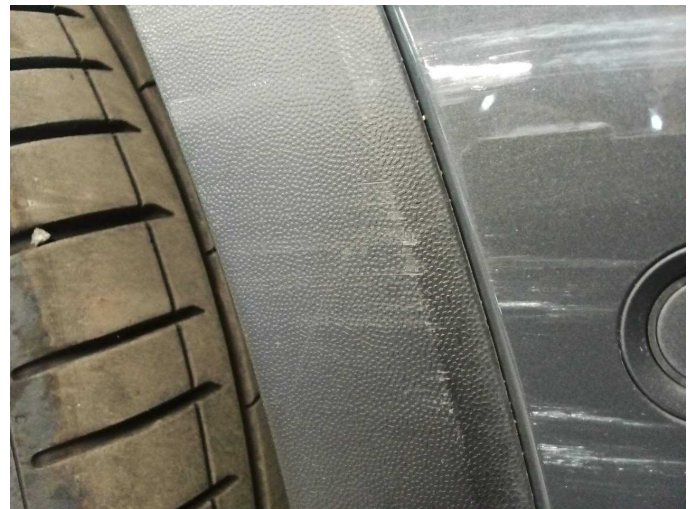
| No. | Component group | Description |
|---|---|---|
| 11 | Mudguard - right side | Wheel well extension - Scratched - Replace |

**Damage 11:** Mudguard - right side: Wheel well extension - Scratched - Replace

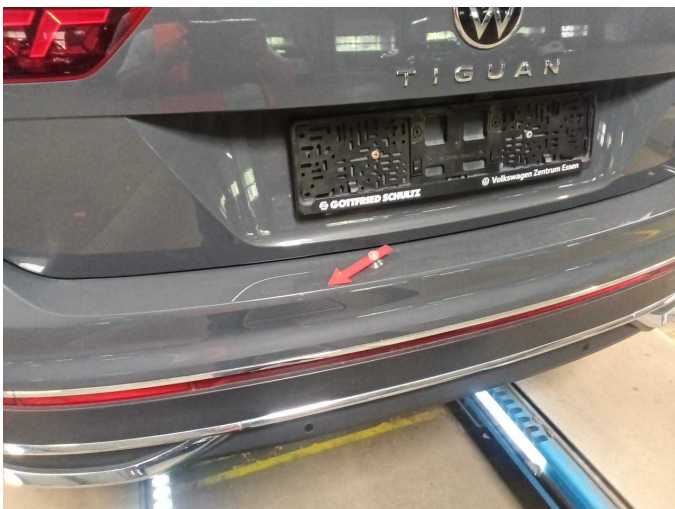
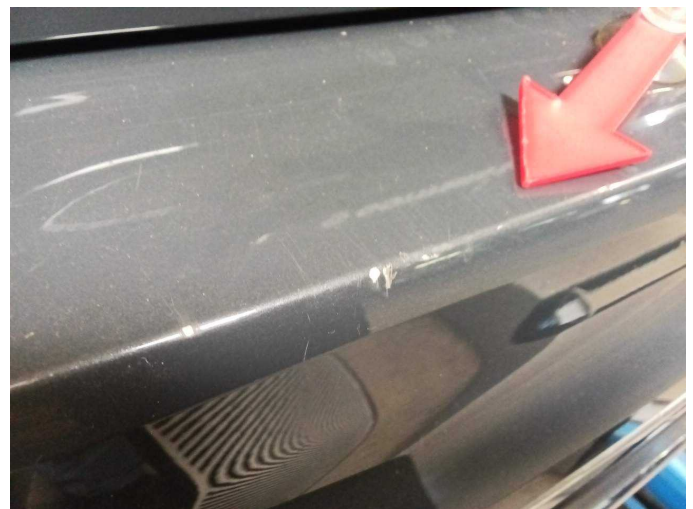
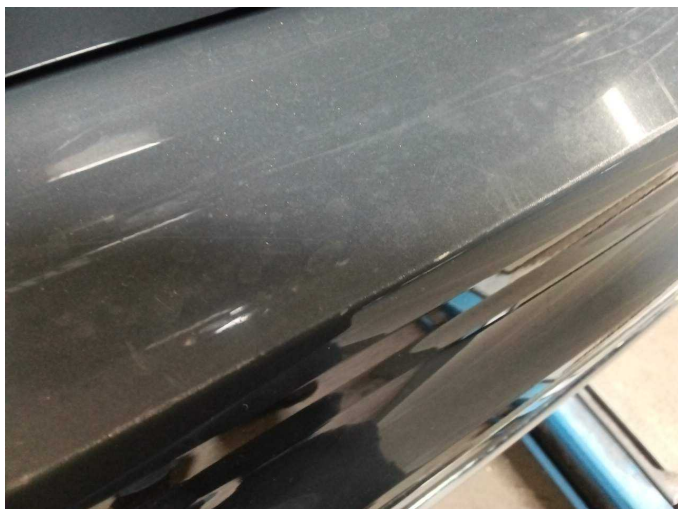
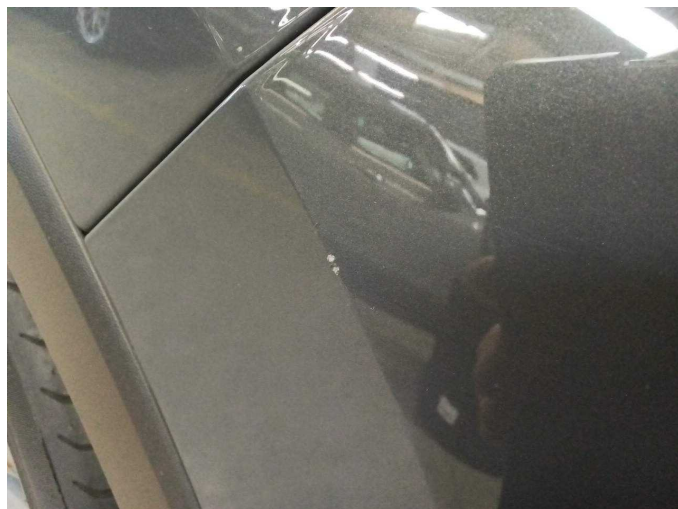
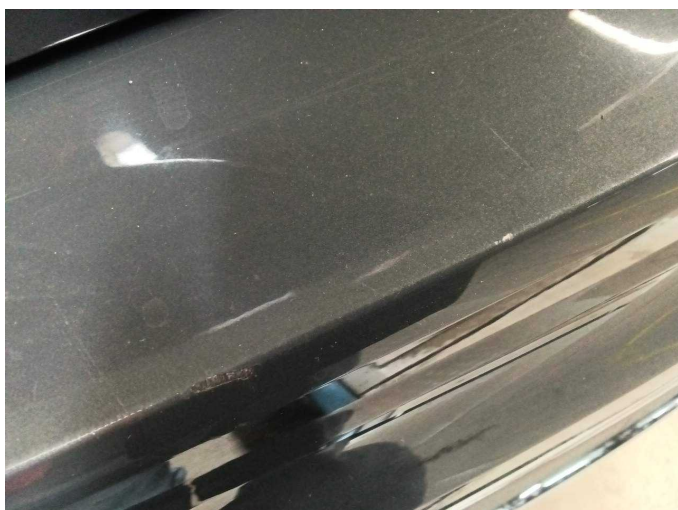
| No. | Component group | Description |
|---|---|---|
| 12 | Rear bumper | Rear bumper - Scratch(es) - Paint |

**Damage 12:** Rear bumper: Rear bumper - Scratch(es) - Paint

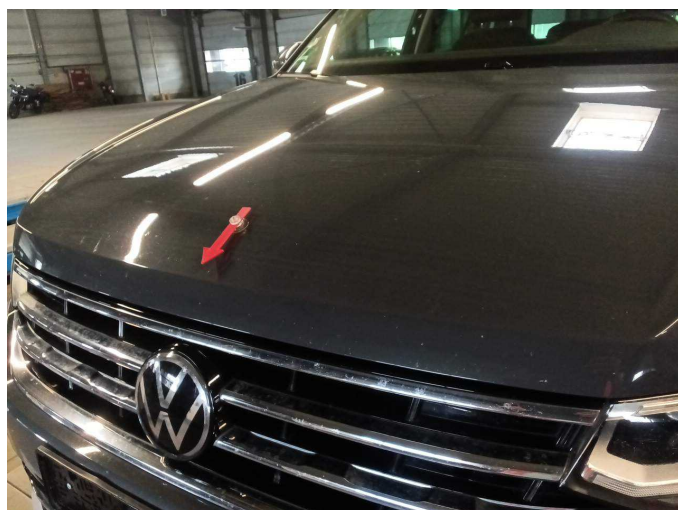
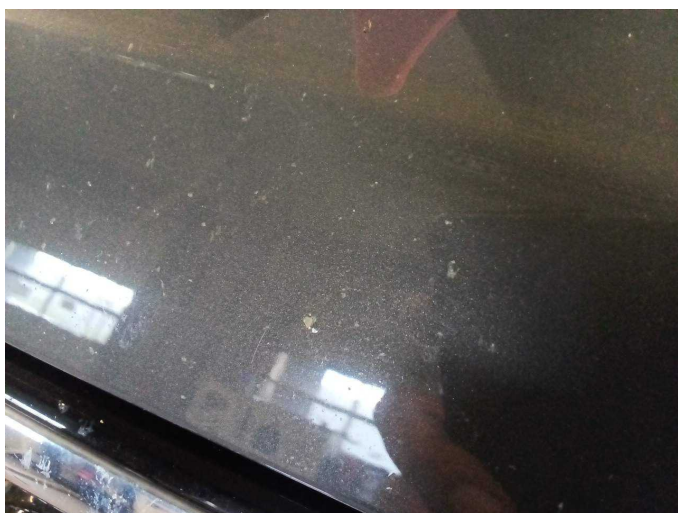
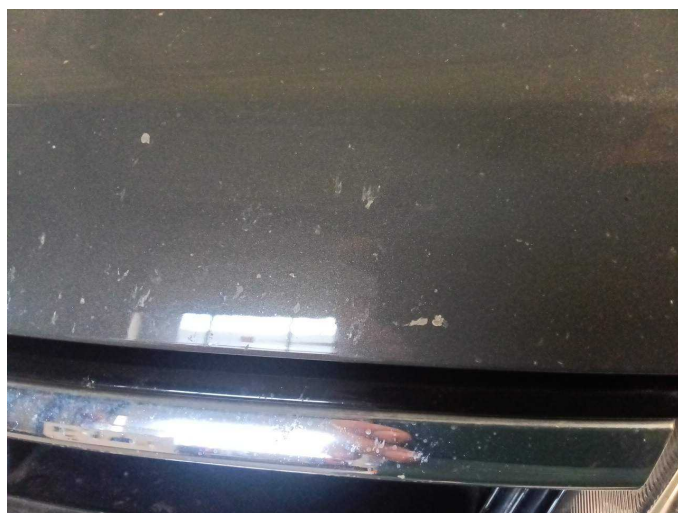
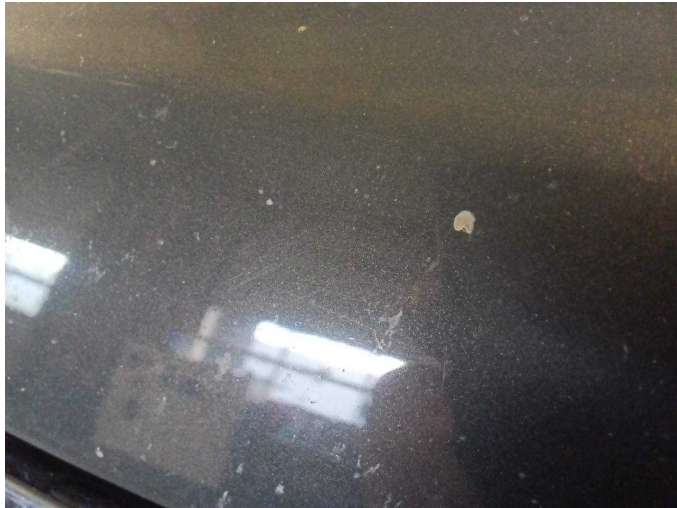
| No. | Component group | Description |
|---|---|---|
| 13 | Bonnet | Bonnet - Stone chips - Paint |

**Damage 13:** Bonnet: Bonnet - Stone chips - Paint

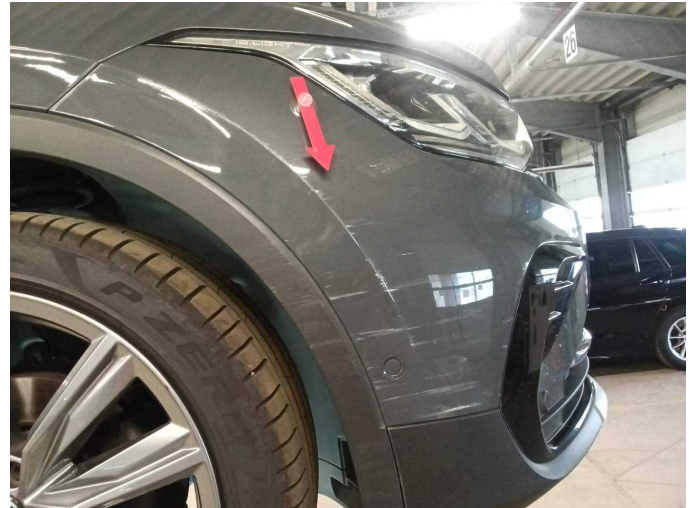
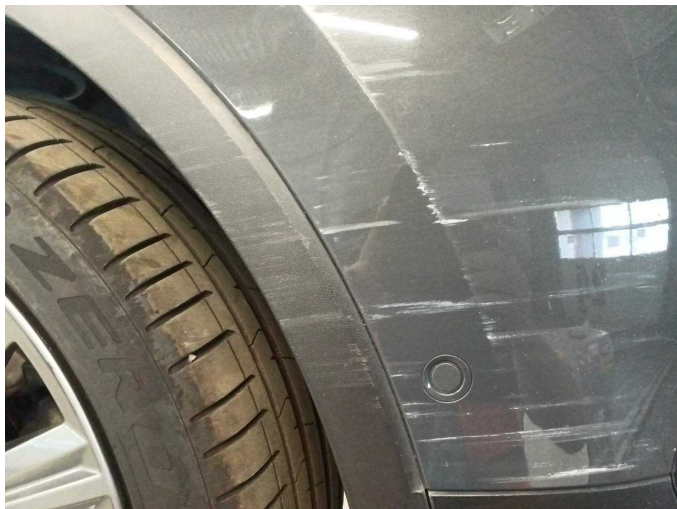
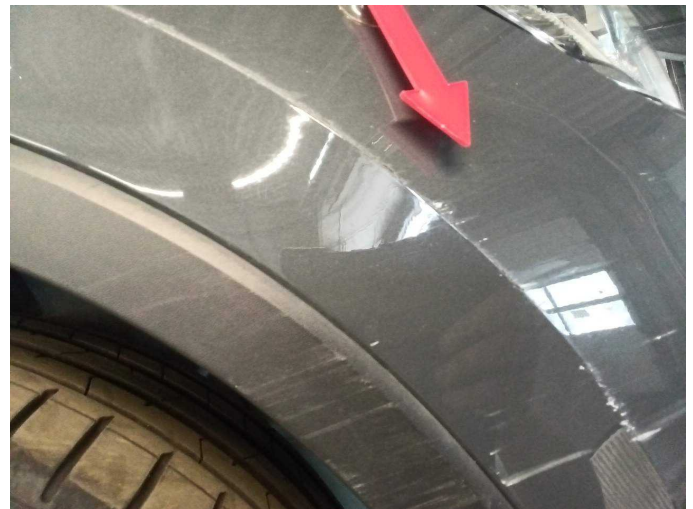
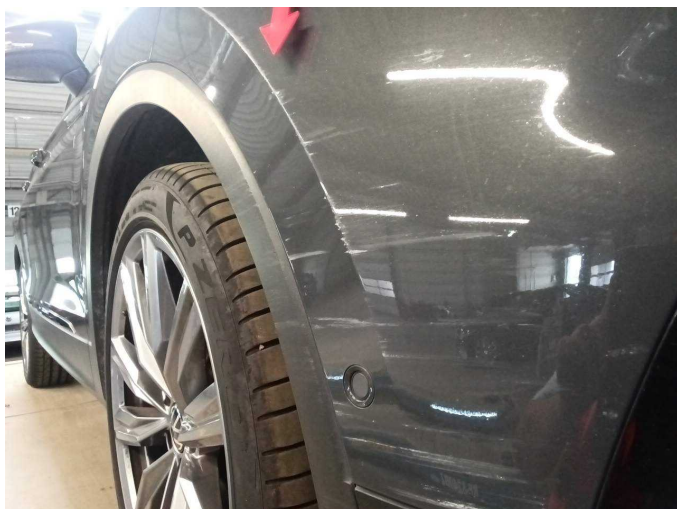
| No. | Component group | Description |
|---|---|---|
| 14 | Front bumper | Front bumper - Scratched - Paint |

**Damage 14:** Front bumper: Front bumper - Scratched - Paint

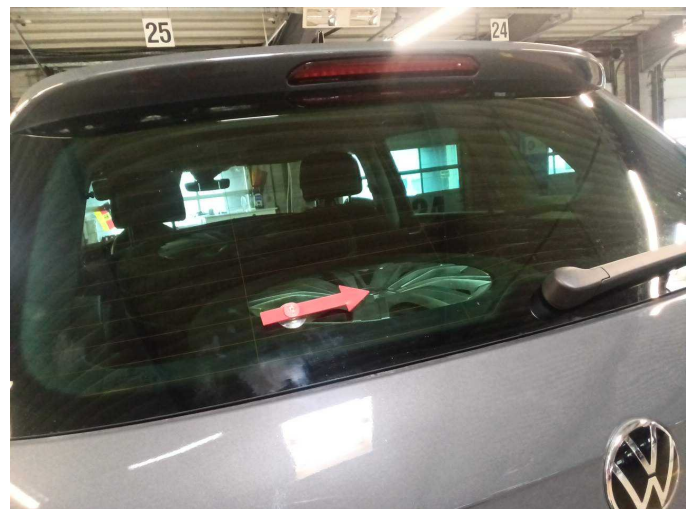
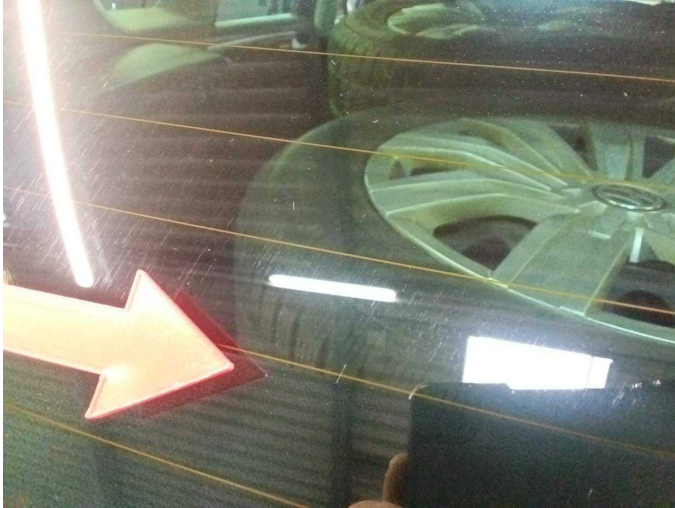
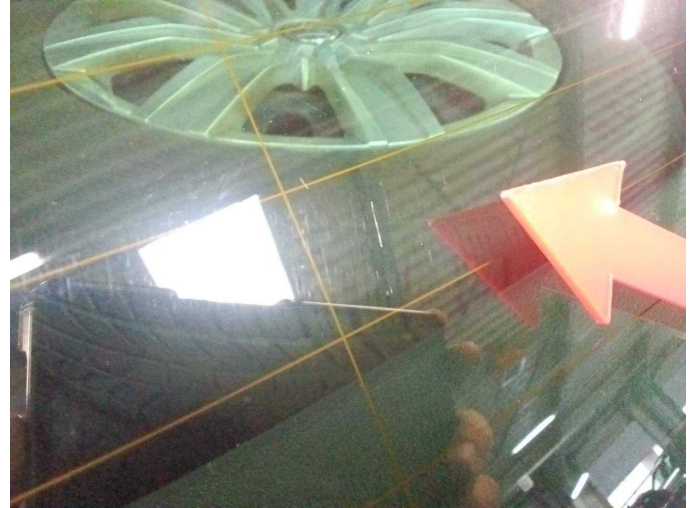
| No. | Component group | Description |
|---|---|---|
| 15 | Vehicle glazing | Rear window - Scratch(es) - Replace |

**Damage 15:** Vehicle glazing: Rear window - Scratch(es) - Replace

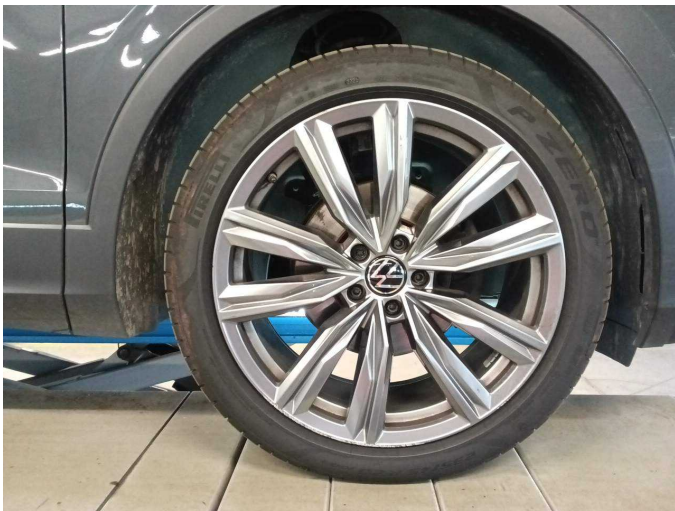
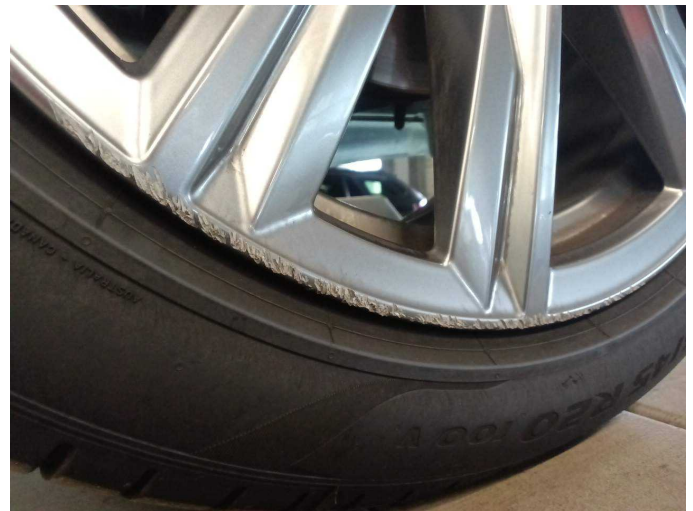
| No. | Component group | Description |
|---|---|---|
| 16 | Wheel / tyres | Alloy rim - front right side - Scratched - Replace |

**Damage 16:** Wheel / tyres: Alloy rim - front right side - Scratched - Replace

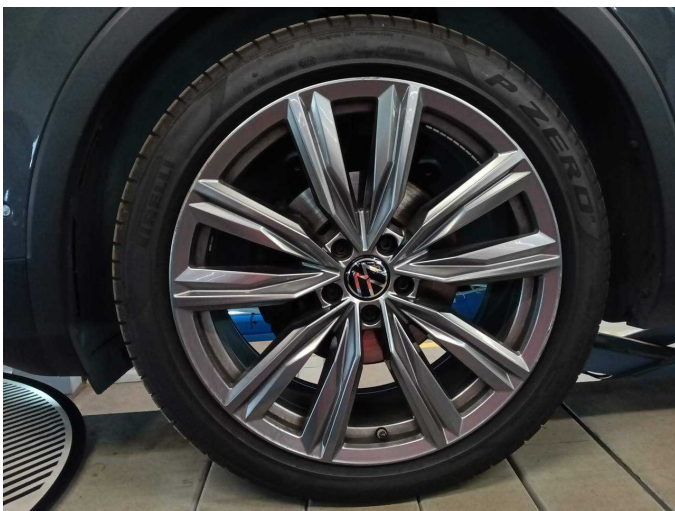
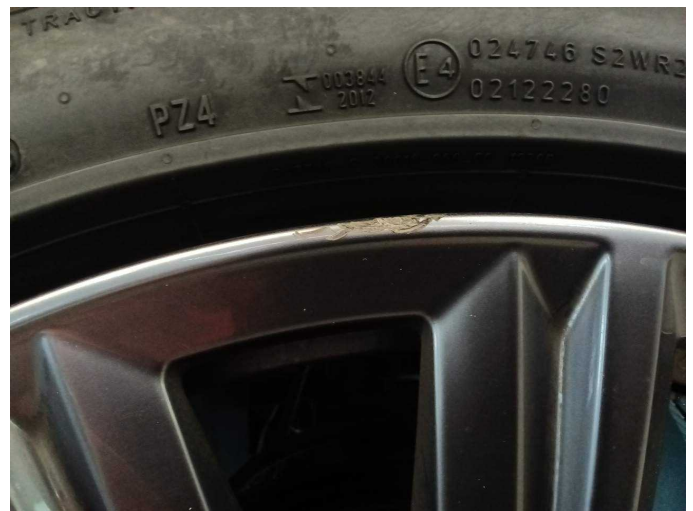
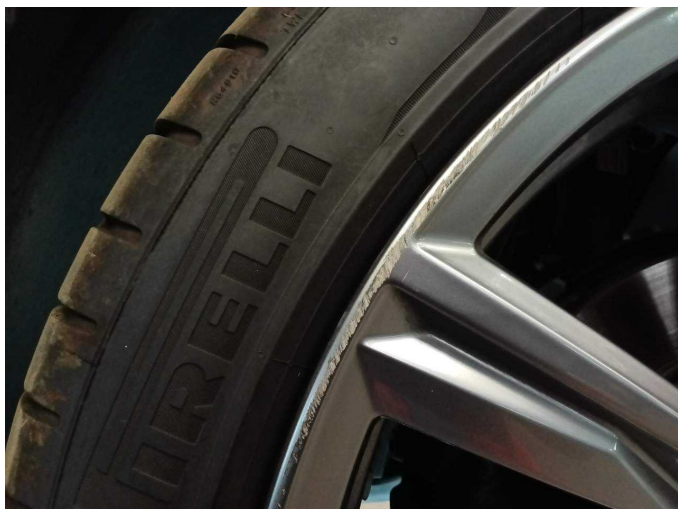
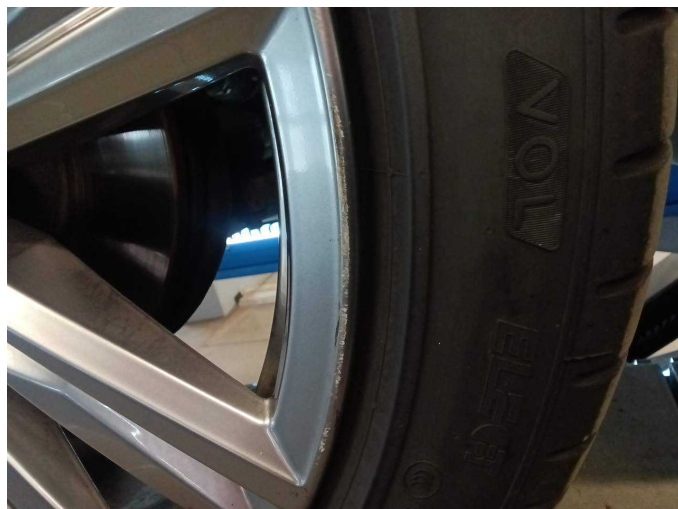
| No. | Component group | Description |
|---|---|---|
| 17 | Wheel / tyres | Alloy rim - front left side - Scratched - Replace |

**Damage 17:** Wheel / tyres: Alloy rim - front left side - Scratched - Replace
