Expertise

Protocol number: 46649321  
Order No. / Reference: 26716056  
Inspection date: 22 Jul 2026

Model: Astra 1.2 Turbo Business Elegance

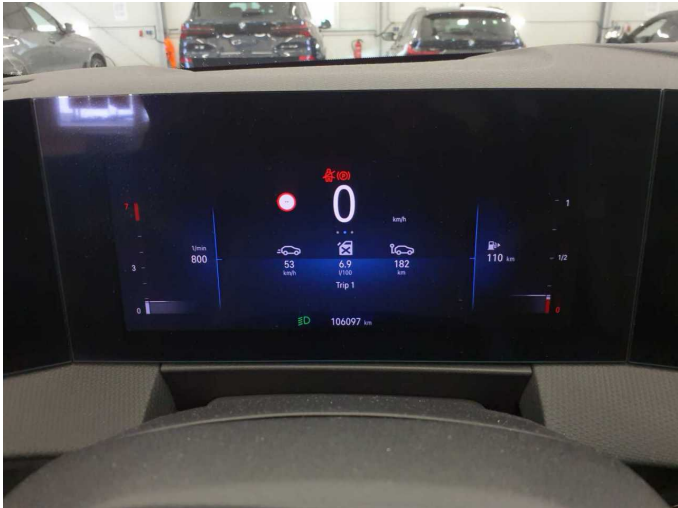
| Mileage (Read) | 106,097 km |

Figure 7: Instrument cluster

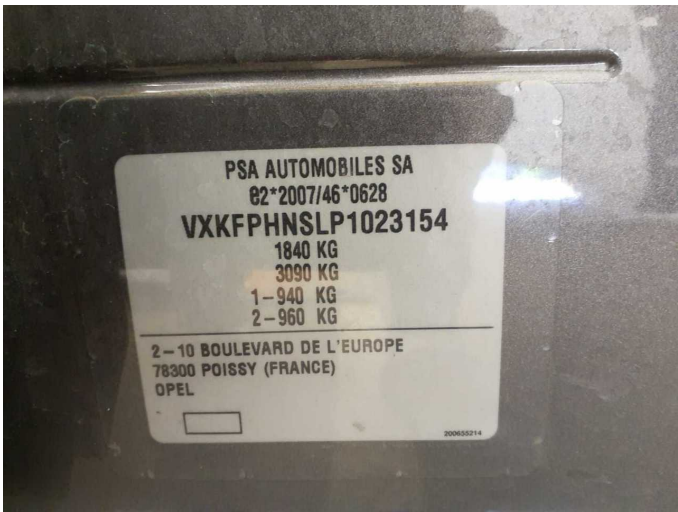
| VIN comparison | The vehicle identification number (VIN) was read from the vehicle and its conformity with the submitted documents was confirmed by the undersigned during the inspection. |

Figure 11: VIN

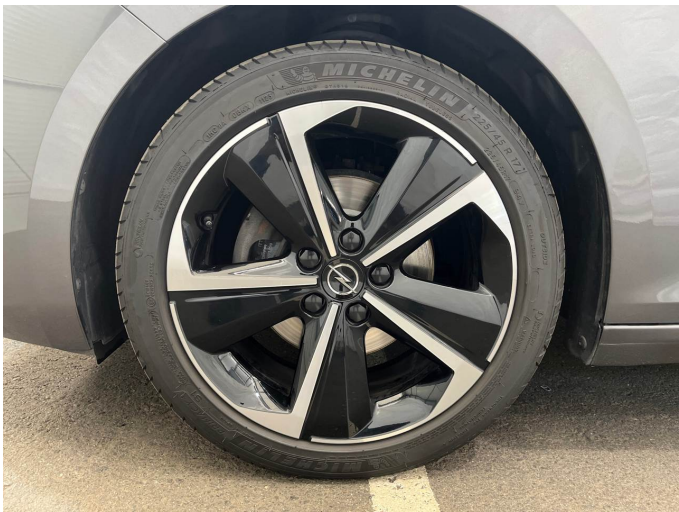
| # | Tyre size | Type of tyre | Manufacturer | Tread depth |
|---|---|---|---|---|
| 1) | 225/45 R17 94V | Summer tyres on Light alloy | Michelin | 4mm / 4mm |
| 2) | 225/45 R17 94V | Summer tyres on Light alloy | Michelin | 4mm / 4mm |

Figure 12: Mounted tyres

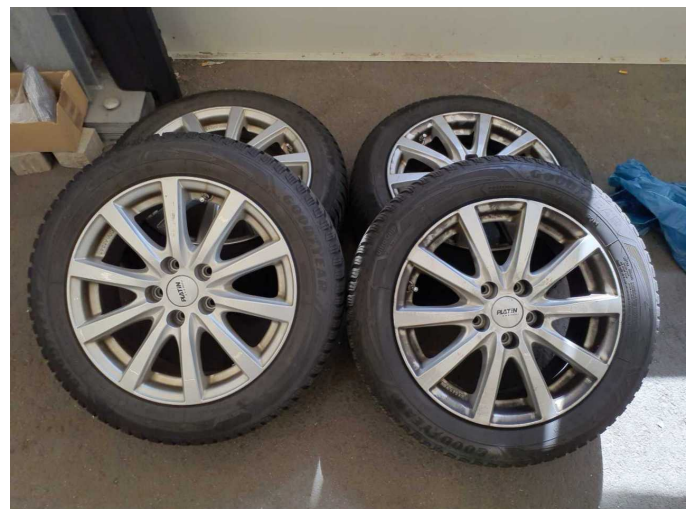
| # | Tyre size | Type of tyre | Manufacturer | Tread depth |
|---|---|---|---|---|
| 1) | 205/55 R16 91H | Winter tyres on Light alloy | Goodyear | 5mm / 5mm |
| 2) | 205/55 R16 91H | Winter tyres on Light alloy | Goodyear | 7mm / 7mm |

Figure 18: Additional tyres

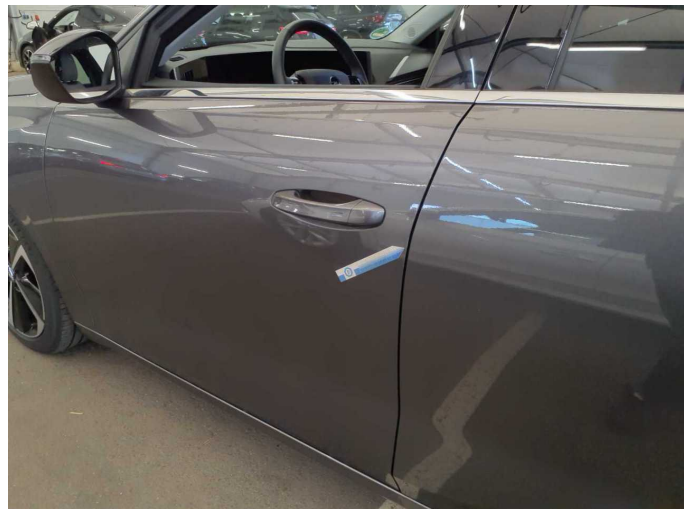
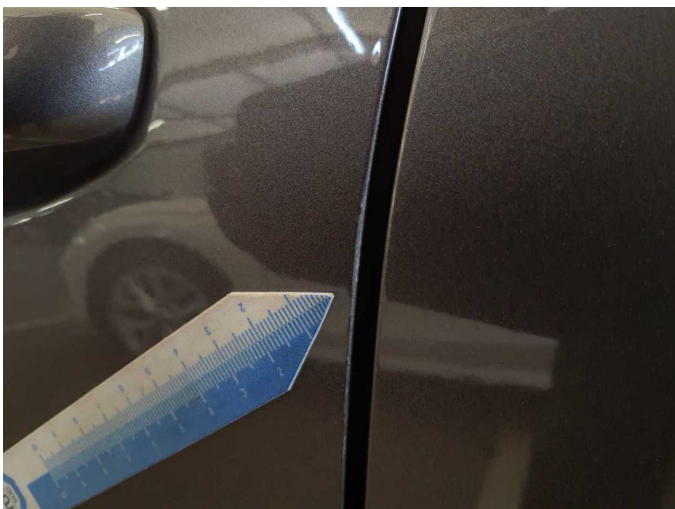
| No. | Component group | Description |
|---|---|---|
| 1 | Door - front left side | Door edge - Scratch(es) - Smart repair |

**Damage 1:** Door - front left side: Door edge - Scratch(es) - Smart repair

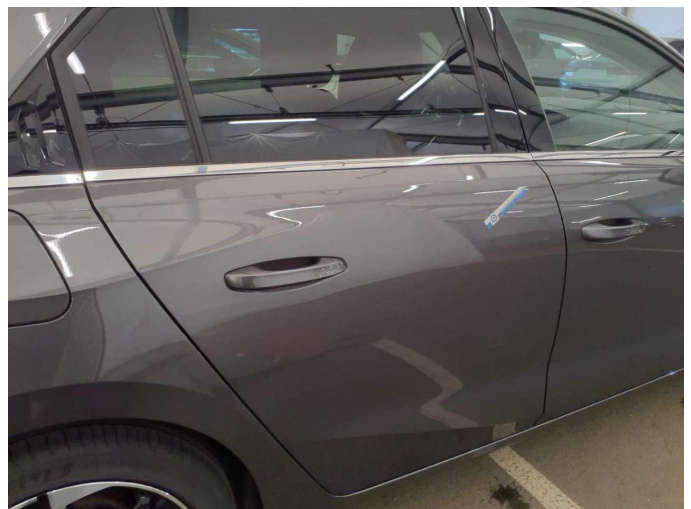
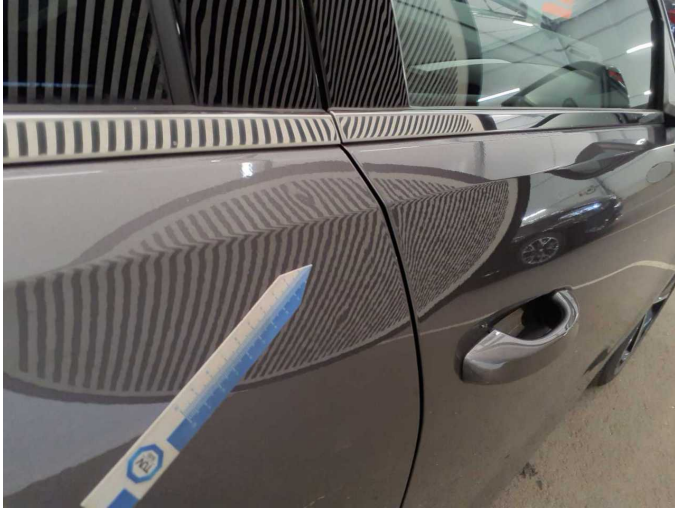
| No. | Component group | Description |
|---|---|---|
| 2 | Door - rear right side | Door - dent(s) - Smart repair |

**Damage 2:** Door - rear right side: Door - dent(s) - Smart repair
