Expertise

Protocol number: 46156914  
Order No. / Reference: 26381379  
Inspection date: 25 Jun 2026

Manufacturer: Volvo

Model: V60 B4 D Geartronic Momentum Pro

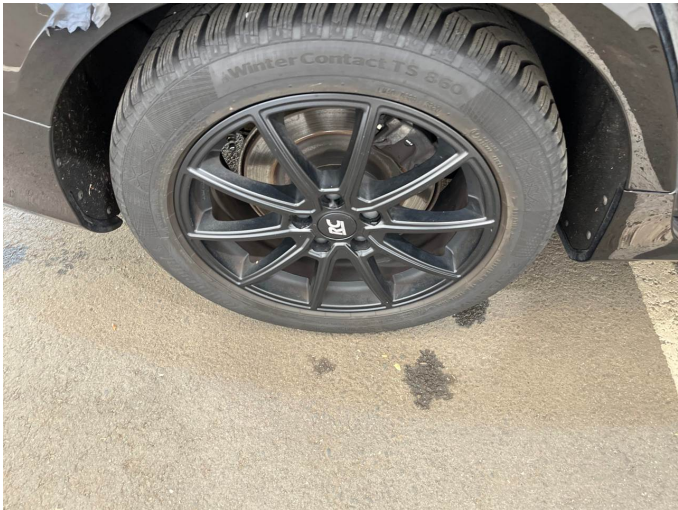
Figure 12: Mounted tyres

| Tyres | | | | |
|---|---|---|---|---|
| 1) | 225/50 R17 98H | Winter tyres on Light alloy | Pirelli | 6mm / 6mm |
| 2) | 225/50 R17 98H | Winter tyres on Light alloy | Continental | 6mm / 6mm |

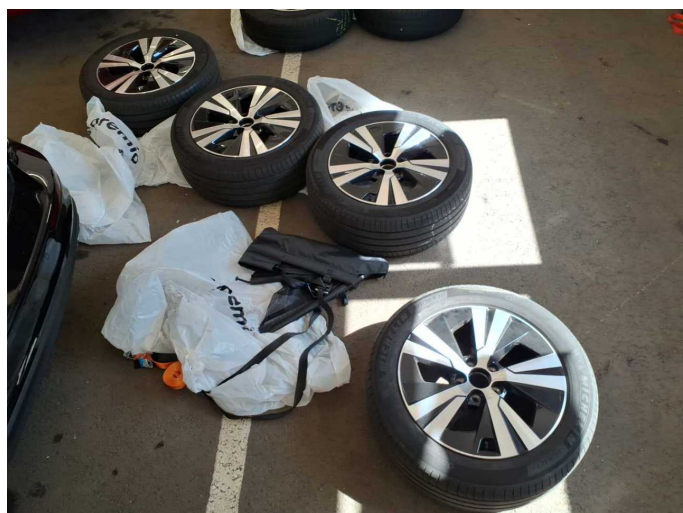
Figure 18: Additional tyres

| Tyres | | | | |
|---|---|---|---|---|
| 1) | 225/50 R17 98V | Summer tyres on Light alloy | Michelin | 4mm / 4mm |
| 2) | 225/50 R17 98V | Summer tyres on Light alloy | Michelin | 5mm / 5mm |

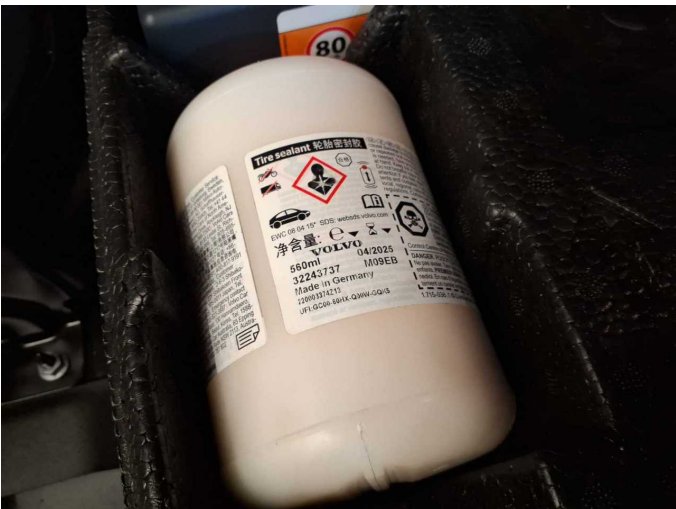
| No. | Component group | Description |
|---|---|---|
| 2 | Equipment | Tirefit filler - Expired - Replace |

Damage 2: Equipment: Tirefit filler - Expired - Replace

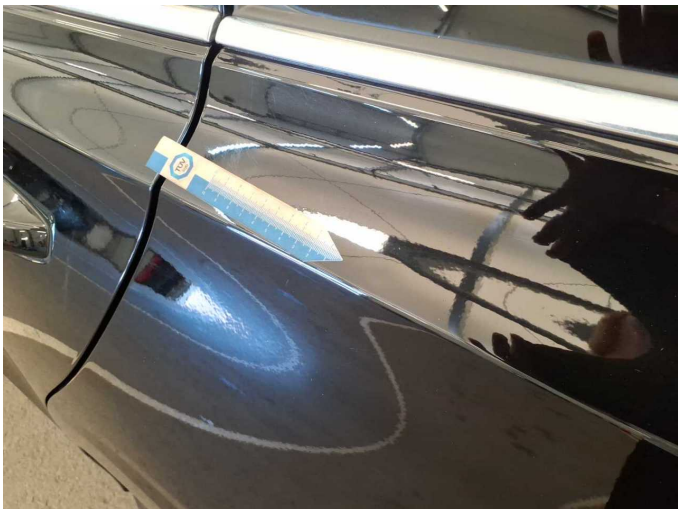
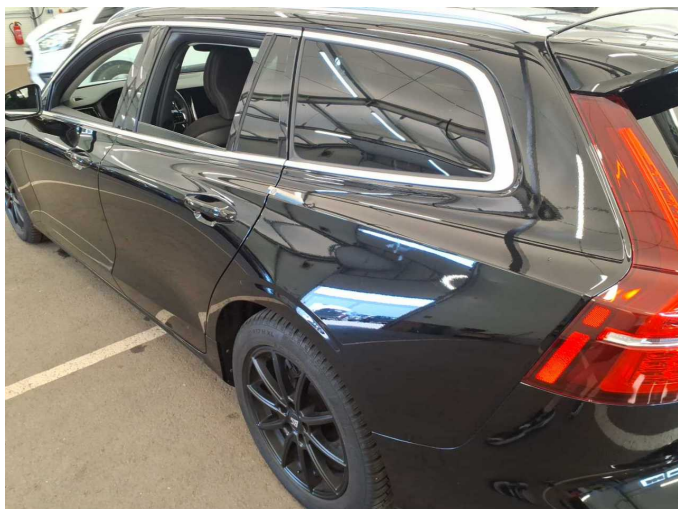
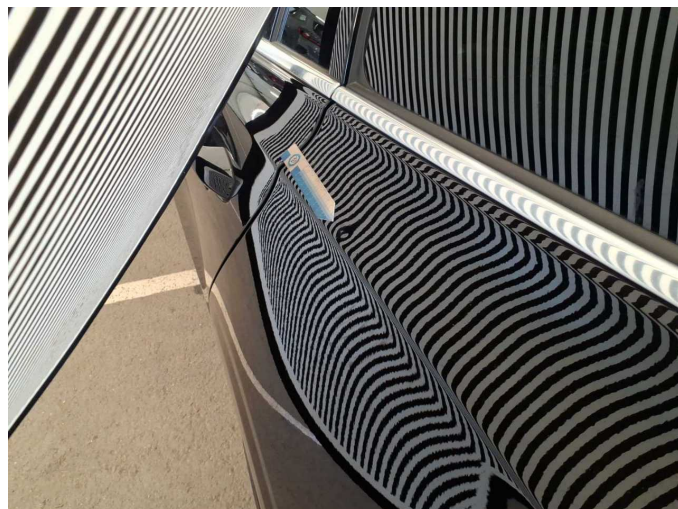
| No. | Component group | Description |
|---|---|---|
| 3 | Side panel - rear left side | Side panel - dent(s) - Smooth repair work |

Damage 3: Side panel - rear left side: Side panel - dent(s) - Smooth repair work

**Damage 3:** Side panel - rear left side: Side panel - dent(s) - Smooth repair work

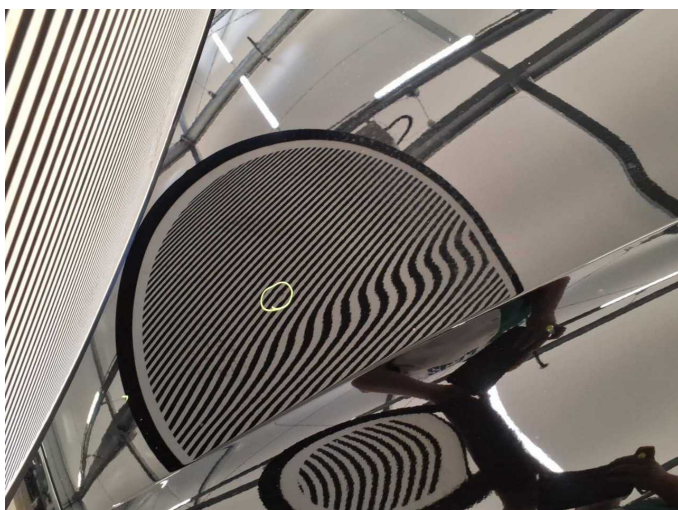
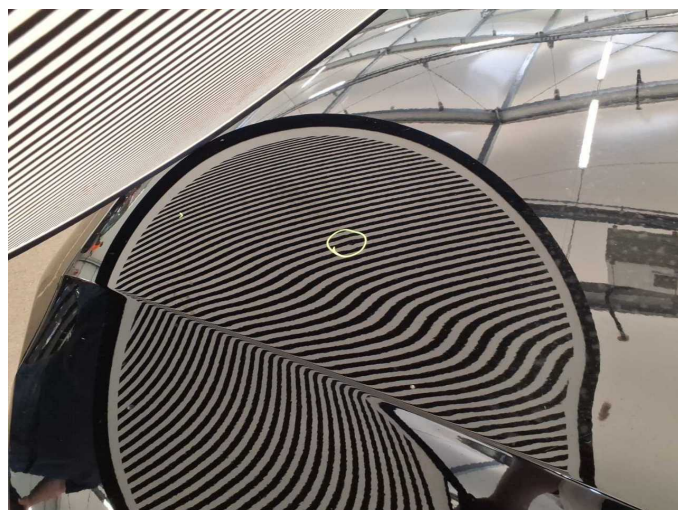
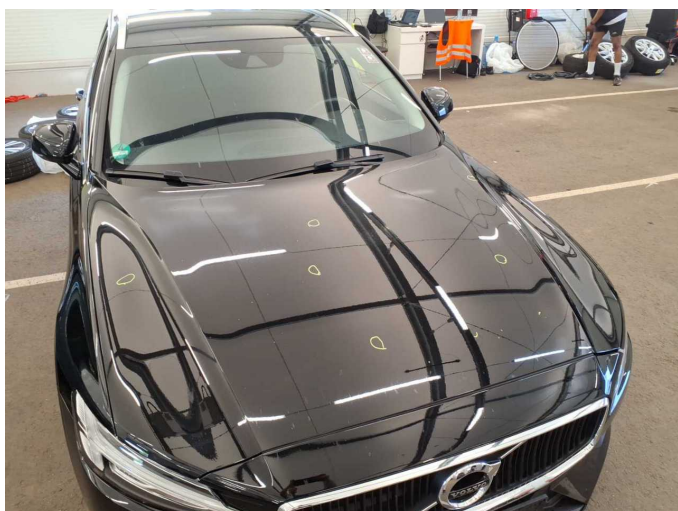
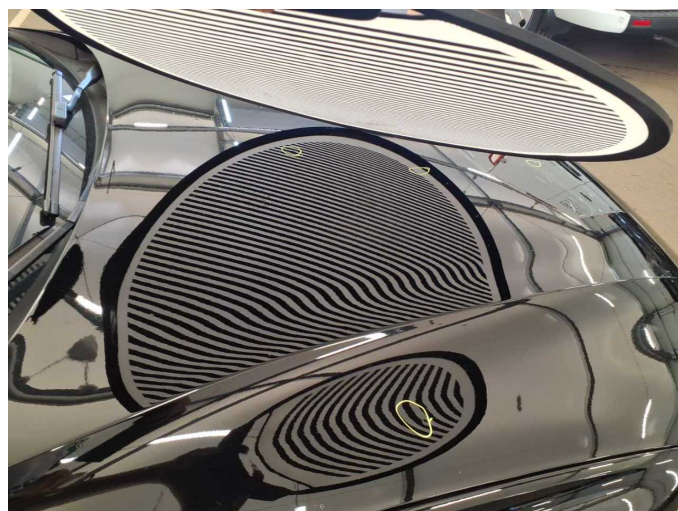
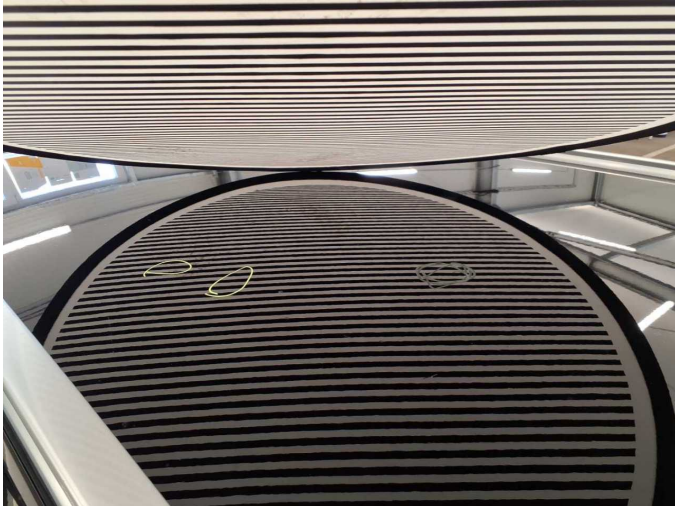
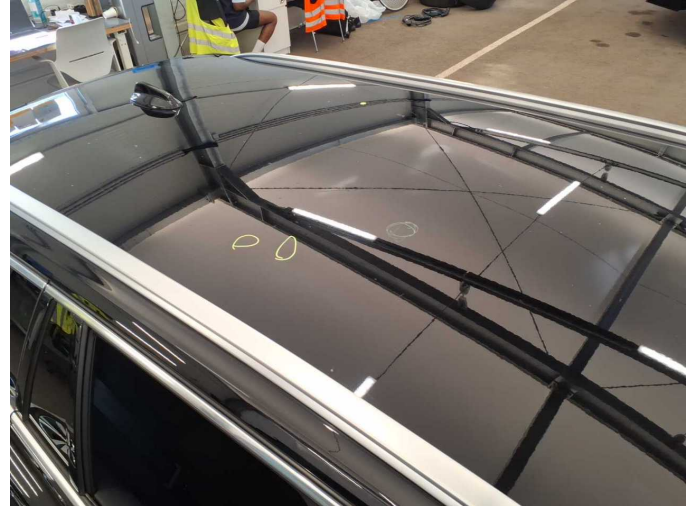
| No. | Component group | Description |
|---|---|---|
| 4 | Body | Body - Damage by hail - Smooth repair work |

**Damage 4:** Body: Body - Damage by hail - Smooth repair work

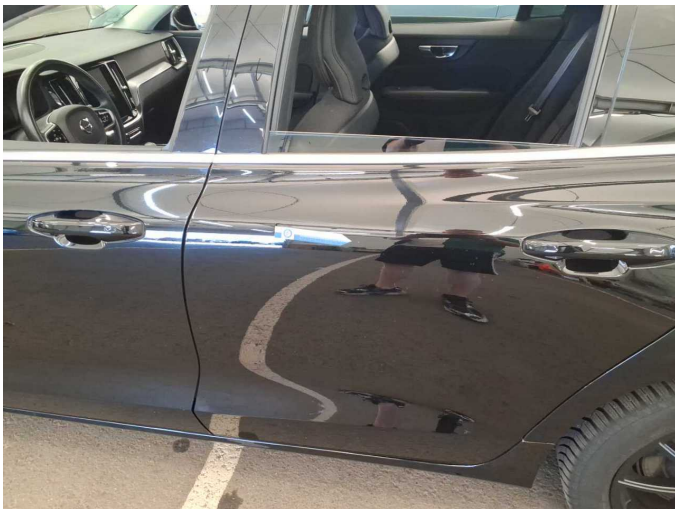
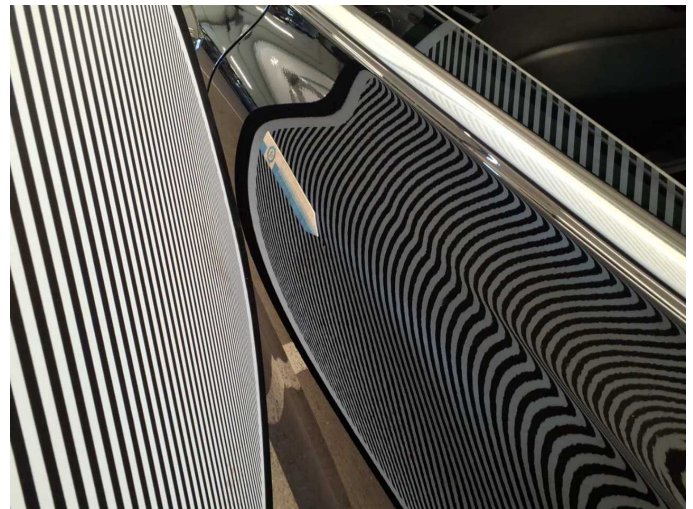
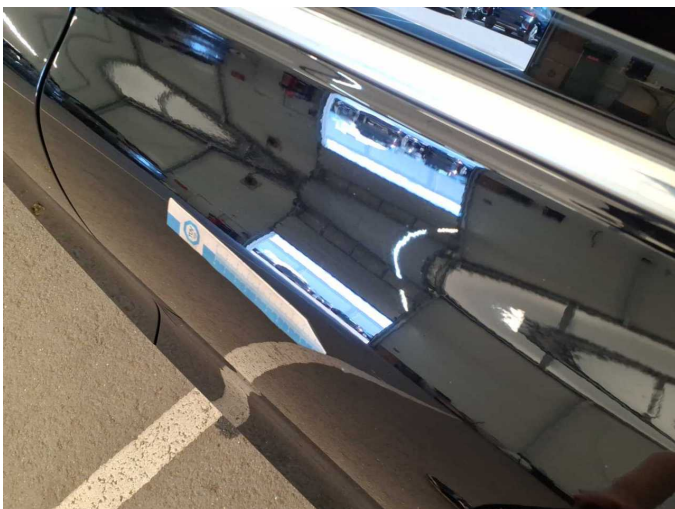
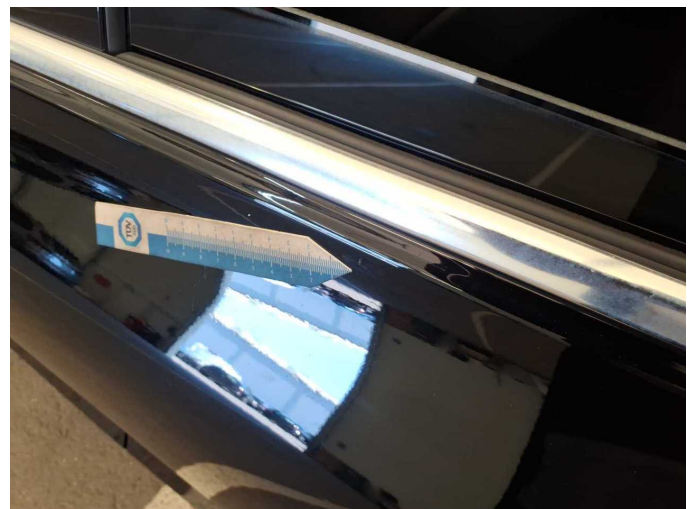
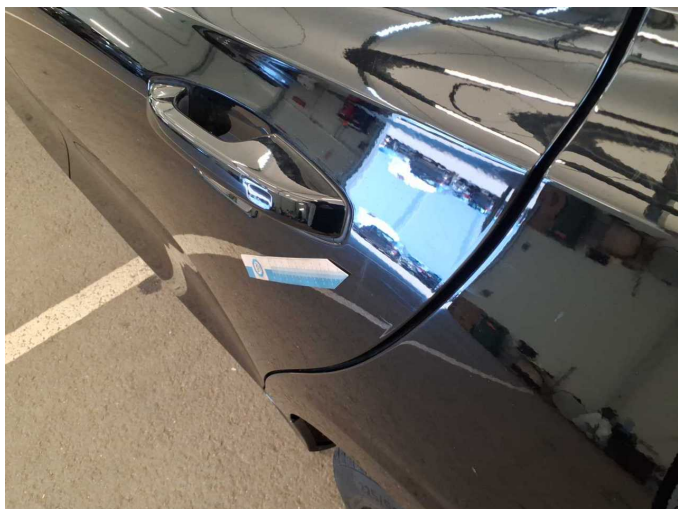
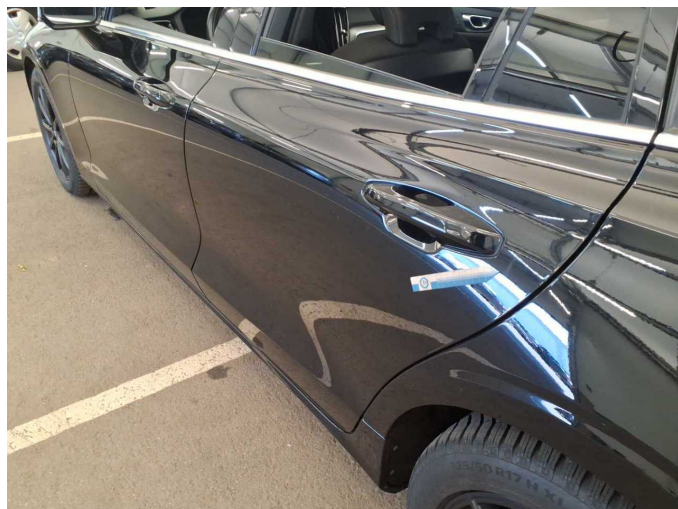
| No. | Component group | Description |
|---|---|---|
| 5 | Door - rear left side | Door - Dent / paintcoat damage - Repair and paint |

**Damage 5:** Door - rear left side: Door - Dent / paintcoat damage - Repair and paint

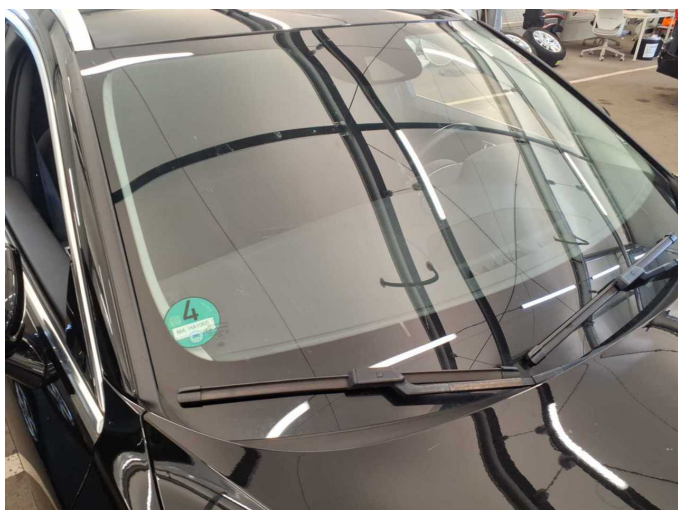
| No. | Component group | Description |
|---|---|---|
| 1 | Vehicle glazing | Windscreen - Stone chips - No deduction |

**Wear and tear 1:** Vehicle glazing: Windscreen - Stone chips - No deduction

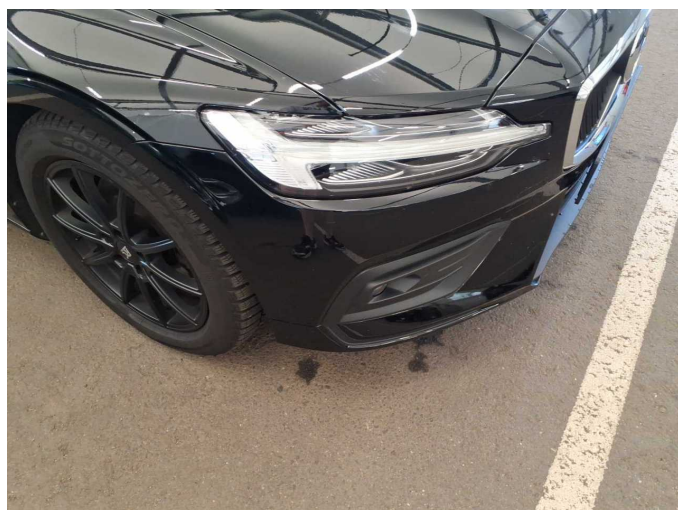
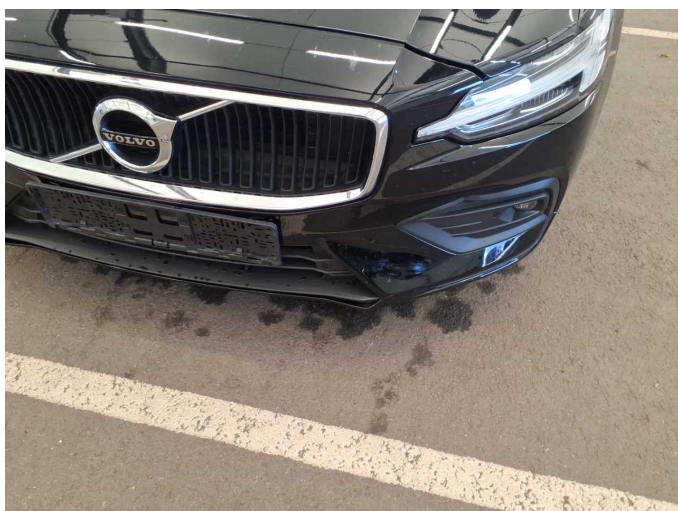
| No. | Component group | Description |
|---|---|---|
| 2 | Front bumper | Front bumper - Stone chips - No deduction |

**Wear and tear 2:** Front bumper: Front bumper - Stone chips - No deduction

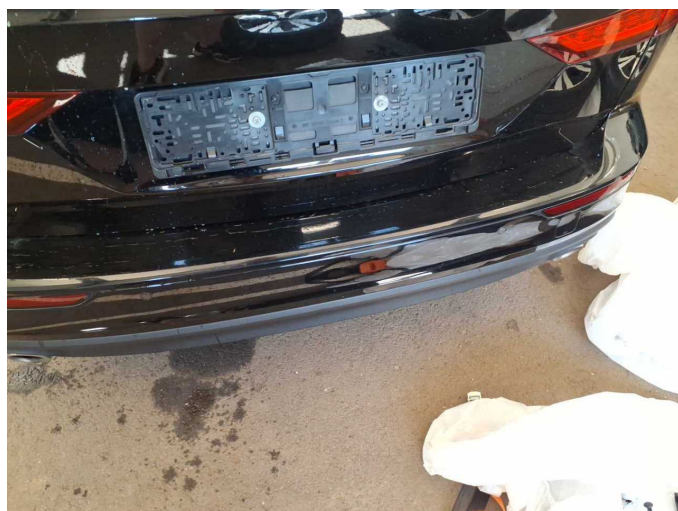
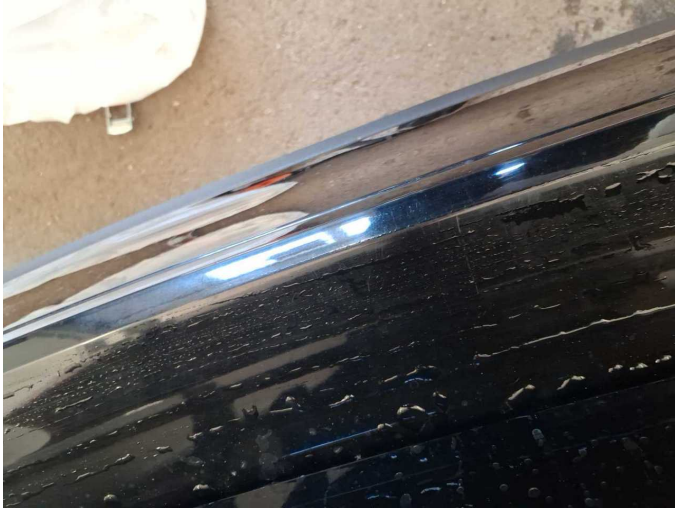
| No. | Component group | Description |
|---|---|---|
| 5 | Rear bumper | Rear bumper - Scratch(es) - No deduction |

**Wear and tear 5:** Rear bumper: Rear bumper - Scratch(es) - No deduction
