Expertise

Protocol number: 46334157  
Order No. / Reference: 26581895  
Inspection date: 6 Jul 2026

| Manufacturer: Ford | Model: Focus Turnier 1.0 EcoBoost Hybrid Aut. ACTIVE |

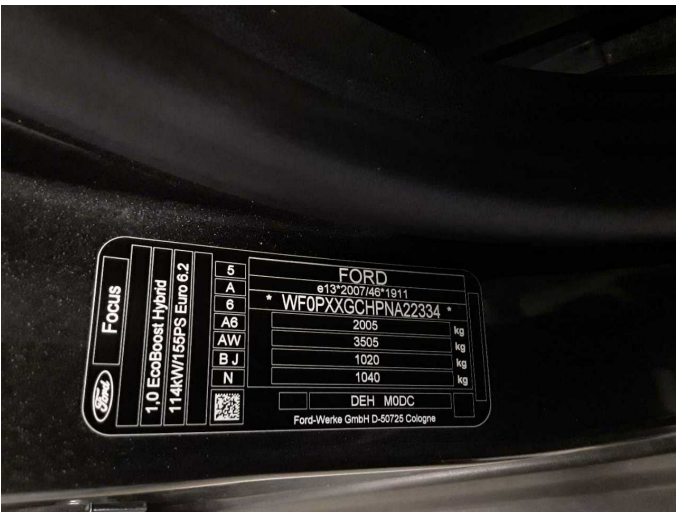
Figure 11: VIN

| VIN comparison | The vehicle identification number (VIN) was read from the vehicle and its conformity with the submitted documents was confirmed by the undersigned during the inspection. |

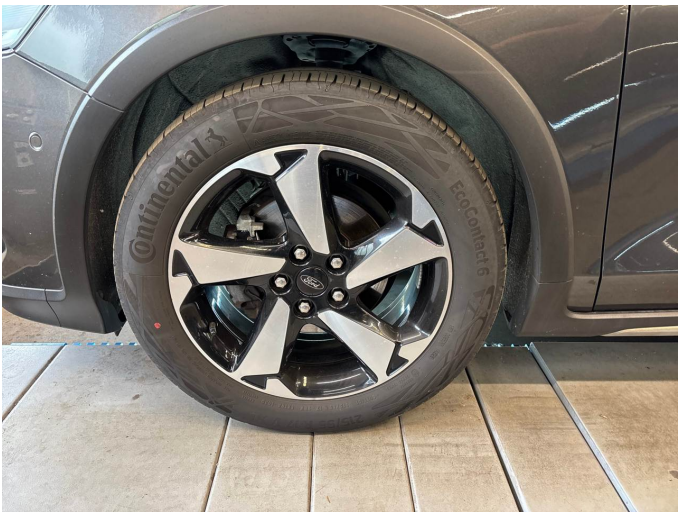
Figure 12: Mounted tyres

| Tyres | | | | |
|---|---|---|---|---|
| 1) | 215/55 R17 98V | Summer tyres on Light alloy | Continental | 4mm / 4mm |
| 2) | 215/55 R17 98V | Summer tyres on Light alloy | Continental | 4mm / 4mm |

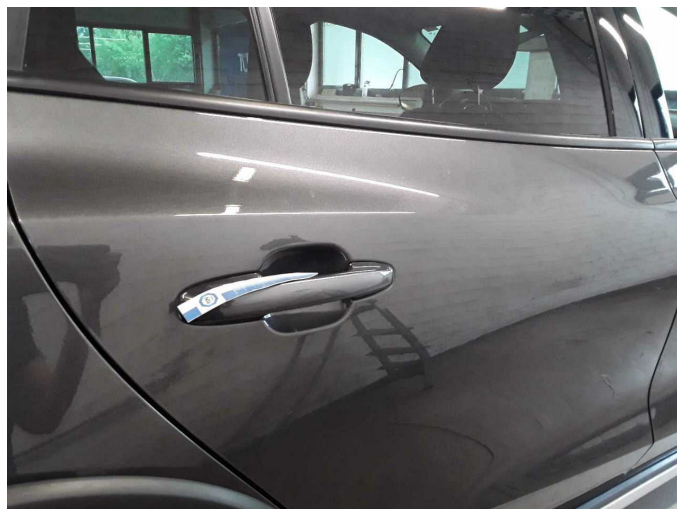
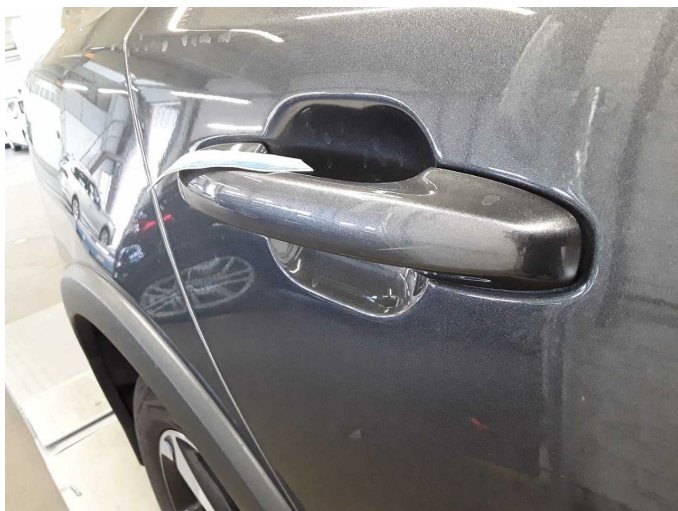
| No. | Component group | Description |
|---|---|---|
| 1 | Door - rear right side | Door handle - outside - Scratch(es) - Smart repair |

**Damage 1:** Door - rear right side: Door handle - outside - Scratch(es) - Smart repair

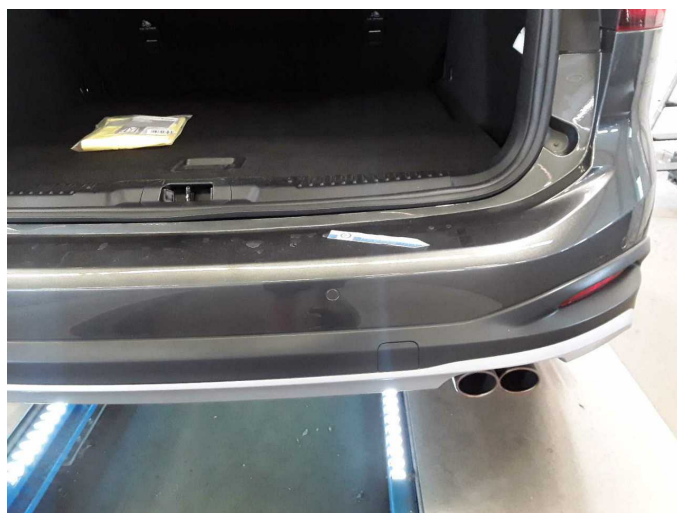
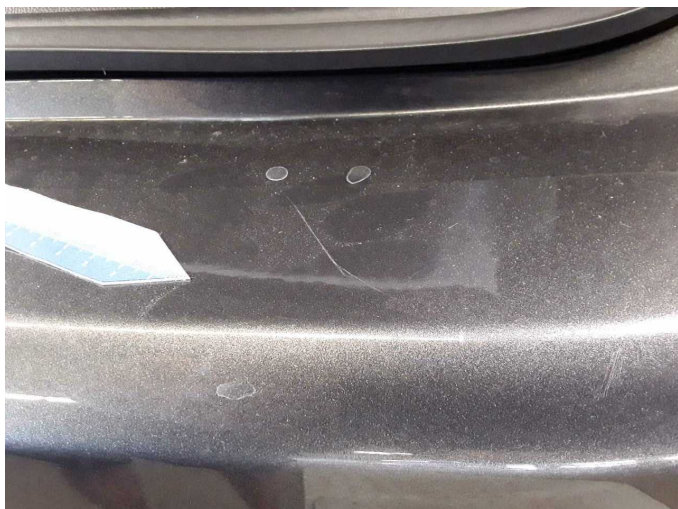
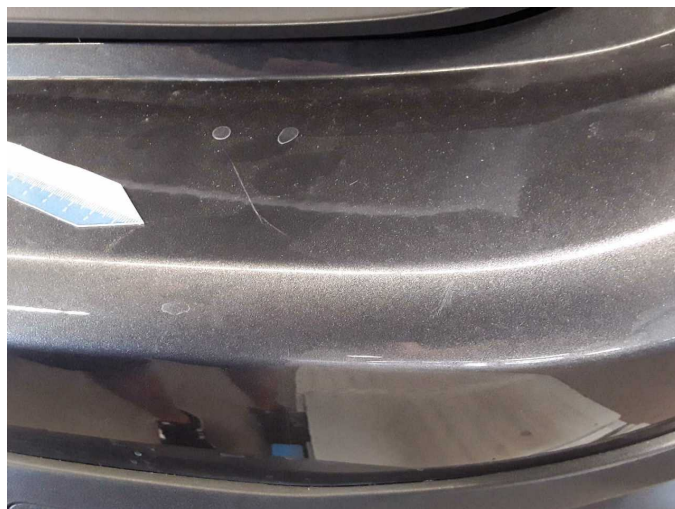
| No. | Component group | Description |
|---|---|---|
| 3 | Rear bumper | Rear bumper - Scratch(es) - Smart repair |

**Damage 3:** Rear bumper: Rear bumper - Scratch(es) - Smart repair

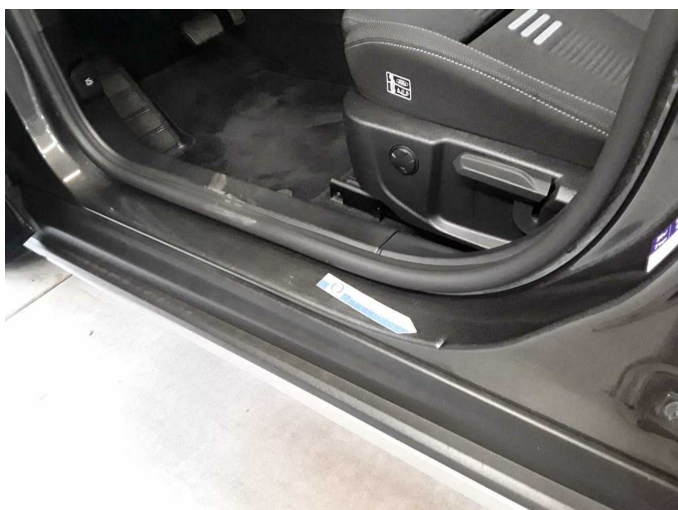
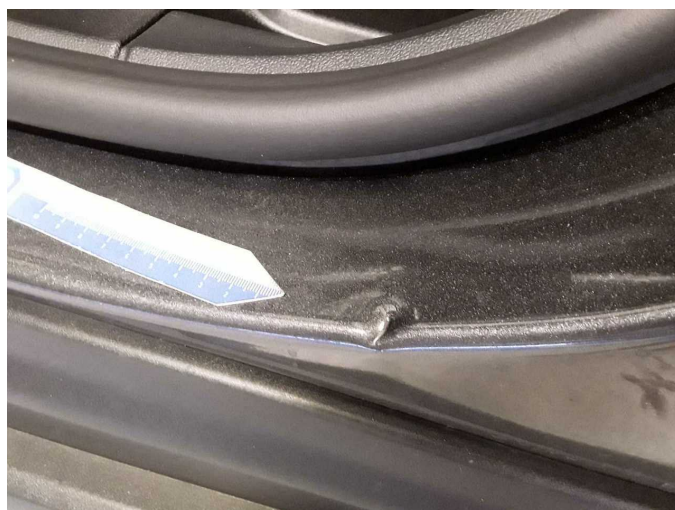
| No. | Component group | Description |
|---|---|---|
| 4 | Sill - left side | Sill - Deformed - Smart repair |

**Damage 4:** Sill - left side: Sill - Deformed - Smart repair

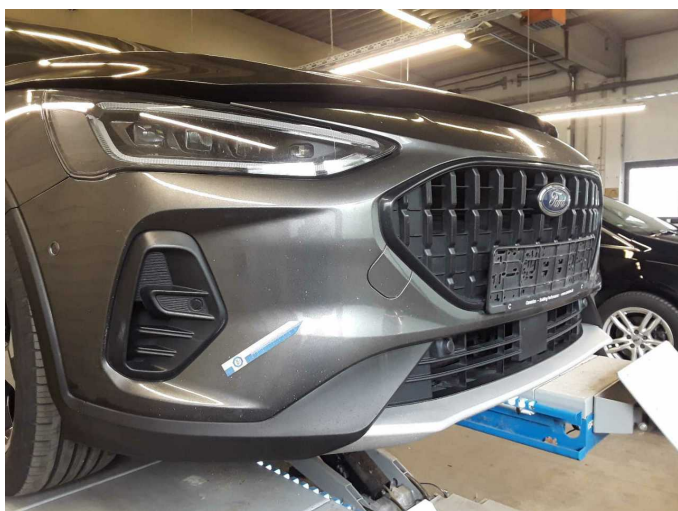
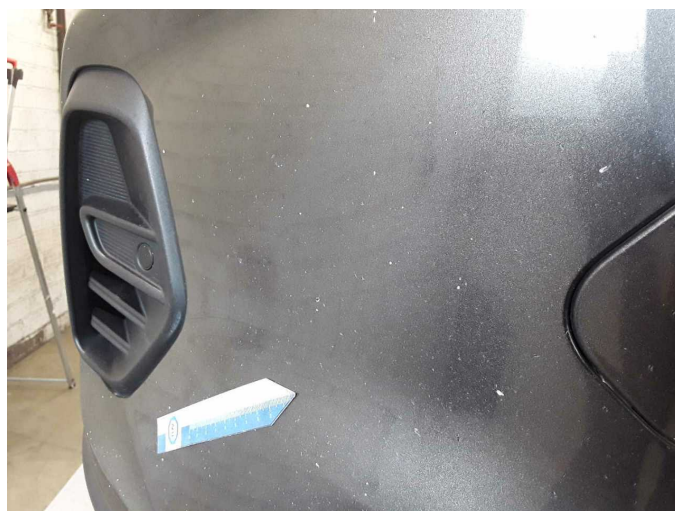
| No. | Component group | Description |
|---|---|---|
| 5 | Front bumper | Front bumper (Sandstrahleffekt) - Stone chips - Paint |

**Damage 5:** Front bumper: Front bumper (Sandstrahleffekt) - Stone chips - Paint

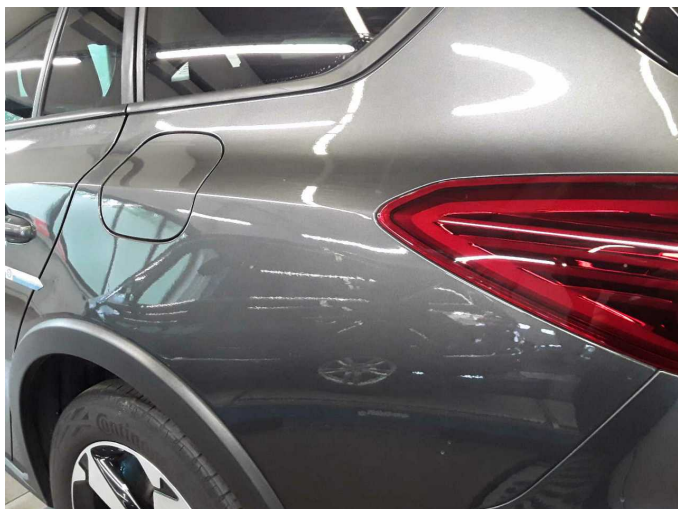
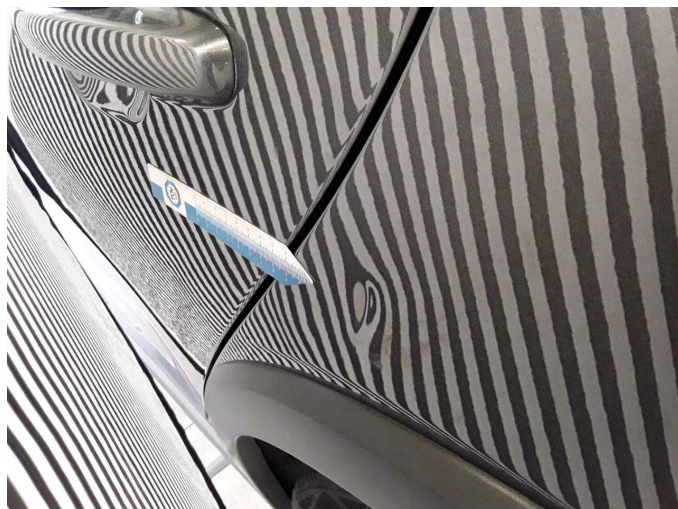
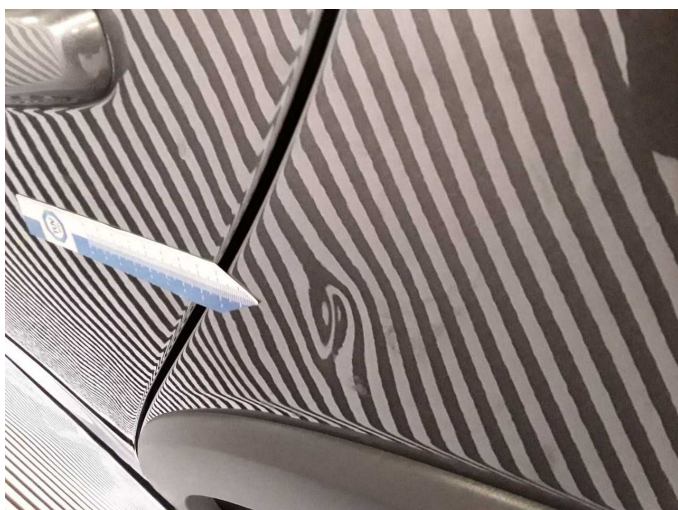
| No. | Component group | Description |
|---|---|---|
| 6 | Side panel - rear left side | Side panel - Deformed - Repair and paint |

**Damage 6:** Side panel - rear left side: Side panel - Deformed - Repair and paint

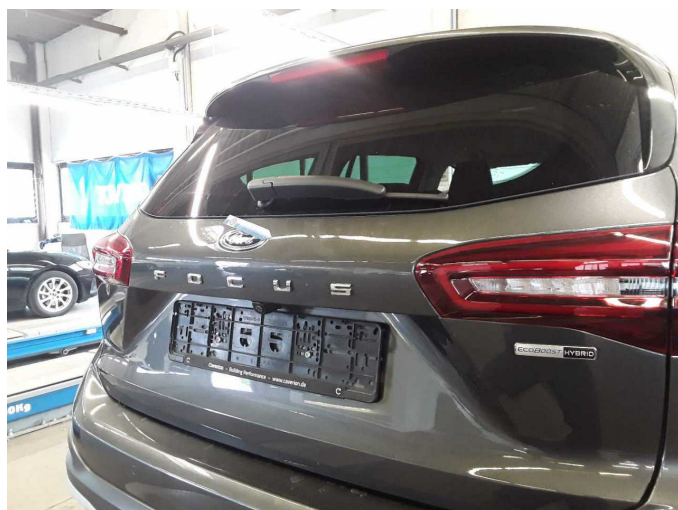
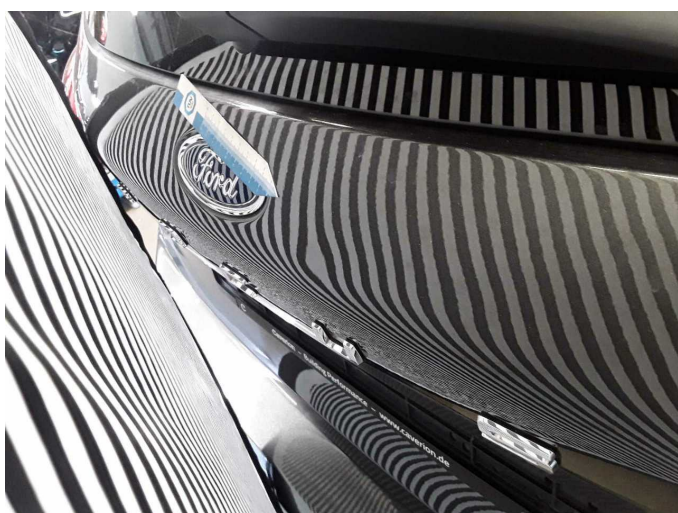
| No. | Component group | Description |
|---|---|---|
| 7 | Boot lid / rear door | Boot lid - Deformed - Repair and paint |

**Damage 7:** Boot lid / rear door: Boot lid - Deformed - Repair and paint
