Expertise

Protocol number: 46665983  
Order No. / Reference: 26687525  
Inspection date: 23 Jul 2026

Model: C 220 d T 9G-TRONIC Avantgarde

VIN: W1KAH0EB6PF104786

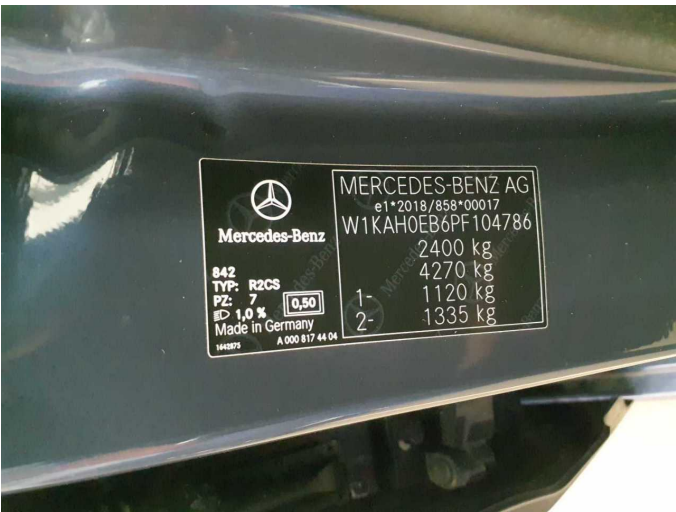
Figure 11: VIN

| VIN comparison | The vehicle identification number (VIN) was read from the vehicle and its conformity with the submitted documents was confirmed by the undersigned during the inspection. |

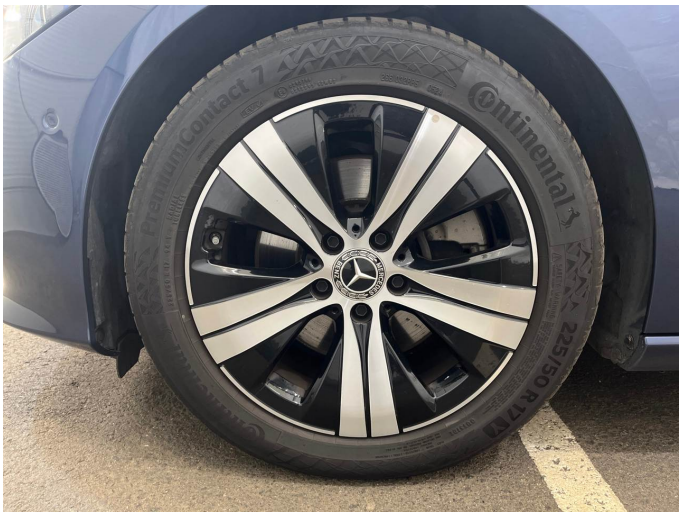
Figure 12: Mounted tyres

| # | Tyre size | Type of tyre | Manufacturer | Tread depth |
|---|---|---|---|---|
| 1) | 225/50 R17 94Y | Summer tyres on Light alloy | Continental | 5mm / 5mm |
| 2) | 225/50 R17 94Y | Summer tyres on Light alloy | Continental | 6mm / 6mm |

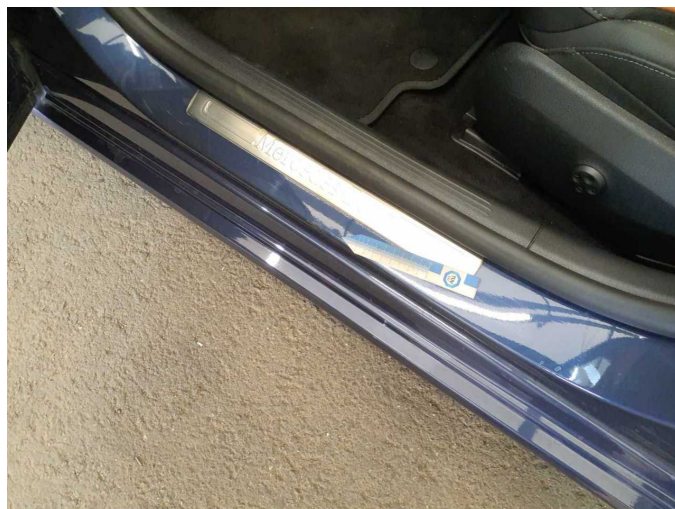
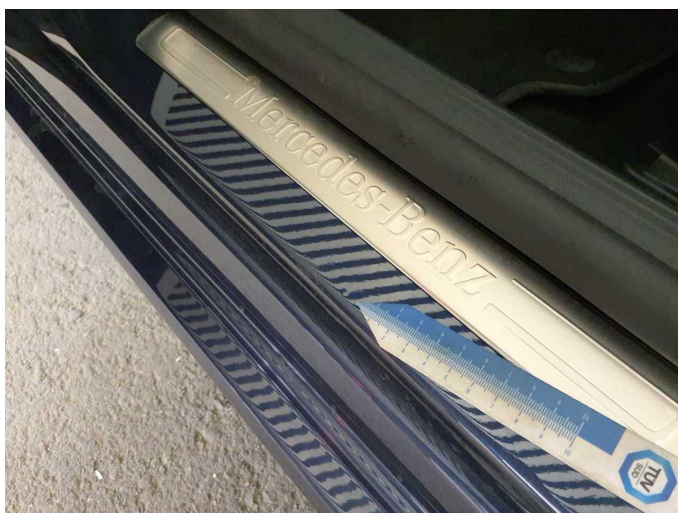
| No. | Component group | Description |
|---|---|---|
| 1 | Sill - left side | Sill - dent(s) - Smart repair |

**Damage 1:** Sill - left side: Sill - dent(s) - Smart repair

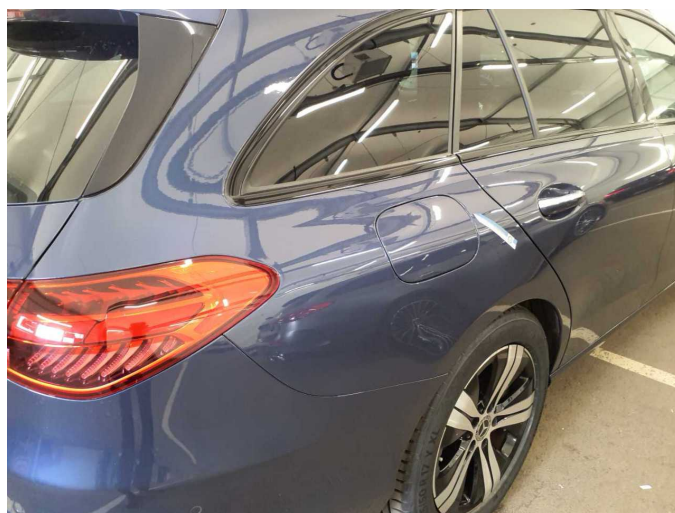
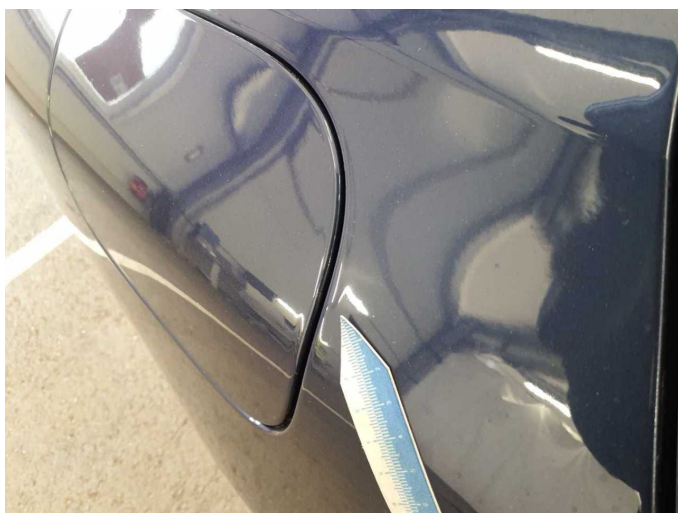
| No. | Component group | Description |
|---|---|---|
| 2 | Side panel - rear right side | Side panel (Lackläufer) - Paint defect - Paint |

**Damage 2:** Side panel - rear right side: Side panel (Lackläufer) - Paint defect - Paint

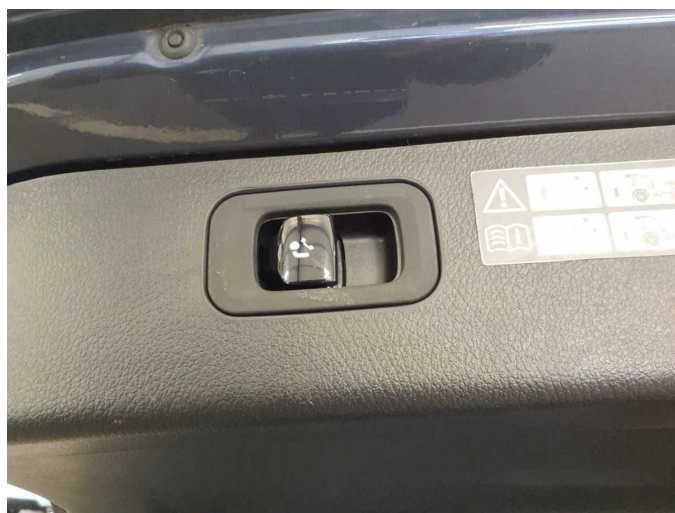
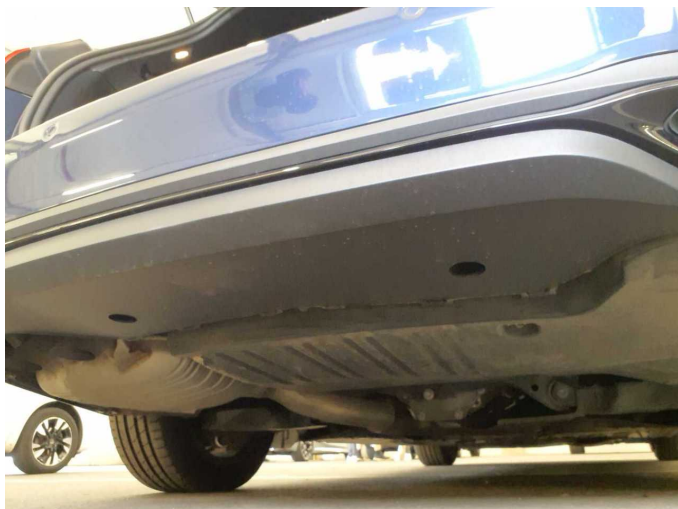
| No. | Component group | Description |
|---|---|---|
| 3 | Rear of vehicle | Trailer hitch (mit ESP (550)) - Missing - Replace |

**Damage 3:** Rear of vehicle: Trailer hitch (mit ESP (550)) - Missing - Replace

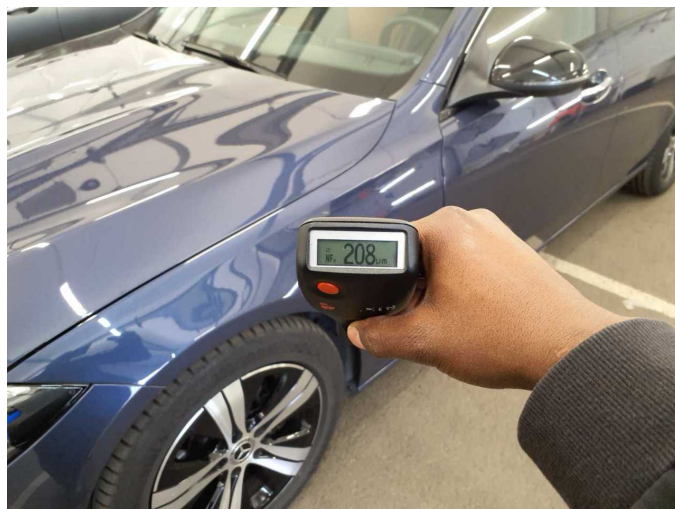
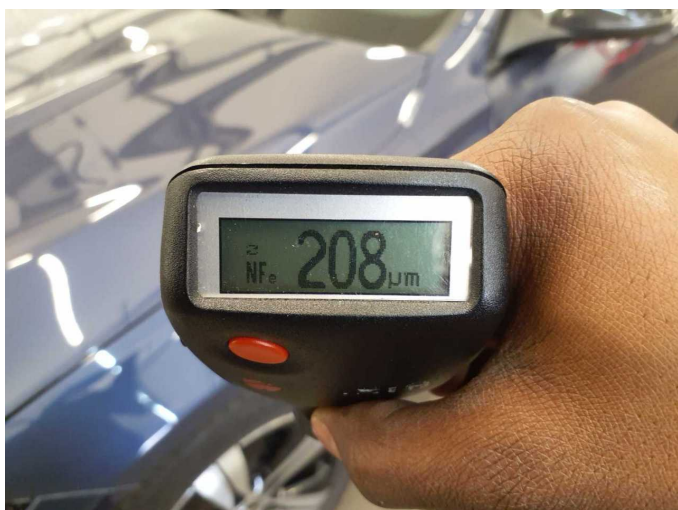
| No. | Repainting |
|---|---|
| 1 | Mudguard - left side, Professionally carried out, Invoice of repair done Non-existent |

| Mudguard - left side | 208 µm | Side panel - rear right side | 232 µm |

**Repainting 1:** Mudguard - left side

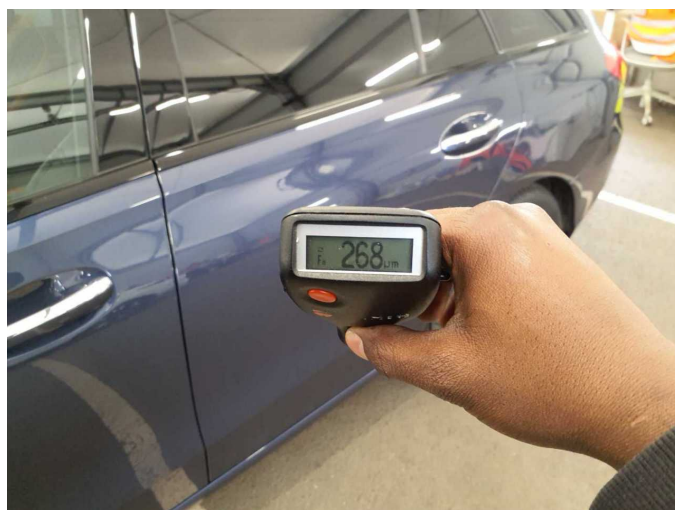
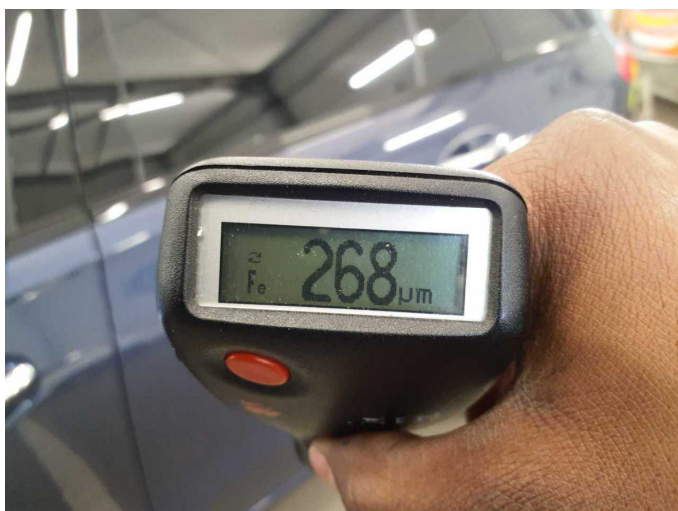
| No. | Repainting |
|---|---|
| 2 | Door - rear left side, Professionally carried out, Invoice of repair done Non-existent |

| Door - rear left side | 268 µm | Door - rear right side | 255 µm |

**Repainting 2:** Door - rear left side

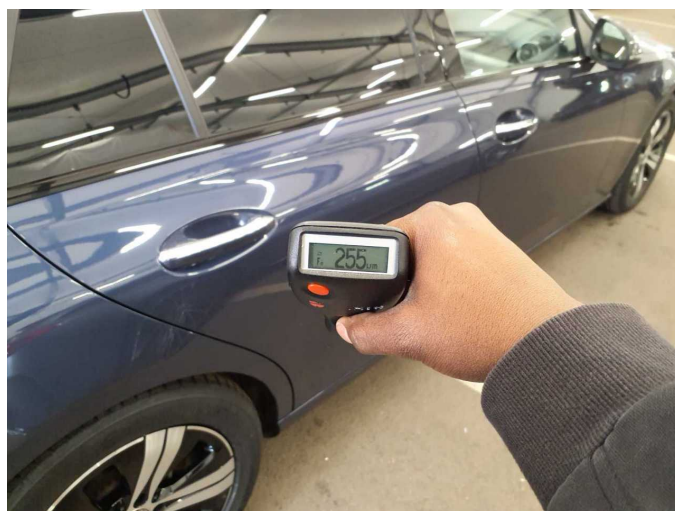
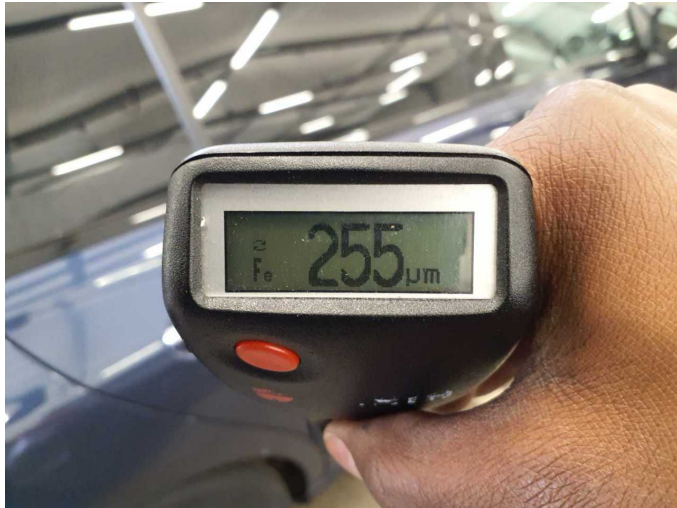
| No. | Repainting |
|---|---|
| 3 | Door - rear right side, Professionally carried out, Invoice of repair done Non-existent |

**Repainting 3:** Door - rear right side

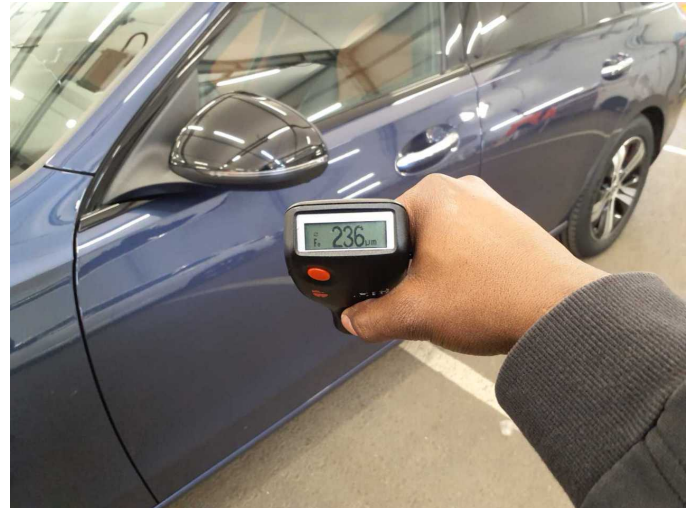
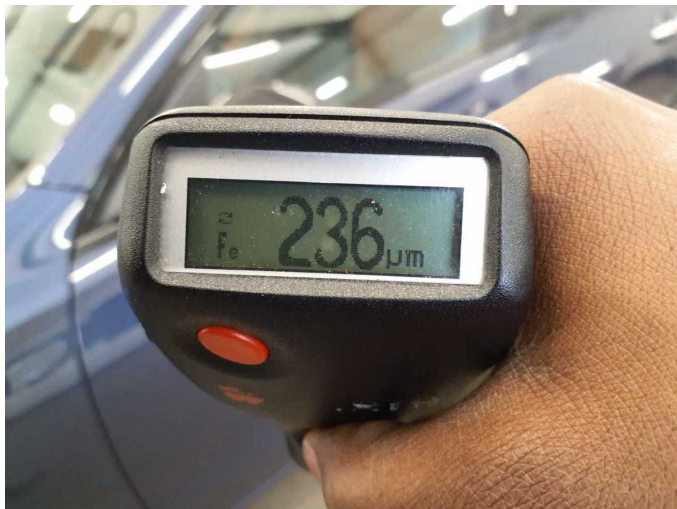
| No. | Repainting |
|---|---|
| 4 | Door - front left side, Professionally carried out, Invoice of repair done Non-existent |

| Door - front left side | 236 µm | | |

**Repainting 4:** Door - front left side

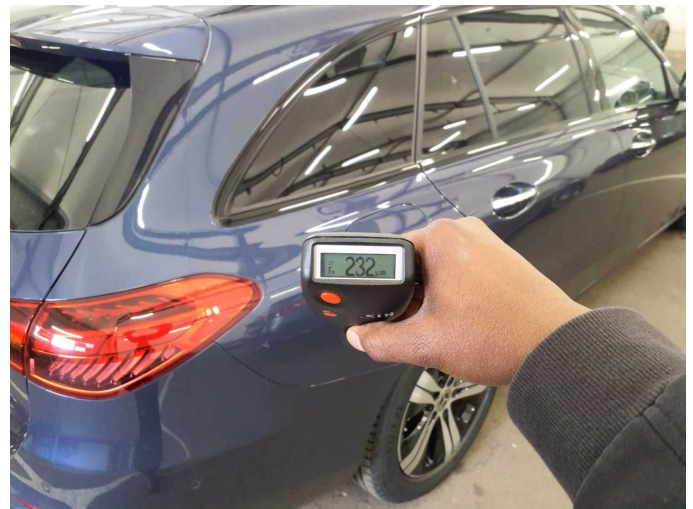
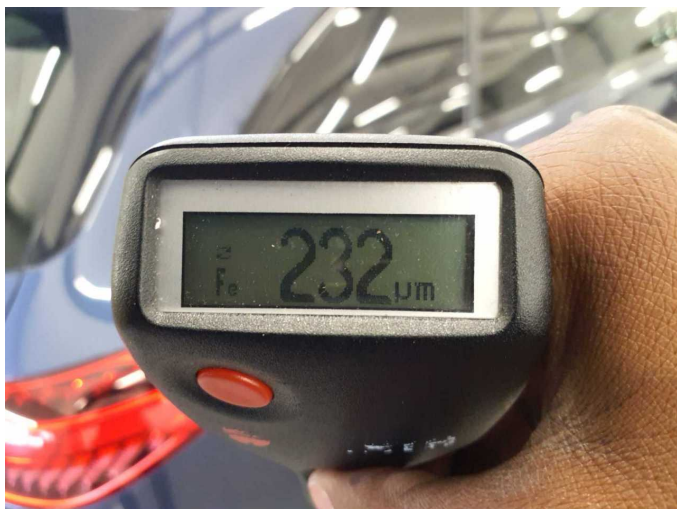
| No. | Repainting |
|---|---|
| 5 | Side panel - rear right side, Unprofessionally carried out, Invoice of repair done Non-existent |

**Repainting 5:** Side panel - rear right side
